June 13th, 2024

Re: Roof Consulting
Mountain View Villas
78000 Betty Barker Way
Indian Wells, CA 92210

Alliance Consulting & Testing Inc. has completed our initial roof surveys and we have the following report of our findings and opinions regarding the roofing systems on this property. We understand the purpose of the surveys was to determine the overall condition of the roofing systems including past repairs, what repairs still need to be made, the remaining service life of the systems and/or does the roofing systems need to be replaced.

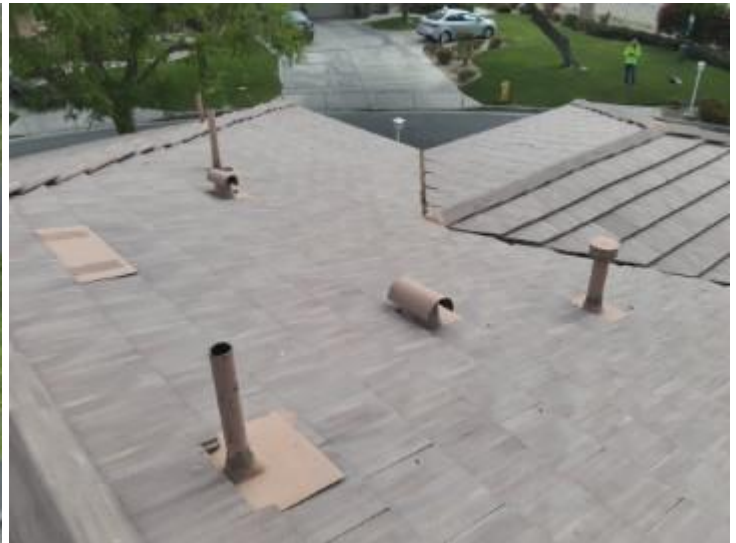
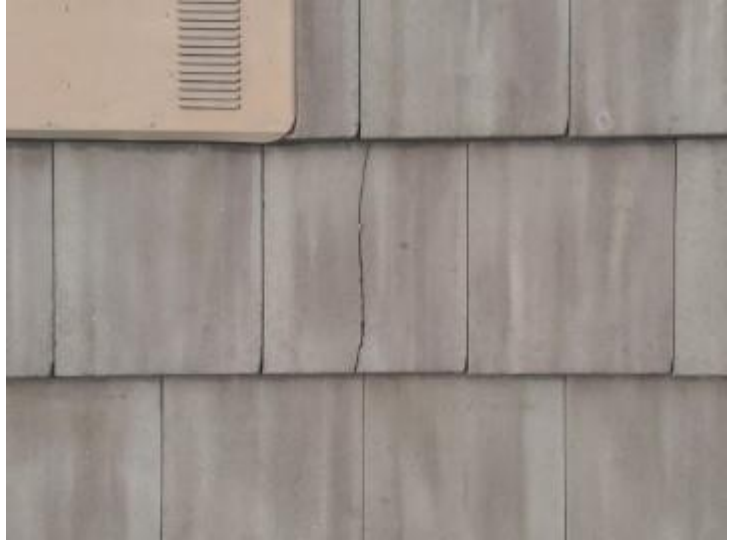
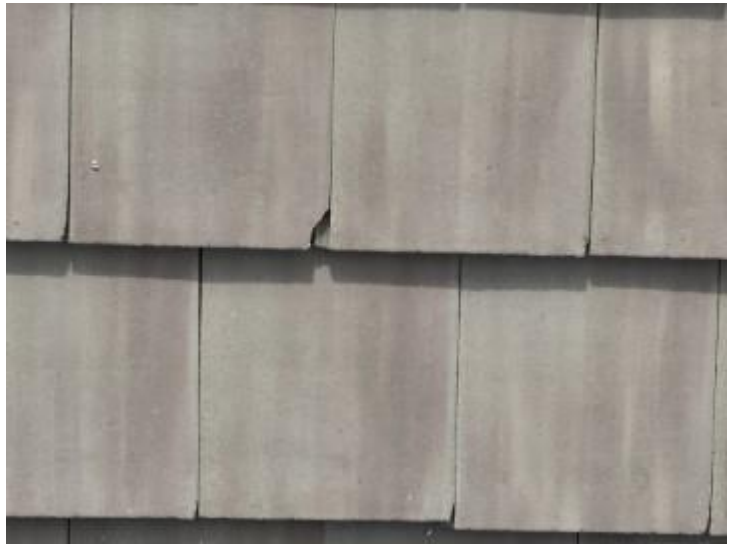
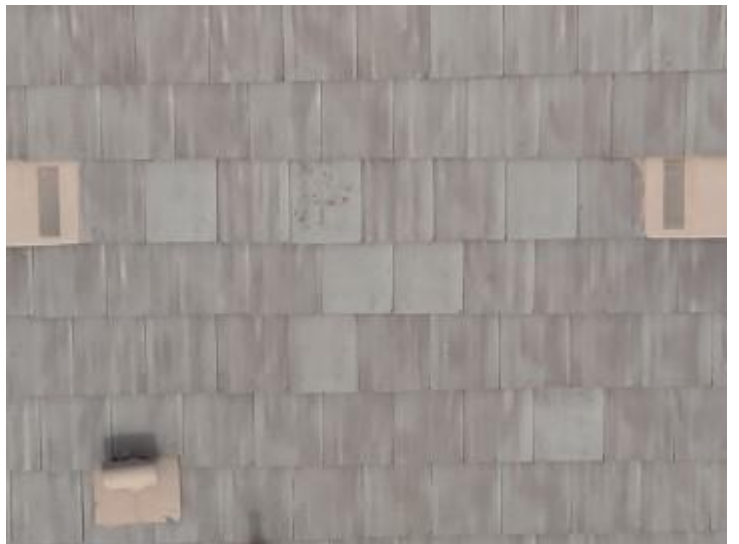
Building 1 -

ITEM	Good	Fair	Poor	N/A	COMMENTS
A - Perimeter details	X				
B - Drainage		X			Some debris noted in the valleys.
C - Penetration flashings		X			
D - Overall Tile condition		X			Some isolated cracked tiles noted. Some isolated chipped tiles noted.
E - Wall/Curb flashings				X	
F - Insulation				X	
G - Other				X

- Building 1 – Replace cracked tile where needed.
- Building 2 – Replace cracked tile where needed.
- Building 4 – Remove unused tiles from rooftop.
- Building 6 – Replace cracked/broken tile where needed.

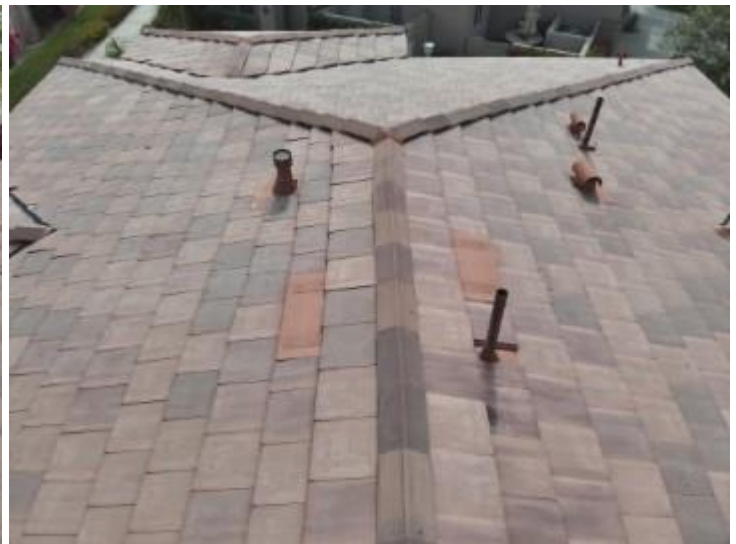
Building 3 -

ITEM	Good	Fair	Poor	N/A	COMMENTS
A - Perimeter details	X				
B - Drainage		X			
C - Penetration flashings		X			
D - Overall Tile condition		X			Some isolated cracked tiles noted. Some isolated chipped tiles noted. Some cracking noted at mortar.
E - Wall/Curb flashings				X	
F - Insulation				X	
G - Other				X

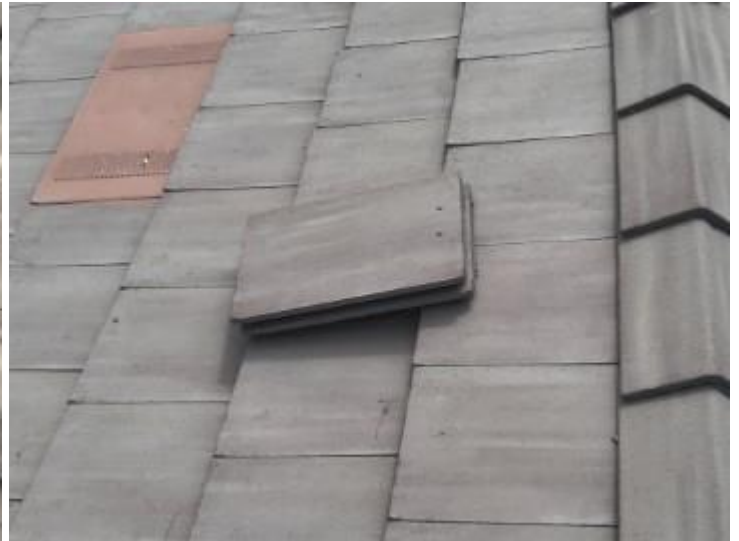
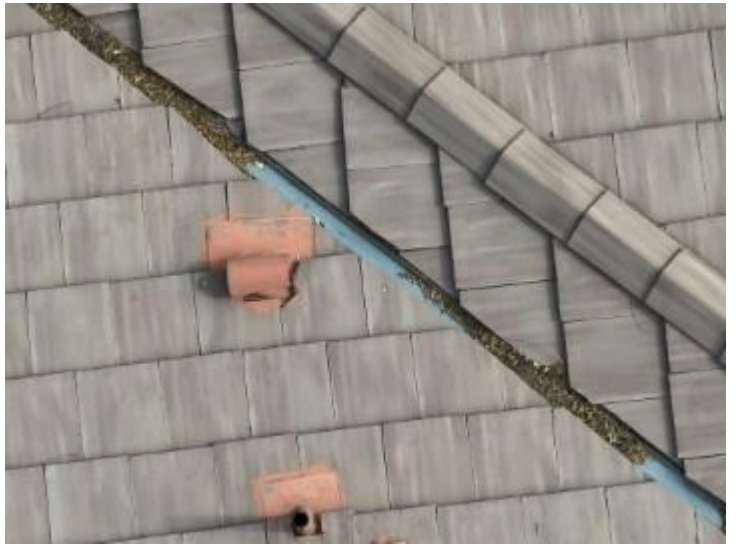
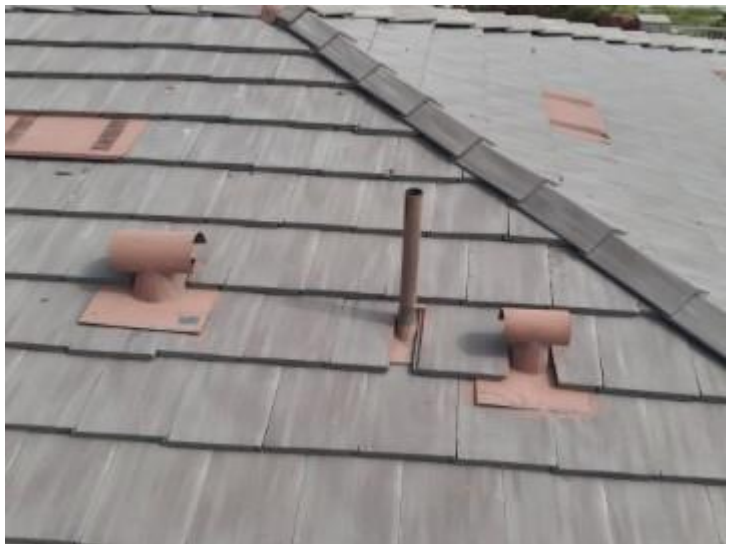
Building 4 -

ITEM	Good	Fair	Poor	N/A	COMMENTS
A - Perimeter details	X				
B - Drainage		X			Some debris noted in the valleys.
C - Penetration flashings		X			
D - Overall Tile condition		X			A broken cap tile noted. Some isolated chipped tiles noted. Some cracking noted at mortar.
E - Wall/Curb flashings				X	
F - Insulation				X	
G - Other				X	Some loose tiles left on the roof, likely from a past repair.

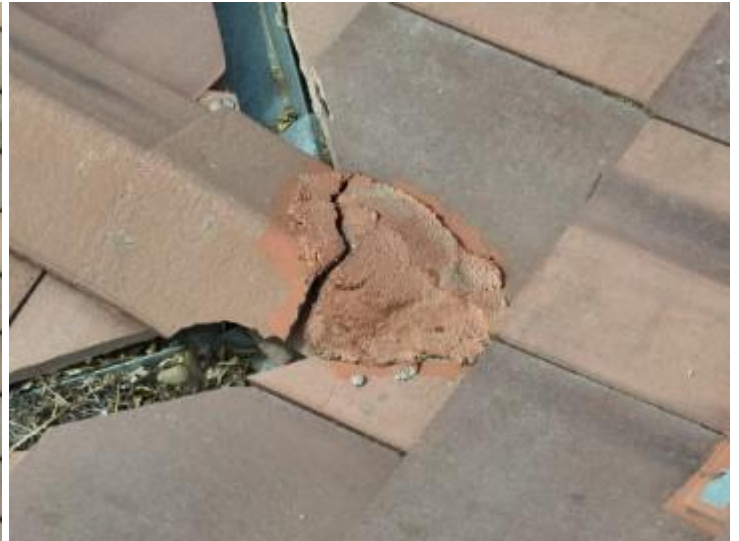
Building 5 -

ITEM	Good	Fair	Poor	N/A	COMMENTS
A - Perimeter details		X			
B - Drainage		X			Some debris noted in the valleys.
C - Penetration flashings		X			
D - Overall Tile condition		X			Some cracking noted at mortar.
E - Wall/Curb flashings				X	
F - Insulation				X	
G - Other				X

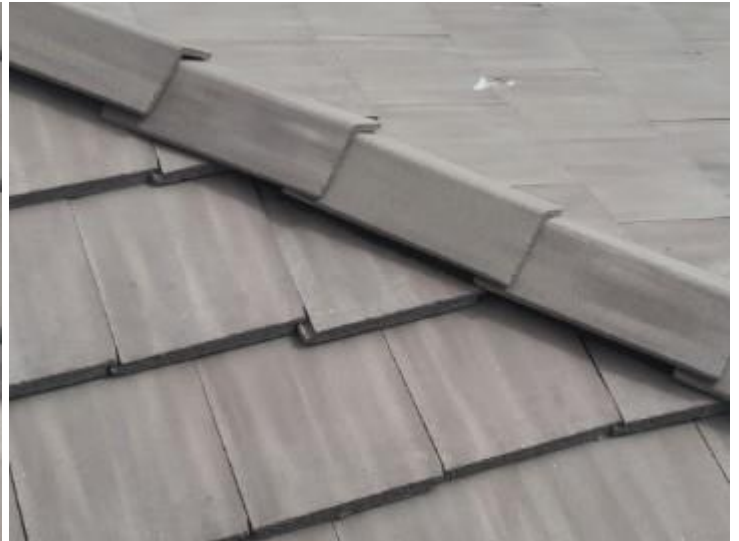
Building 6 -

ITEM	Good	Fair	Poor	N/A	COMMENTS
A - Perimeter details		X			
B - Drainage		X			Some debris noted in the valleys.
C - Penetration flashings		X			
D - Overall Tile condition		X			Some isolated cracked tiles noted. Some cracking noted at mortar. Some isolated slipping tiles noted.
E - Wall/Curb flashings				X	
F - Insulation				X	
G - Other				X

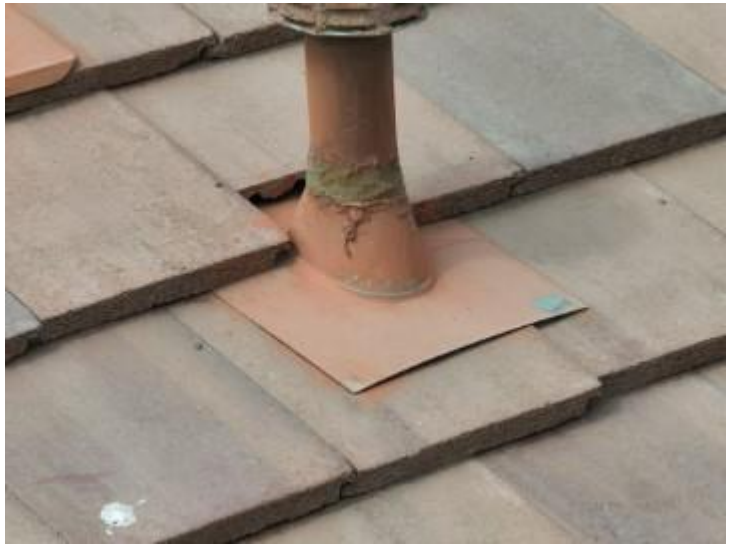
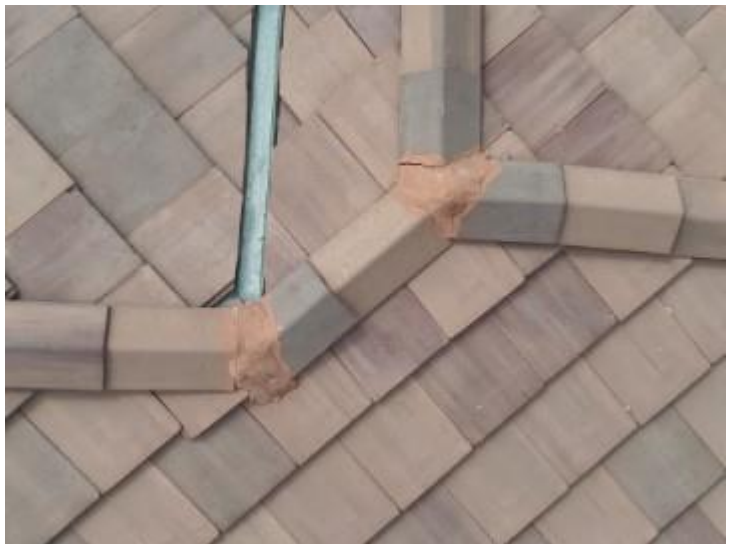
Building 8 -

ITEM	Good	Fair	Poor	N/A	COMMENTS
A - Perimeter details		X			
B - Drainage		X			Some debris noted in the valleys.
C - Penetration flashings		X			
D - Overall Tile condition		X			Some isolated cracked tiles noted. Some isolated chipped tiles noted. Some cracking noted at mortar.
E - Wall/Curb flashings				X	
F - Insulation				X	
G - Other				X

- Building 8 – Replace cracked tile where needed.
- Building 9 – Secure loose pipe flashing.
- Building 12 – Repair and replace dislodged and broken tiles that may be letting pets into the attic.

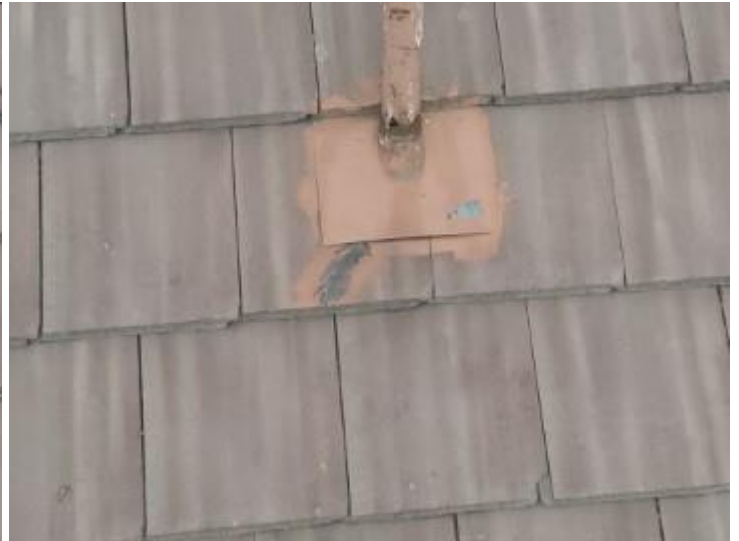
Building 9 -

ITEM	Good	Fair	Poor	N/A	COMMENTS
A - Perimeter details		X			
B - Drainage		X			Some debris noted in the valleys.
C - Penetration flashings		X			A loose pipe flashing noted.
D - Overall Tile condition		X			Some isolated cracked tiles noted. Some isolated chipped tiles noted. Some cracking noted at mortar.
E - Wall/Curb flashings				X	
F - Insulation				X	
G - Other				X	Areas of past repairs noted including replacement of tiles and sealing of a crack.

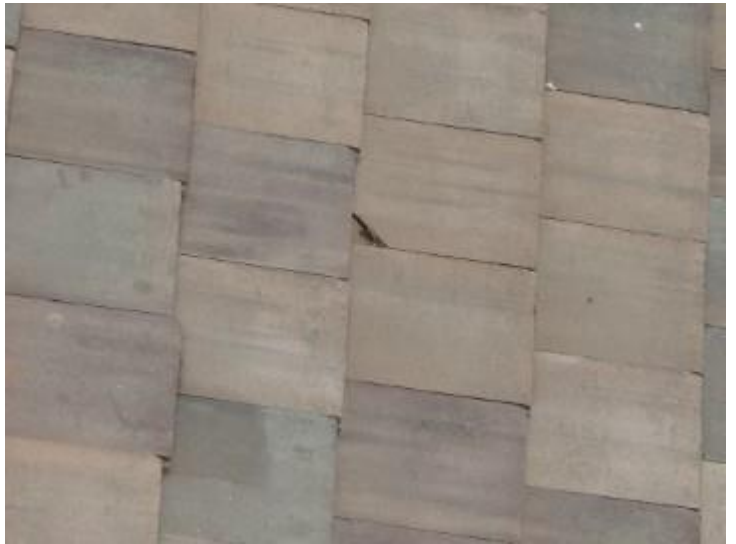
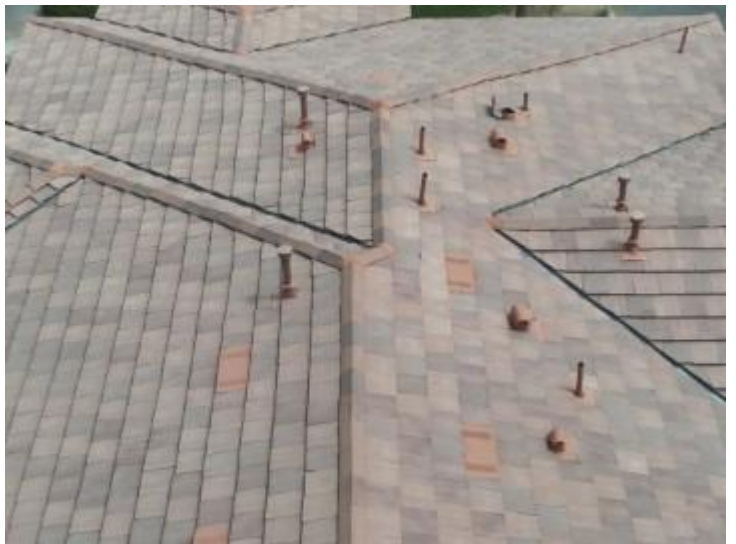
Building 12 -

ITEM	Good	Fair	Poor	N/A	COMMENTS
A - Perimeter details		X			
B - Drainage		X			Some debris noted in the valleys.
C - Penetration flashings		X			
D - Overall Tile condition		X			Some isolated cracked tiles noted. Some isolated chipped tiled noted. Some cracking noted at mortar. Some dislodged tiles noted.
E - Wall/Curb flashings				X	
F - Insulation				X	
G - Other				X	Damaged and dislodged tiles may be allowing pests into the building/attic.

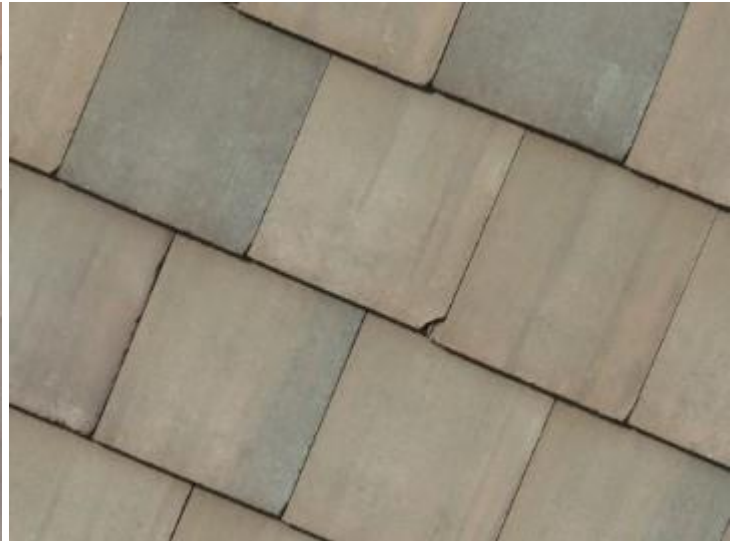
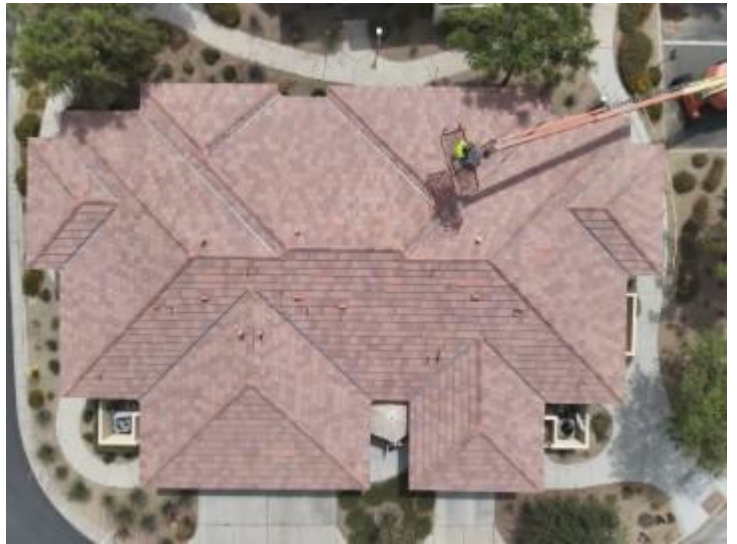
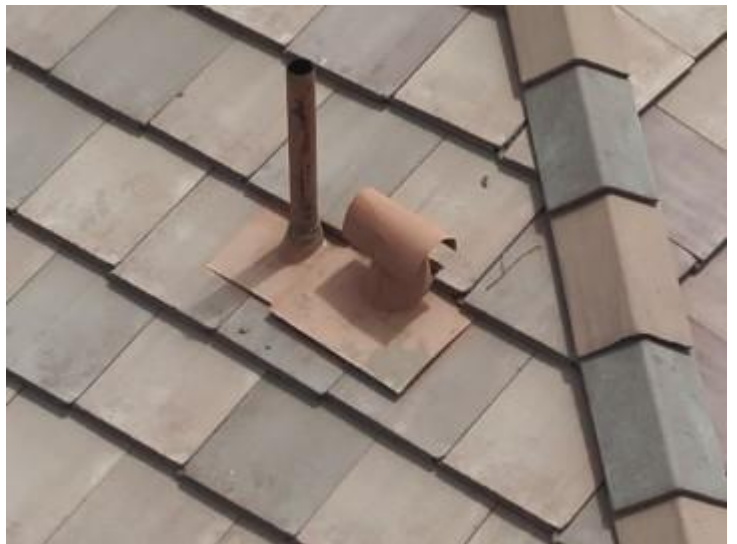
Building 14 -

ITEM	Good	Fair	Poor	N/A	COMMENTS
A - Perimeter details		X			
B - Drainage		X			
C - Penetration flashings		X			
D - Overall Tile condition		X			Some isolated cracked tiles noted. Some isolated chipped tiles noted. Some cracking noted at mortar.
E - Wall/Curb flashings				X	
F - Insulation				X	
G - Other				X

- Building 12 – Replace cracked tiles where needed.
- Building 14 – Replace cracked tiles where needed.
- Building 19 – Replace missing tile in valley.
- Building 20 – Replace cracked tile where needed.

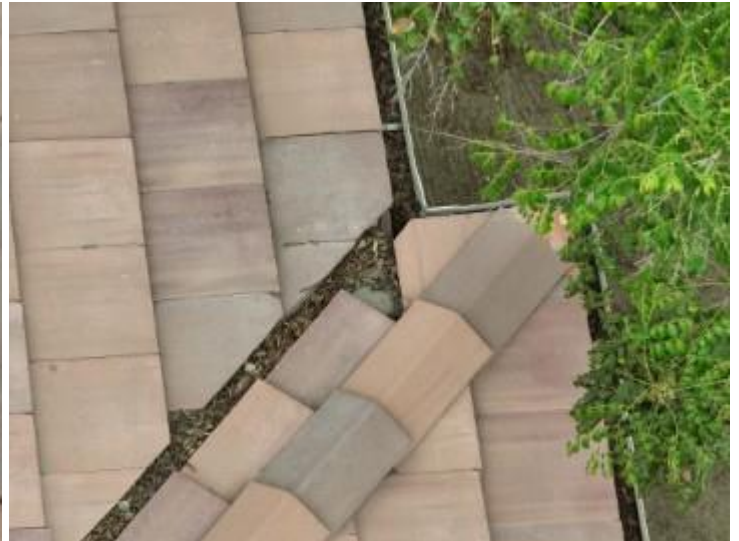
Building 19 -

ITEM	Good	Fair	Poor	N/A	COMMENTS
A - Perimeter details		X			
B - Drainage		X			Some debris noted in the valleys.
C - Penetration flashings		X			
D - Overall Tile condition		X			Some cracking noted at mortar. A missing tile notes at valley.
E - Wall/Curb flashings				X	
F - Insulation				X	
G - Other				X

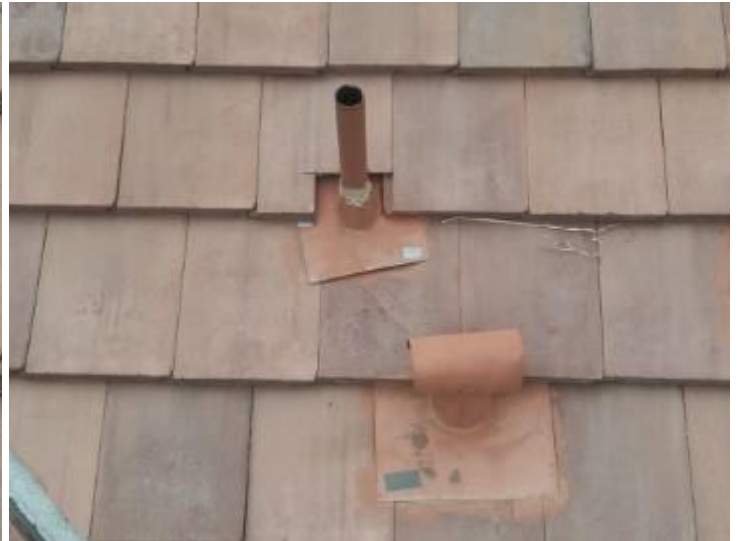
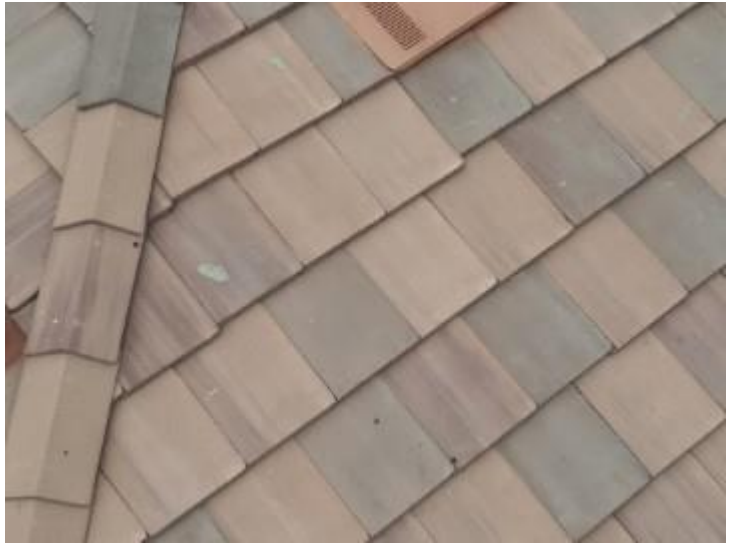
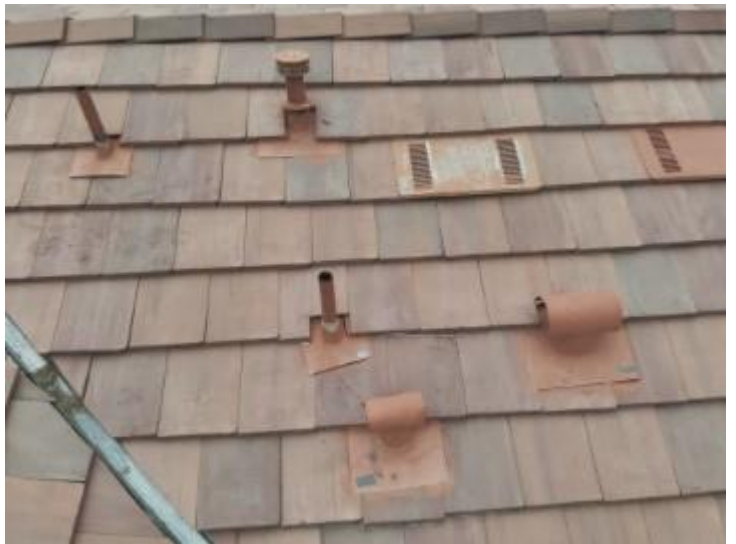
Building 28 -

ITEM	Good	Fair	Poor	N/A	COMMENTS
A - Perimeter details		X			
B - Drainage		X			Some debris noted in the valleys.
C - Penetration flashings		X			A loose flashing was noted at a plumbing vent.
D - Overall Tile condition		X			Some isolated chipped tiles noted. Some cracking noted at mortar.
E - Wall/Curb flashings				X	
F - Insulation				X	
G - Other				X

- Building 27 – Replace broken tile at drip edge.
- Building 28 – Secure loose flashing at plumbing vent.
- Building 29 – Replace broken tile where needed.

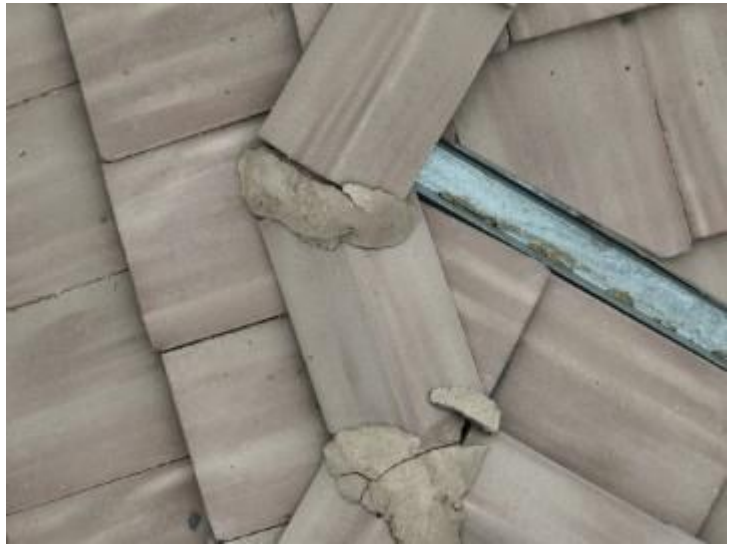
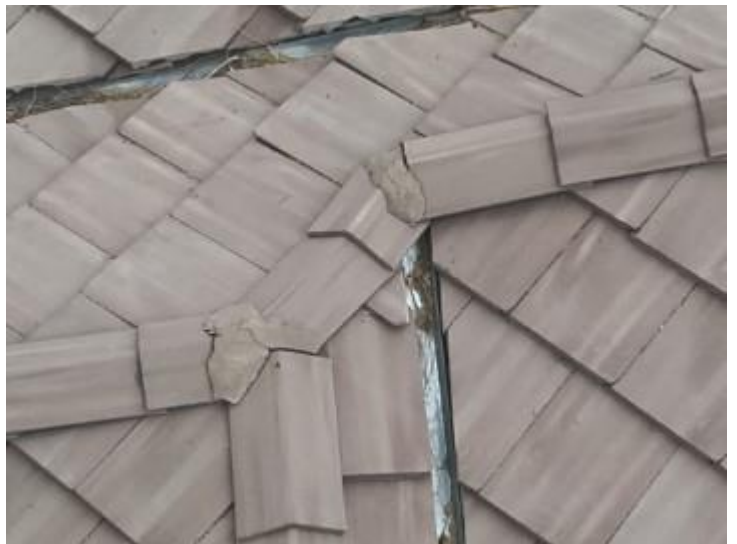
Building 29 -

ITEM	Good	Fair	Poor	N/A	COMMENTS
A - Perimeter details		X			
B - Drainage		X			Some debris noted in the valleys.
C - Penetration flashings		X			
D - Overall Tile condition		X			Some isolated cracked tiles noted. Some isolated chipped tiles noted. Some cracking noted at mortar.
E - Wall/Curb flashings				X	
F - Insulation				X	
G - Other				X

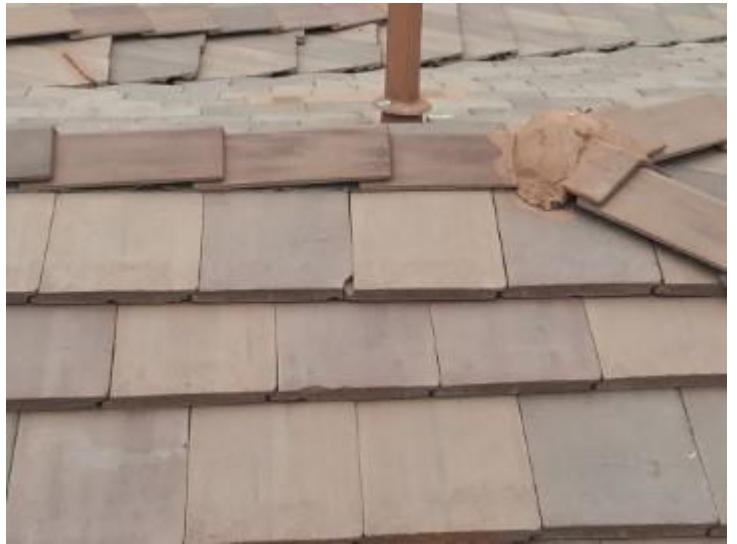
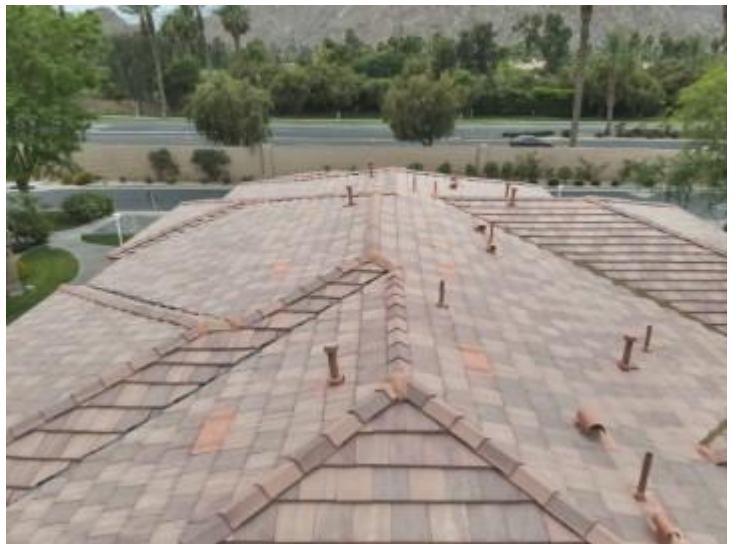
Building 30 -

ITEM	Good	Fair	Poor	N/A	COMMENTS
A - Perimeter details		X			
B - Drainage		X			Some debris noted in the valleys.
C - Penetration flashings		X			
D - Overall Tile condition		X			Some isolated cracked tiles noted. Some isolated chipped tiles noted. Some cracking noted at mortar.
E - Wall/Curb flashings				X	
F - Insulation				X	
G - Other				X

- Building 30 – Replace broken tiles where needed.
- Building 31 – Repair slipped tile in valley.
- Building 33 – Replace broken tile at drip edge.
- Building 34 – Replace broken tiles where needed.

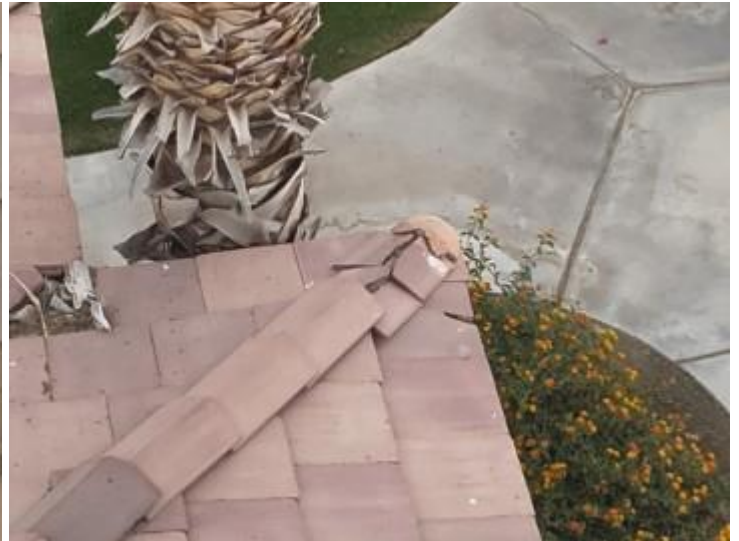
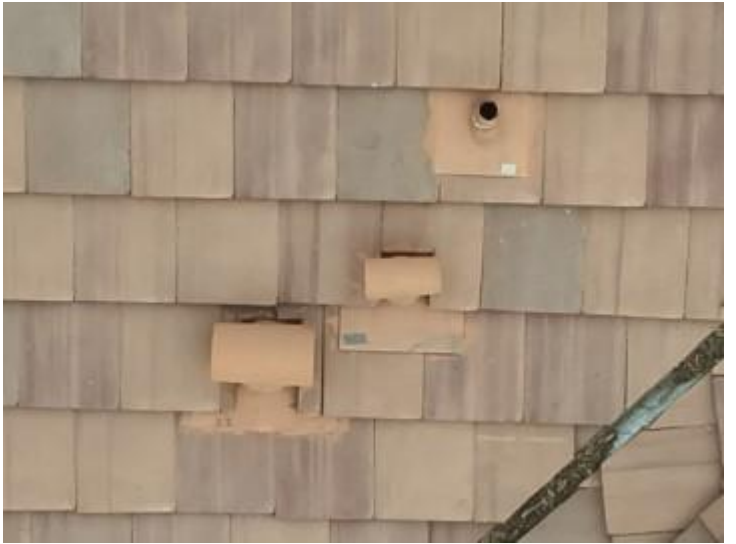
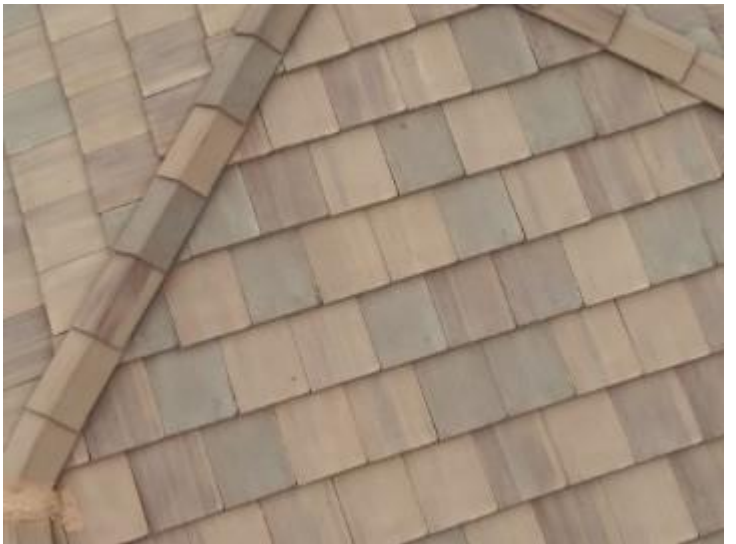
Building 34 -

ITEM	Good	Fair	Poor	N/A	COMMENTS
A - Perimeter details		X			
B - Drainage		X			Some debris noted in the valleys.
C - Penetration flashings		X			
D - Overall Tile condition		X			Some isolated cracked/ broken tiles noted. Some isolated chipped tiles noted. Some cracking noted at mortar.
E - Wall/Curb flashings				X	
F - Insulation				X	
G - Other				X

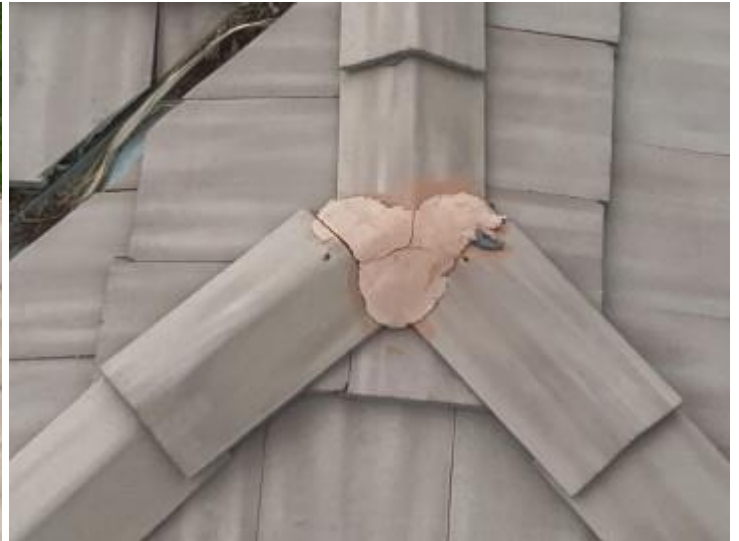
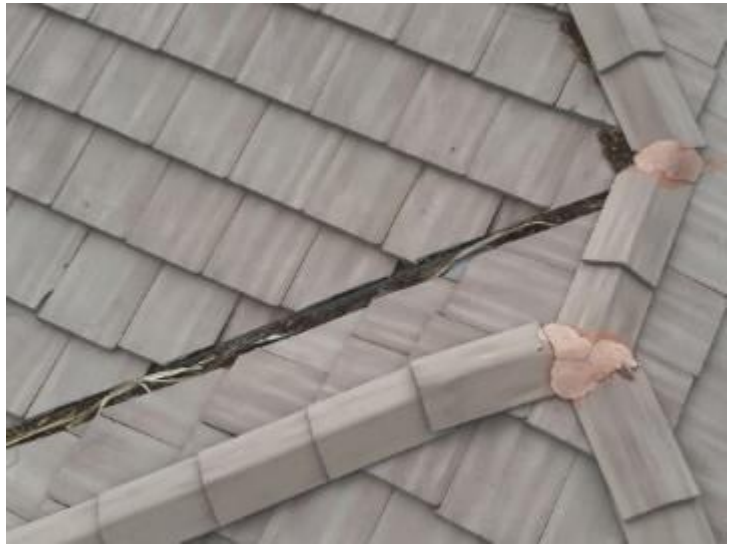
Building 35 -

ITEM	Good	Fair	Poor	N/A	COMMENTS
A - Perimeter details		X			
B - Drainage		X			Some debris noted in the valleys.
C - Penetration flashings		X			
D - Overall Tile condition		X			Some isolated cracked/broken tiles noted. Some isolated chipped tiles noted. Some cracking noted at mortar.
E - Wall/Curb flashings				X	
F - Insulation				X	
G - Other				X

- Building 35 – Replace broken tile at drip edge.
- Building 38 – Repair bent attic vent.
- Building 42 – Replace broken tiles where needed.
- Building 46 – Replace broken tiles where needed.

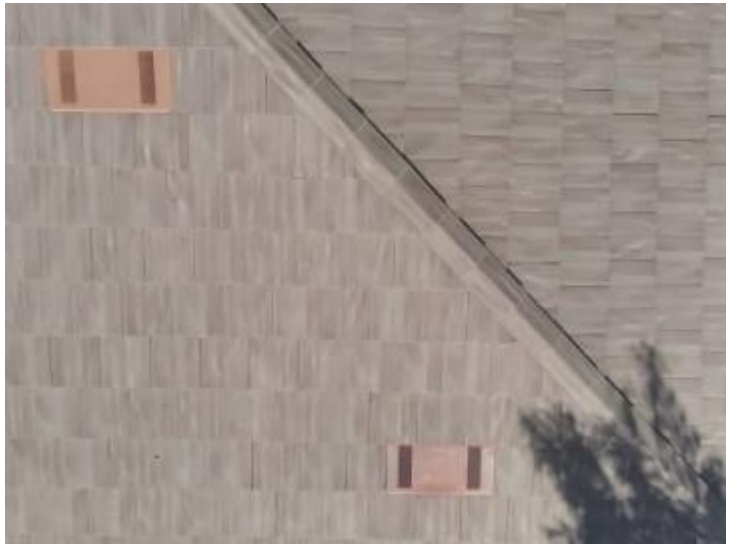
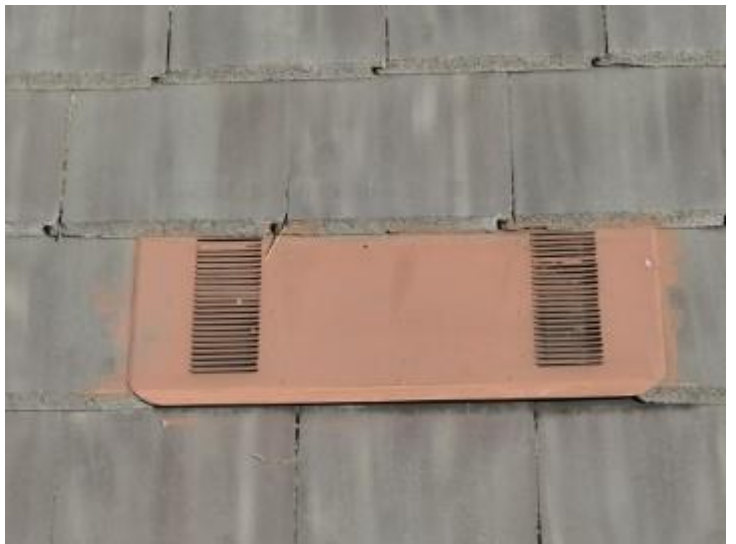
Building 42 -

ITEM	Good	Fair	Poor	N/A	COMMENTS
A - Perimeter details		X			
B - Drainage		X			Some debris noted in the valleys.
C - Penetration flashings		X			
D - Overall Tile condition		X			Some isolated cracked/broken tiles noted. Some isolated chipped tiles noted. Some cracking noted at mortar.
E - Wall/Curb flashings				X	
F - Insulation				X	
G - Other				X

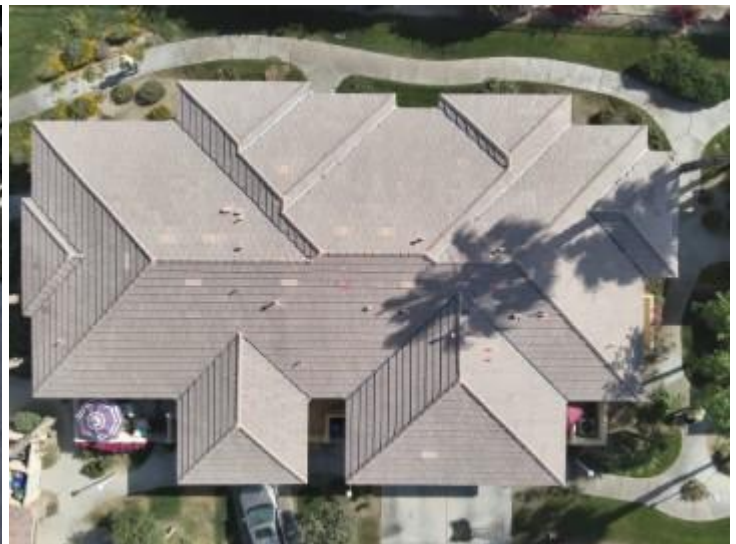
Building 46 -

ITEM	Good	Fair	Poor	N/A	COMMENTS
A - Perimeter details		X			
B - Drainage		X			Some debris noted in the valleys.
C - Penetration flashings		X			
D - Overall Tile condition		X			Some isolated cracked/broken tiles noted. Some isolated chipped tiled noted. Some cracking noted at mortar.
E - Wall/Curb flashings				X	
F - Insulation				X	
G - Other				X
