## HOUSING AUTHORITY Meeting Agenda

Thursday, November 7, 2024

Re: **Roof Consulting**  
Indian Wells Villas  
74800 Village Center Drive  
Indian Wells, CA 92210

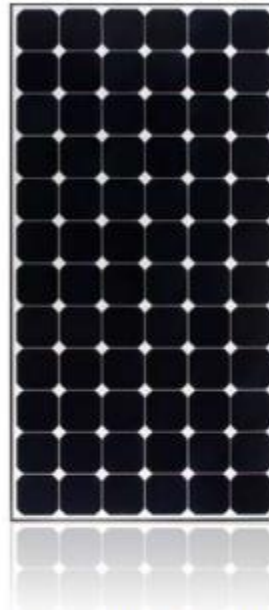
## 230 SOLAR PANEL

The SunPower 230 Solar Panel provides today's highest efficiency and performance. Utilizing 72 next generation SunPower all-back contact solar cells and an optimized panel design, the SunPower 230 delivers an unprecedented total panel conversion efficiency of 18.5%. The 230 panel's reduced voltage-temperature coefficient and exceptional low-light performance attributes provide far higher energy delivery per peak power than conventional panels.

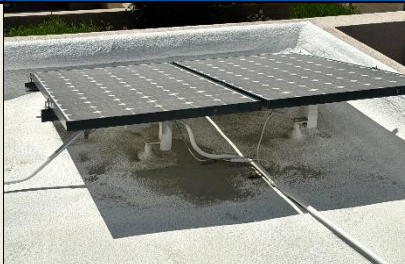
4.	Grounding cable was loose and not attached.

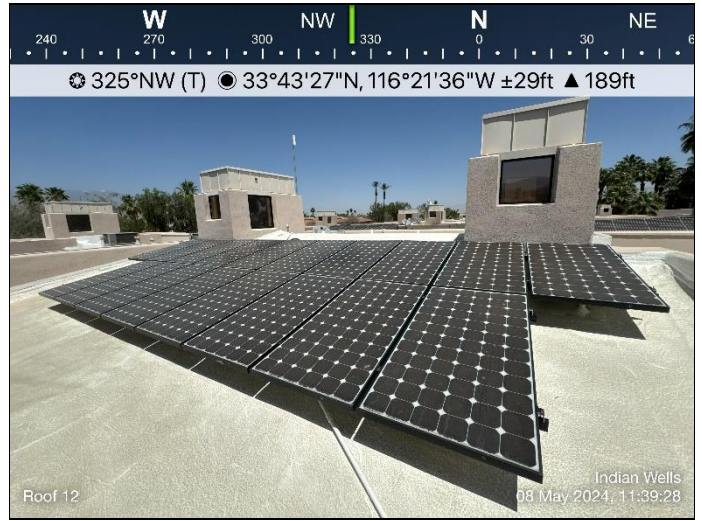
2. Solar Modules

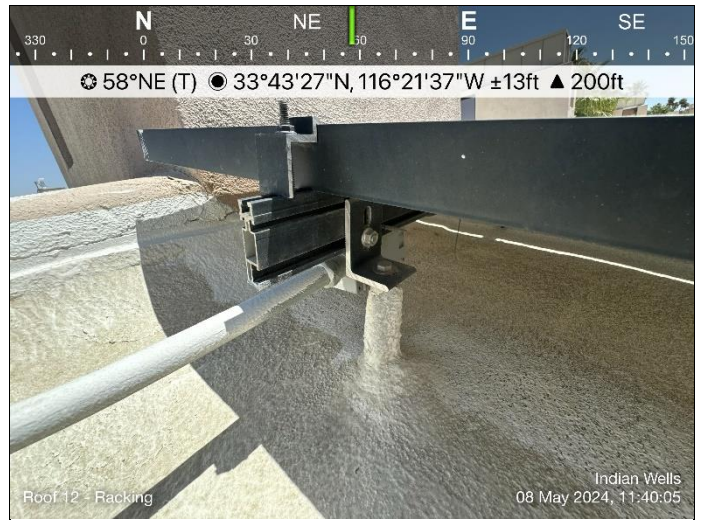
4. Connections are not torque marked

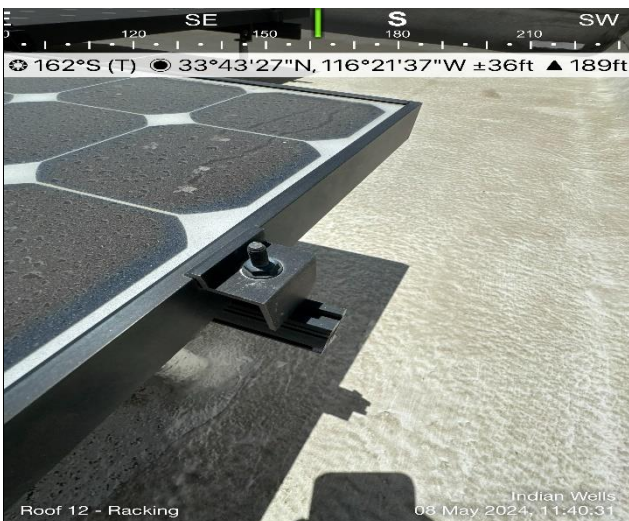
5. Racking

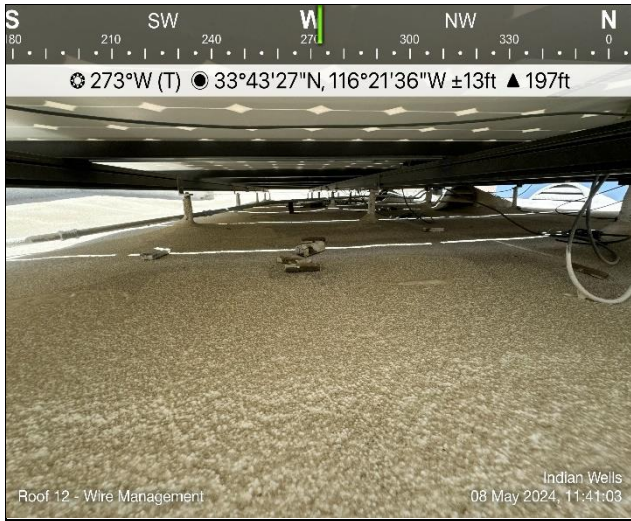
7. DC wires

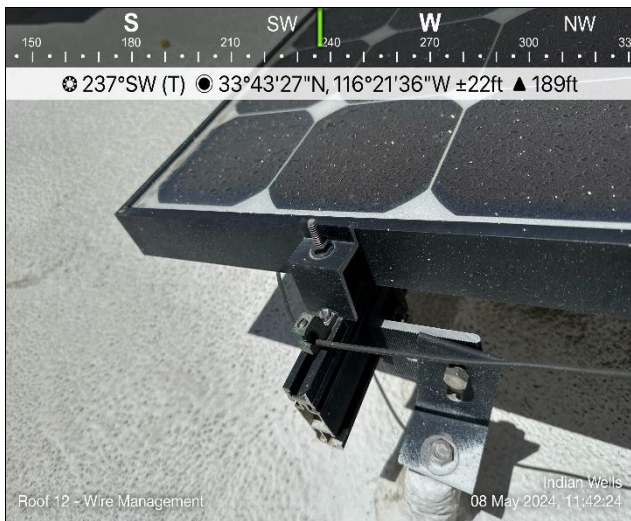
9. Grounding

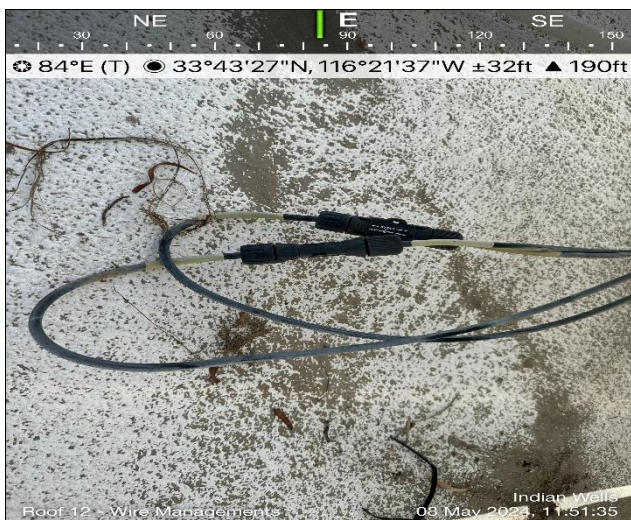
11. Wires

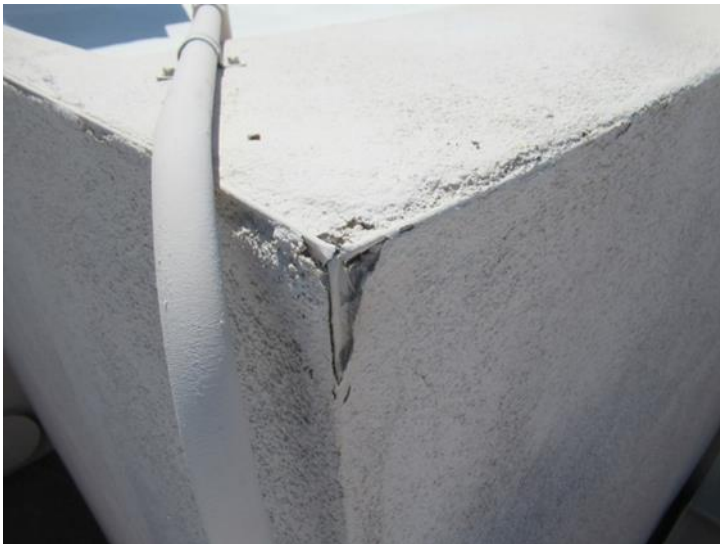
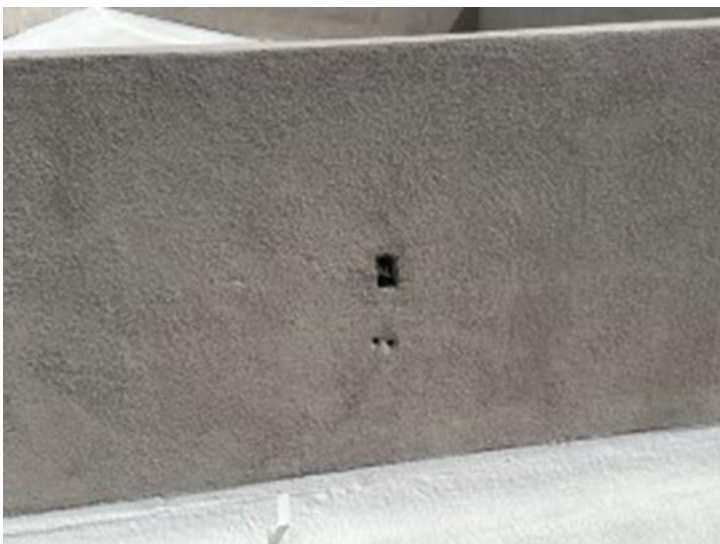
Walls show signs of cracking and minor to moderate deterioration especially at corners, windows, wall tops and roof to wall intersections.

A variety of issues noted at the drains including: clogged, coated over and broken/missing baskets.

The foam at the curtain walls is deteriorated likely due to animals.

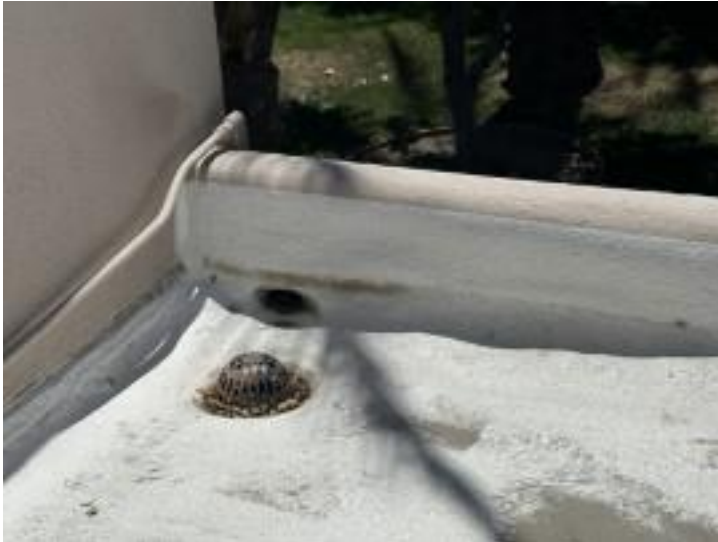
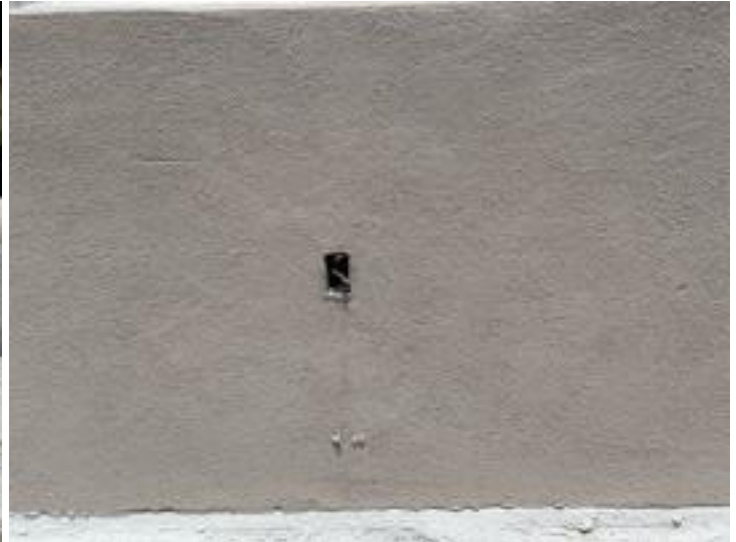
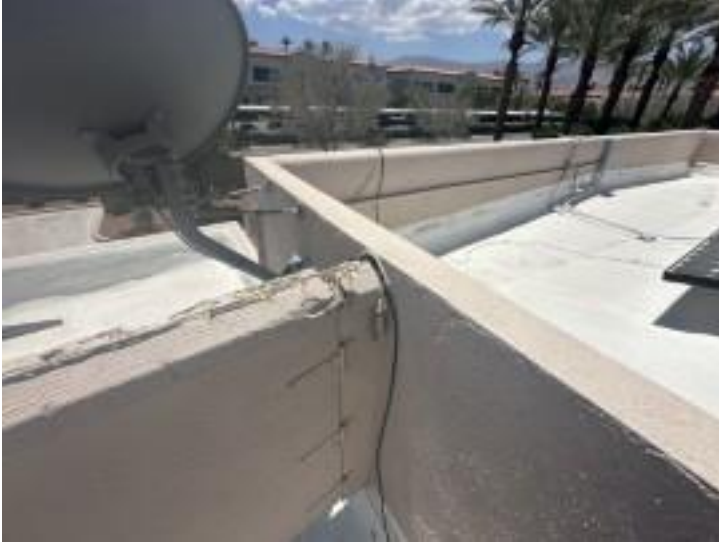
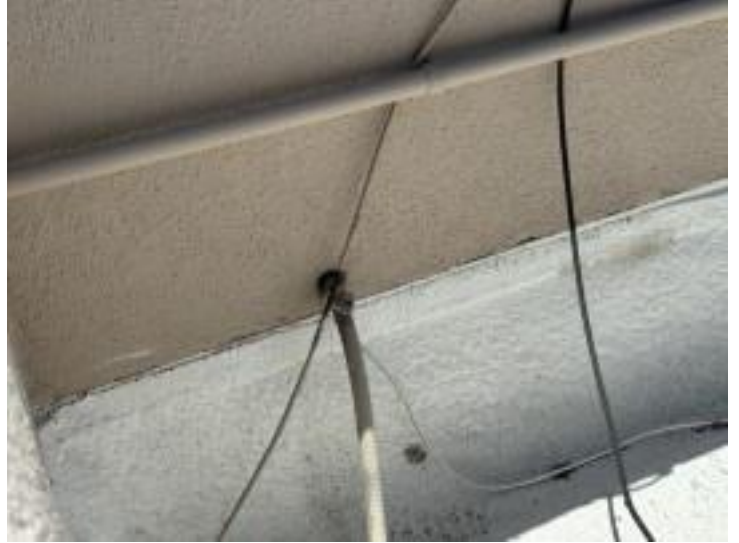
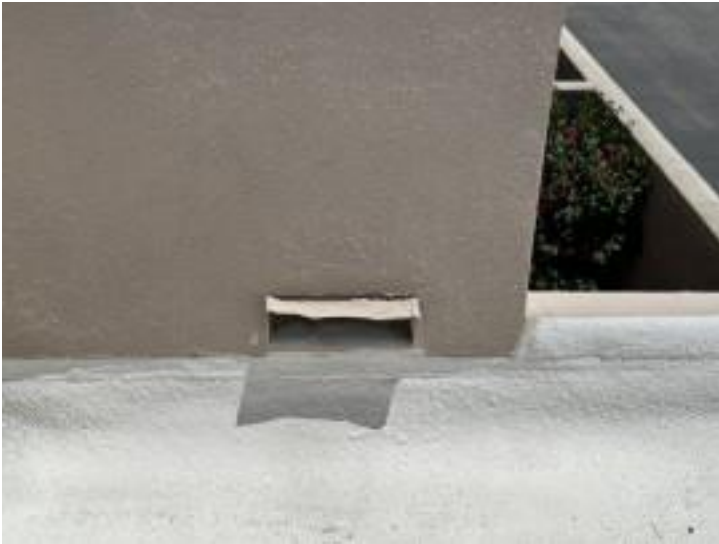
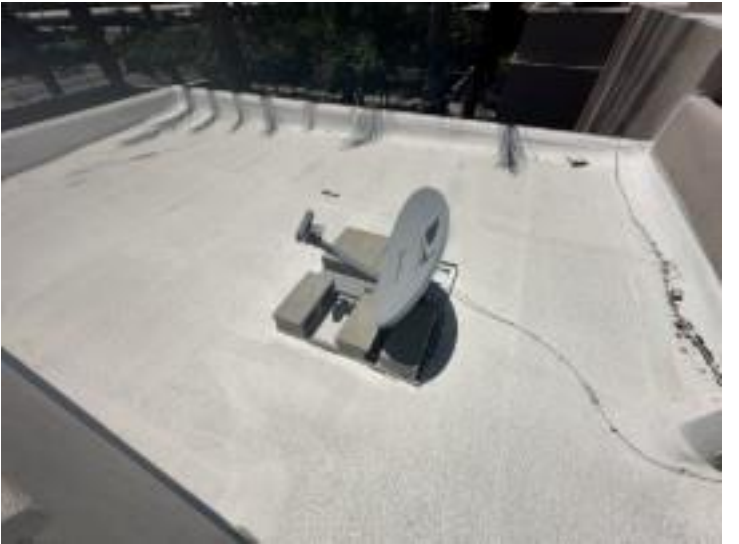
**GENERAL PHOTOS**

ITEM	Good	Fair	Poor	N/A	COMMENTS
A - Perimeter details		X			Deteriorated foam noted at curtain walls. Dish wires preventing curtain wall door from opening.
B - Drainage		X			Missing covers noted at drains. Debris(leaves) noted at drains.
C - Penetration flashings	X				
D - Overall membrane condition	X				
E - Walls/Curbs		X			Cracking and deterioration noted at walls.
F - Insulation				X	
G - Other				X	Wall penetrations both active and abandoned are not properly sealed.

ACTION/MONITORING ITEMS	
<b>Specific Action Items</b>	
Building 1 – Reroute Dish wires to ensure curtain wall access door properly opens. Building 3 – Reseal deteriorated coating in scupper. Building 14 – Further investigate and properly repair and seal window with temporary tape repair. Building 15 – Repair/seal large gap noted at membrane in back corner.	
<b>General Action Items</b>	
Further evaluate and repair walls where needed as cracking and deterioration noted at several locations of all buildings. Recoat/repair deterioration at roof to wall intersections (Wall Flashings.) Ensure all wall penetrations are properly sealed. Several holes where noted where items have been removed from the walls (Satellite dishes?). Ensure windows at penthouses are regularly maintained and sealed. Remove debris from roofs and drains where needed. Replace broken and missing drain covers. Ensure sleepers blocks and slip sheets installed where needed. Replace/repair damaged curtain wall foam tops.

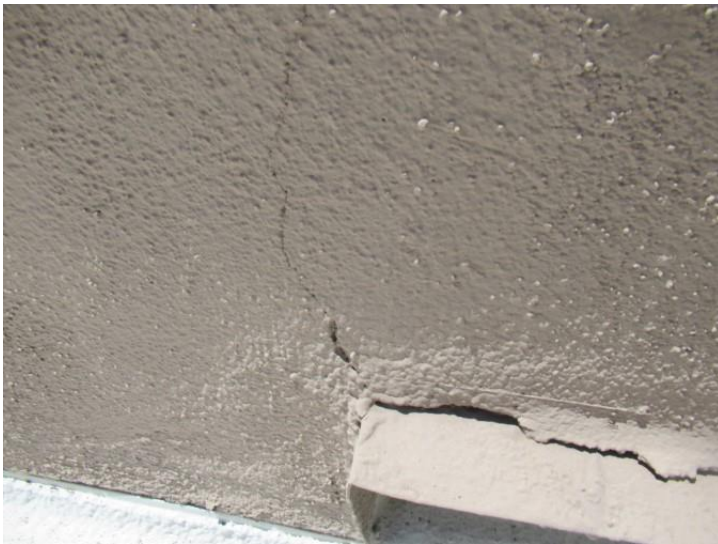
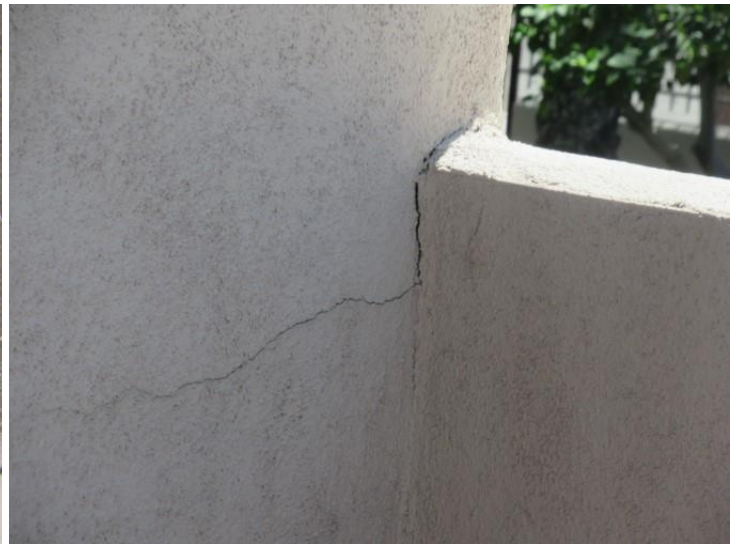
**GENERAL PHOTOS**

ITEM	Good	Fair	Poor	N/A	COMMENTS
A - Perimeter details		X			Deteriorated foam noted at curtain walls.
B - Drainage		X			Missing covers noted at drains. Debris(leaves) noted at drains.
C - Penetration flashings	X				
D - Overall membrane condition	X				
E - Walls/Curbs		X			Cracking and deterioration noted at walls.
F - Insulation				X	
G - Other				X	Wall penetrations both active and abandoned are not properly sealed.

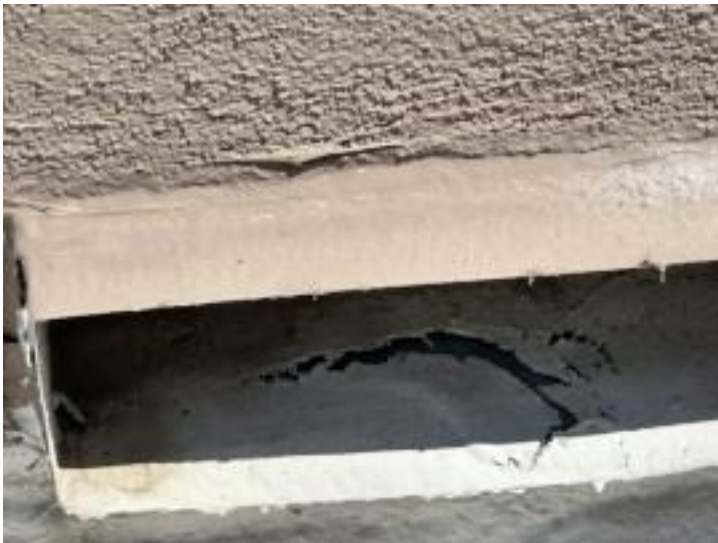
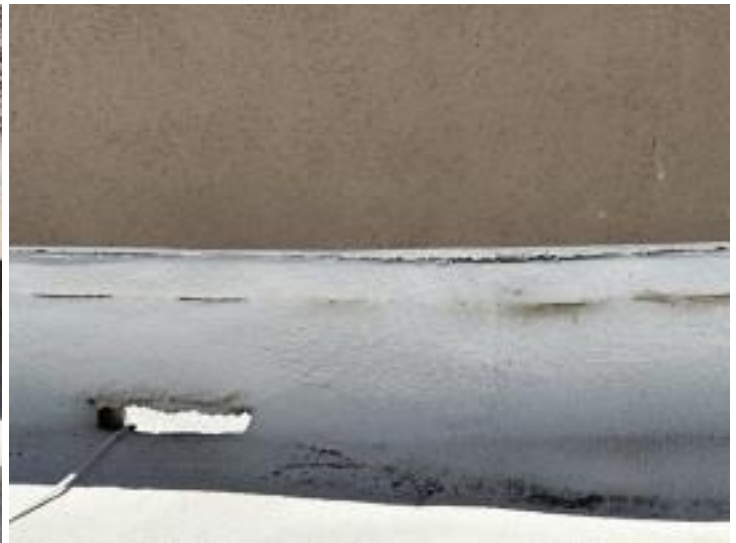
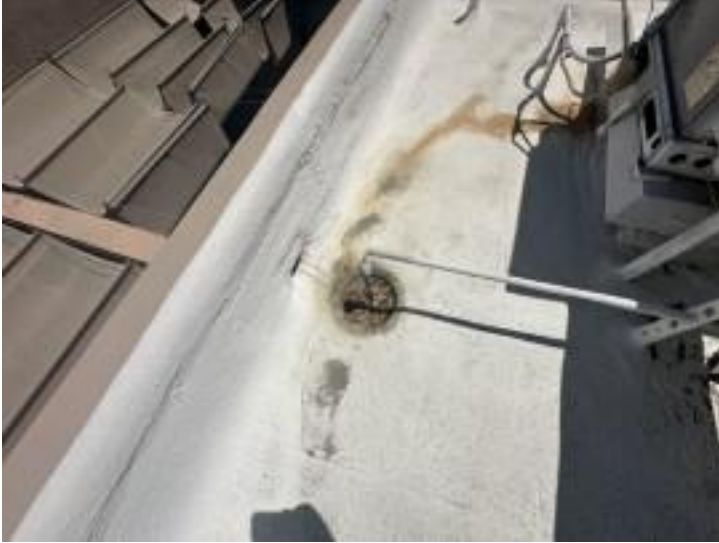
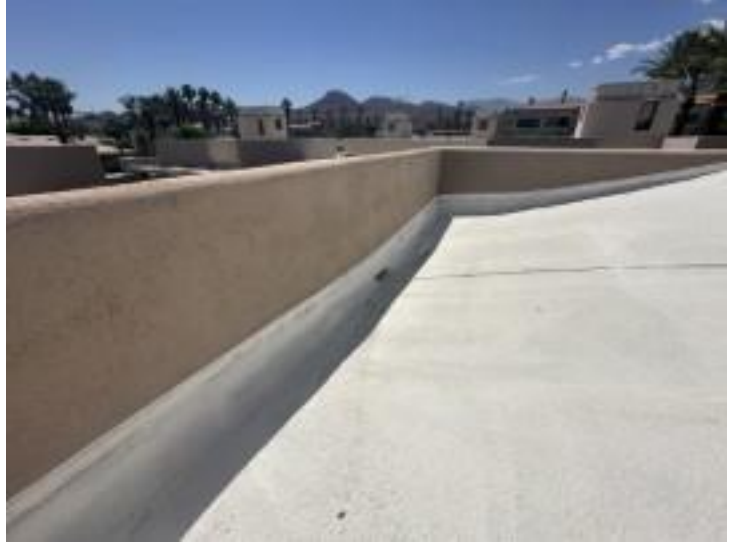
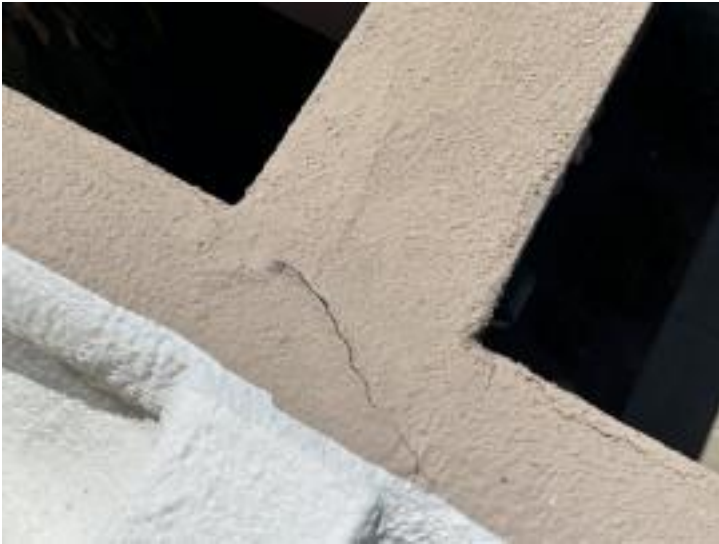
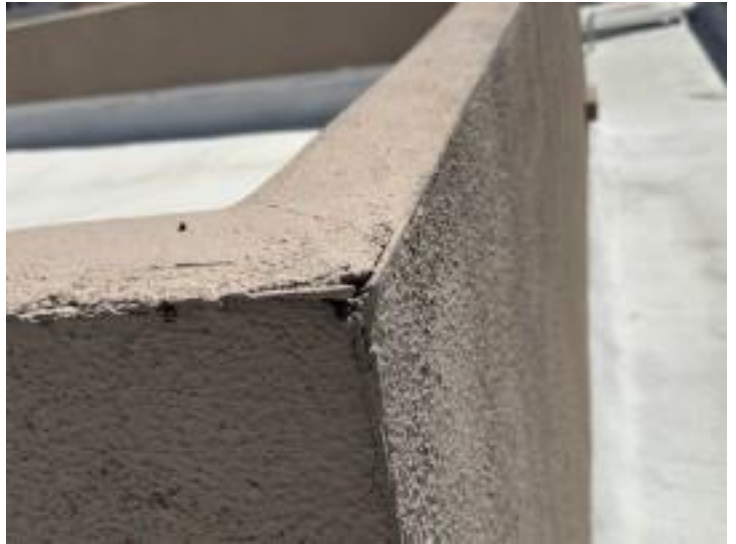
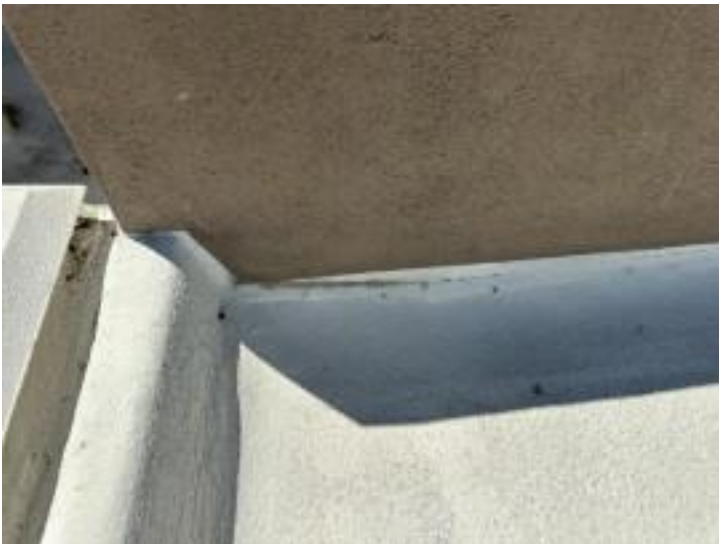
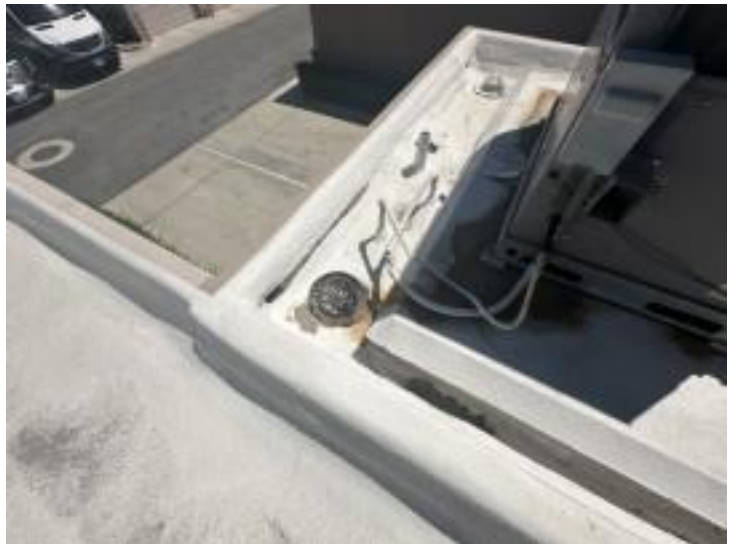
**Building 3 -**

ITEM	Good	Fair	Poor	N/A	COMMENTS
A - Perimeter details		X			Deteriorated foam noted at curtain walls.
B - Drainage		X			Missing covers noted at drains. Debris(leaves) noted at drains.  Some deterioration noted at scupper coating.
C - Penetration flashings	X				
D - Overall membrane condition	X				
E - Walls/Curbs		X			Cracking and deterioration noted at walls.
F - Insulation				X	
G - Other				X	Wall penetrations both active and abandoned are not properly sealed.

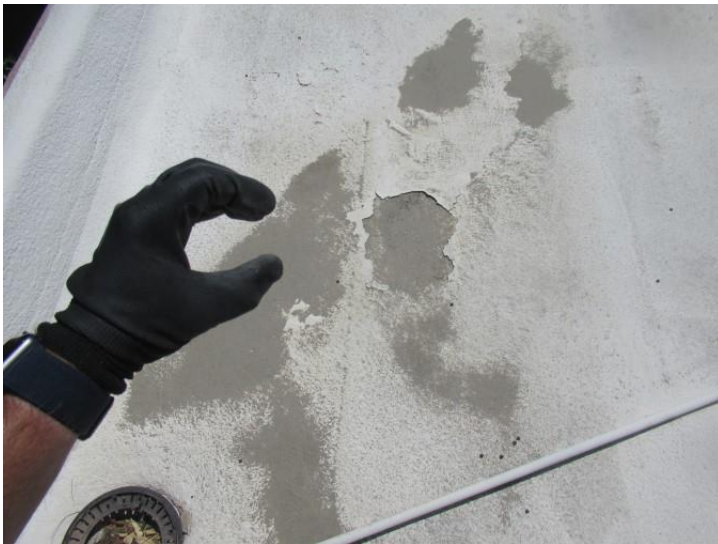
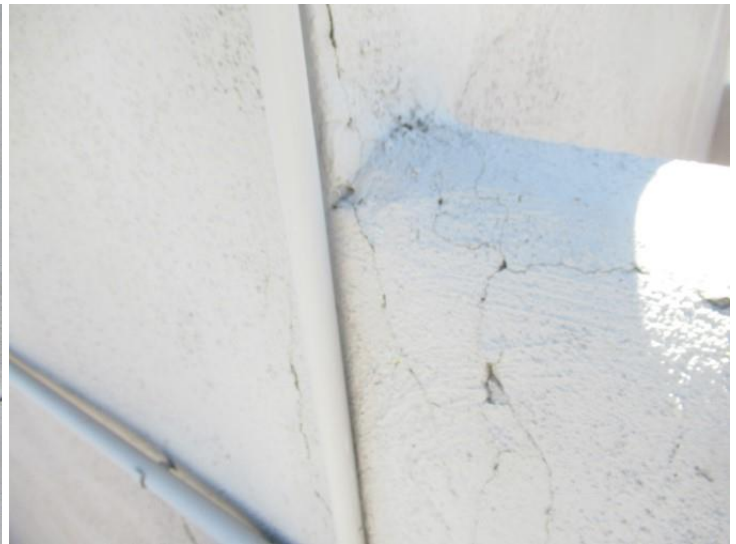
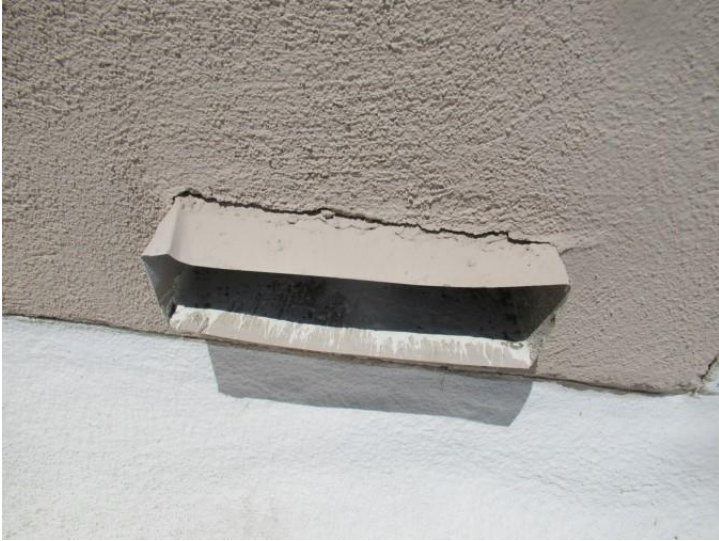
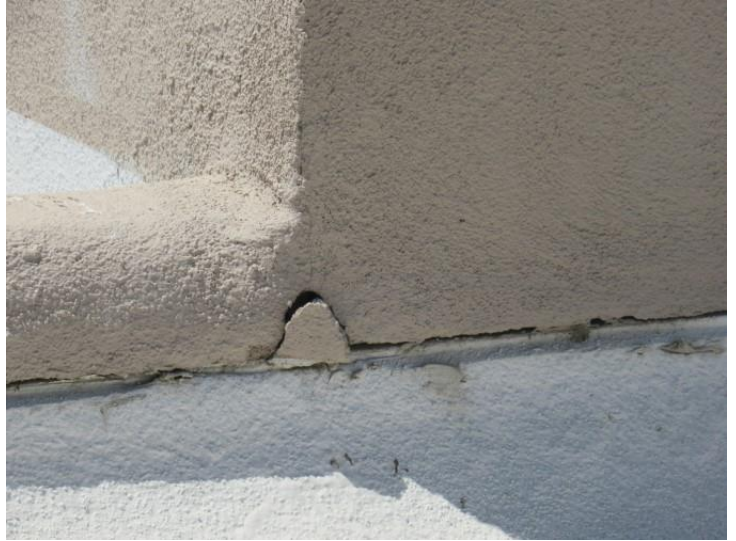
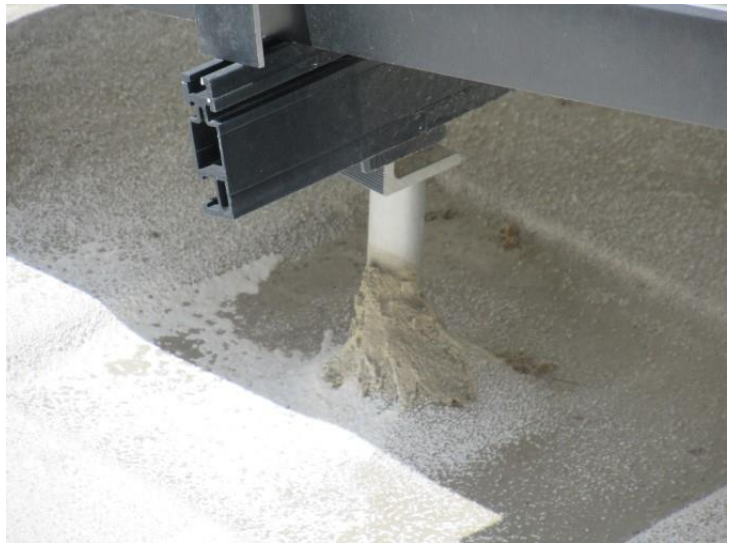
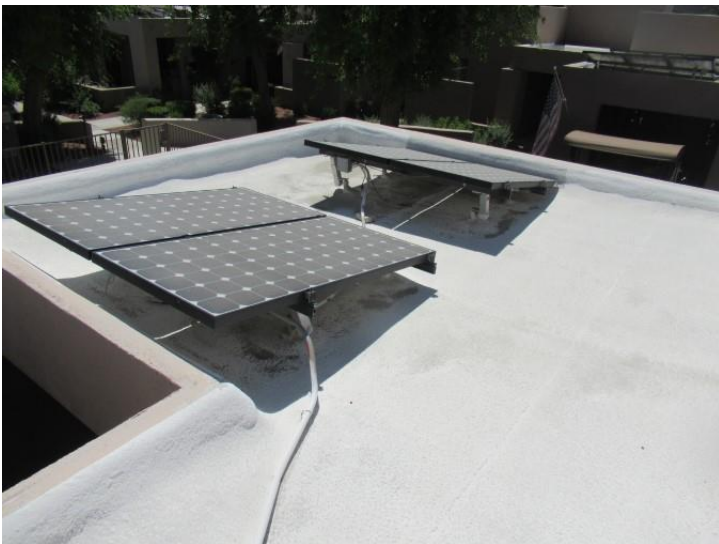
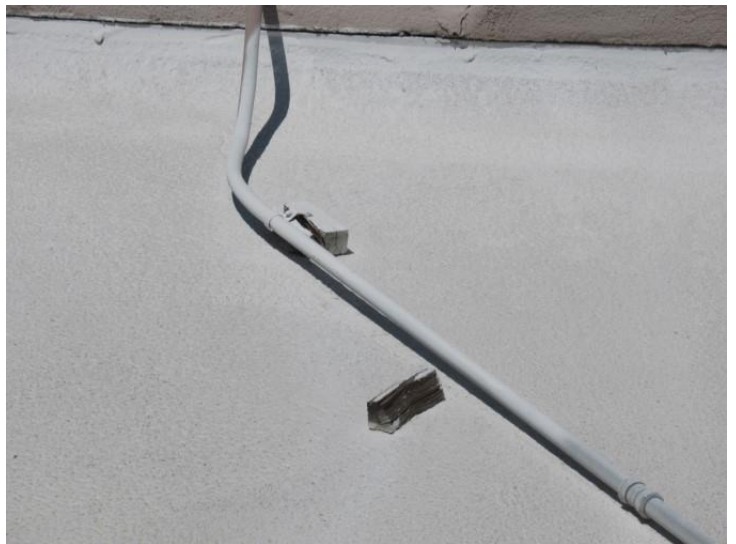
**Building 4 -**

ITEM	Good	Fair	Poor	N/A	COMMENTS
A - Perimeter details		X			Deteriorated foam noted at curtain walls.
B - Drainage		X			Missing covers noted at drains. Debris(leaves) noted at drains.
C - Penetration flashings	X				
D - Overall membrane condition	X				Some coating deterioration noted in isolated locations.
E - Walls/Curbs		X			Cracking and deterioration noted at walls.
F - Insulation				X	
G - Other				X	Wall penetrations both active and abandoned are not properly sealed.

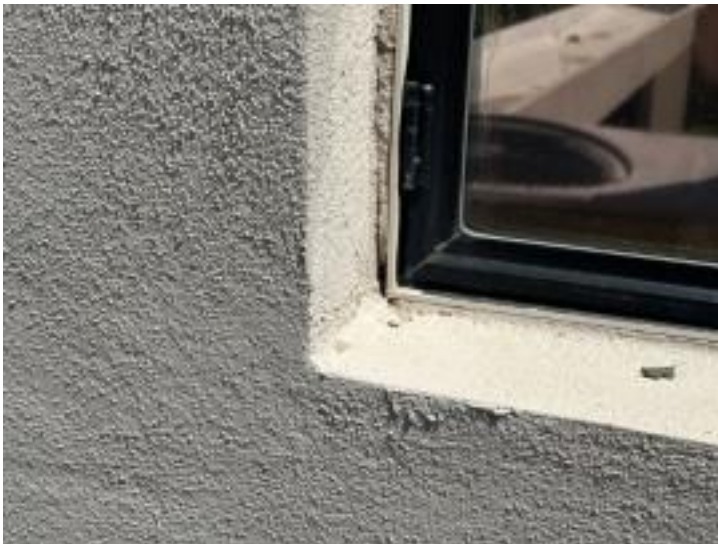
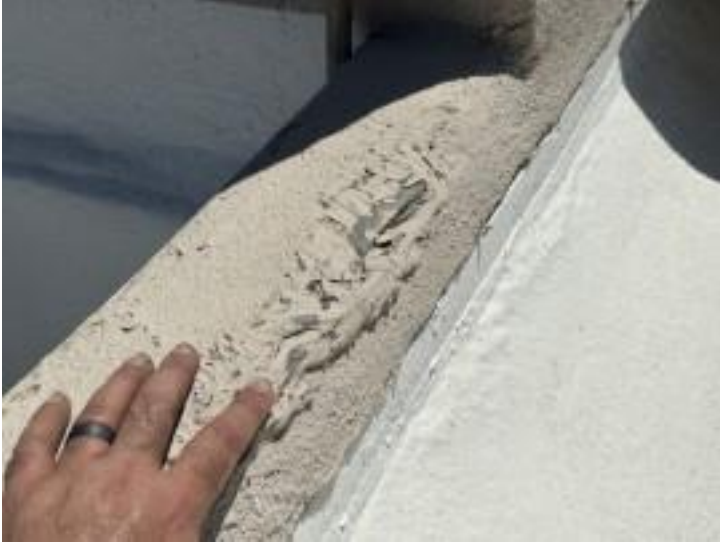
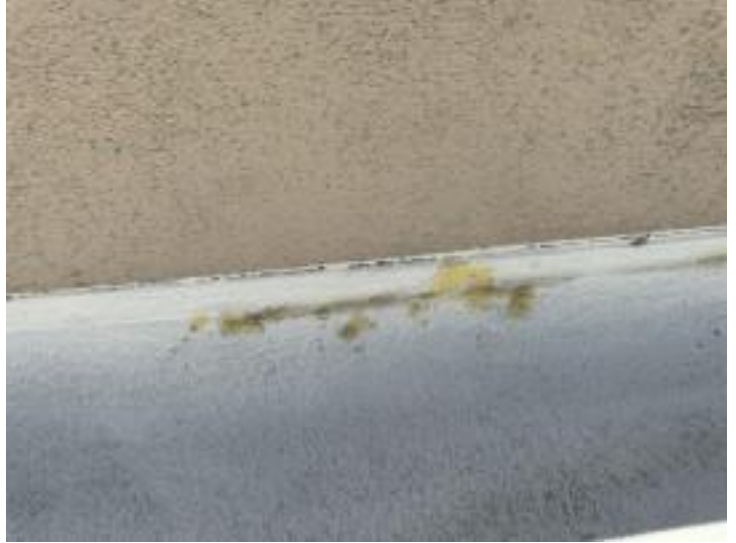
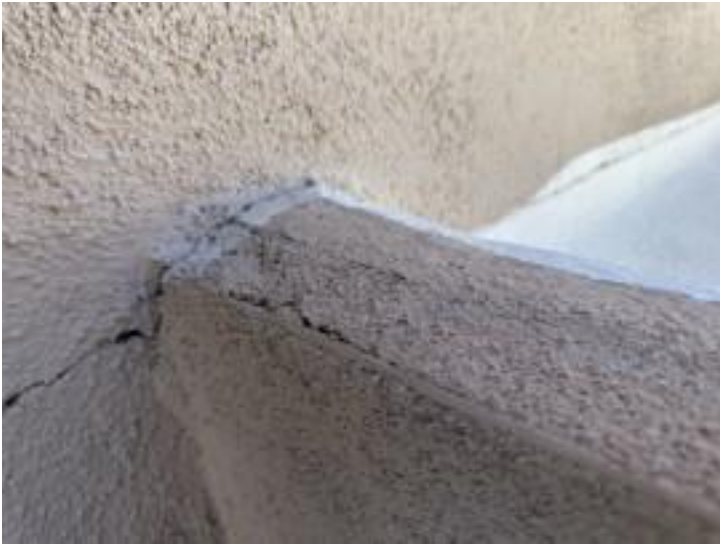
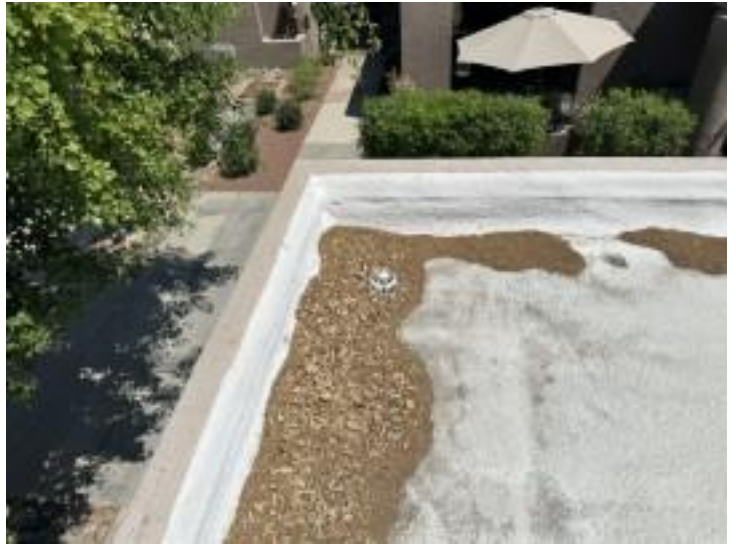
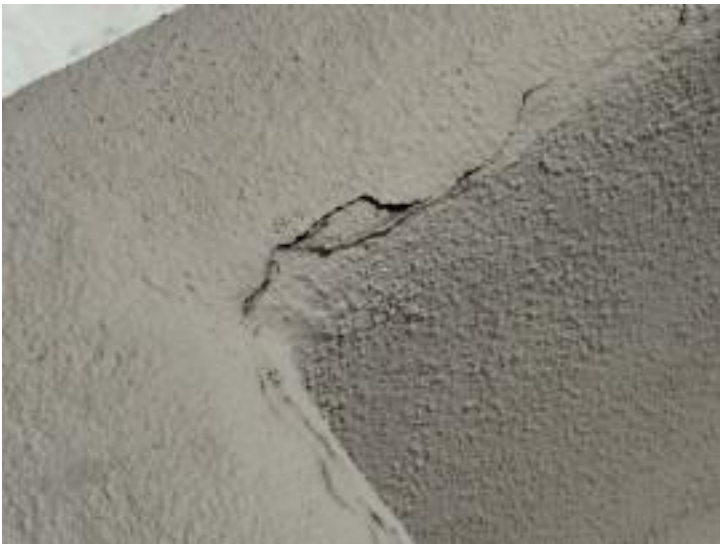
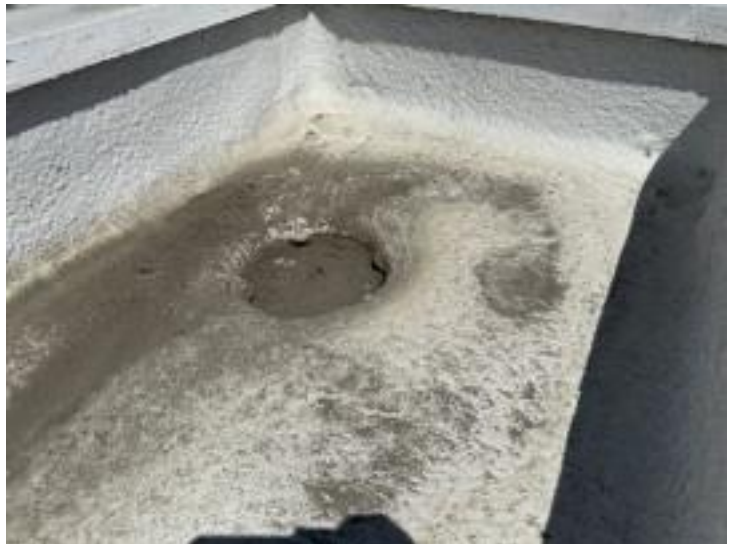
**Building 5 -**

ITEM	Good	Fair	Poor	N/A	COMMENTS
A - Perimeter details		X			Deteriorated foam noted at curtain walls.
B - Drainage		X			Missing covers noted at drains. Debris(leaves) noted at drains.
C - Penetration flashings	X				
D - Overall membrane condition	X				
E - Walls/Curbs		X			Cracking and deterioration noted at walls.
F - Insulation				X	
G - Other				X	Wall penetrations both active and abandoned are not properly sealed.

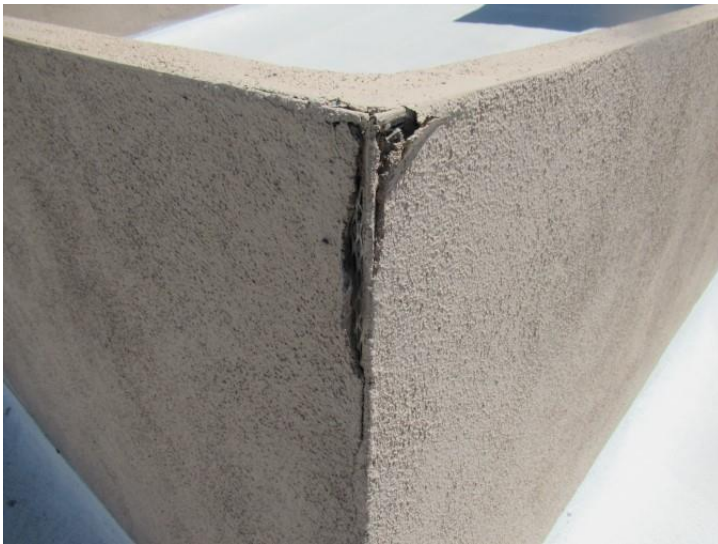
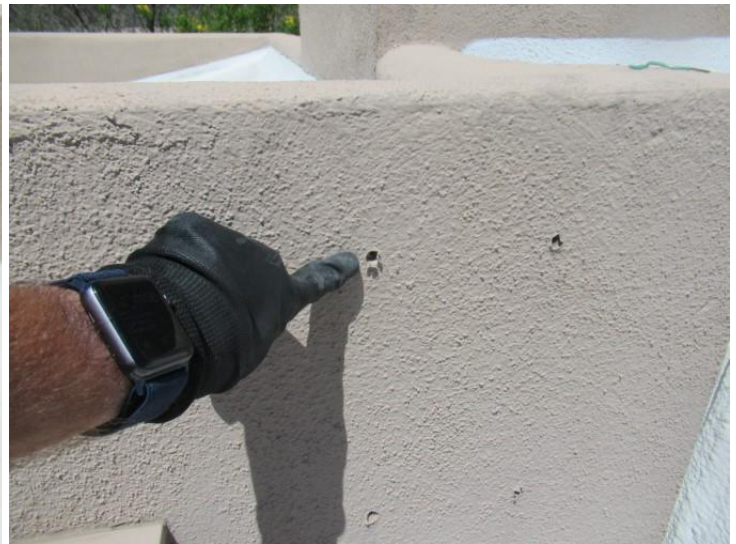
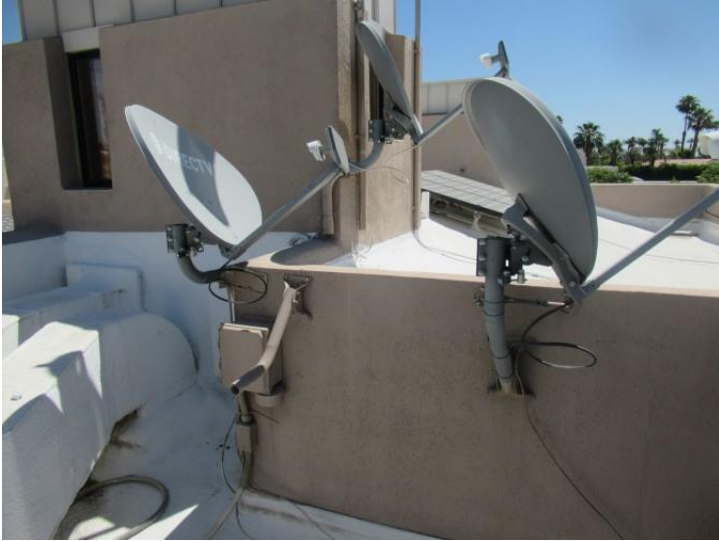
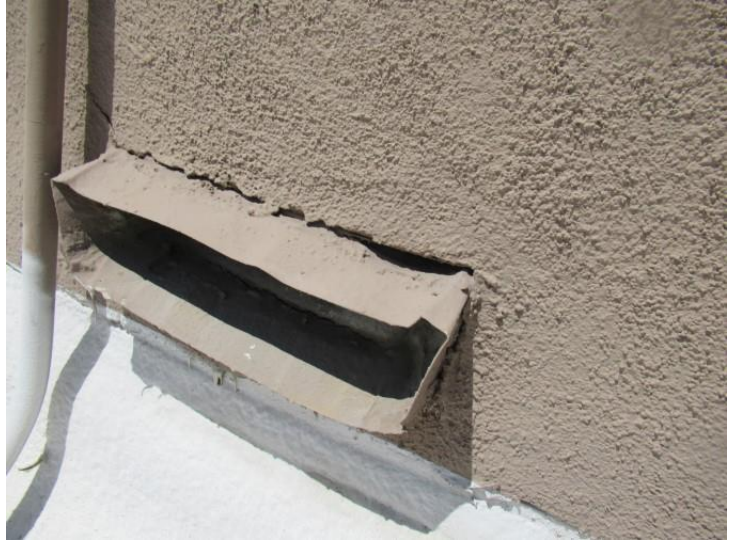
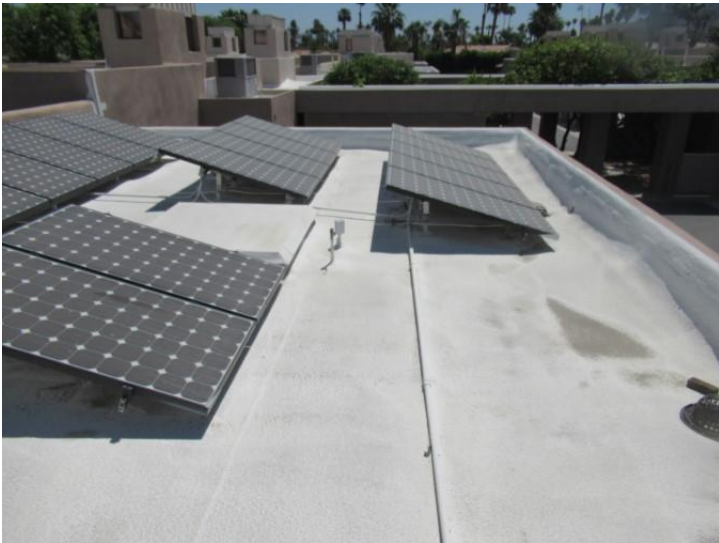
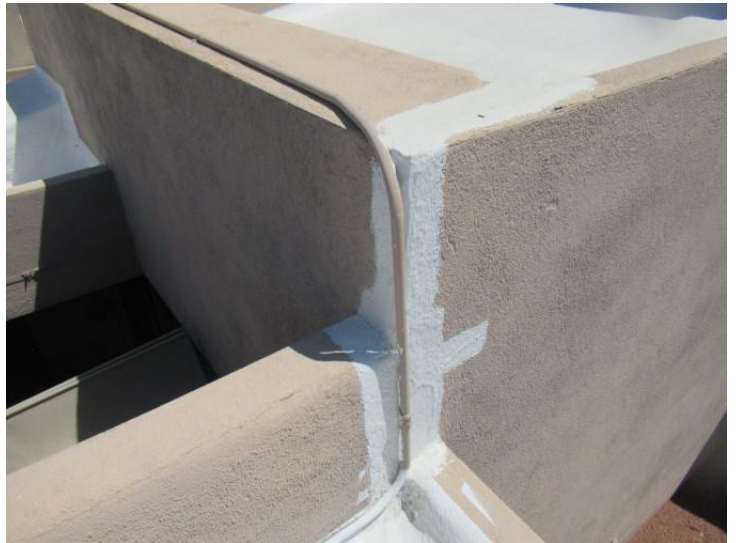
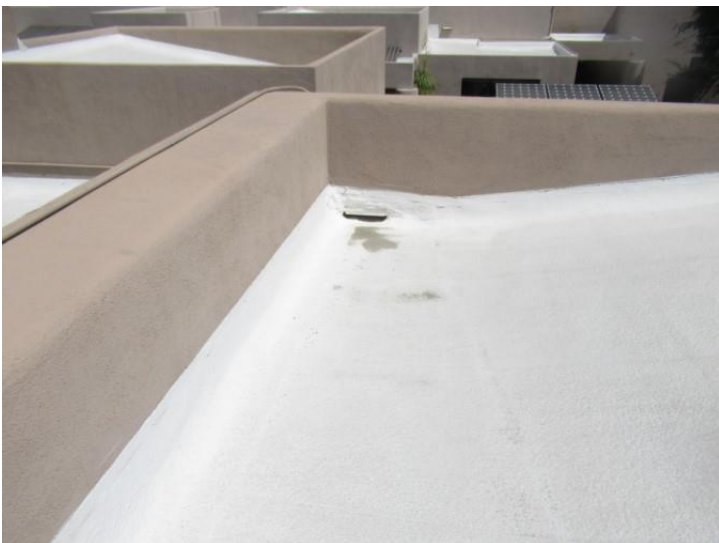
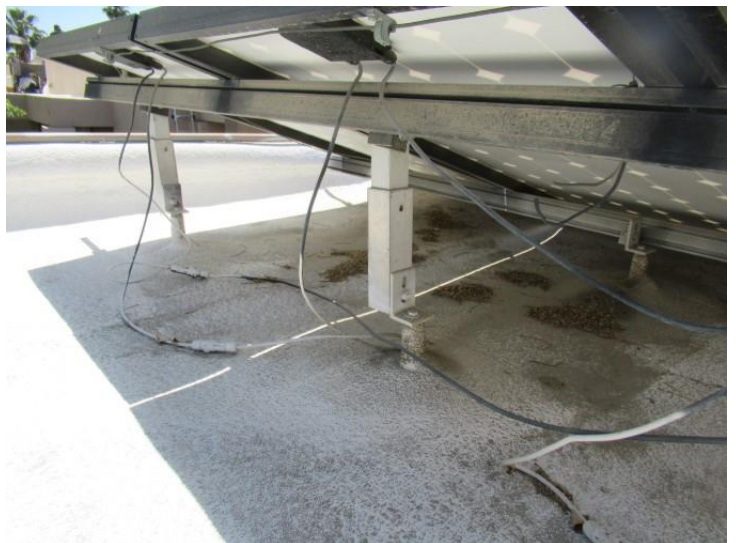
**Building 6 -**

ITEM	Good	Fair	Poor	N/A	COMMENTS
A - Perimeter details		X			Deteriorated foam noted at curtain walls.
B - Drainage		X			Missing covers noted at drains. Debris(leaves) noted at drains.
C - Penetration flashings	X				
D - Overall membrane condition	X				
E - Walls/Curbs		X			Cracking and deterioration noted at walls.
F - Insulation				X	
G - Other				X	Wall penetrations both active and abandoned are not properly sealed.

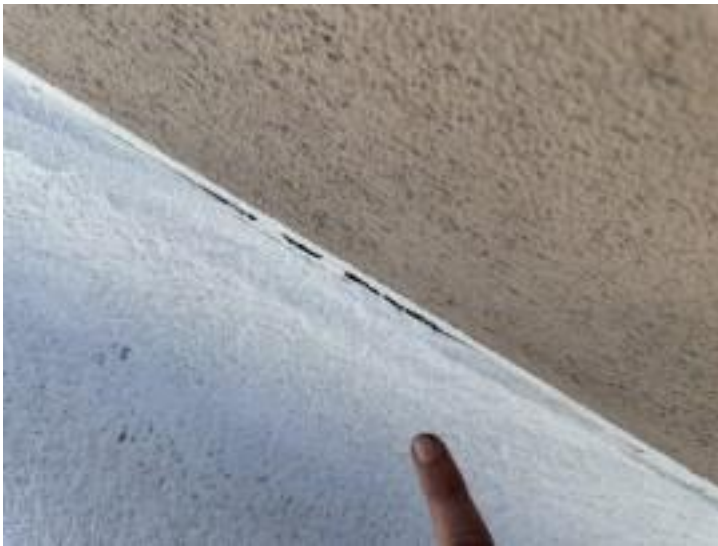
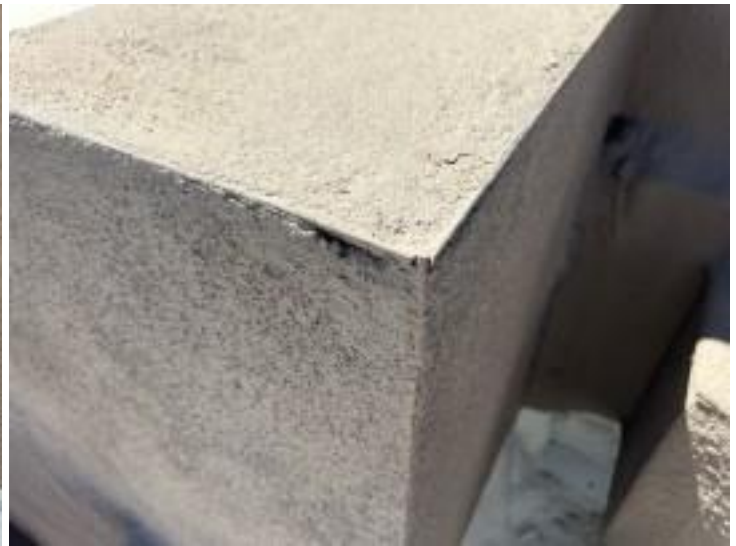
**Building 7 -**

ITEM	Good	Fair	Poor	N/A	COMMENTS
A - Perimeter details		X			Deteriorated foam noted at curtain walls.
B - Drainage		X			Missing covers noted at drains. Debris(leaves) noted at drains.
C - Penetration flashings	X				
D - Overall membrane condition	X				
E - Walls/Curbs		X			Cracking and deterioration noted at walls.
F - Insulation				X	
G - Other				X	Wall penetrations both active and abandoned are not properly sealed.
