## HOUSING AUTHORITY Meeting Agenda

Thursday, November 7, 2024

Re: **Roof Consulting**  
Indian Wells Villas  
74800 Village Center Drive  
Indian Wells, CA 92210

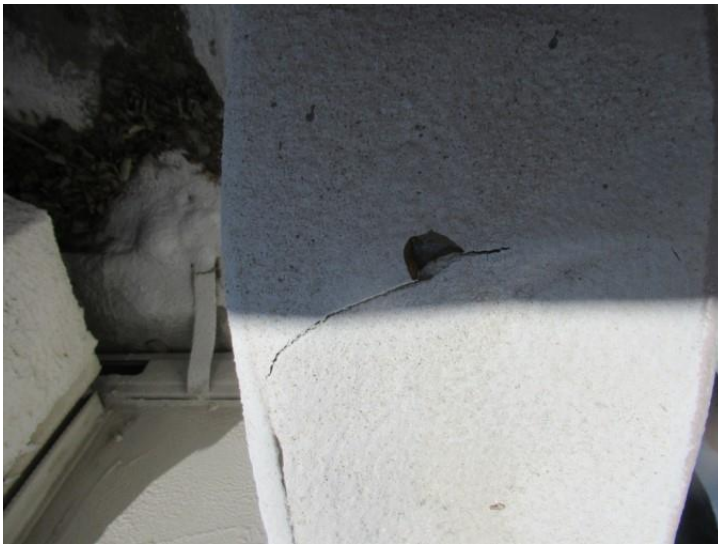
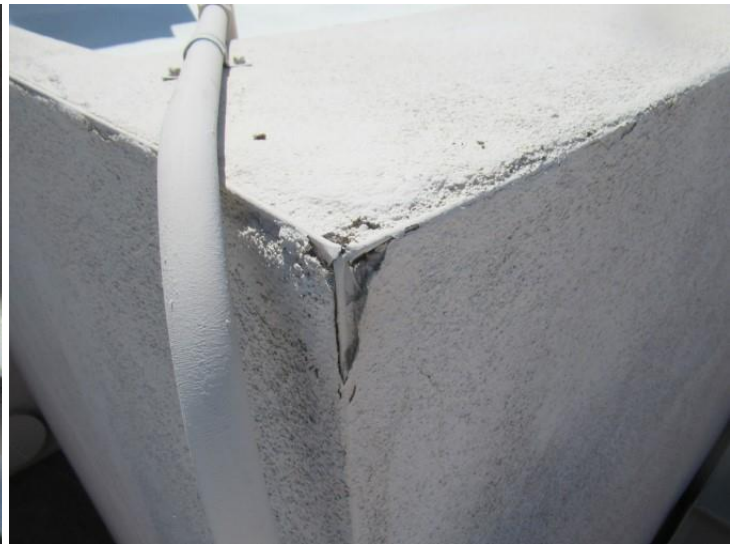
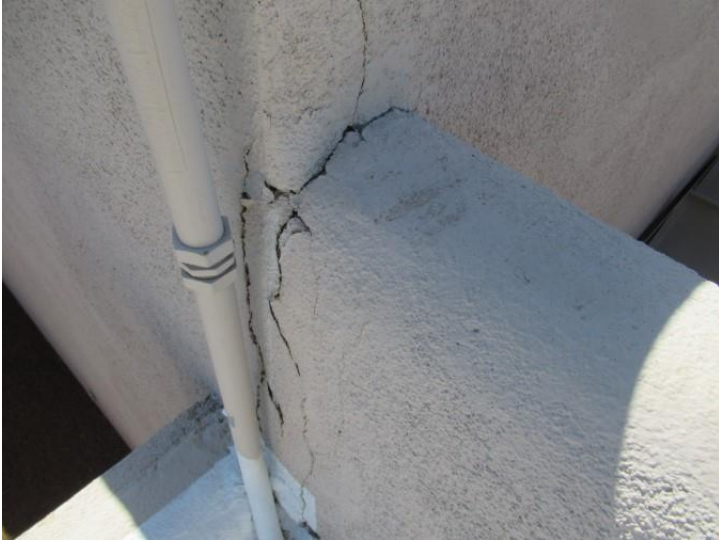
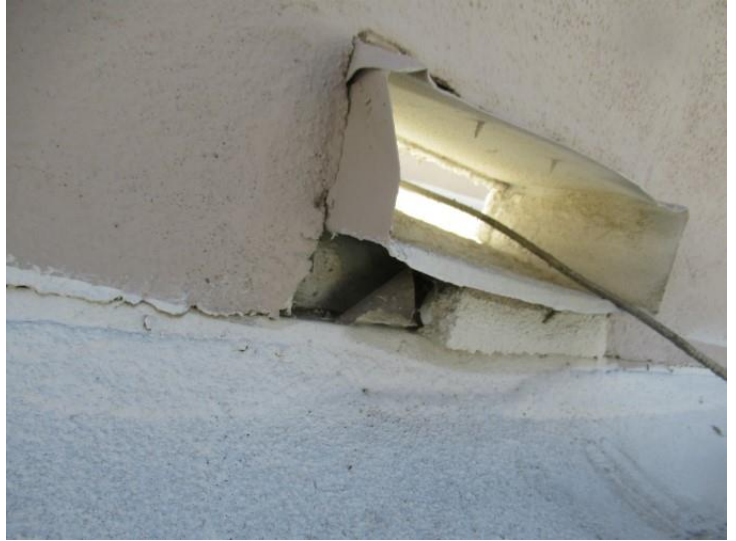
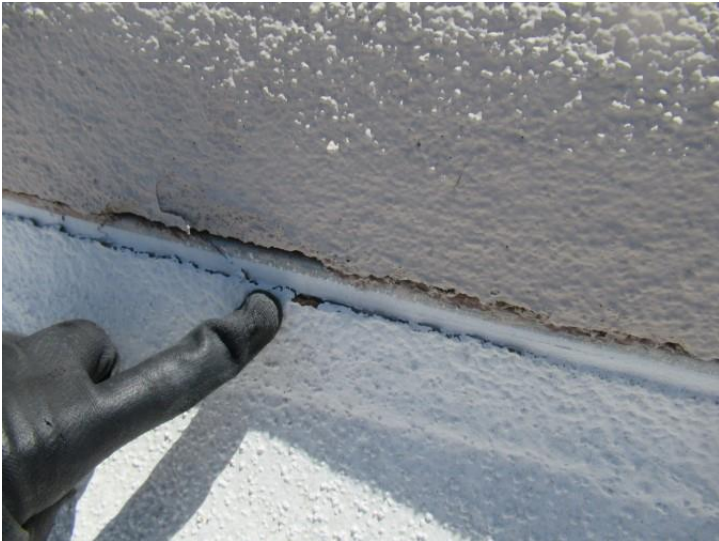
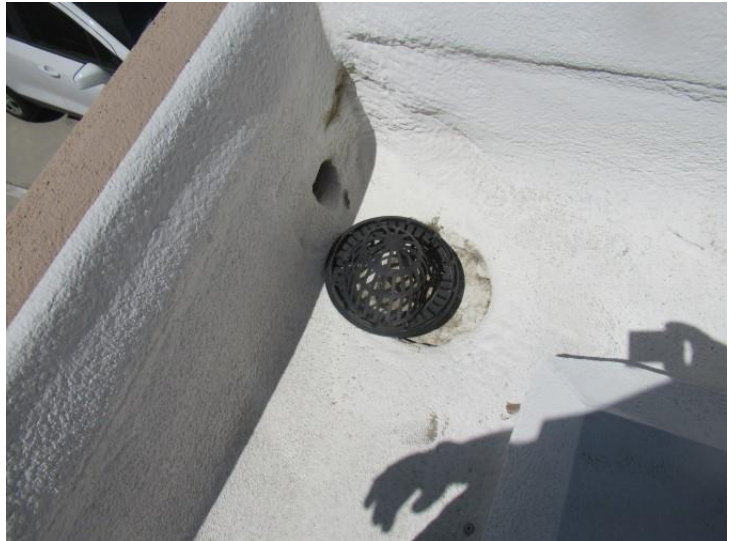
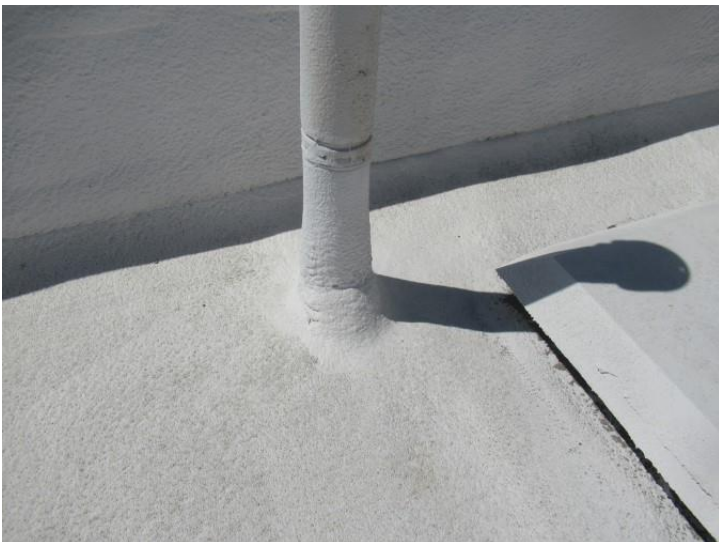
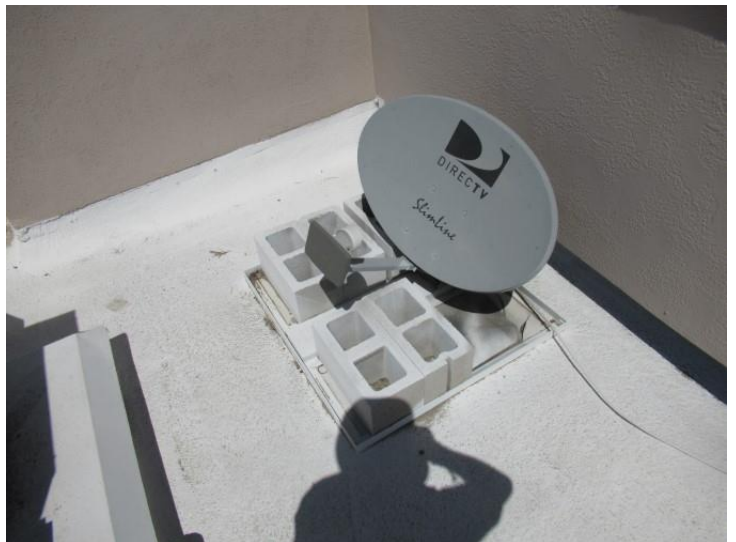
**Building 8 -**

ITEM	Good	Fair	Poor	N/A	COMMENTS
A - Perimeter details		X			Deteriorated foam noted at curtain walls.
B - Drainage		X			Missing covers noted at drains. Debris(leaves) noted at drains.
C - Penetration flashings	X				
D - Overall membrane condition	X				
E - Walls/Curbs		X			Cracking and deterioration noted at walls.
F - Insulation				X	
G - Other				X	Wall penetrations both active and abandoned are not properly sealed.

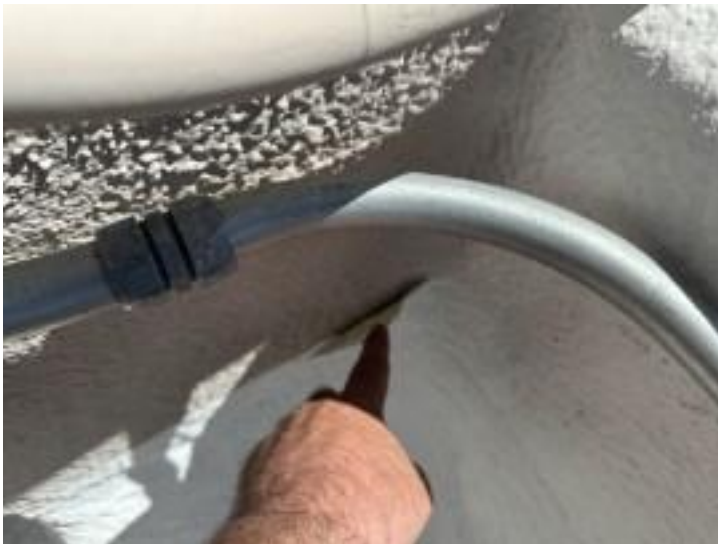
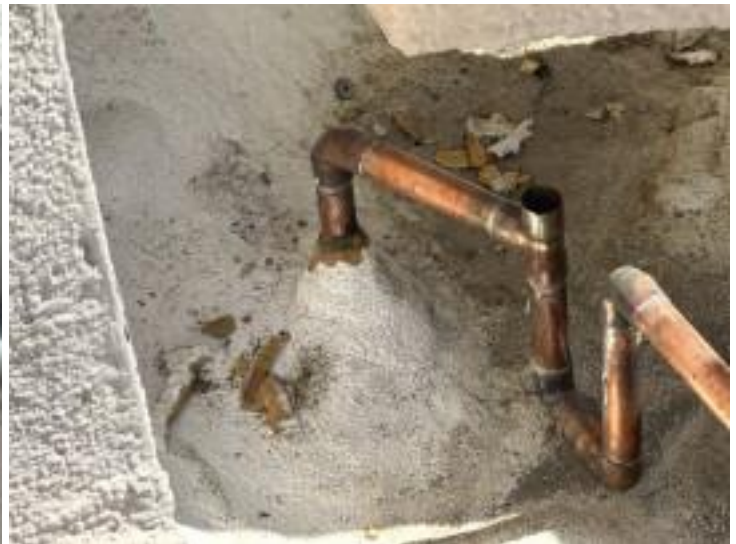
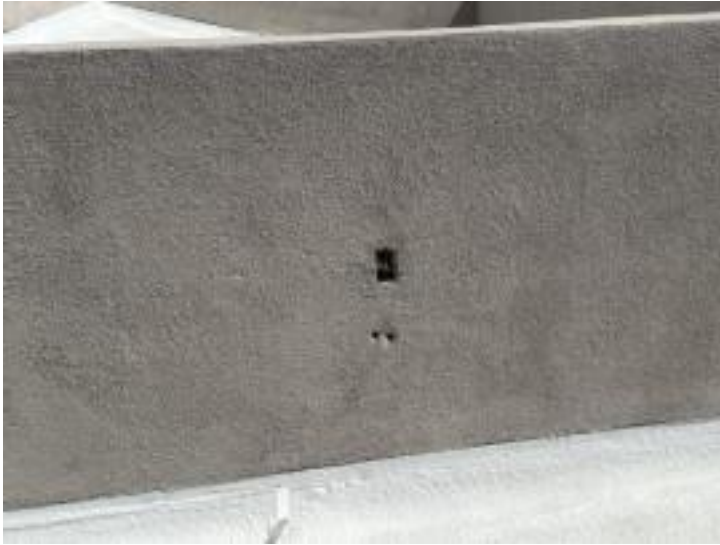
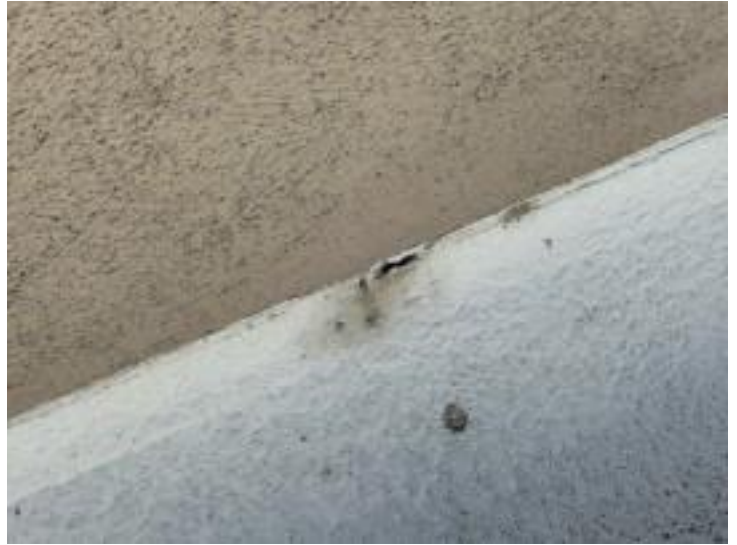
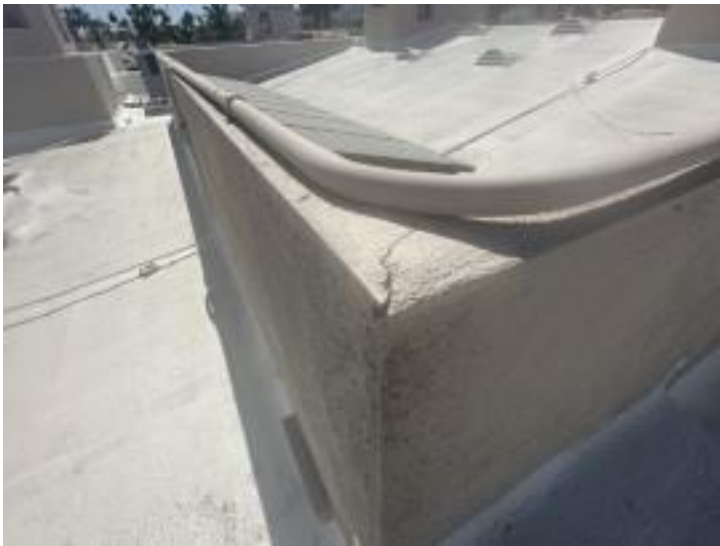
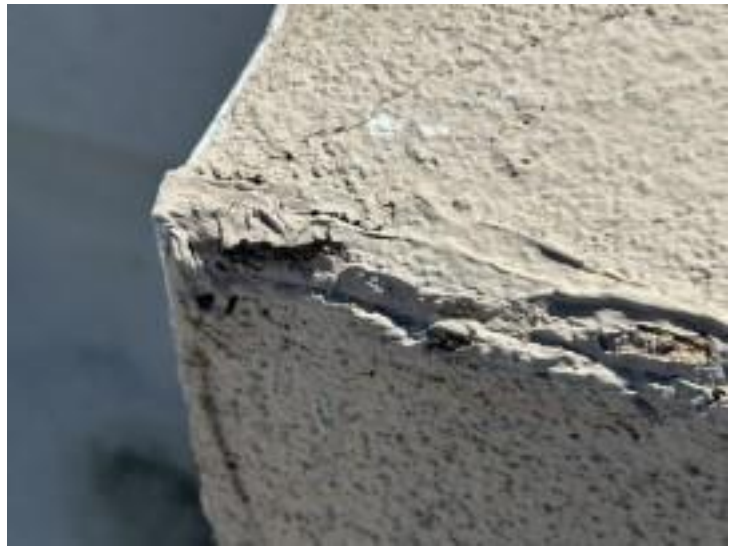
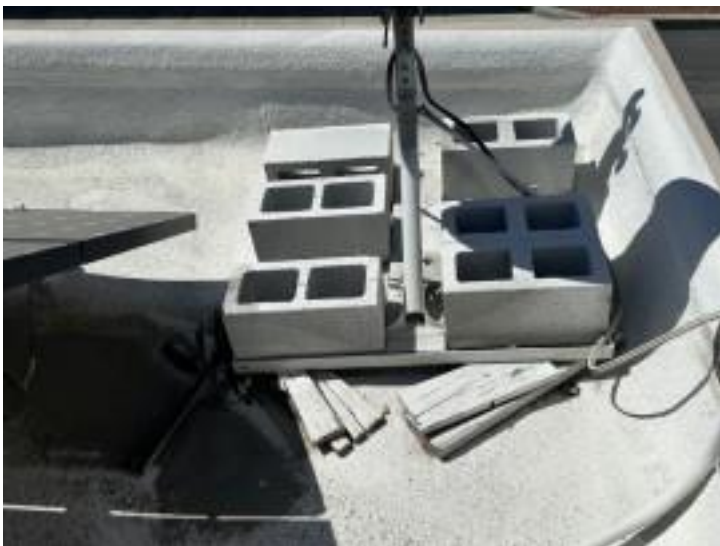
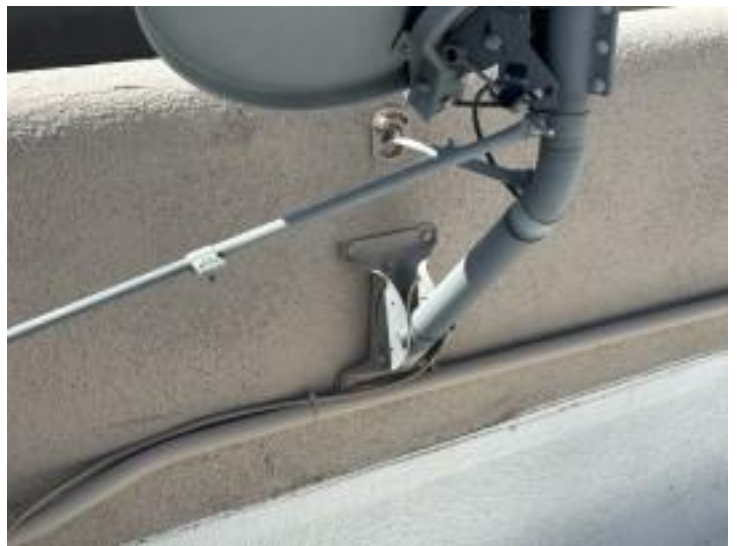
**Building 9 -**

ITEM	Good	Fair	Poor	N/A	COMMENTS
A - Perimeter details		X			Deteriorated foam noted at curtain walls.
B - Drainage		X			Missing covers noted at drains. Debris(leaves) noted at drains.
C - Penetration flashings		X			Deterioration noted at the copper line penetration flashing.
D - Overall membrane condition	X				
E - Walls/Curbs		X			Cracking and deterioration noted at walls.
F - Insulation				X	
G - Other				X	Wall penetrations both active and abandoned are not properly sealed.

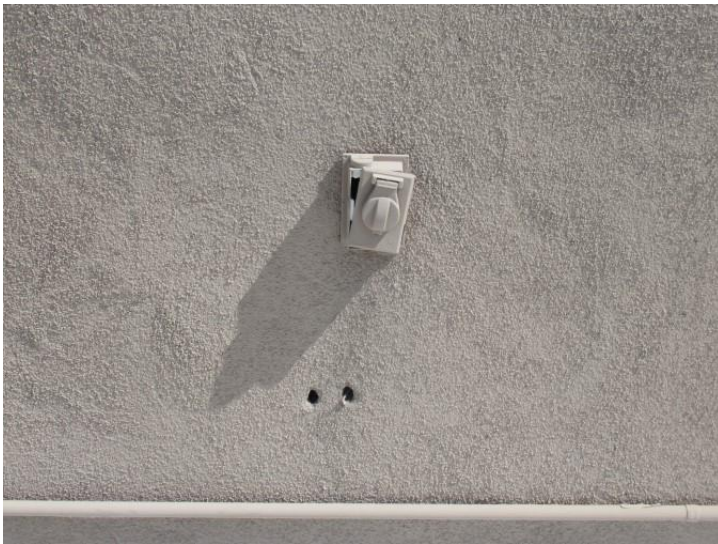
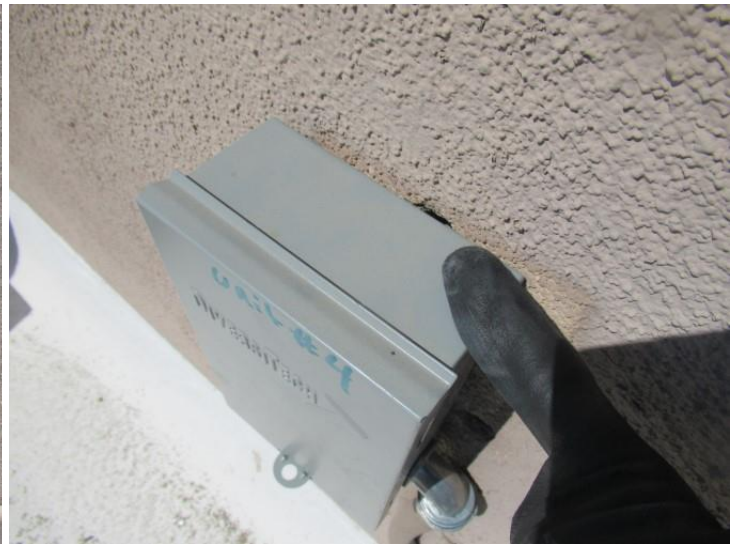
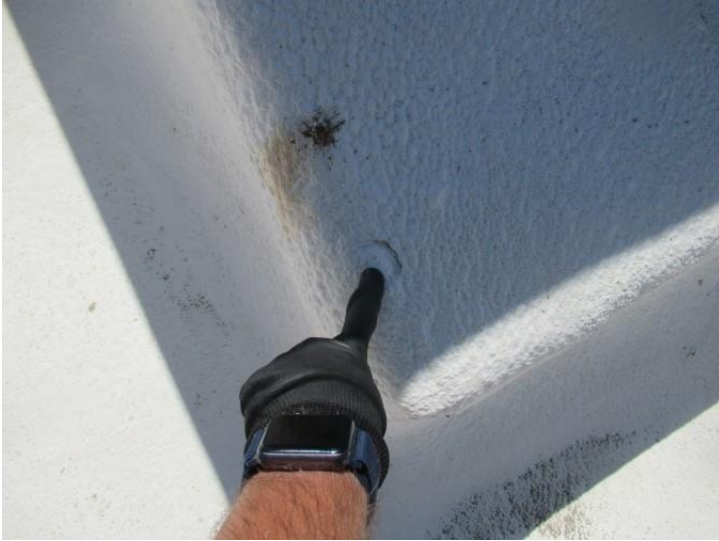
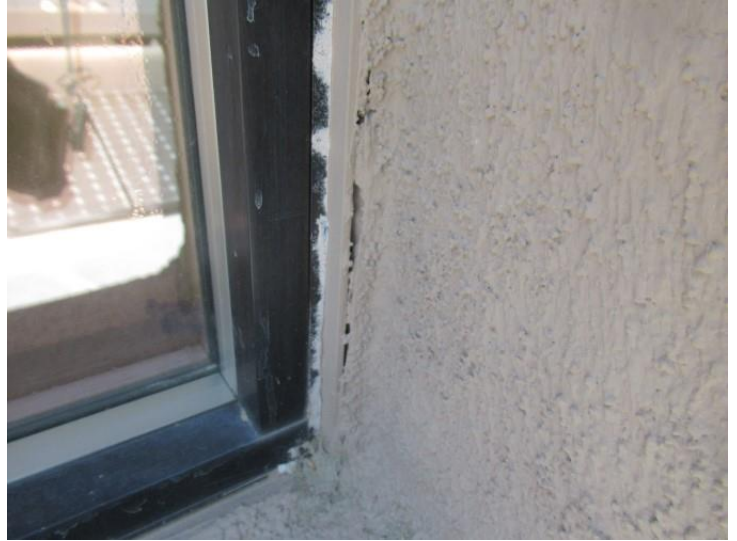
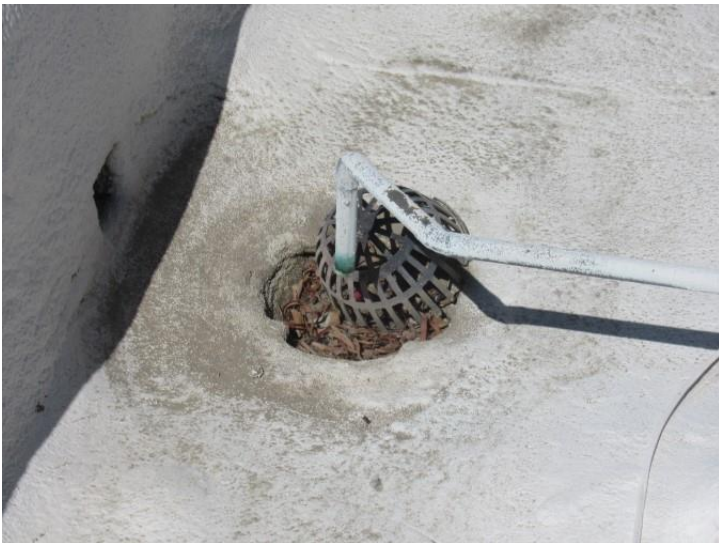
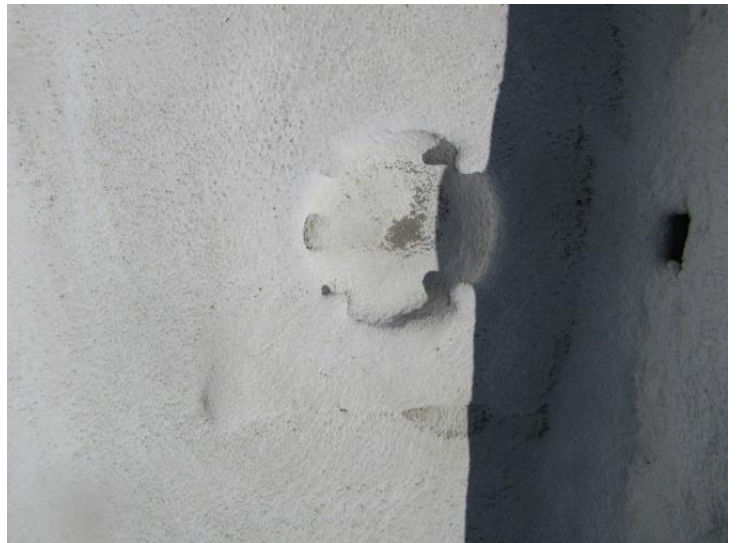
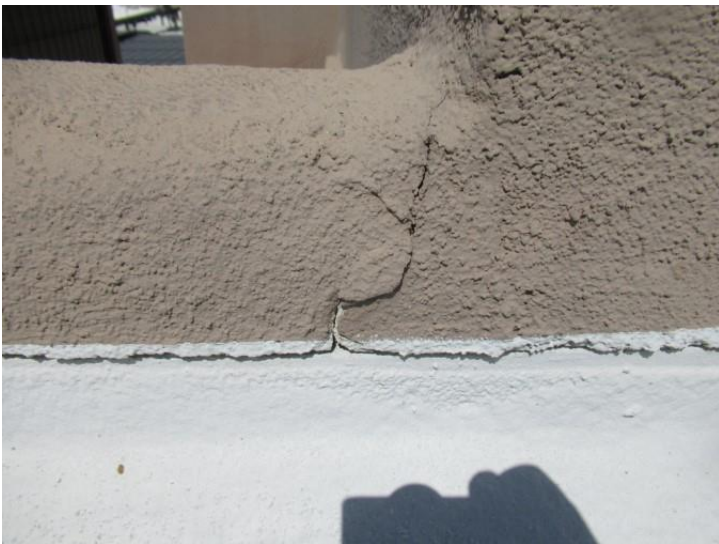
**Building 10 -**

ITEM	Good	Fair	Poor	N/A	COMMENTS
A - Perimeter details		X			Deteriorated foam noted at curtain walls.
B - Drainage		X			Missing covers noted at drains. Debris(leaves) noted at drains.
C - Penetration flashings	X				
D - Overall membrane condition	X				
E - Walls/Curbs		X			Cracking and deterioration noted at walls.
F - Insulation				X	
G - Other				X	Wall penetrations both active and abandoned are not properly sealed.

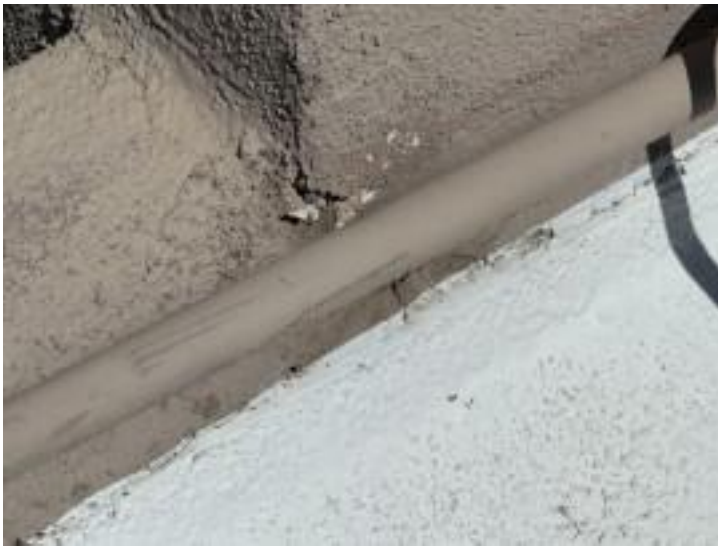
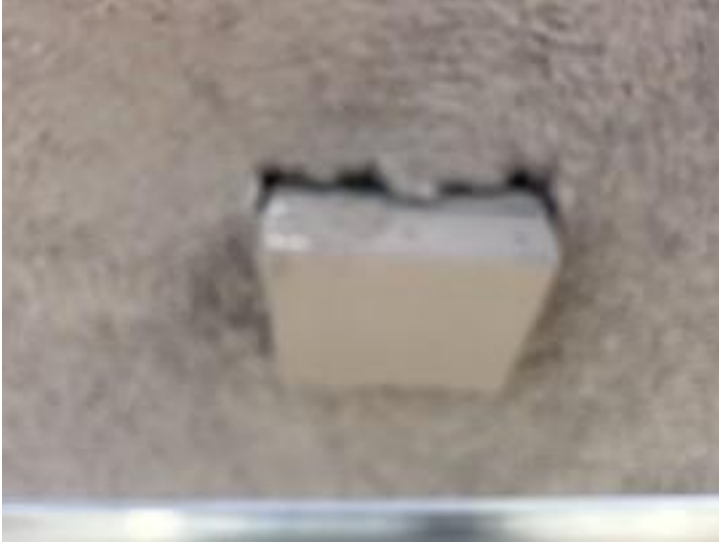
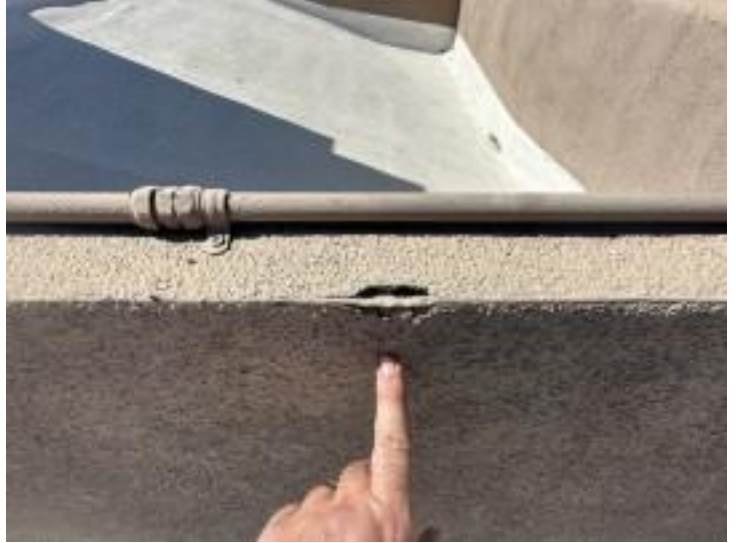
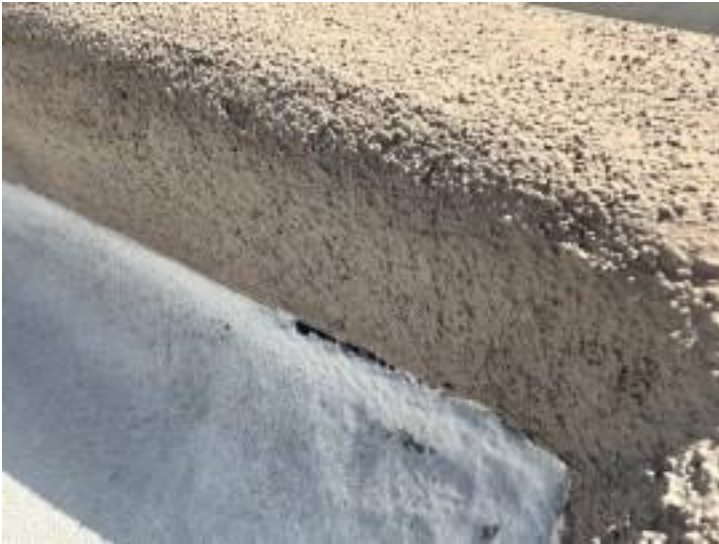
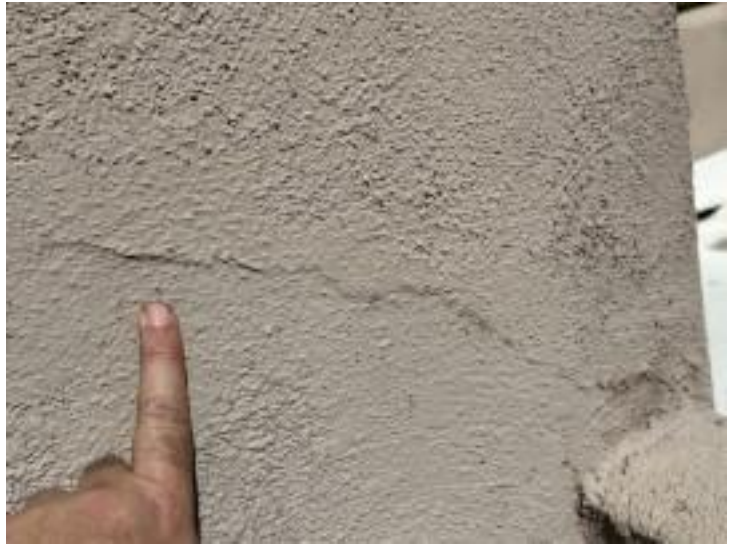
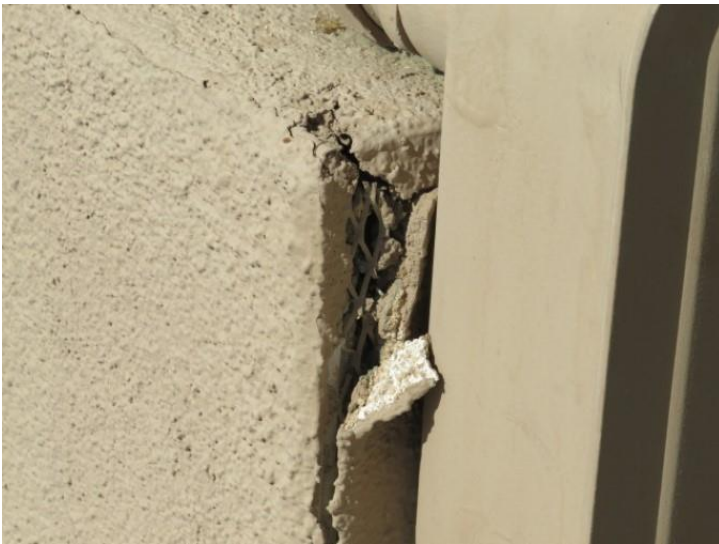
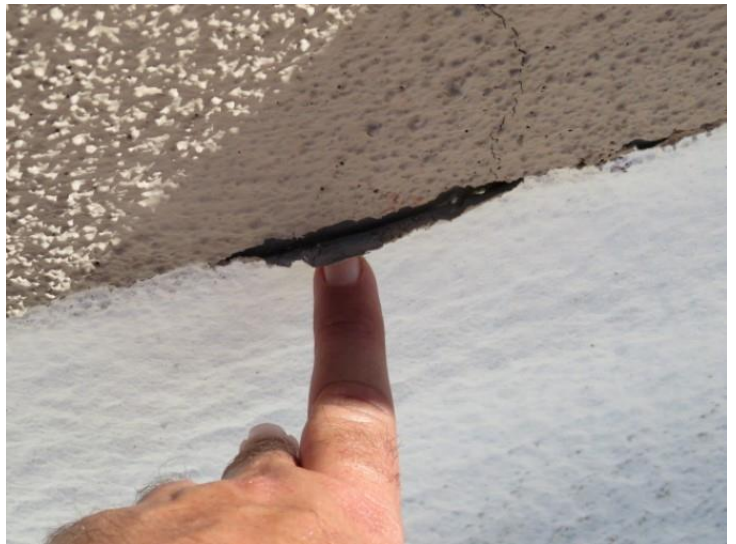
**Building 11 -**

ITEM	Good	Fair	Poor	N/A	COMMENTS
A - Perimeter details		X			Deteriorated foam noted at curtain walls.
B - Drainage		X			Missing covers noted at drains. Debris(leaves) noted at drains.
C - Penetration flashings	X				
D - Overall membrane condition	X				
E - Walls/Curbs		X			Cracking and deterioration noted at walls.
F - Insulation				X	
G - Other				X	Wall penetrations both active and abandoned are not properly sealed.

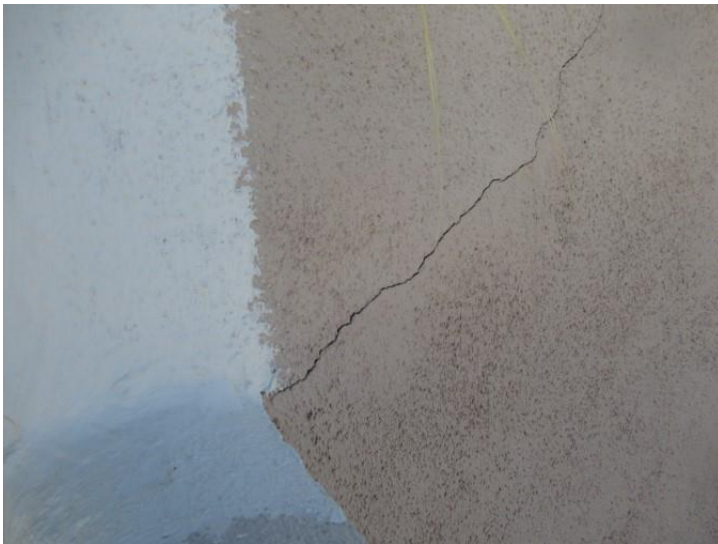
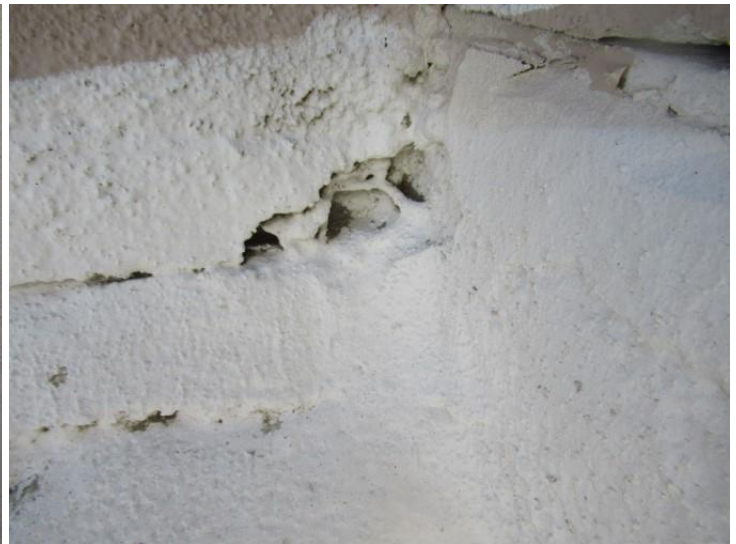
**Building 12 -**

ITEM	Good	Fair	Poor	N/A	COMMENTS
A - Perimeter details		X			Deteriorated foam noted at curtain walls.
B - Drainage		X			Missing covers noted at drains. Debris(leaves) noted at drains.
C - Penetration flashings	X				
D - Overall membrane condition	X				
E - Walls/Curbs		X			Cracking and deterioration noted at walls.
F - Insulation				X	
G - Other				X	Wall penetrations both active and abandoned are not properly sealed.

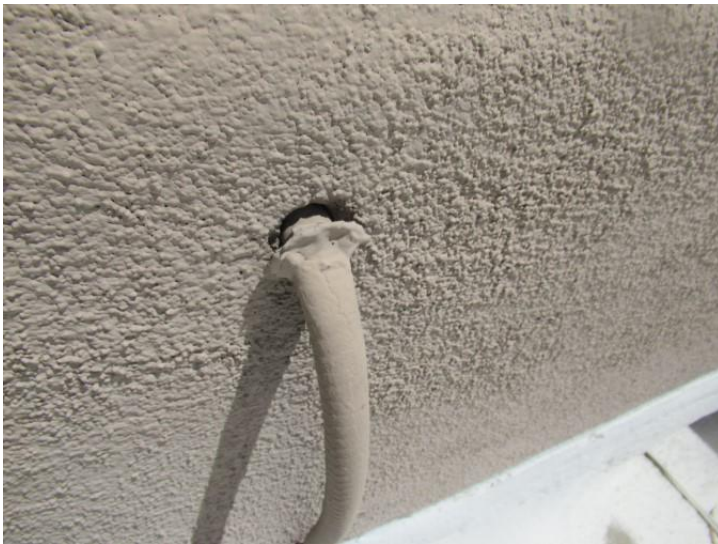
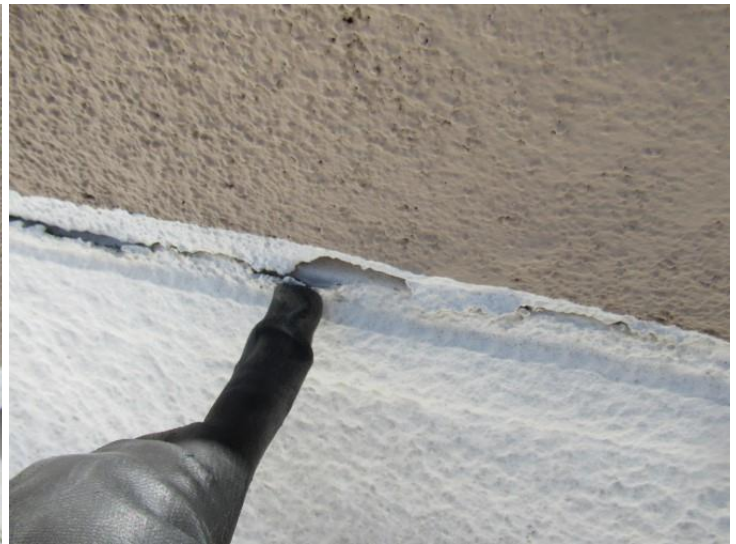
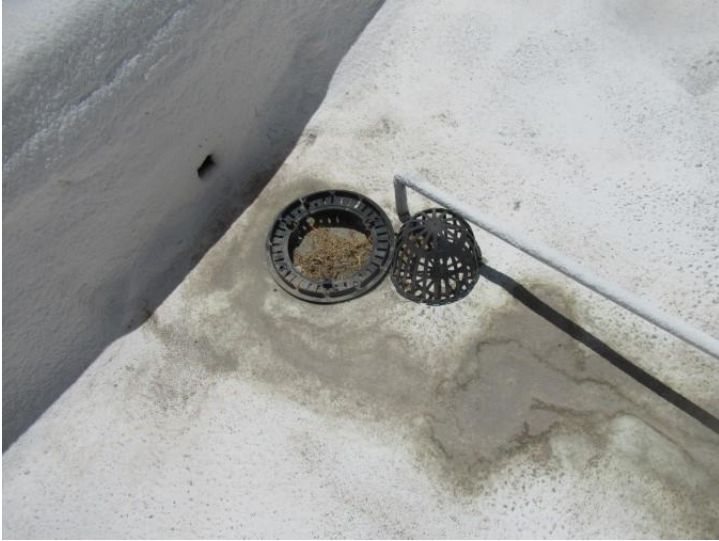
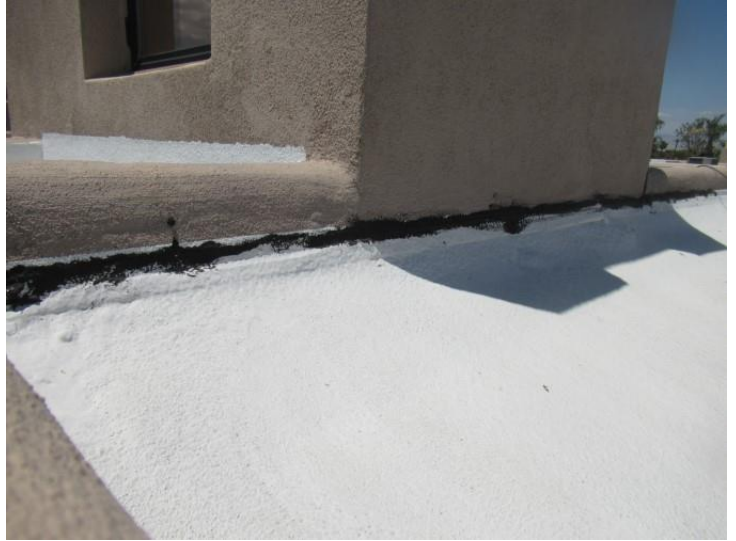
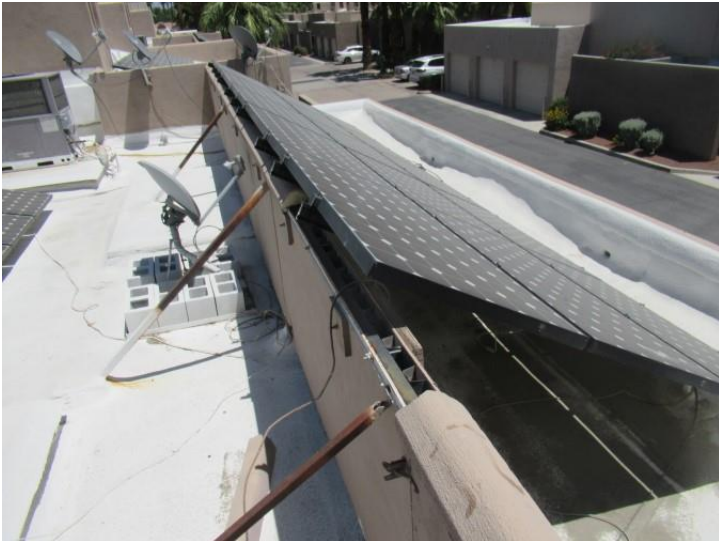
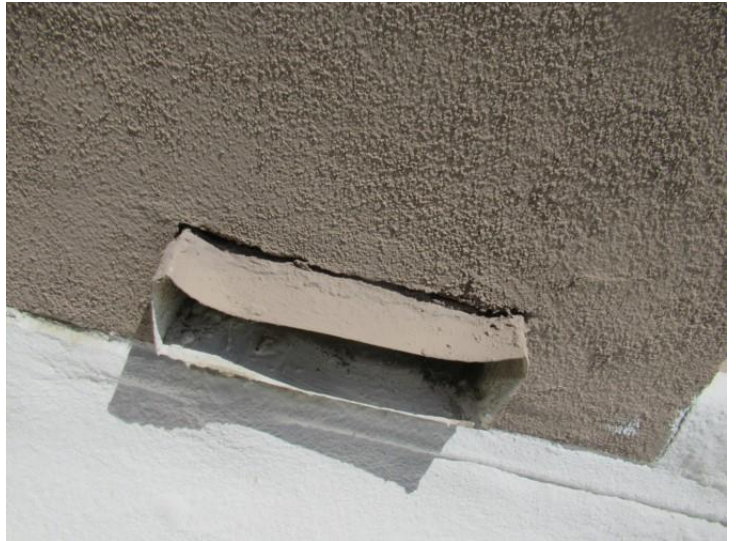
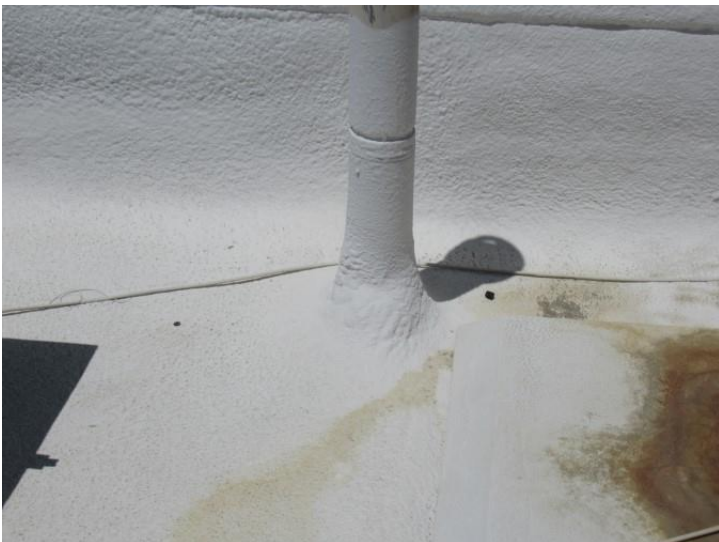
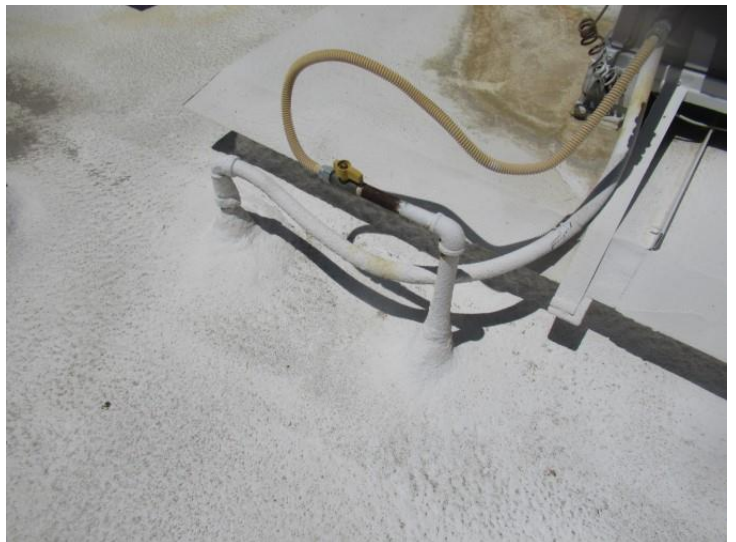
**Building 13 -**

ITEM	Good	Fair	Poor	N/A	COMMENTS
A - Perimeter details		X			Deteriorated foam noted at curtain walls.
B - Drainage		X			Missing covers noted at drains. Debris(leaves) noted at drains.
C - Penetration flashings	X				
D - Overall membrane condition	X				
E - Walls/Curbs		X			Cracking and deterioration noted at walls.
F - Insulation				X	
G - Other				X	Wall penetrations both active and abandoned are not properly sealed.

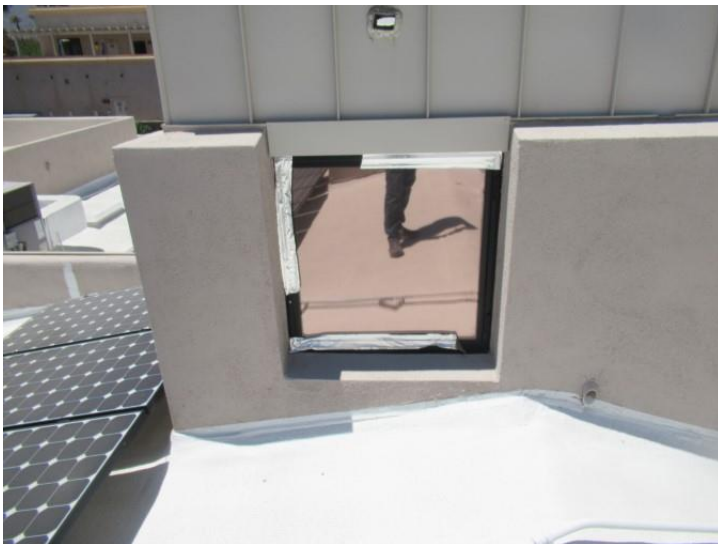
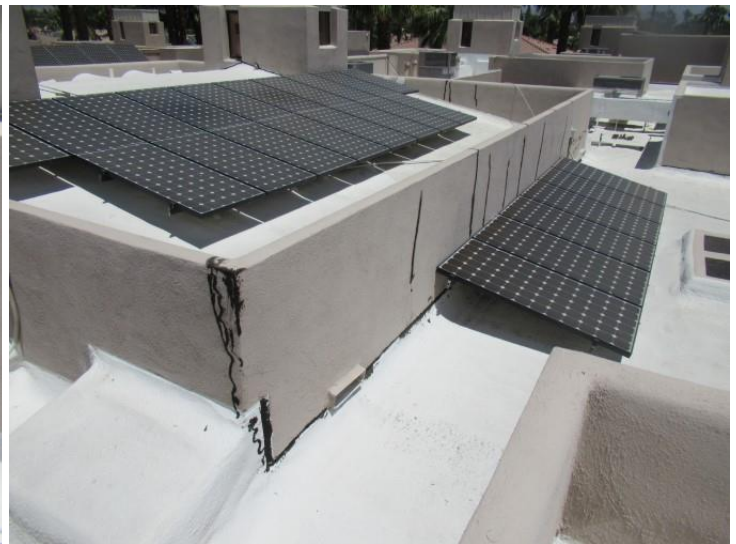
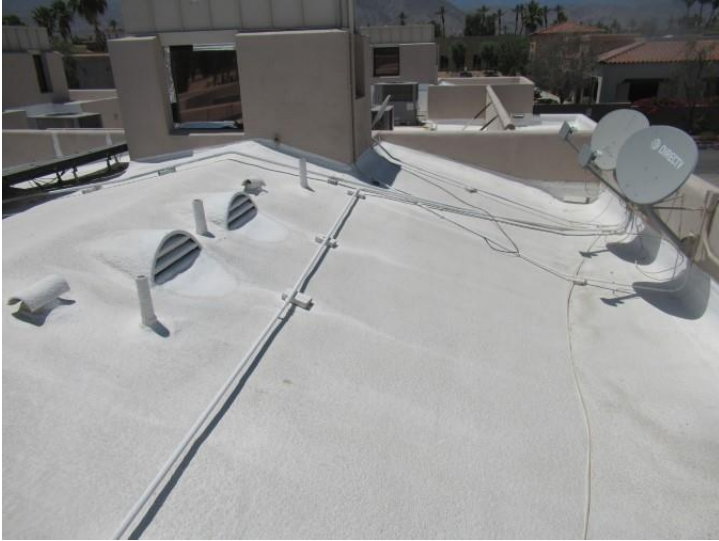
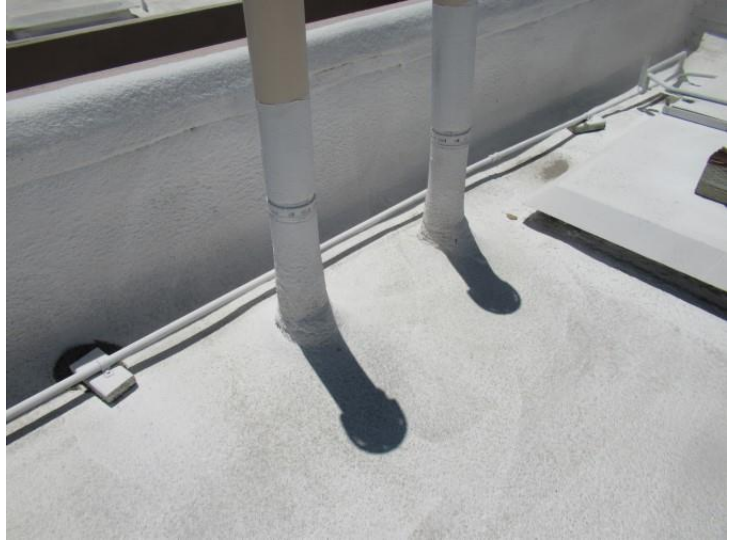
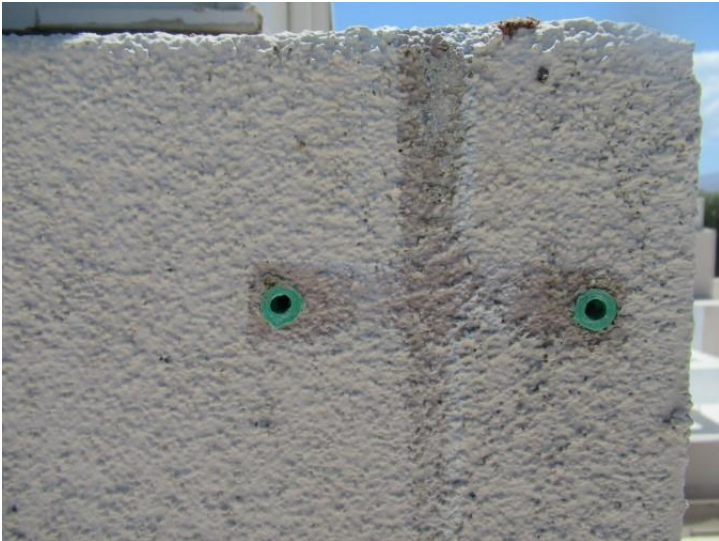
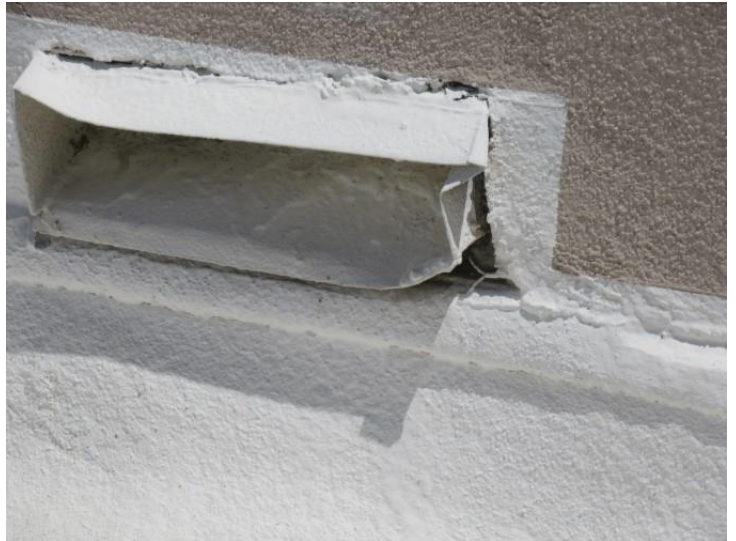
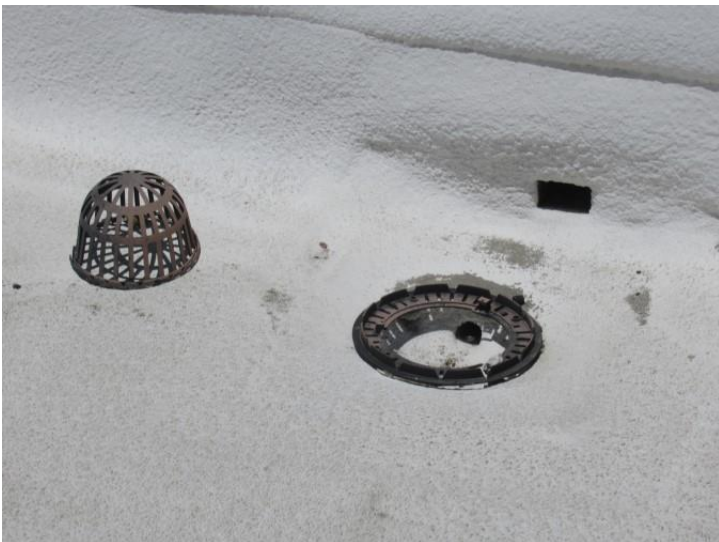
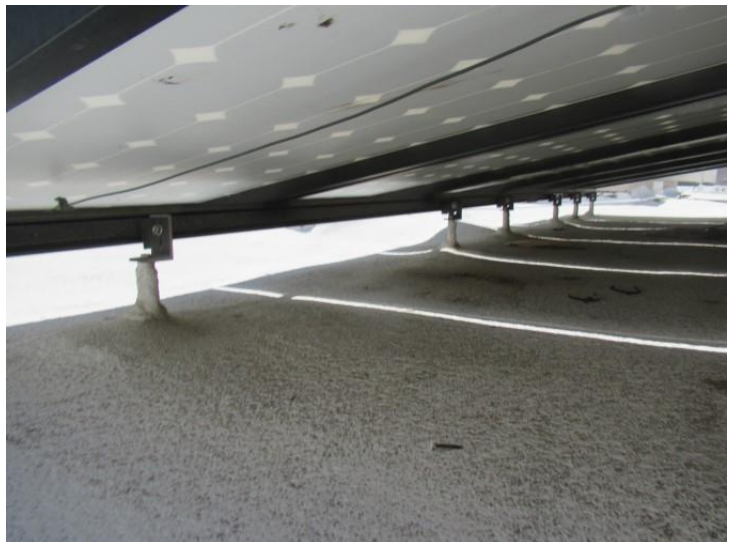
**Building 14 -**

ITEM	Good	Fair	Poor	N/A	COMMENTS
A - Perimeter details		X			Deteriorated foam noted at curtain walls.
B - Drainage		X			Missing covers noted at drains. Debris(leaves) noted at drains.
C - Penetration flashings	X				
D - Overall membrane condition	X				
E - Walls/Curbs		X			Cracking and deterioration noted at walls.
F - Insulation				X	
G - Other				X	Wall penetrations both active and abandoned are not properly sealed.  Tape noted at window, likely temporary repair.

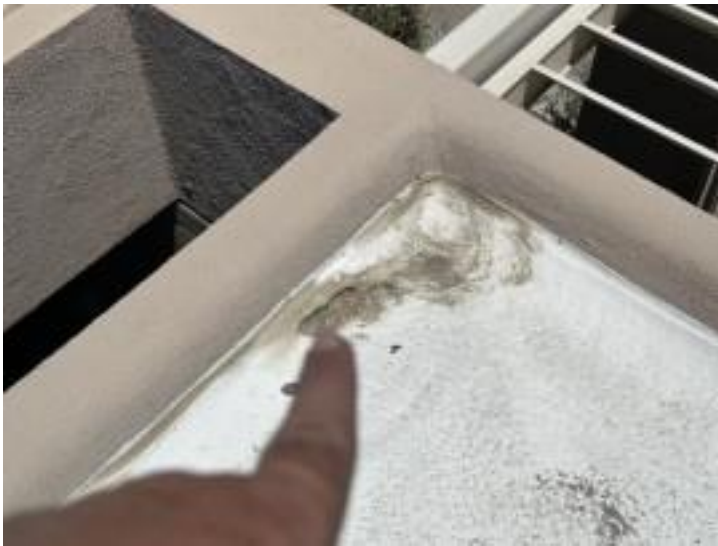
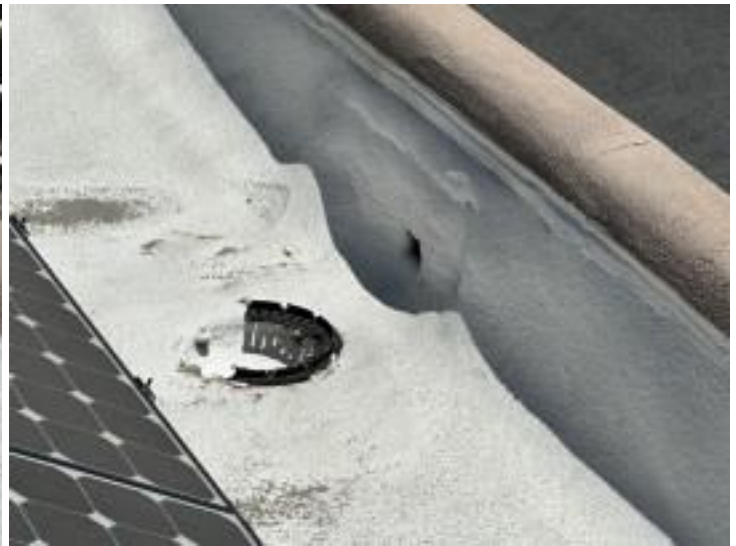
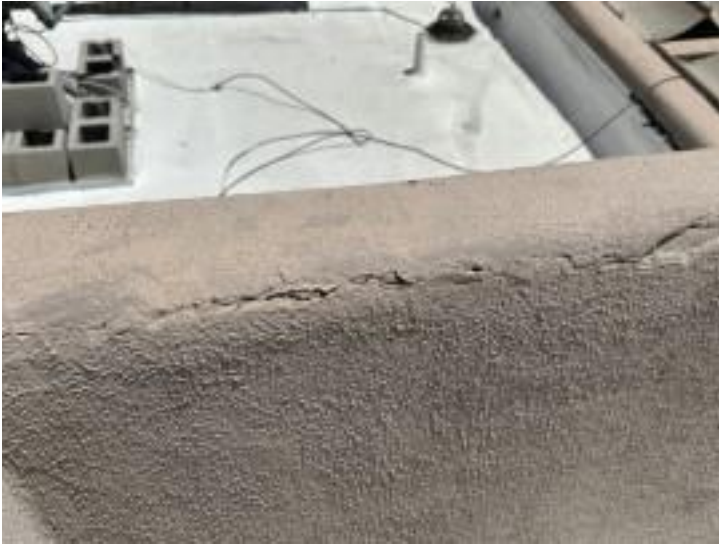
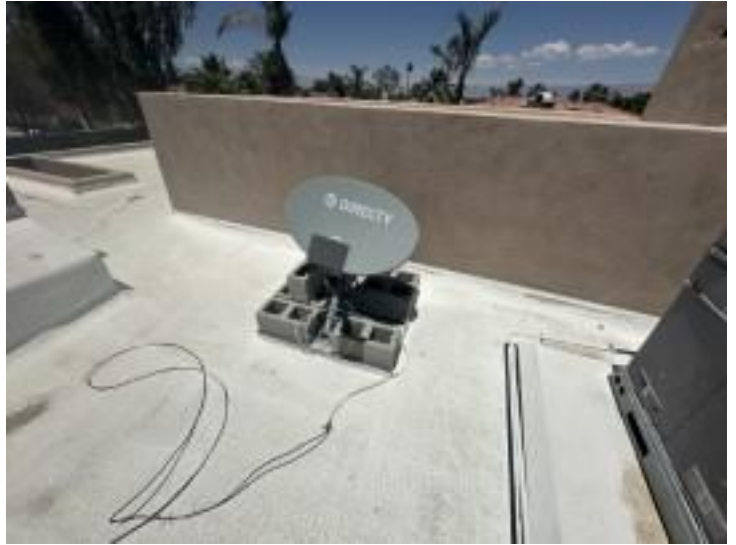
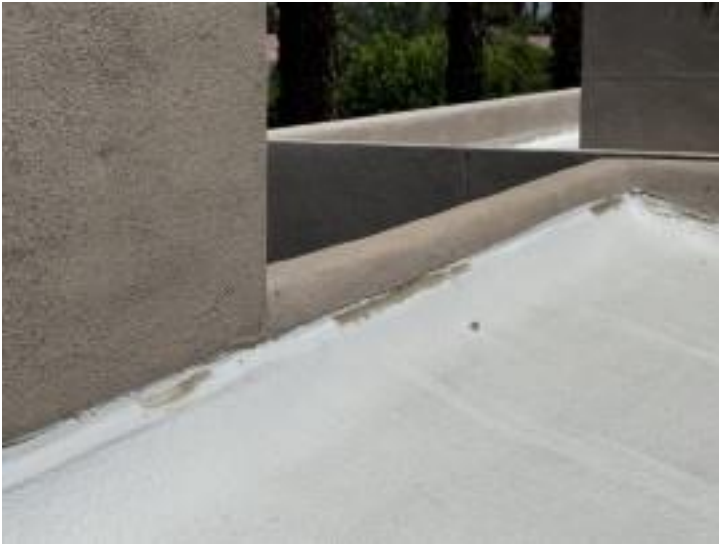
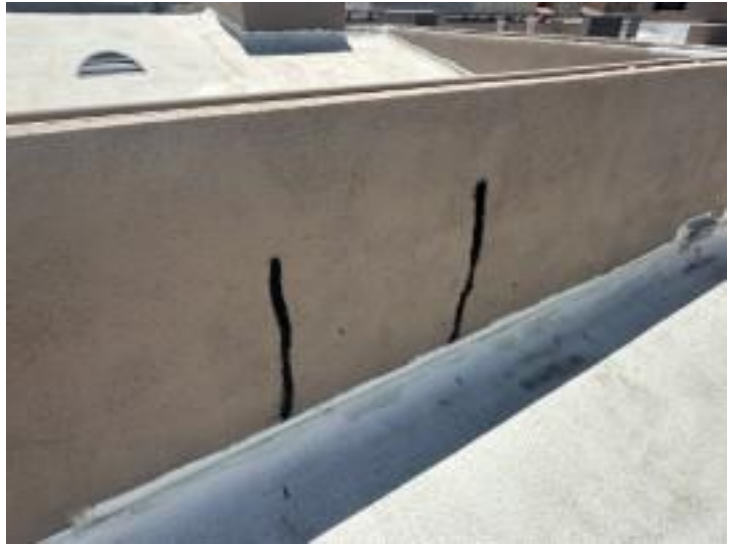
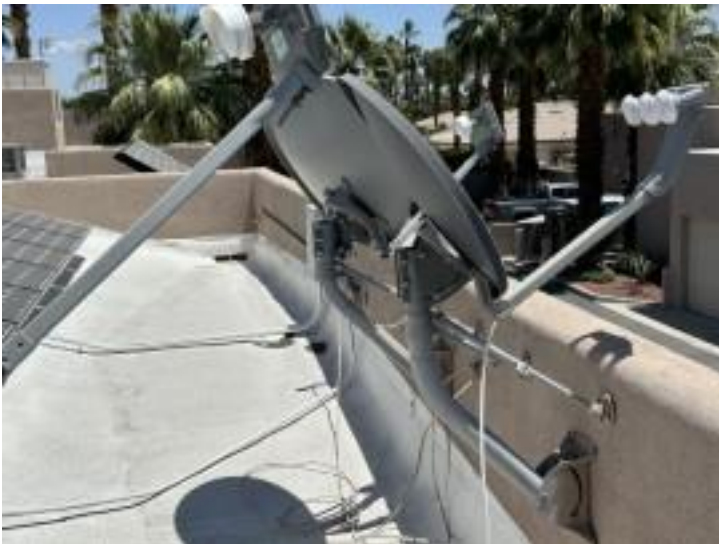
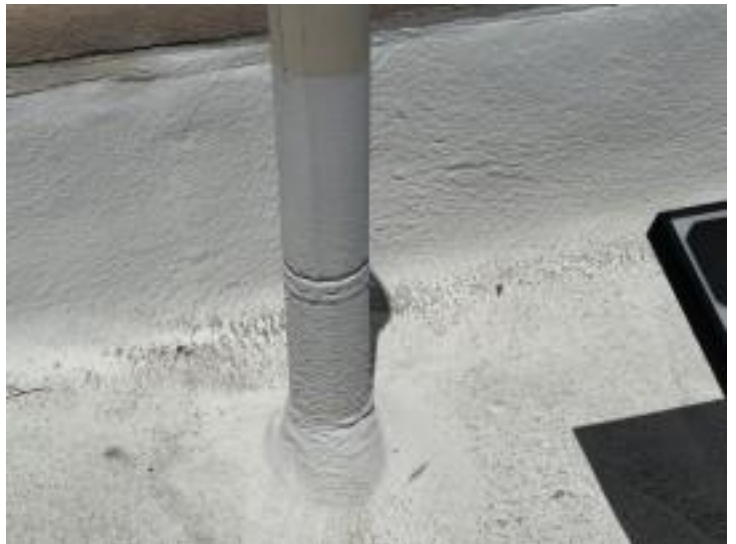
**Building 15 -**

ITEM	Good	Fair	Poor	N/A	COMMENTS
A - Perimeter details		X			Deteriorated foam noted at curtain walls.
B - Drainage		X			Missing covers noted at drains. Debris(leaves) noted at drains.
C - Penetration flashings	X				
D - Overall membrane condition		X			Large gap noted at membrane in back corner.
E - Walls/Curbs		X			Cracking and deterioration noted at walls.
F - Insulation				X	
G - Other				X	Wall penetrations both active and abandoned are not properly sealed.  Ensure satellite dishes have slip sheets.
