## HOUSING AUTHORITY Meeting Agenda

Thursday, November 7, 2024

Re: **Roof Consulting**  
Indian Wells Villas  
74800 Village Center Drive  
Indian Wells, CA 92210

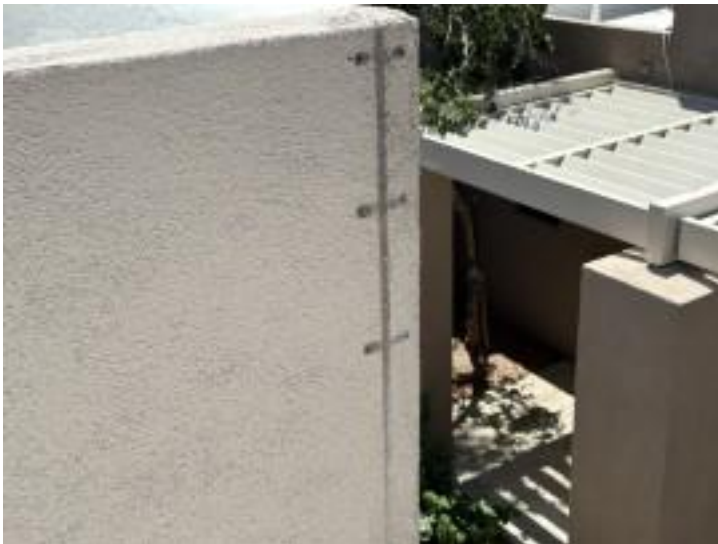
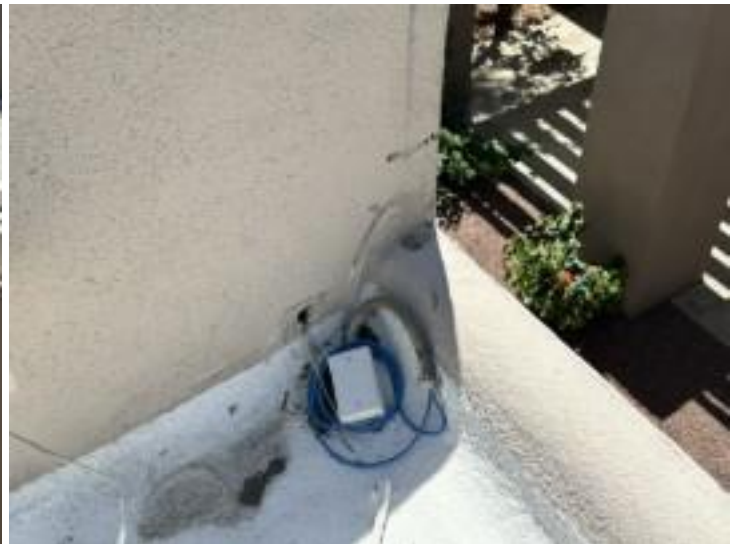
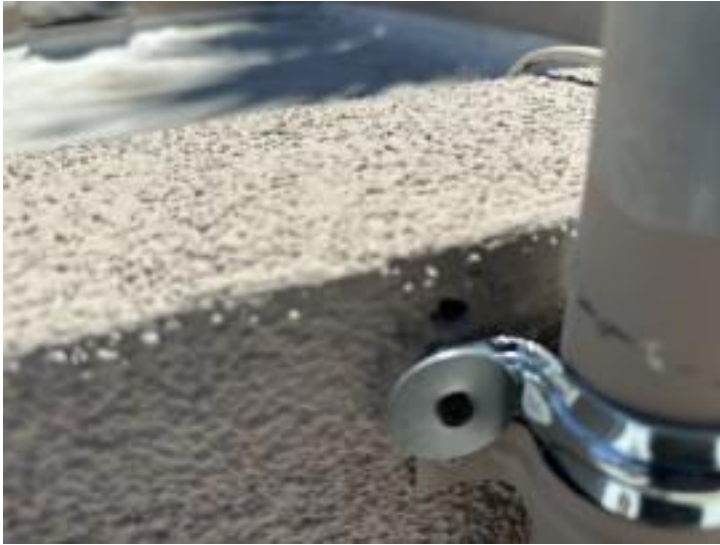
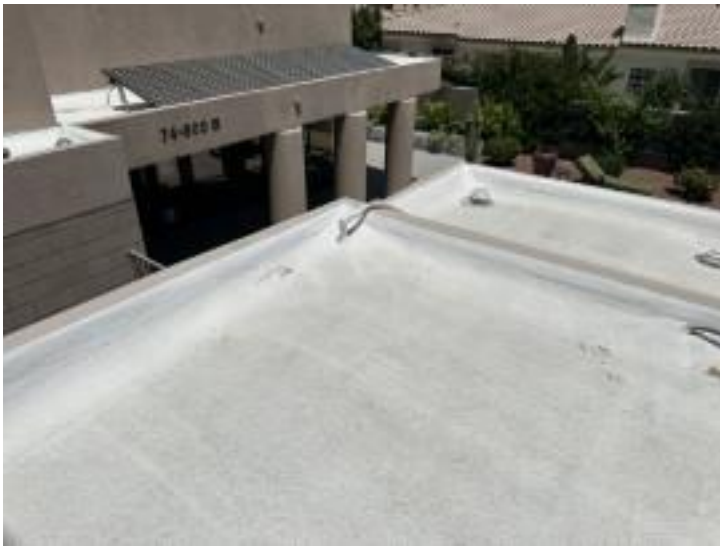
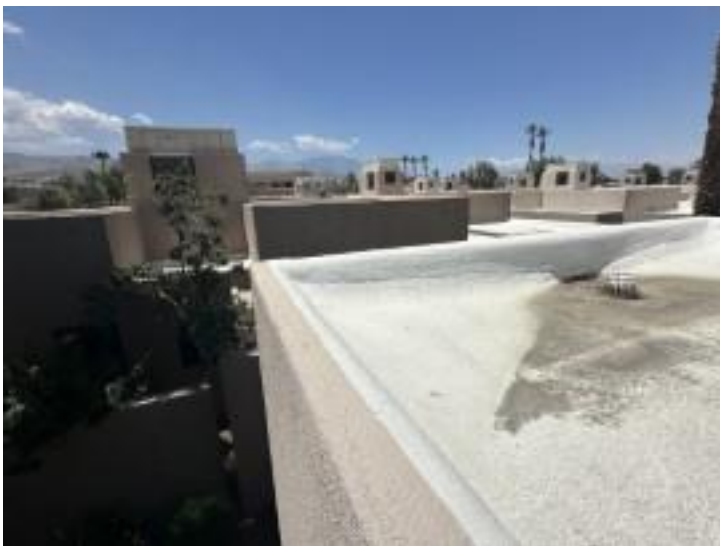
**Building 16 -**

ITEM	Good	Fair	Poor	N/A	COMMENTS
A - Perimeter details		X			Deteriorated foam noted at curtain walls.
B - Drainage		X			Missing covers noted at drains. Debris(leaves) noted at drains.
C - Penetration flashings	X				
D - Overall membrane condition	X				
E - Walls/Curbs		X			Cracking and deterioration noted at walls.
F - Insulation				X	
G - Other				X	Wall penetrations both active and abandoned are not properly sealed.

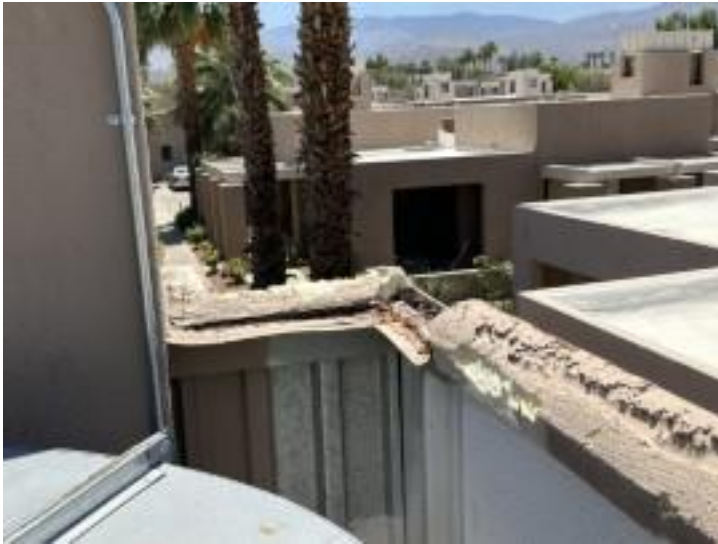
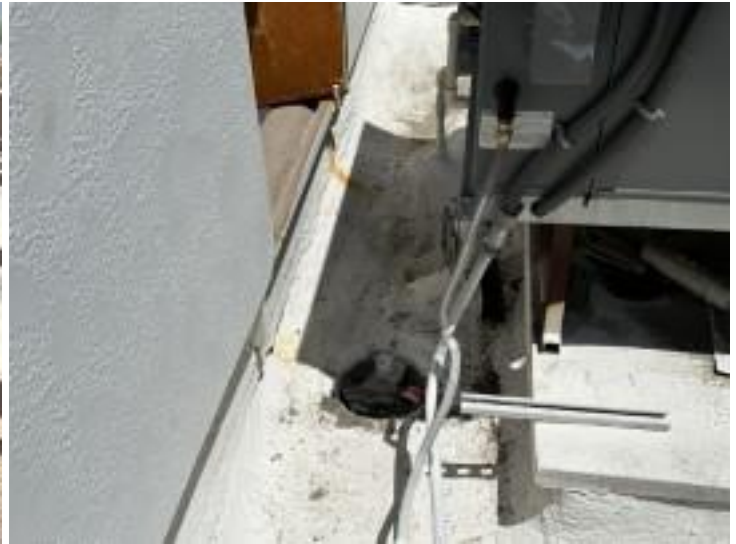
**Building 17 -**

ITEM	Good	Fair	Poor	N/A	COMMENTS
A - Perimeter details		X			Deteriorated foam noted at curtain walls.
B - Drainage		X			Missing covers noted at drains. Debris(leaves) noted at drains.
C - Penetration flashings	X				
D - Overall membrane condition	X				
E - Walls/Curbs		X			Cracking and deterioration noted at walls.
F - Insulation				X	
G - Other				X	Wall penetrations both active and abandoned are not properly sealed.

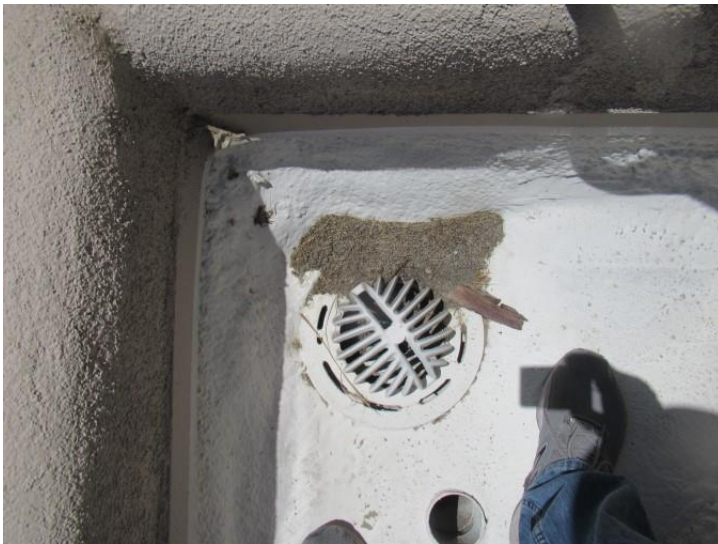
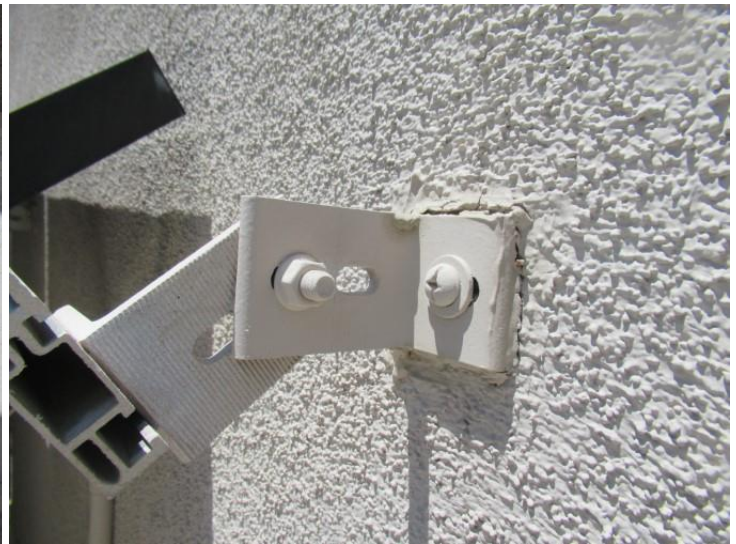
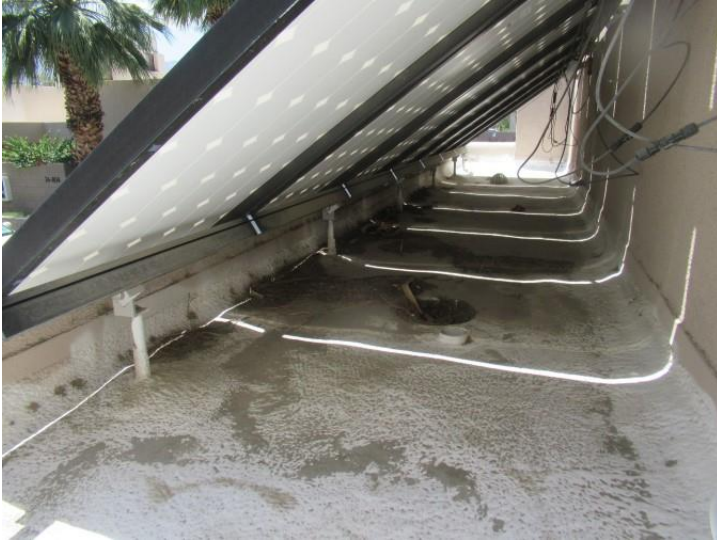
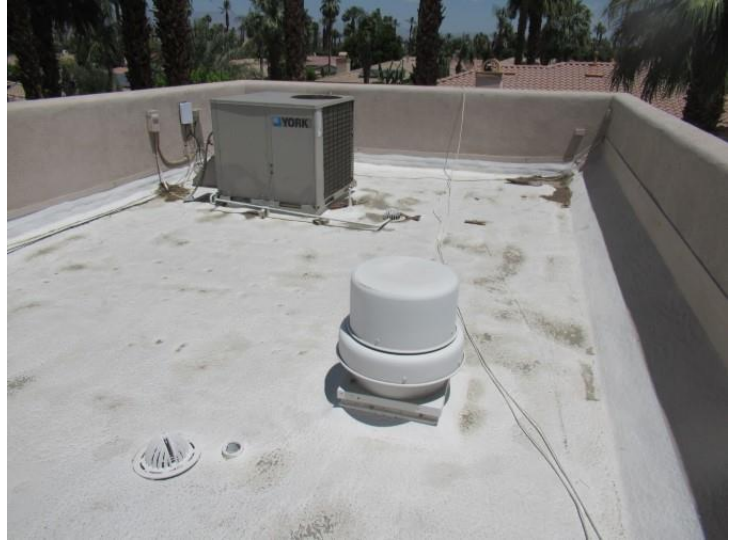
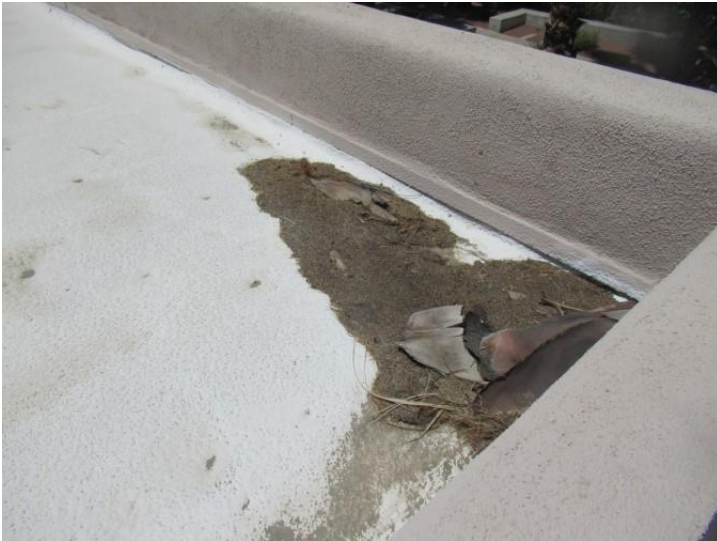
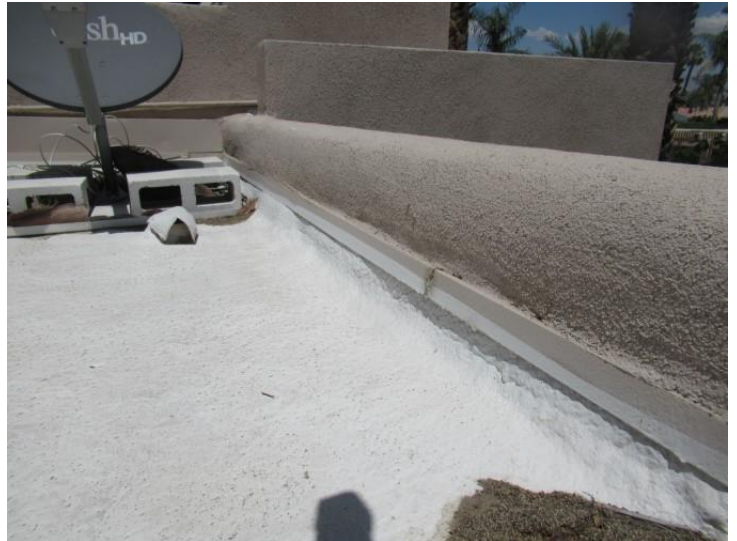
**Building 18 -**

ITEM	Good	Fair	Poor	N/A	COMMENTS
A - Perimeter details		X			Deteriorated foam noted at curtain walls.
B - Drainage		X			Missing covers noted at drains. Debris(leaves) noted at drains.
C - Penetration flashings	X				
D - Overall membrane condition	X				
E - Walls/Curbs		X			Cracking and deterioration noted at walls.
F - Insulation				X	
G - Other				X	Wall penetrations both active and abandoned are not properly sealed.

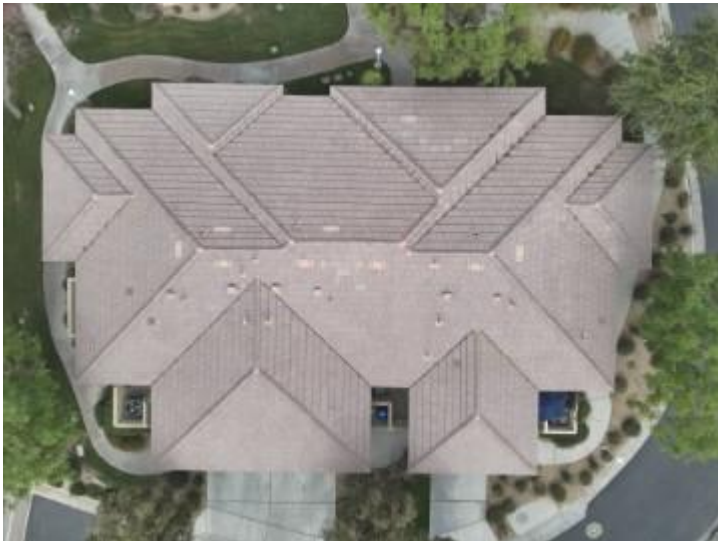
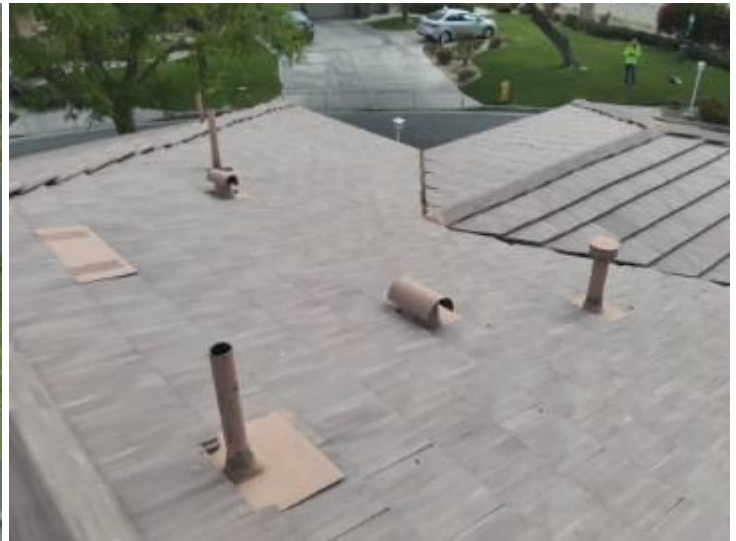
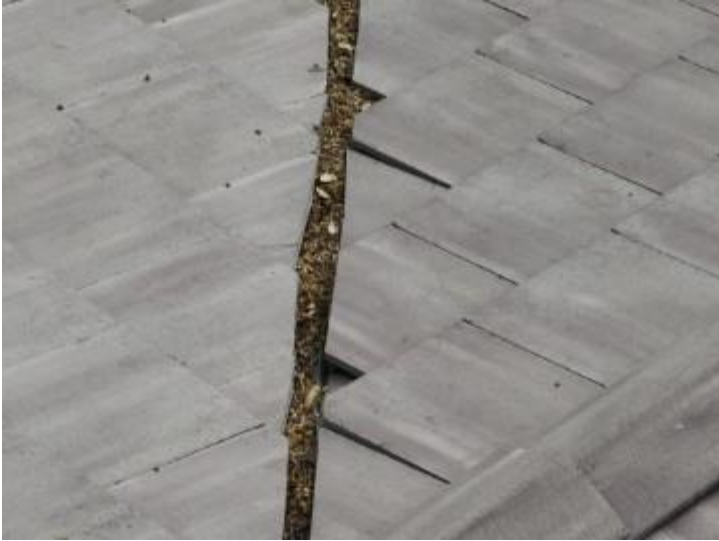
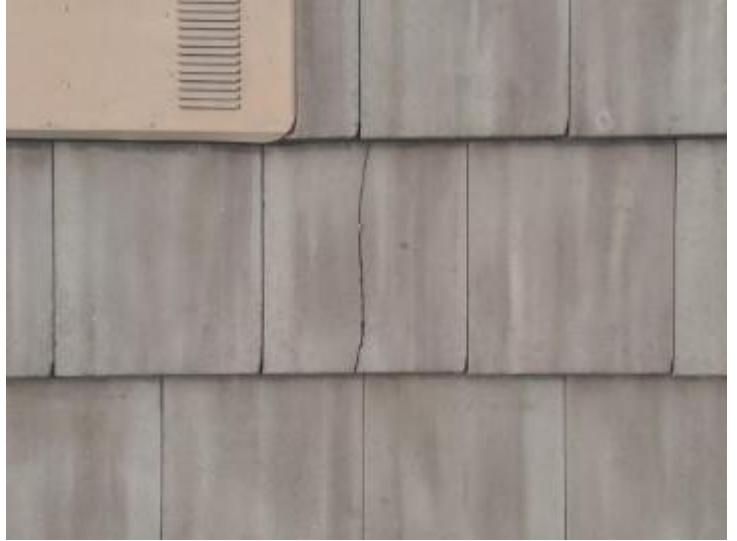
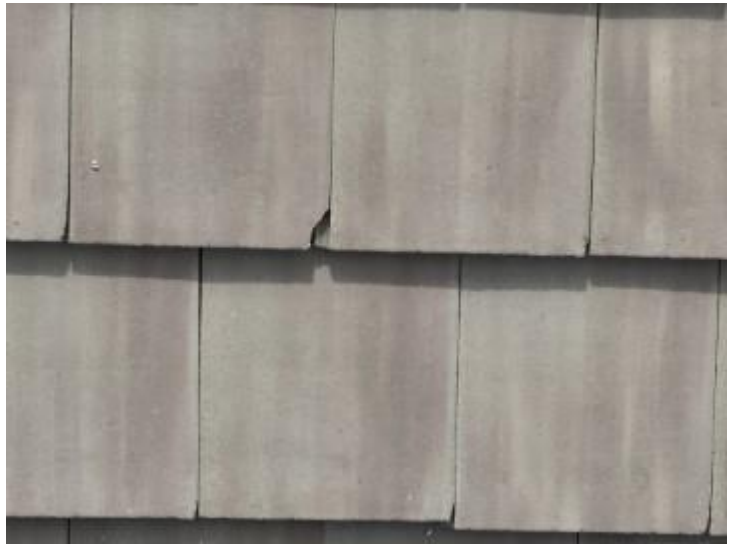
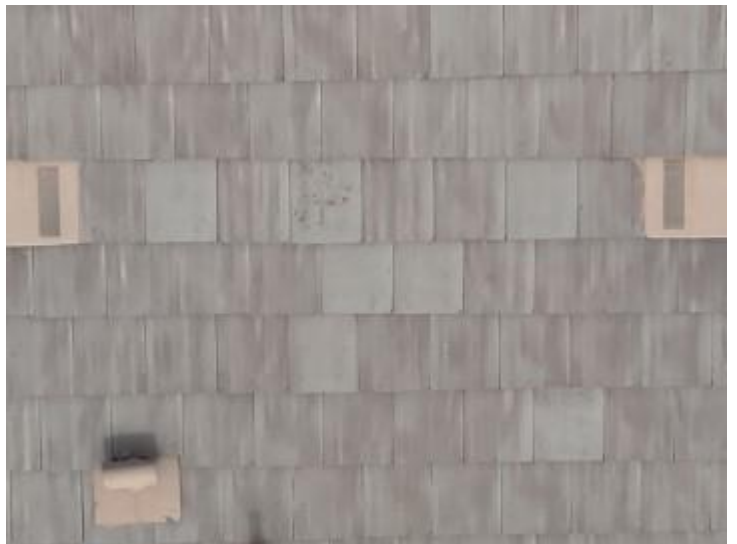
**Building 1 -**

ITEM	Good	Fair	Poor	N/A	COMMENTS
A - Perimeter details	X				
B - Drainage		X			Some debris noted in the valleys.
C - Penetration flashings		X			
D - Overall Tile condition		X			Some isolated cracked tiles noted. Some isolated chipped tiles noted.
E - Wall/Curb flashings				X	
F - Insulation				X	
G - Other				X

- Building 1 – Replace cracked tile where needed.
- Building 2 – Replace cracked tile where needed.
- Building 4 – Remove unused tiles from rooftop.
- Building 6 – Replace cracked/broken tile where needed.

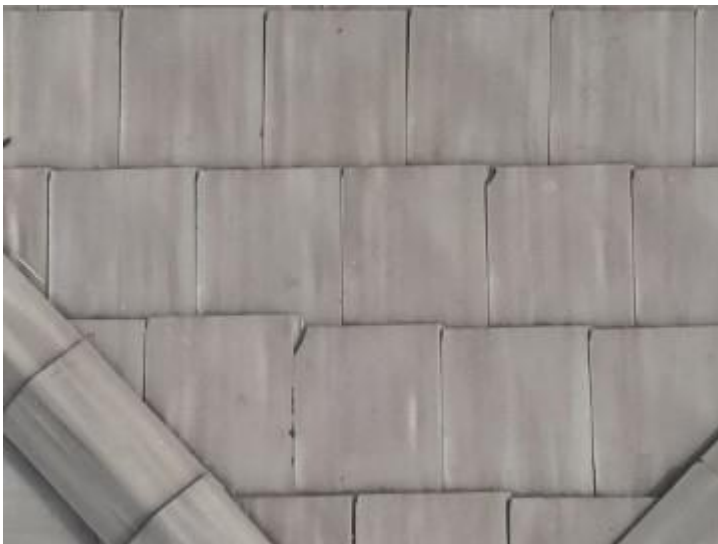
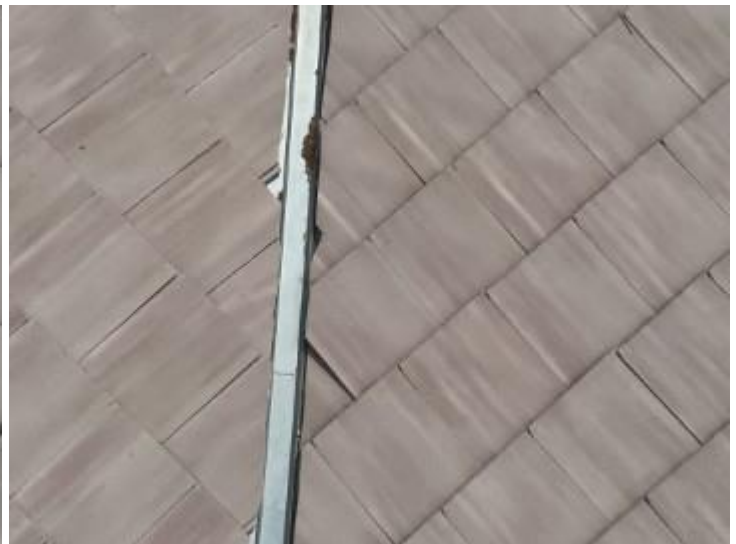
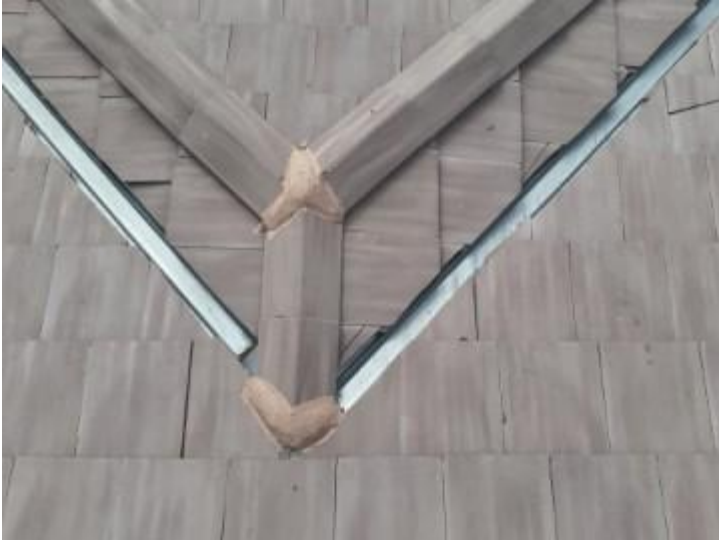
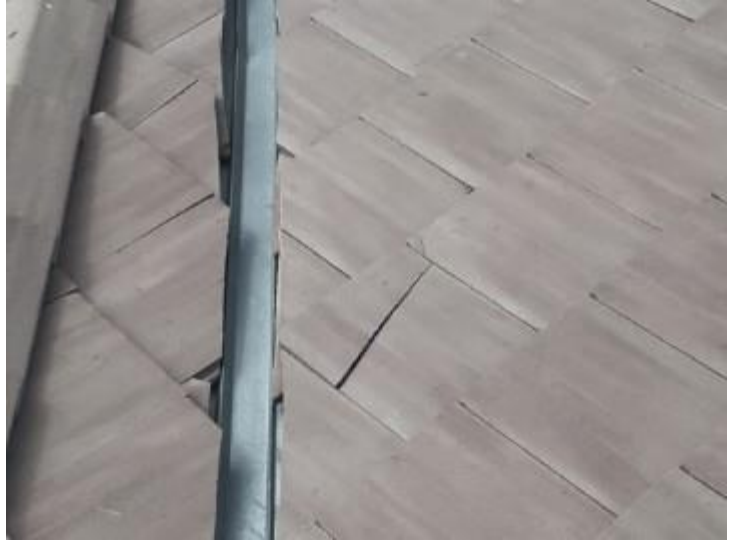
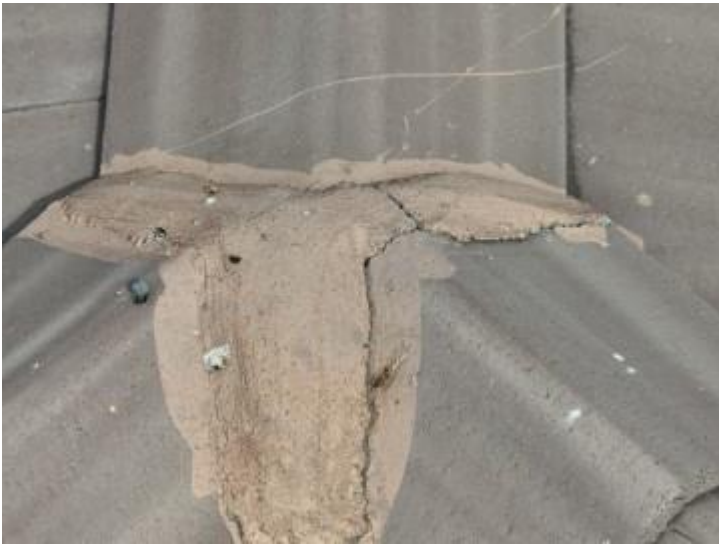
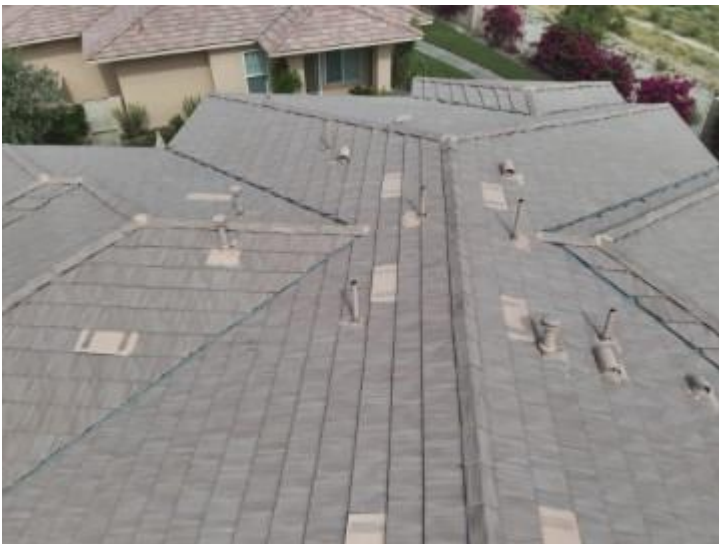
**Building 2 -**

ITEM	Good	Fair	Poor	N/A	COMMENTS
A - Perimeter details	X				
B - Drainage		X			Some debris noted in the valleys.
C - Penetration flashings	X				
D - Overall Tile condition		X			Some isolated cracked tiles noted. Some isolated chipped tiles noted. Some cracking noted at mortar.
E - Wall/Curb flashings				X	
F - Insulation				X	
G - Other				X

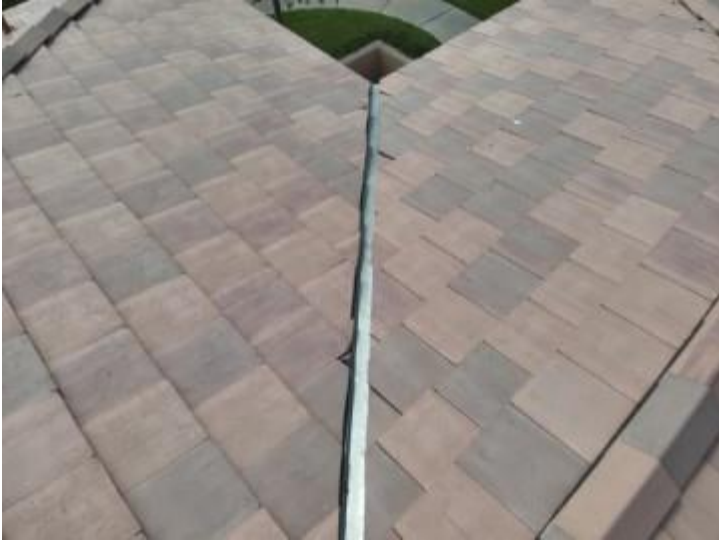
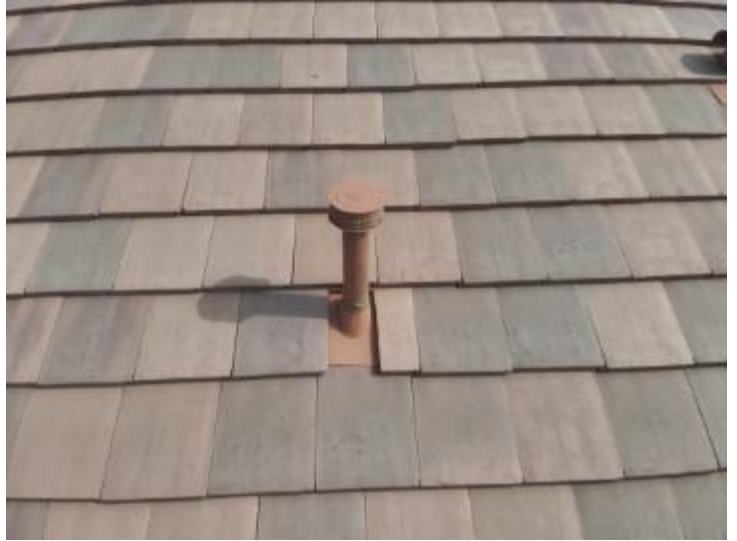
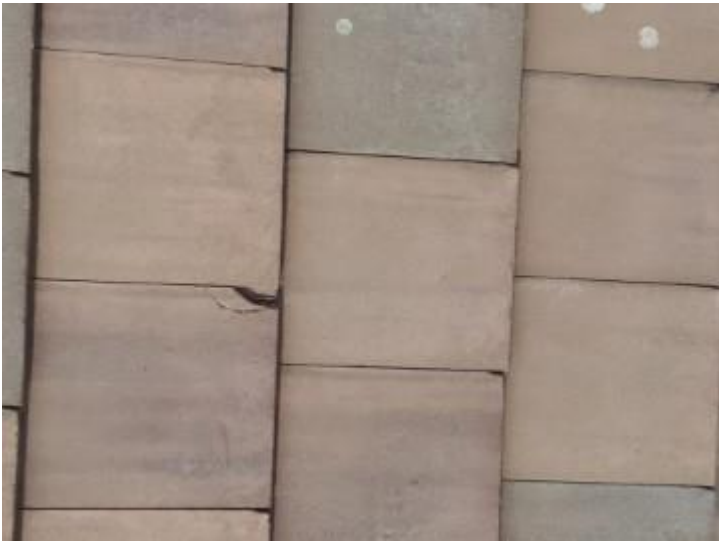
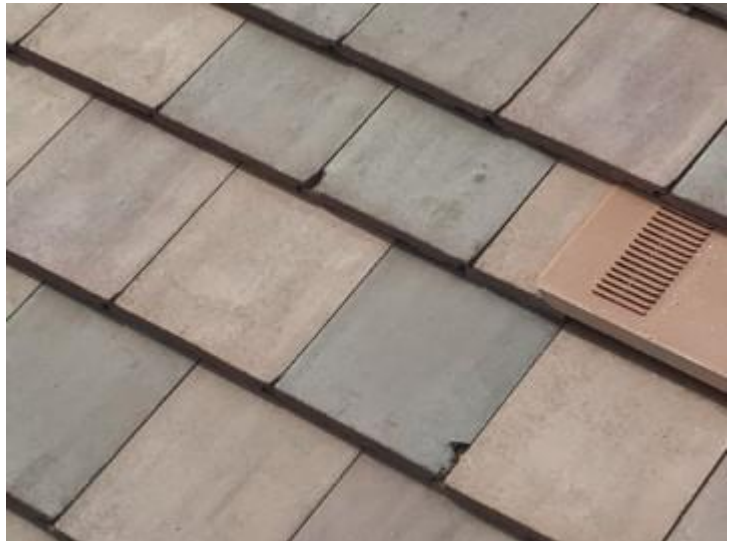
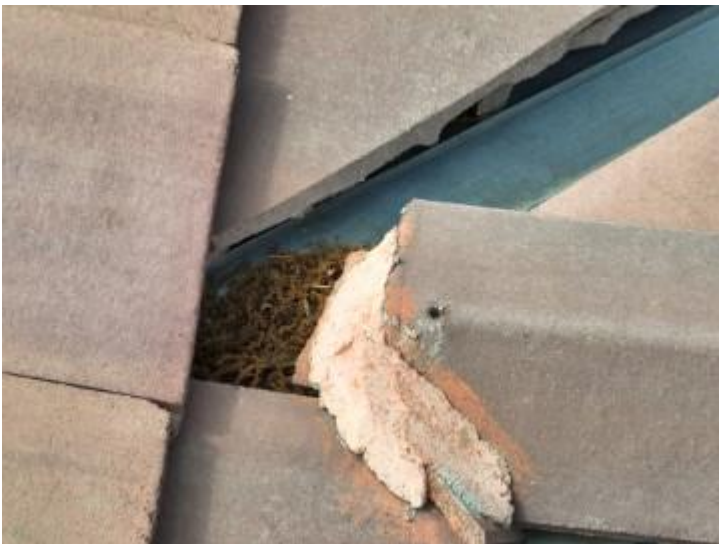
ITEM	Good	Fair	Poor	N/A	COMMENTS
A - Perimeter details	X				
B - Drainage		X			
C - Penetration flashings		X			
D - Overall Tile condition		X			Some isolated cracked tiles noted. Some isolated chipped tiles noted. Some cracking noted at mortar.
E - Wall/Curb flashings				X	
F - Insulation				X	
G - Other				X

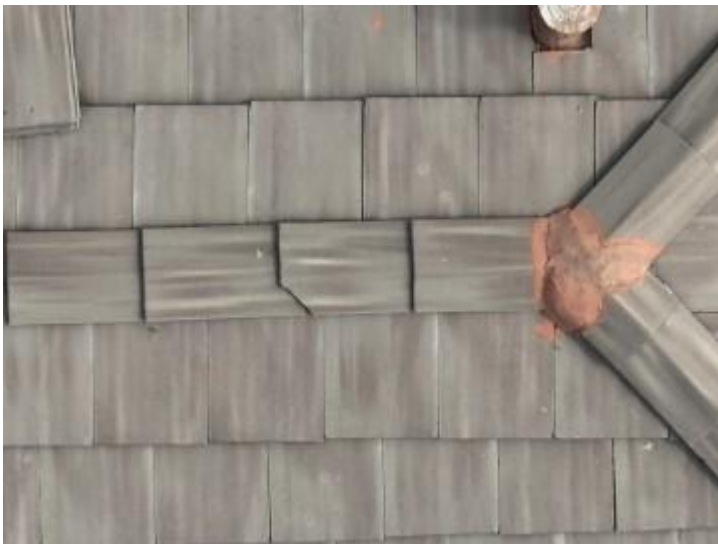
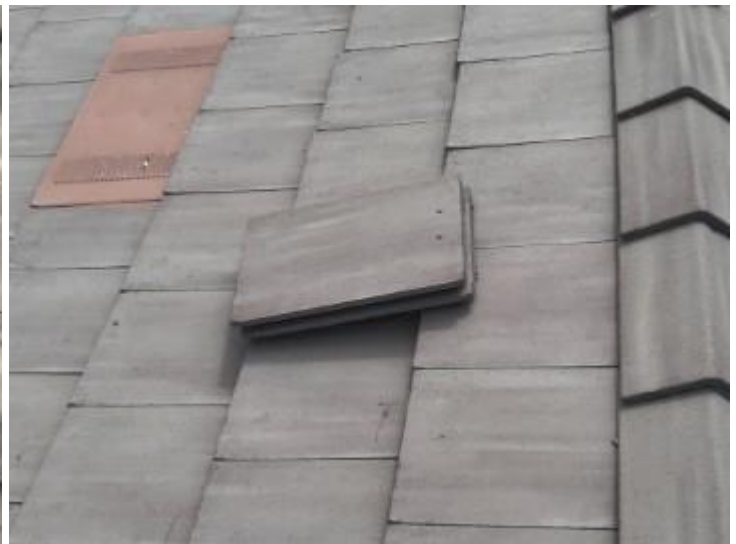
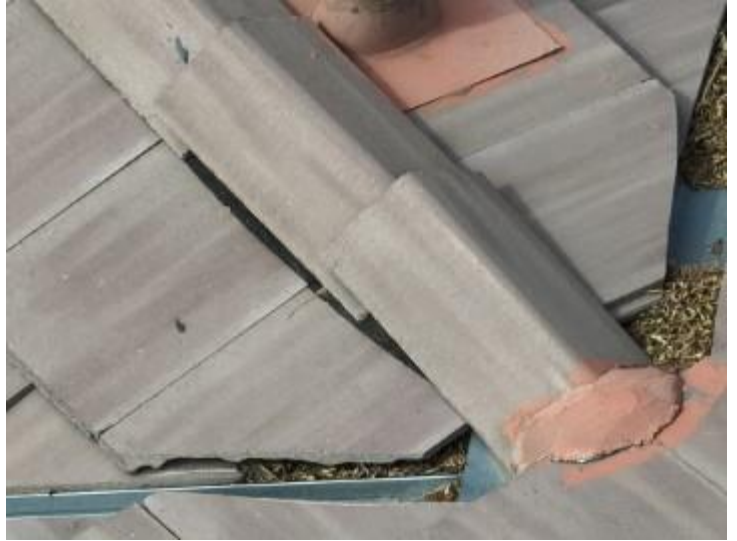
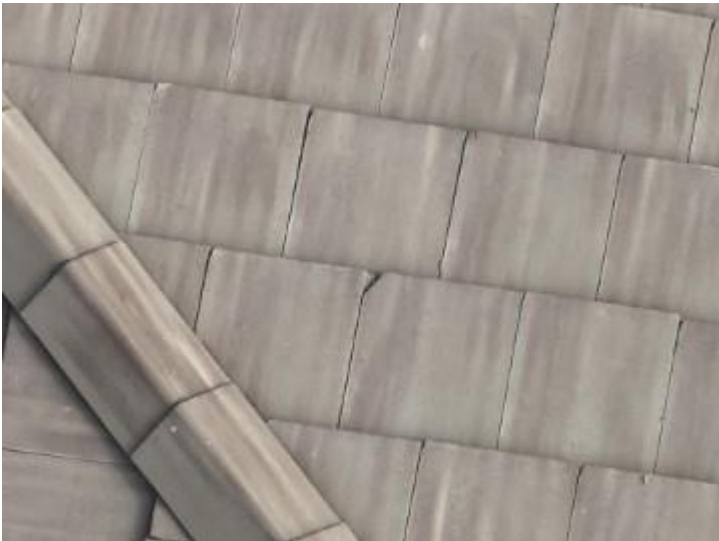
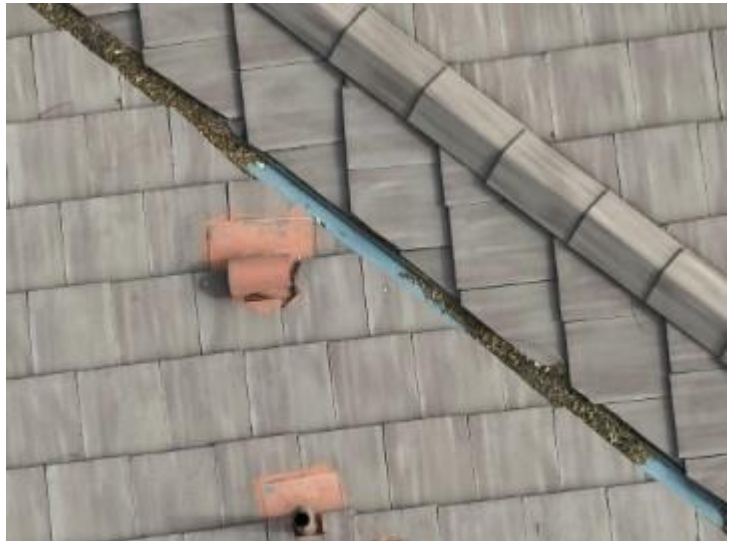
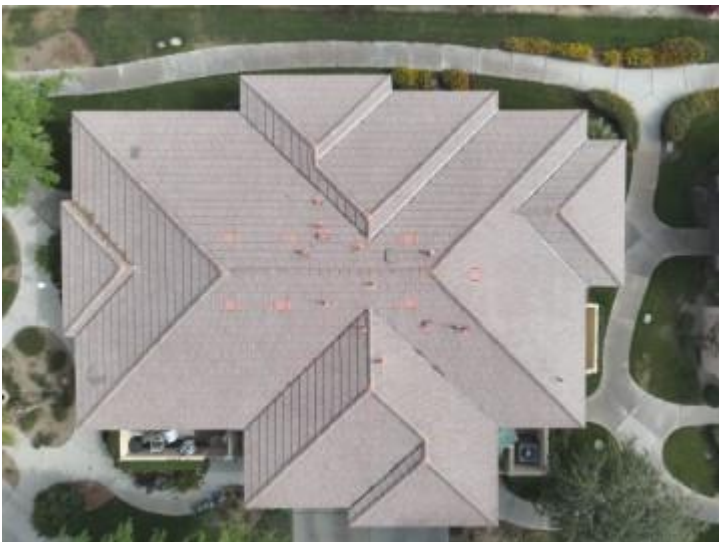
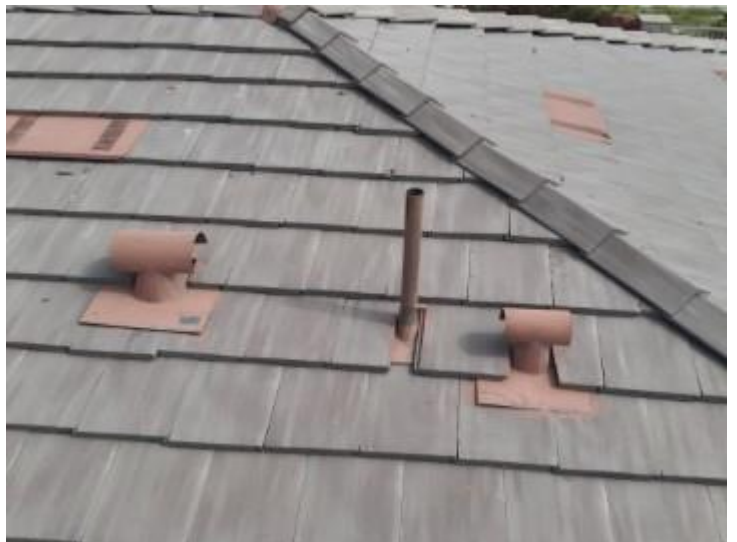
**Building 4 -**

ITEM	Good	Fair	Poor	N/A	COMMENTS
A - Perimeter details	X				
B - Drainage		X			Some debris noted in the valleys.
C - Penetration flashings		X			
D - Overall Tile condition		X			A broken cap tile noted. Some isolated chipped tiles noted. Some cracking noted at mortar.
E - Wall/Curb flashings				X	
F - Insulation				X	
G - Other				X	Some loose tiles left on the roof, likely from a past repair.

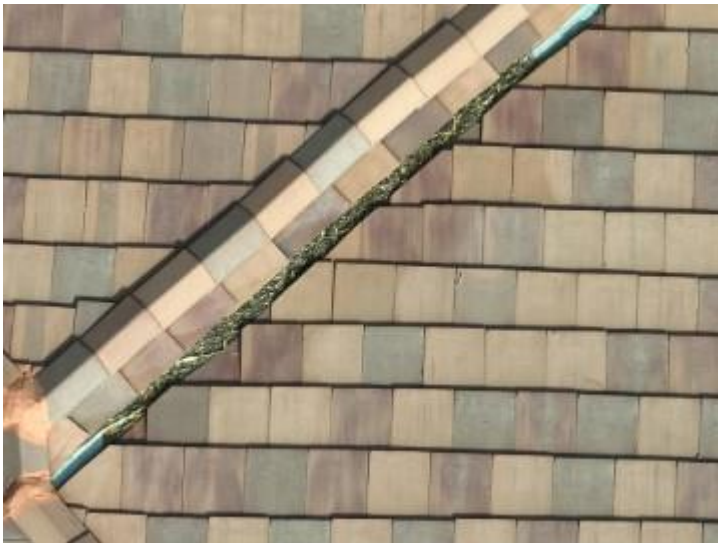
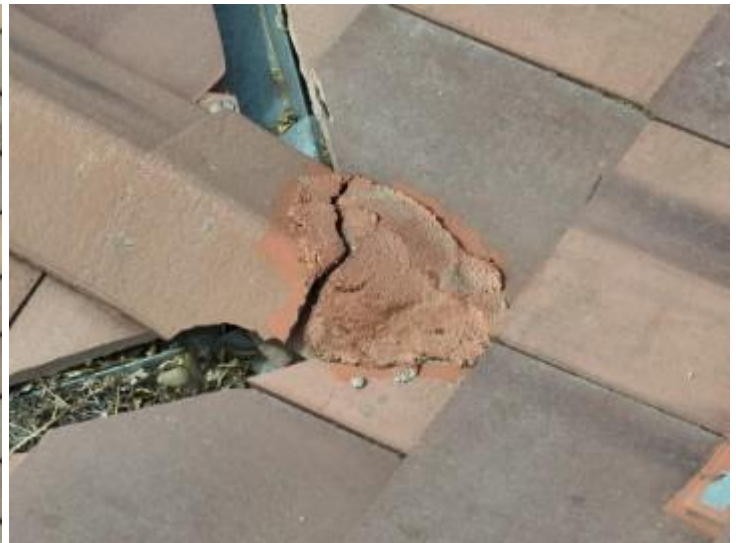
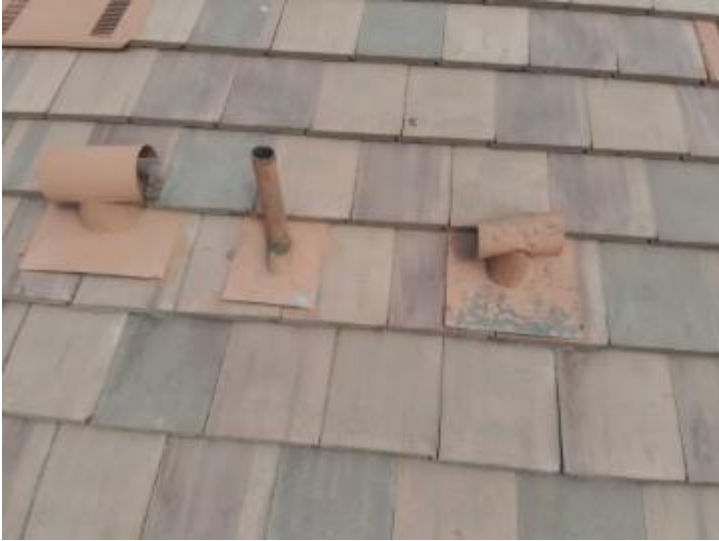
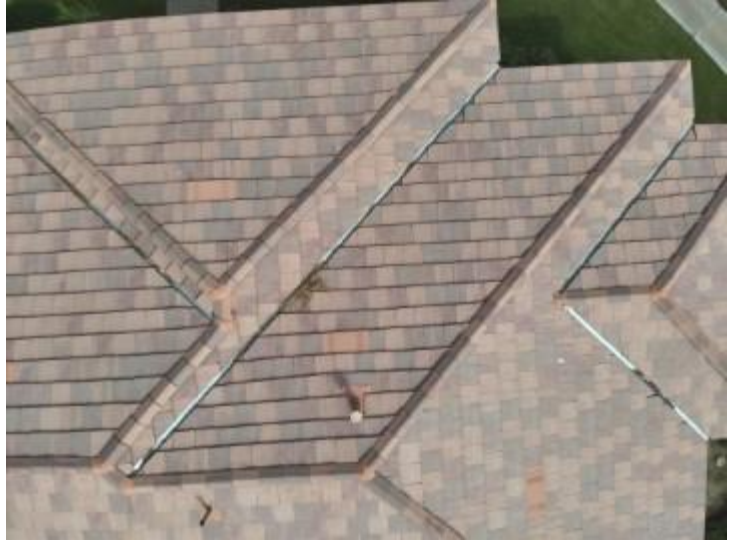
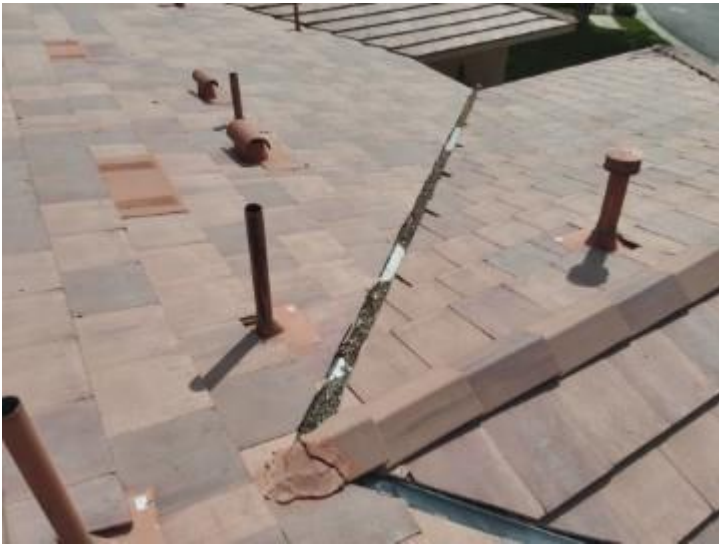
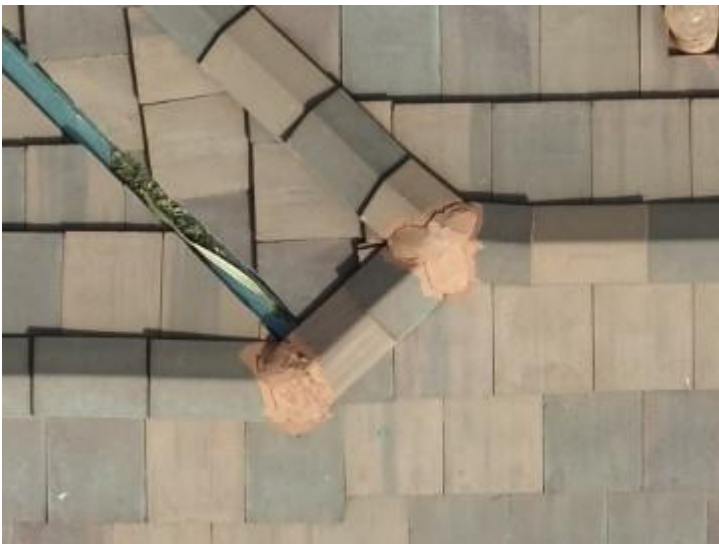
**Building 5 -**

ITEM	Good	Fair	Poor	N/A	COMMENTS
A - Perimeter details		X			
B - Drainage		X			Some debris noted in the valleys.
C - Penetration flashings		X			
D - Overall Tile condition		X			Some cracking noted at mortar.
E - Wall/Curb flashings				X	
F - Insulation				X	
G - Other				X

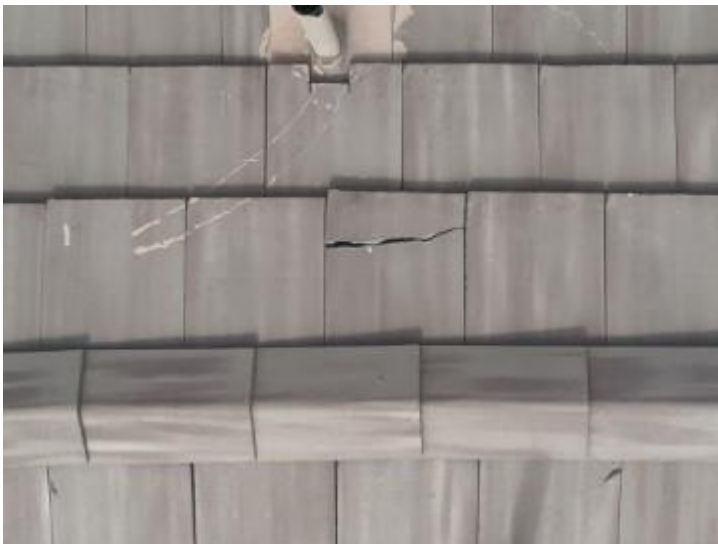
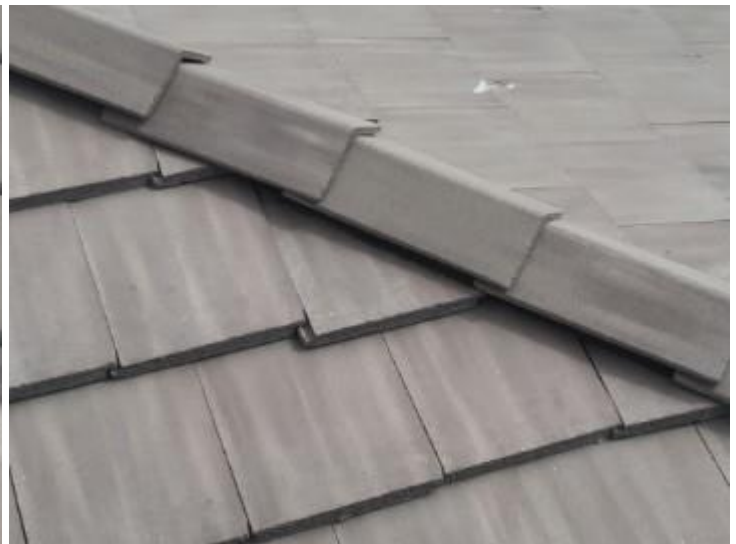
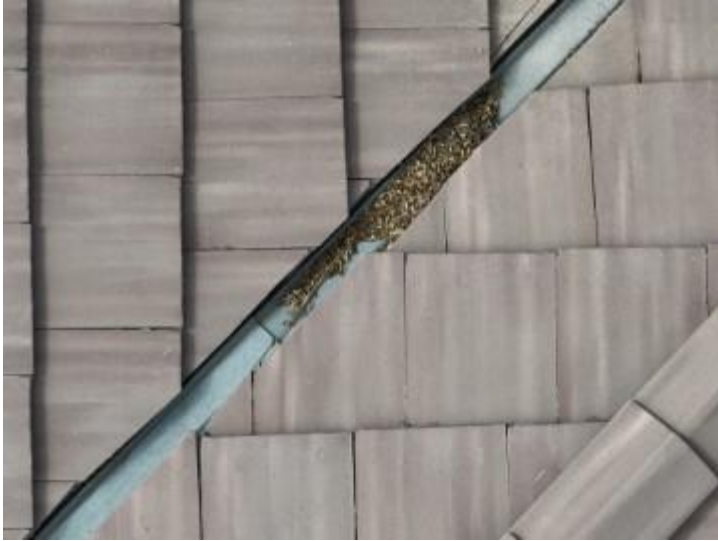
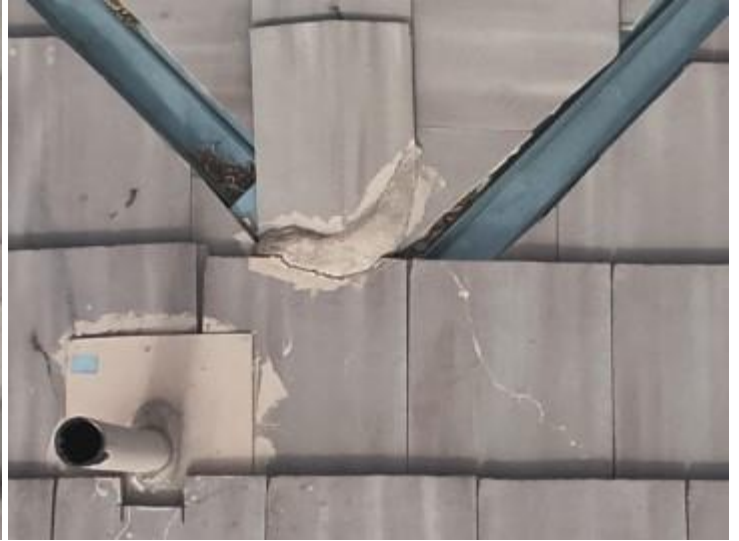
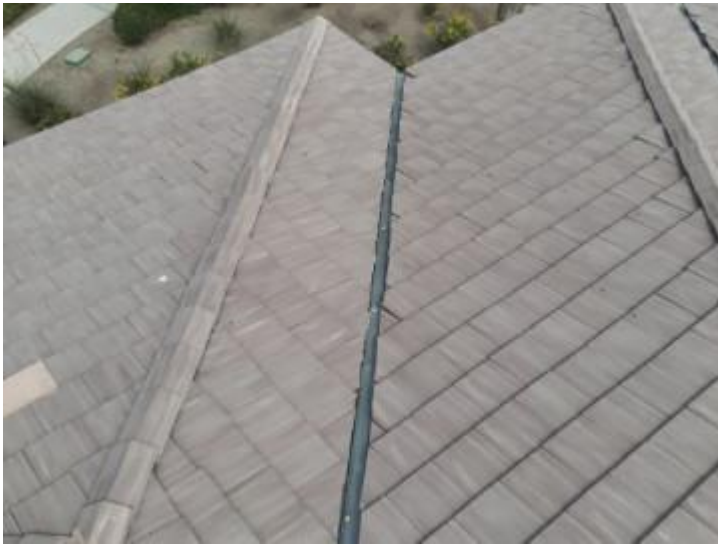
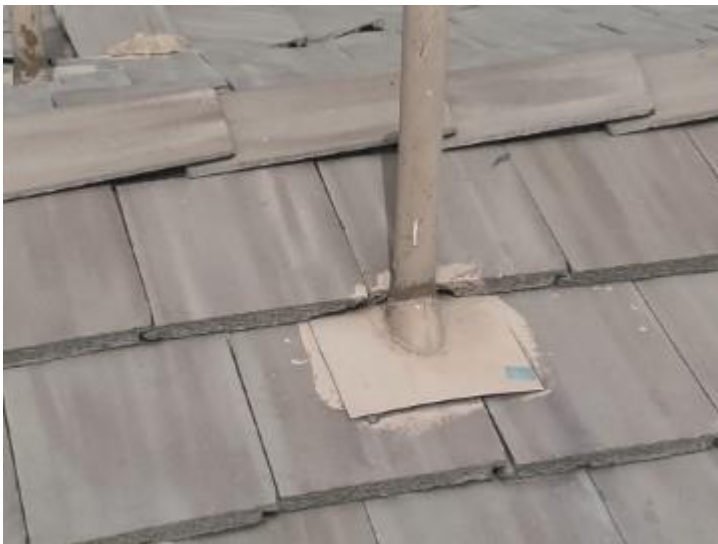
**Building 6 -**

ITEM	Good	Fair	Poor	N/A	COMMENTS
A - Perimeter details		X			
B - Drainage		X			Some debris noted in the valleys.
C - Penetration flashings		X			
D - Overall Tile condition		X			Some isolated cracked tiles noted. Some cracking noted at mortar. Some isolated slipping tiles noted.
E - Wall/Curb flashings				X	
F - Insulation				X	
G - Other				X
