## HOUSING AUTHORITY Meeting Agenda

Thursday, November 7, 2024

Re: **Roof Consulting**  
Indian Wells Villas  
74800 Village Center Drive  
Indian Wells, CA 92210

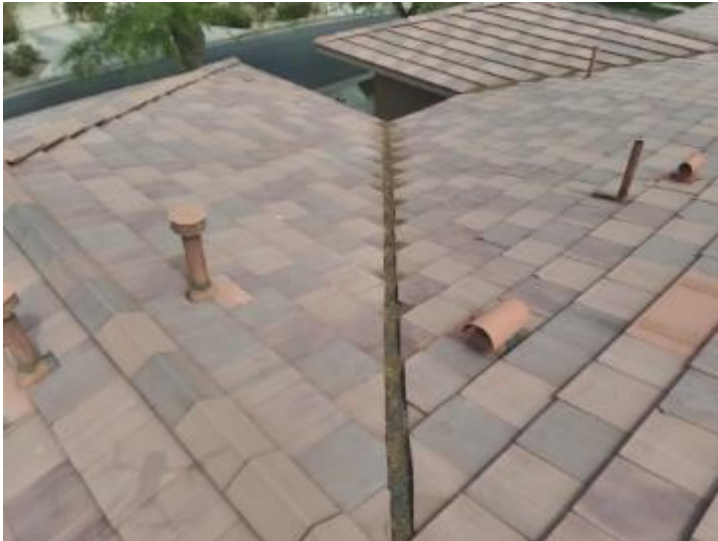
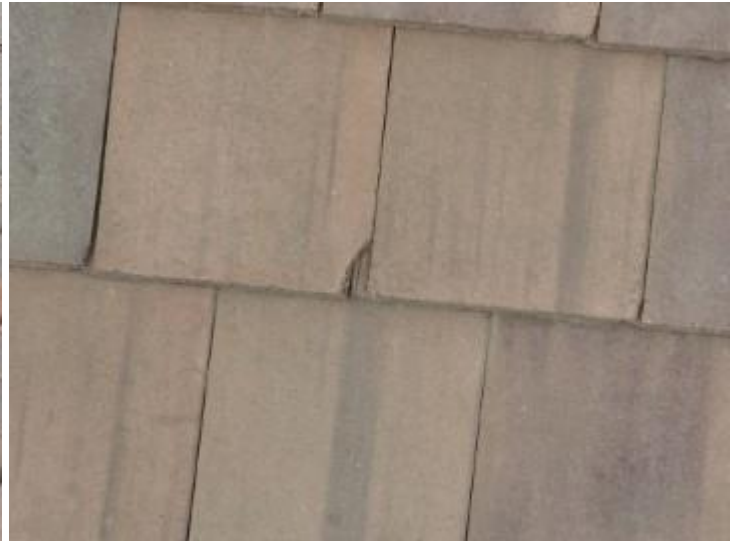
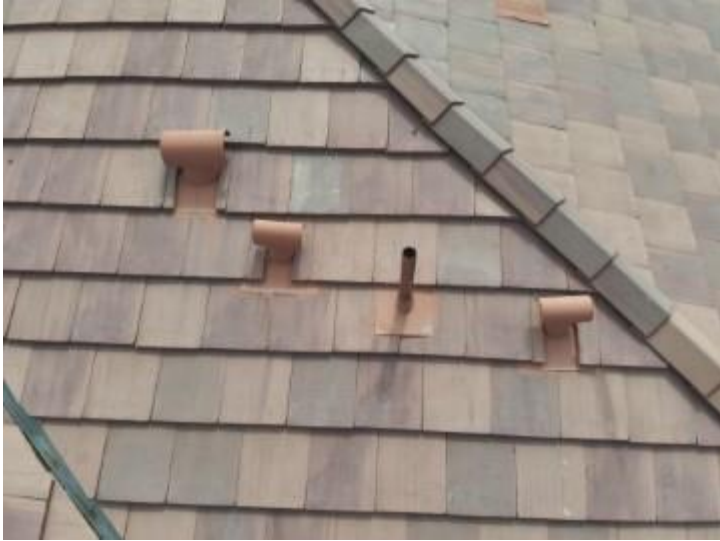
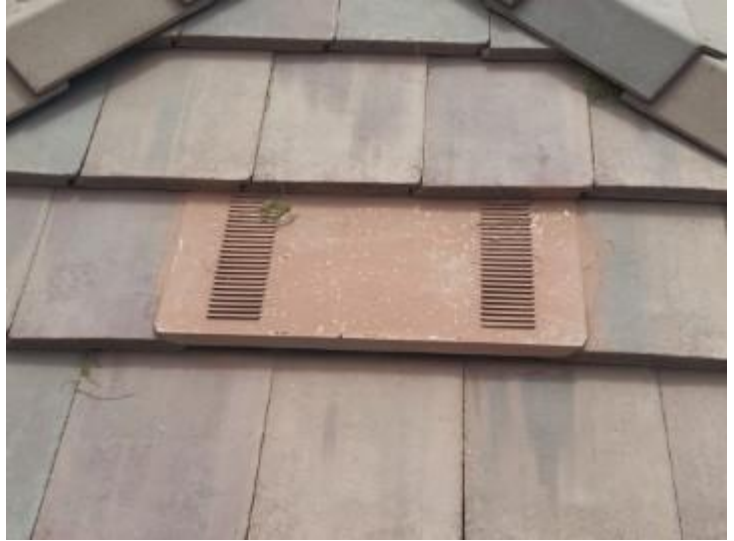
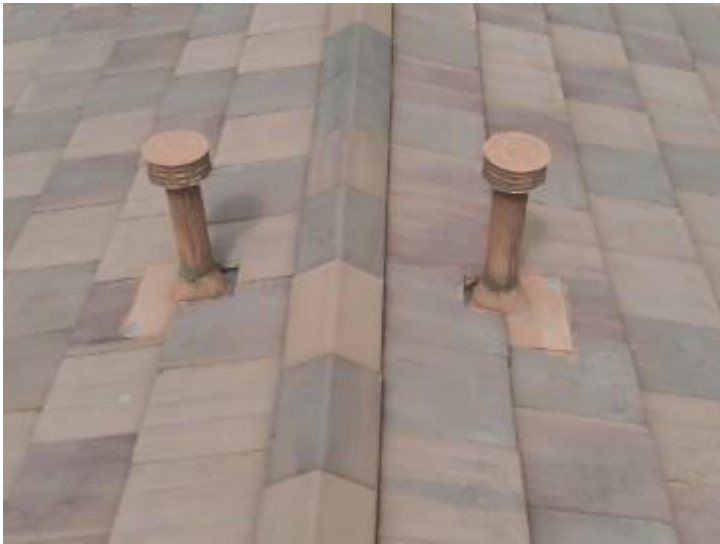
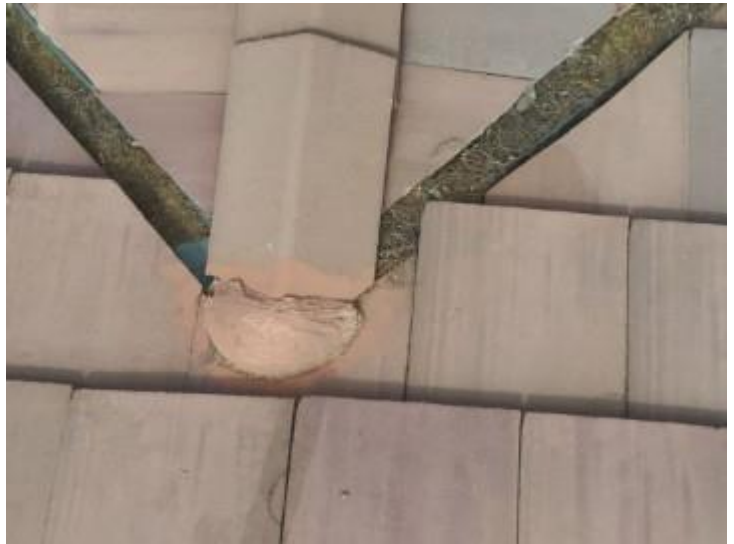
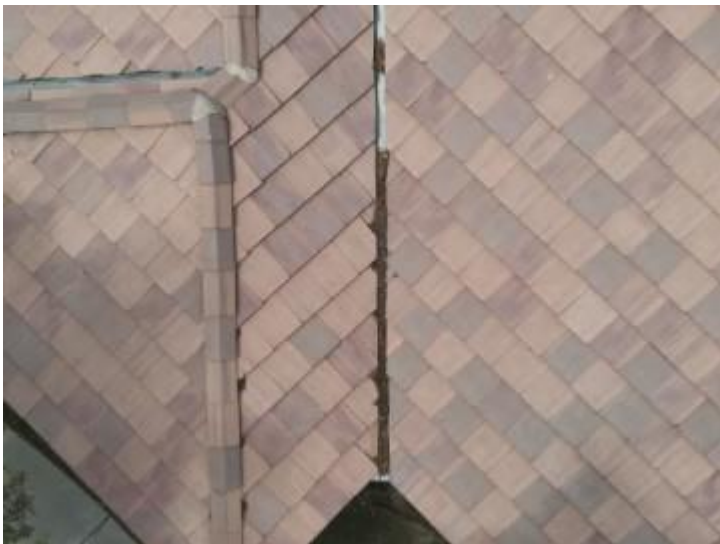
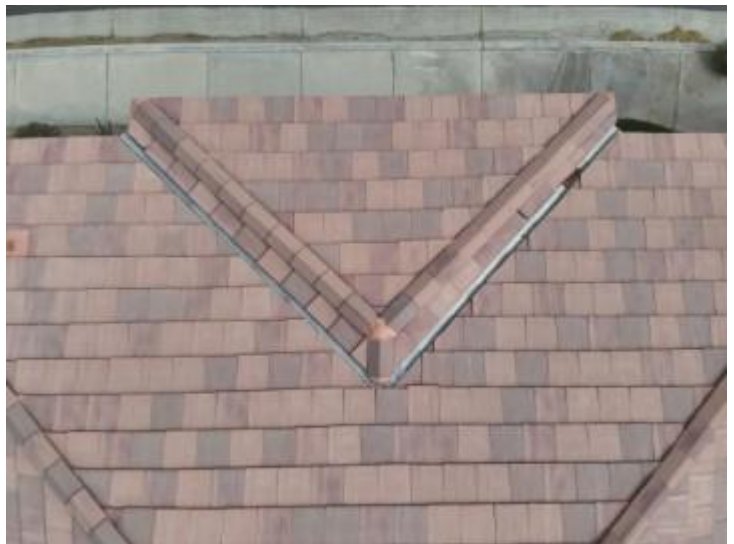
**Building 7 -**

ITEM	Good	Fair	Poor	N/A	COMMENTS
A - Perimeter details		X			
B - Drainage		X			Some debris noted in the valleys.
C - Penetration flashings		X			
D - Overall Tile condition		X			Some isolated chipped tiles noted.
E - Wall/Curb flashings				X	
F - Insulation				X	
G - Other				X

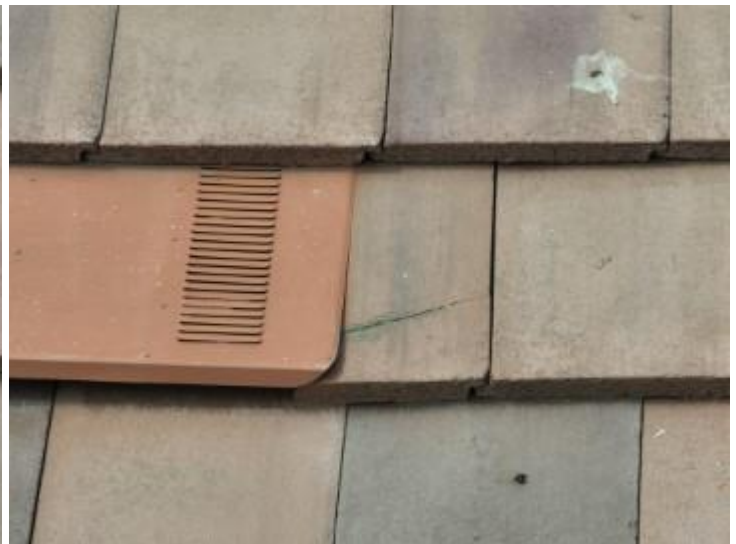
**Building 8 -**

ITEM	Good	Fair	Poor	N/A	COMMENTS
A - Perimeter details		X			
B - Drainage		X			Some debris noted in the valleys.
C - Penetration flashings		X			
D - Overall Tile condition		X			Some isolated cracked tiles noted. Some isolated chipped tiles noted. Some cracking noted at mortar.
E - Wall/Curb flashings				X	
F - Insulation				X	
G - Other				X

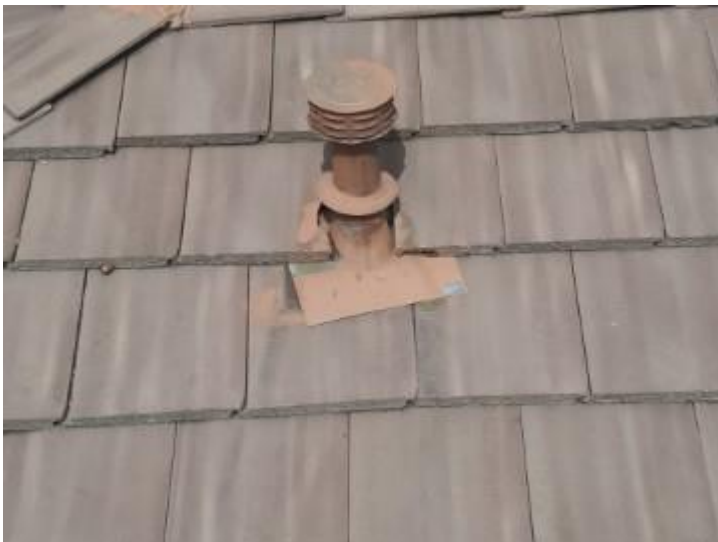
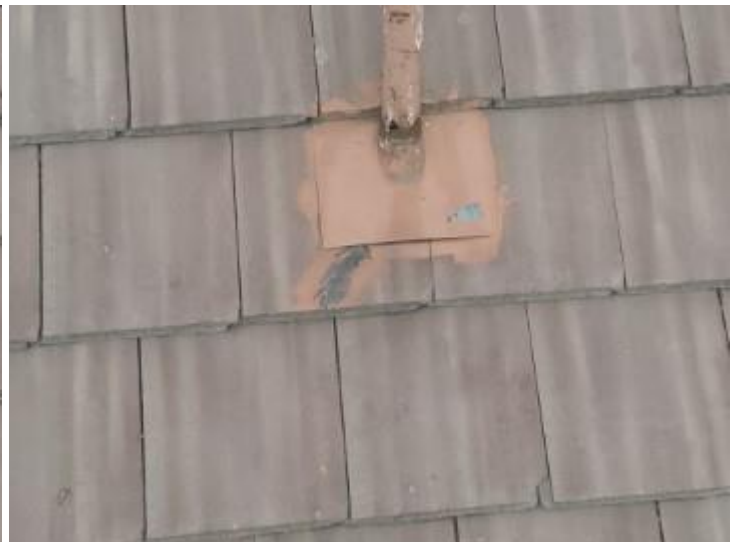
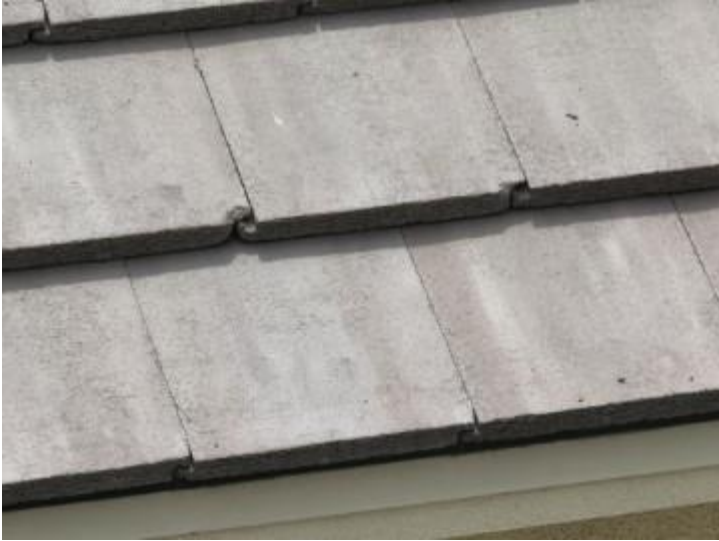
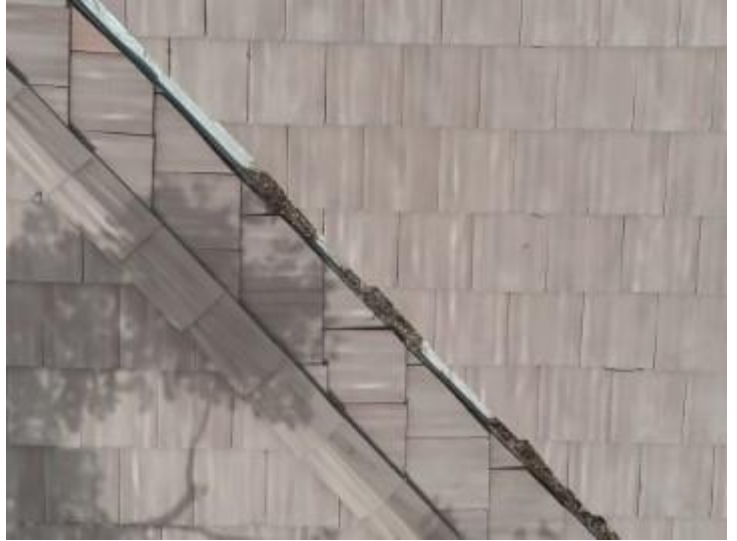
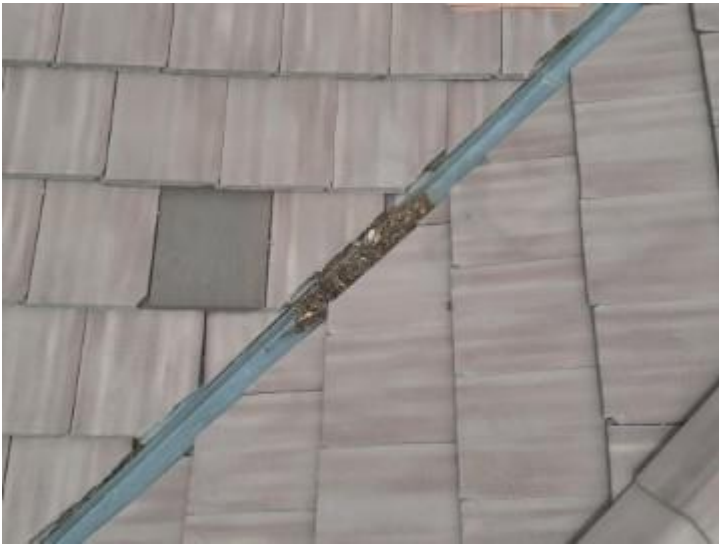
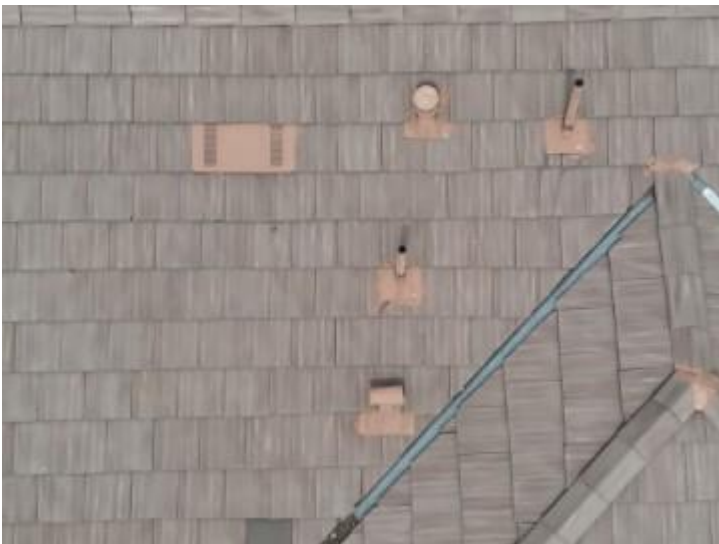
**Building 9 -**

ITEM	Good	Fair	Poor	N/A	COMMENTS
A - Perimeter details		X			
B - Drainage		X			Some debris noted in the valleys.
C - Penetration flashings		X			A loose pipe flashing noted.
D - Overall Tile condition		X			Some isolated cracked tiles noted. Some isolated chipped tiles noted. Some cracking noted at mortar.
E - Wall/Curb flashings				X	
F - Insulation				X	
G - Other				X	Areas of past repairs noted including replacement of tiles and sealing of a crack.

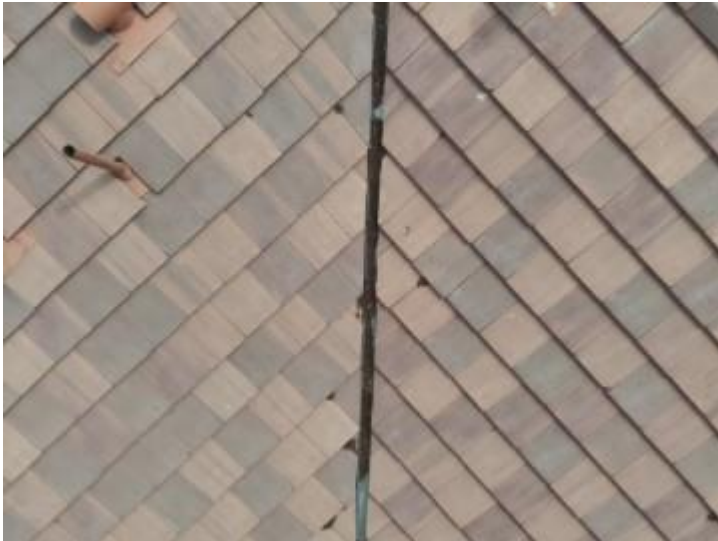
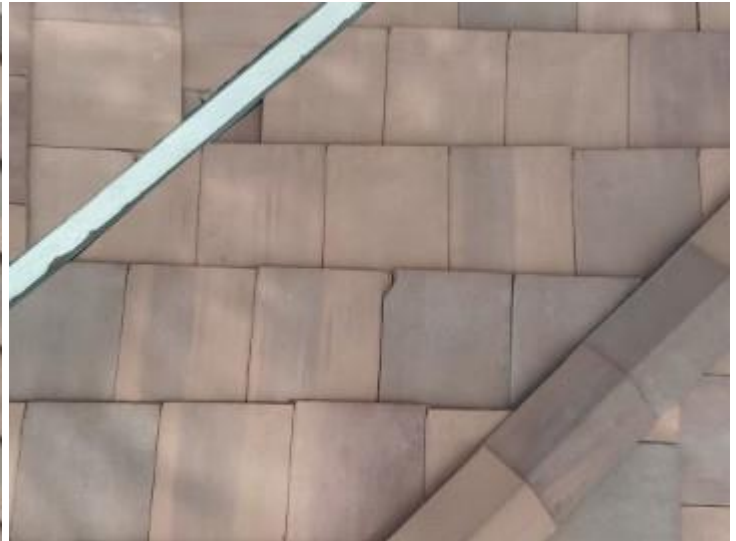
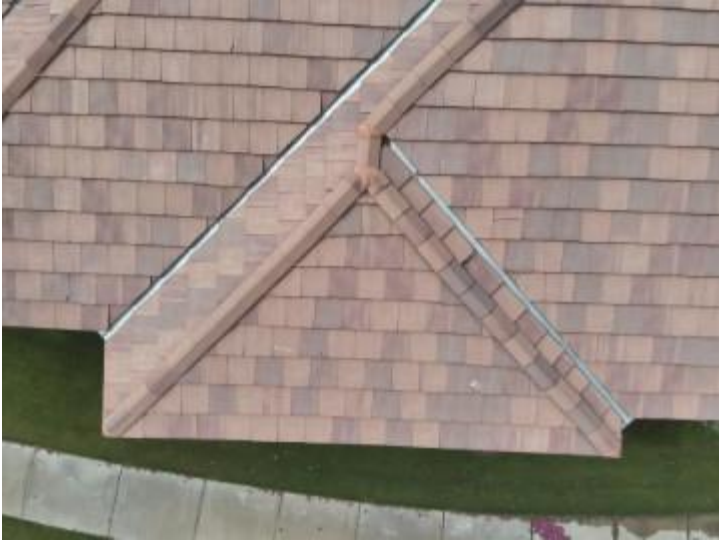
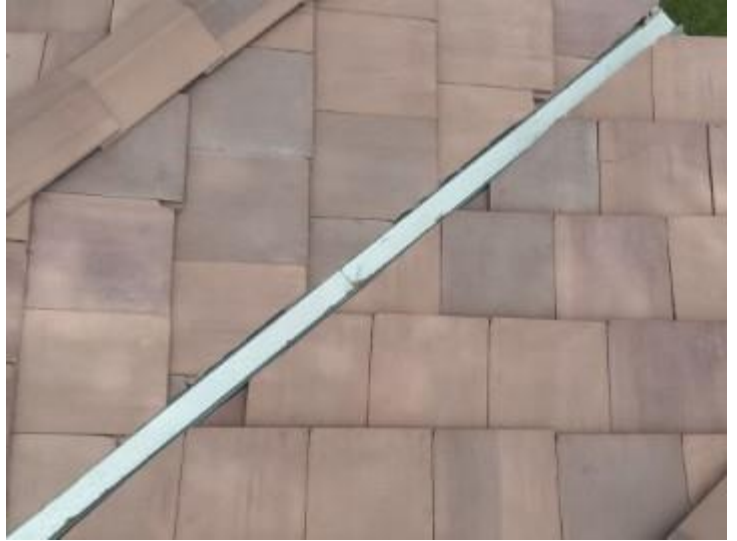
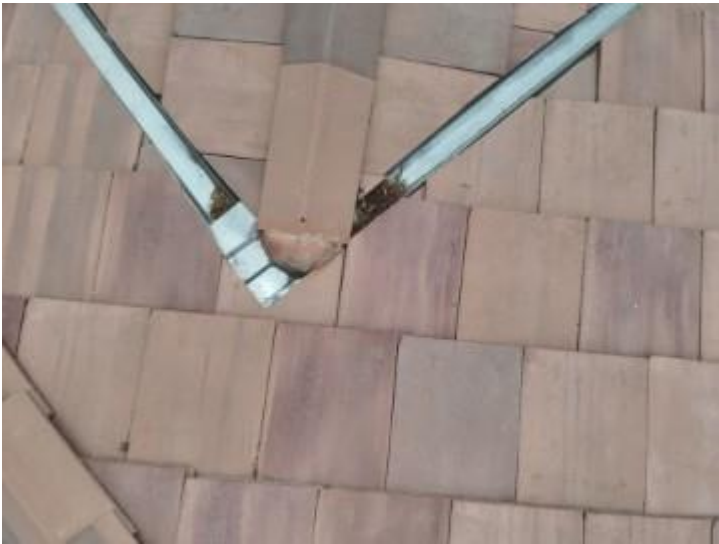
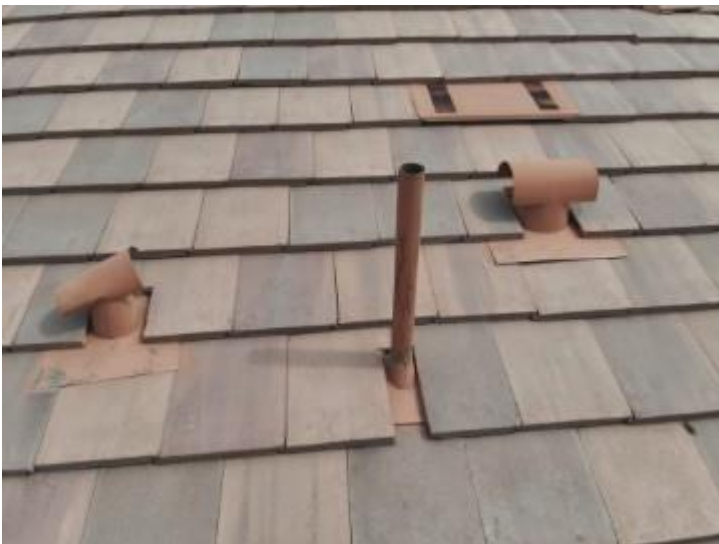
**Building 10 -**

ITEM	Good	Fair	Poor	N/A	COMMENTS
A - Perimeter details		X			
B - Drainage		X			Some debris noted in the valleys.
C - Penetration flashings		X			
D - Overall Tile condition		X			Some isolated chipped tiles noted.
E - Wall/Curb flashings				X	
F - Insulation				X	
G - Other				X

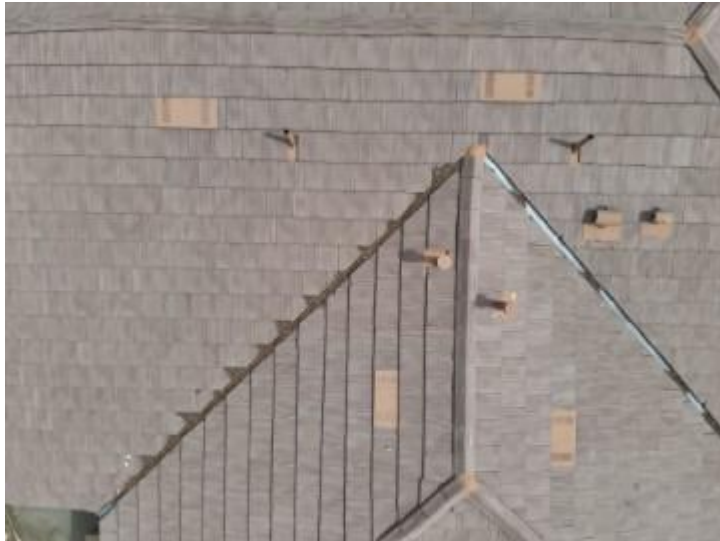
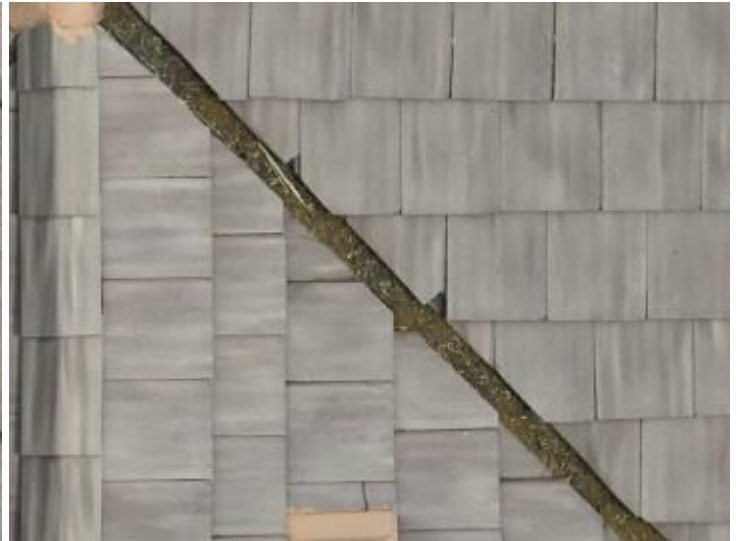
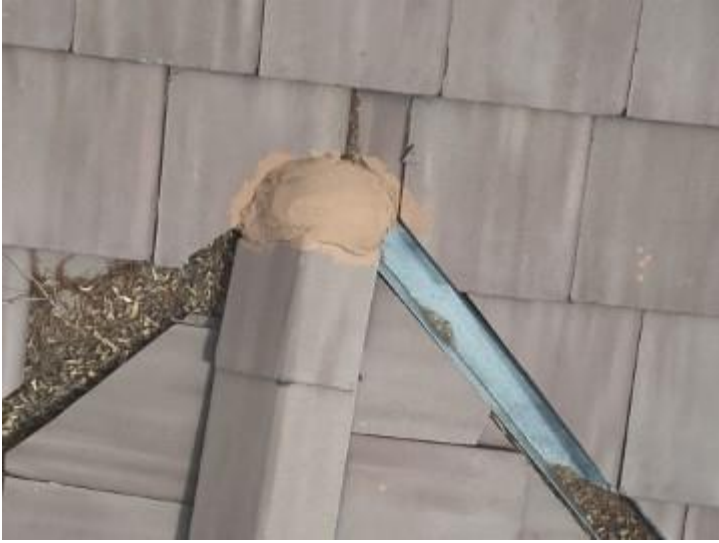
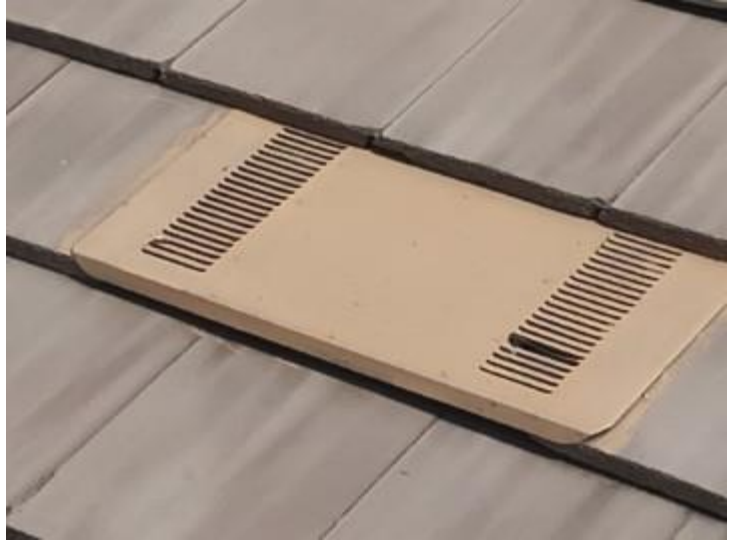
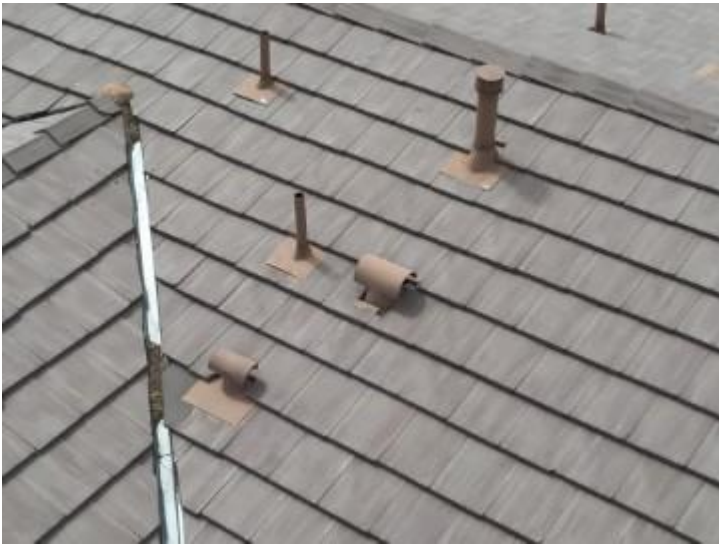
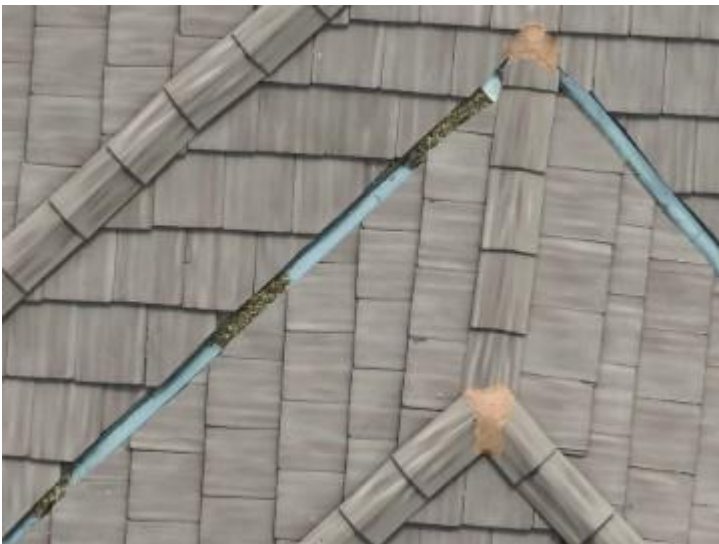
**Building 11 -**

ITEM	Good	Fair	Poor	N/A	COMMENTS
A - Perimeter details		X			
B - Drainage		X			Some debris noted in the valleys.
C - Penetration flashings		X			
D - Overall Tile condition		X			Some isolated chipped tiles noted.
E - Wall/Curb flashings				X	
F - Insulation				X	
G - Other				X

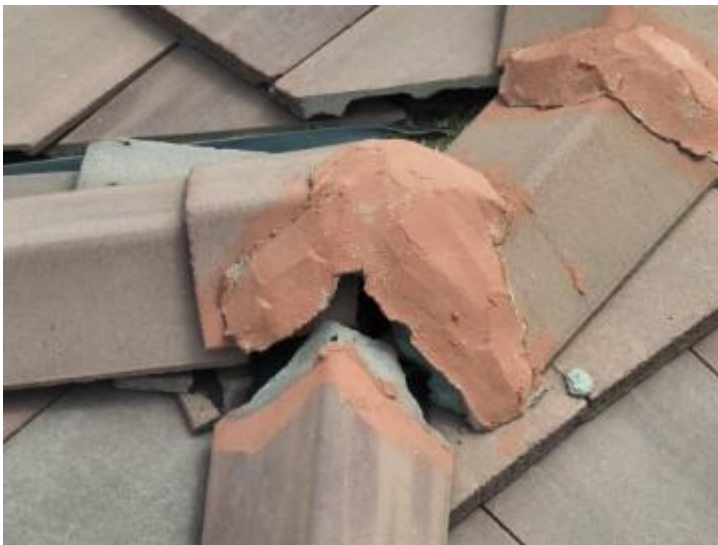
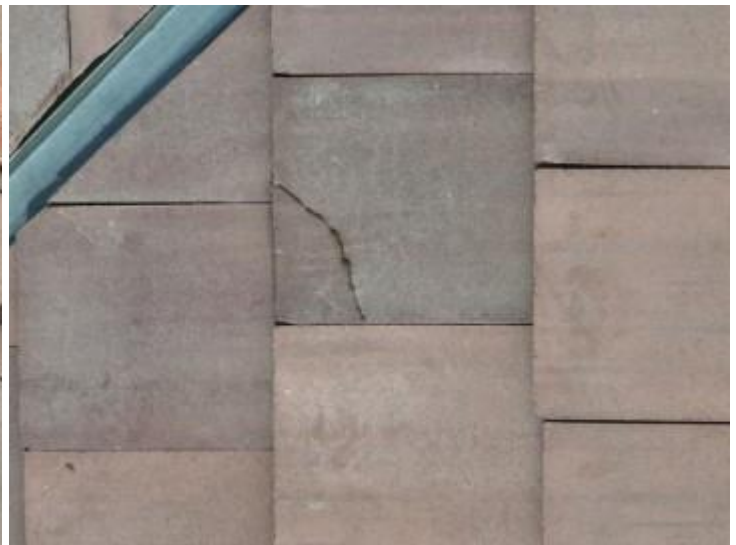
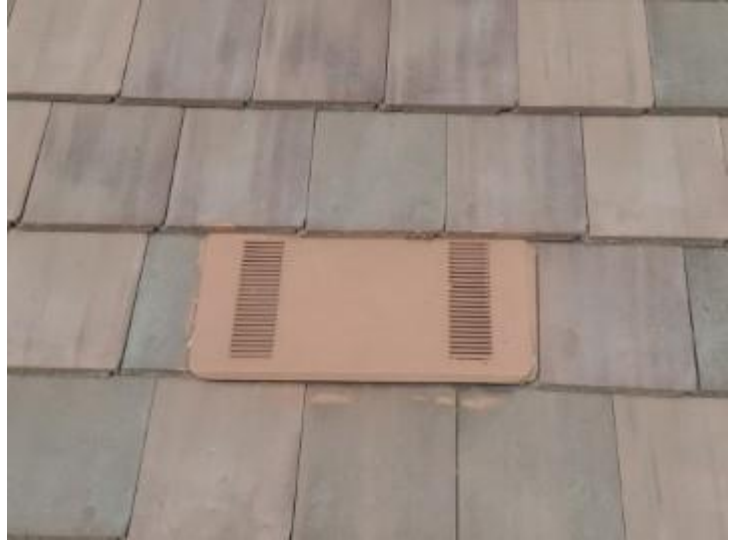
**Building 12 -**

ITEM	Good	Fair	Poor	N/A	COMMENTS
A - Perimeter details		X			
B - Drainage		X			Some debris noted in the valleys.
C - Penetration flashings		X			
D - Overall Tile condition		X			Some isolated cracked tiles noted. Some isolated chipped tiled noted. Some cracking noted at mortar. Some dislodged tiles noted.
E - Wall/Curb flashings				X	
F - Insulation				X	
G - Other				X	Damaged and dislodged tiles may be allowing pests into the building/attic.

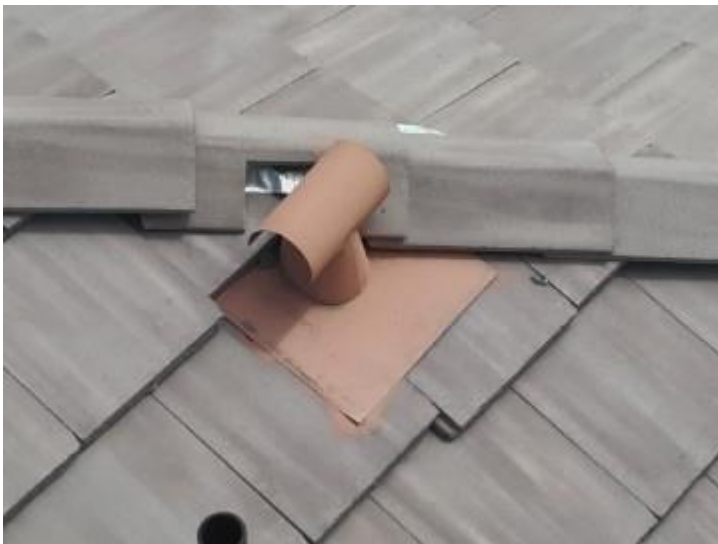
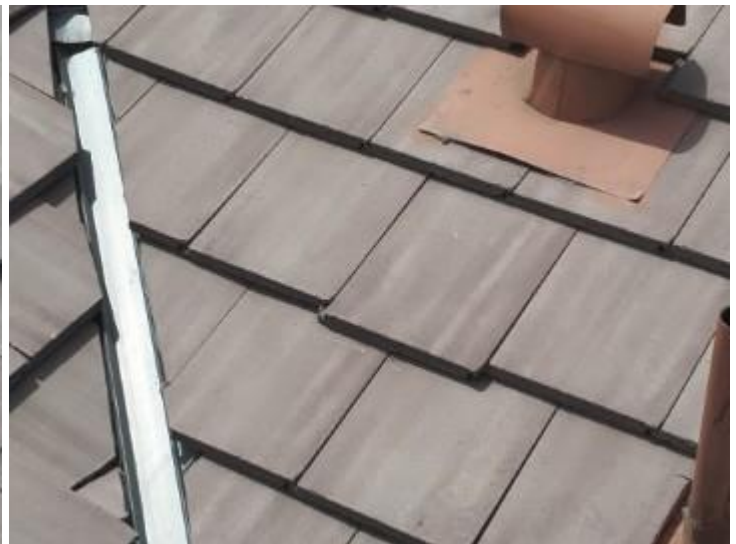
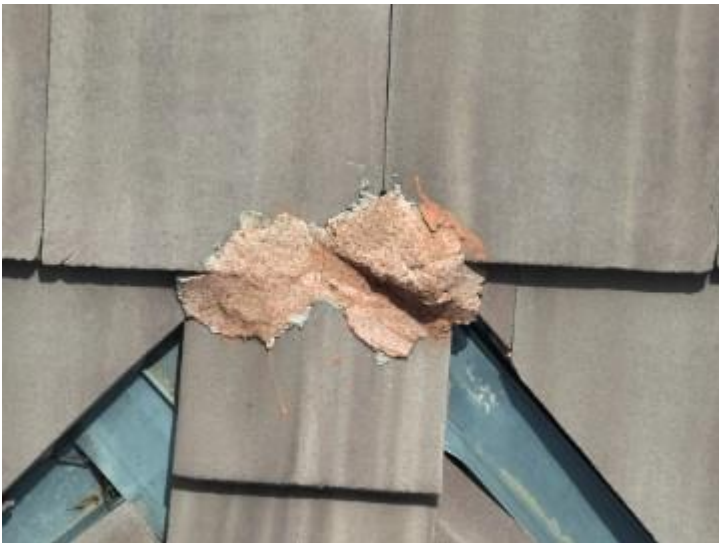
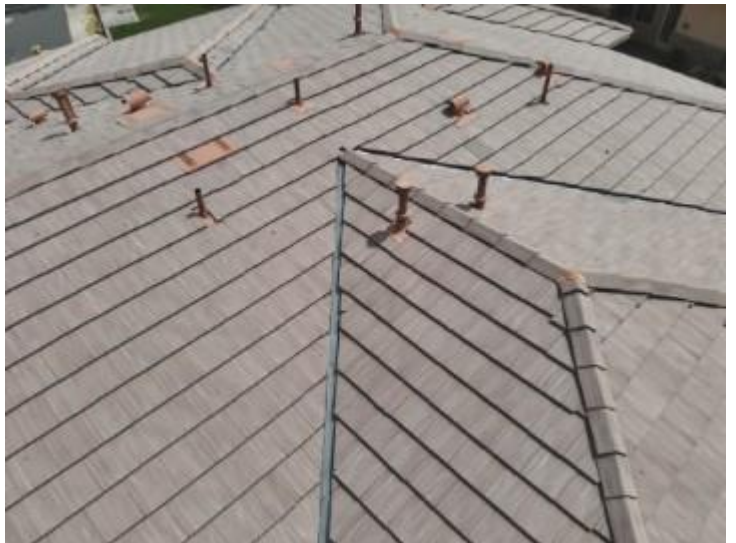
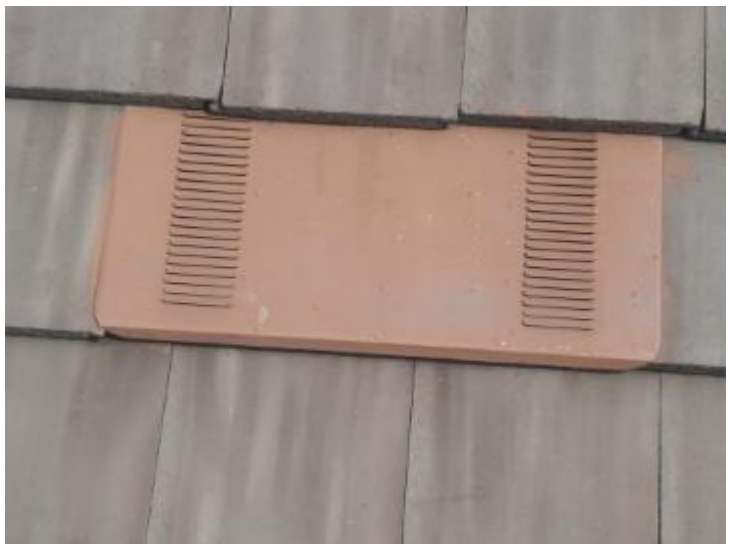
**Building 13 -**

ITEM	Good	Fair	Poor	N/A	COMMENTS
A - Perimeter details		X			
B - Drainage		X			
C - Penetration flashings		X			
D - Overall Tile condition		X			Some isolated tile slippage noted. A tile notched for a penetration may be exposing flashing underneath.
E - Wall/Curb flashings				X	
F - Insulation				X	
G - Other				X

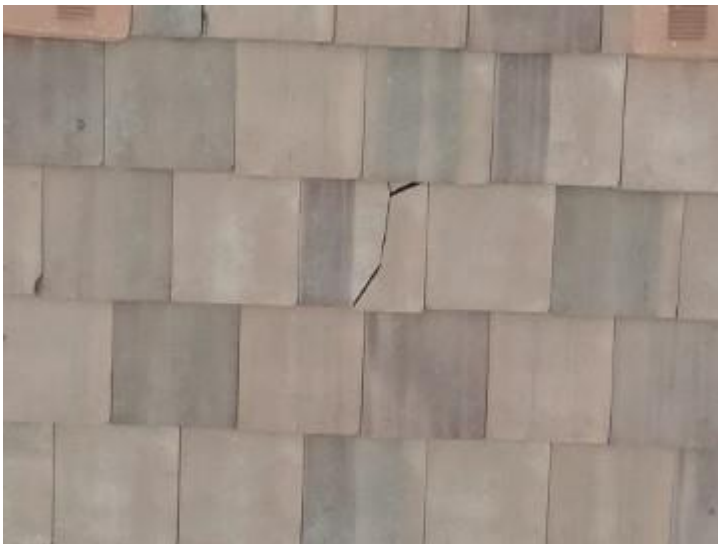
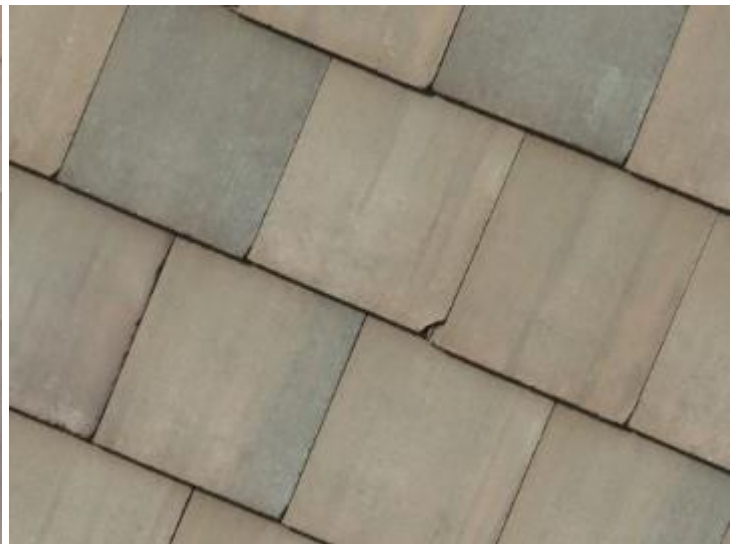
**Building 14 -**

ITEM	Good	Fair	Poor	N/A	COMMENTS
A - Perimeter details		X			
B - Drainage		X			
C - Penetration flashings		X			
D - Overall Tile condition		X			Some isolated cracked tiles noted. Some isolated chipped tiles noted. Some cracking noted at mortar.
E - Wall/Curb flashings				X	
F - Insulation				X	
G - Other				X

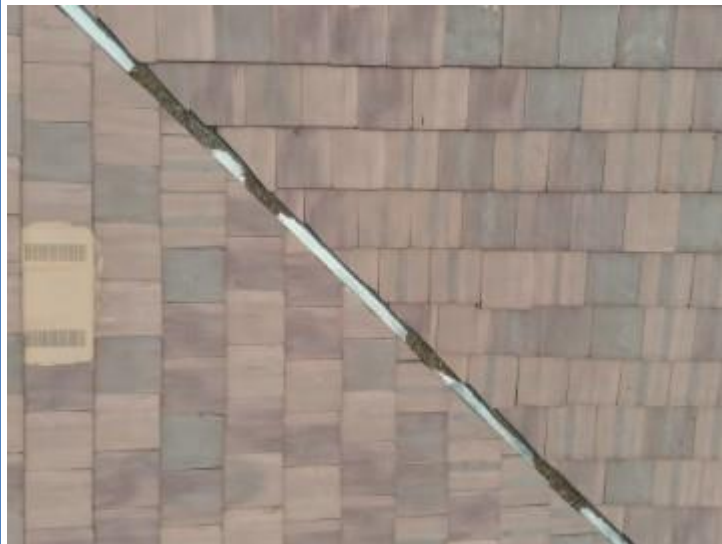
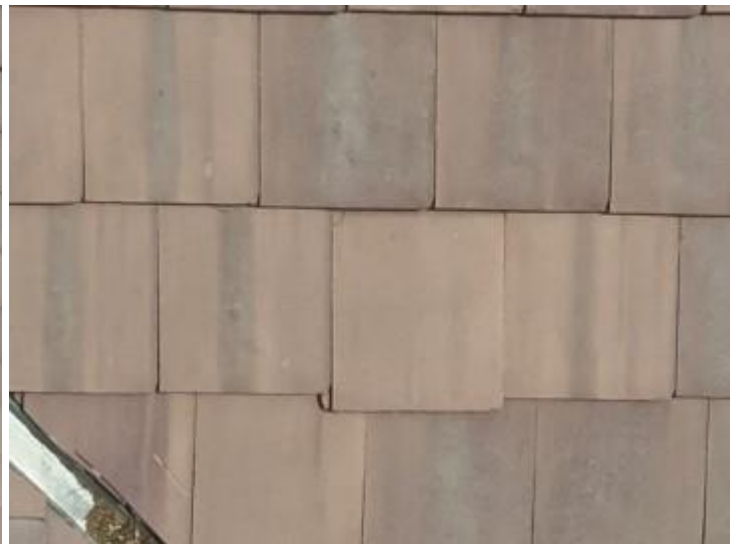
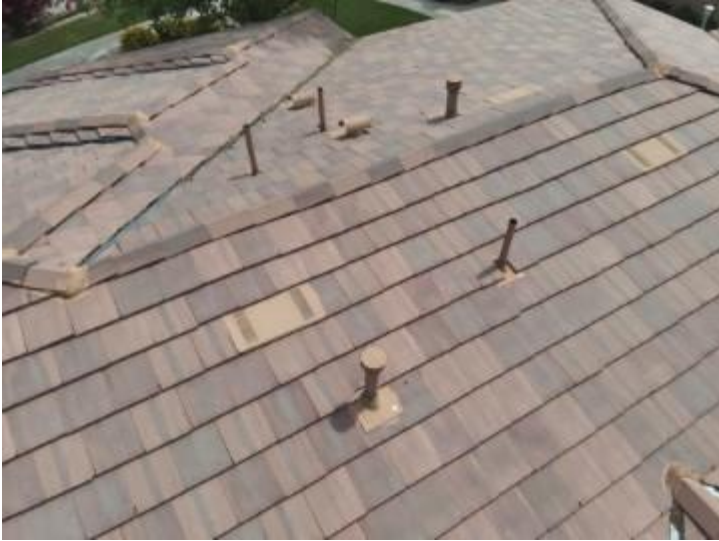
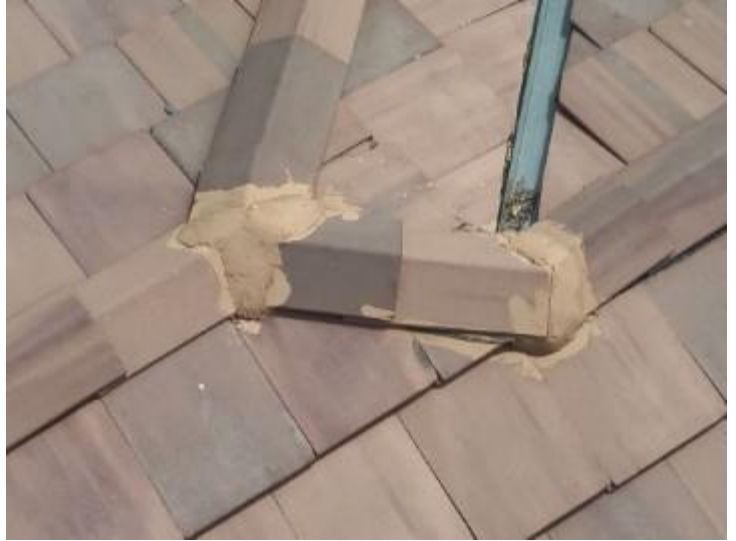
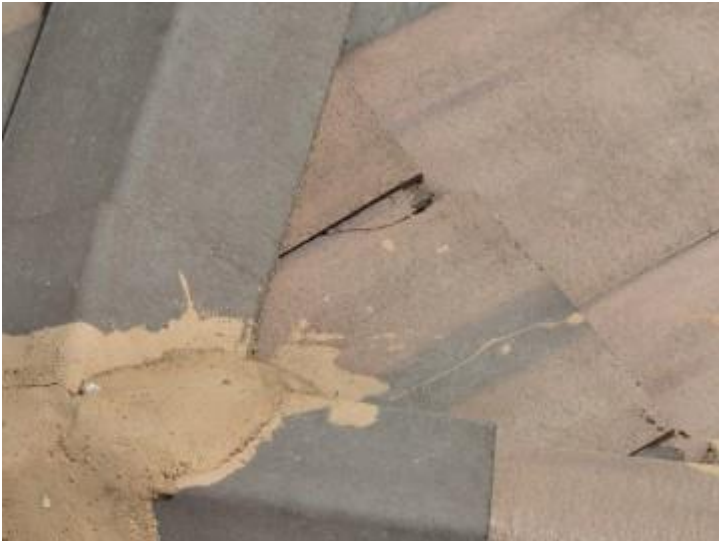
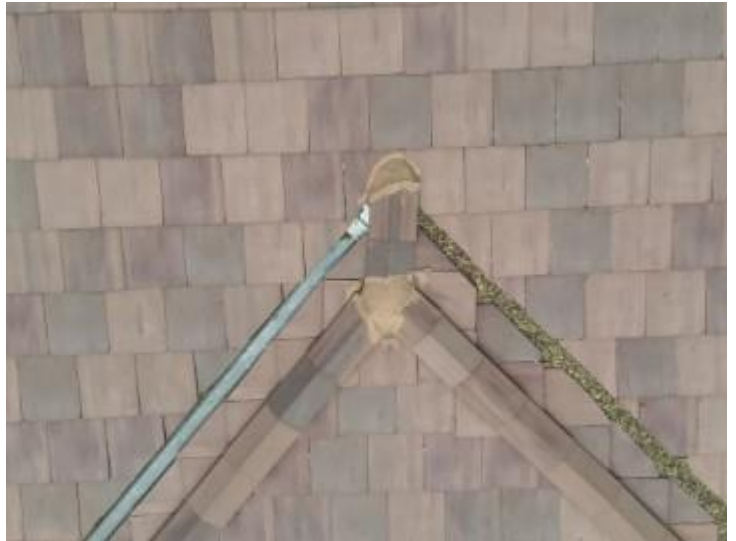
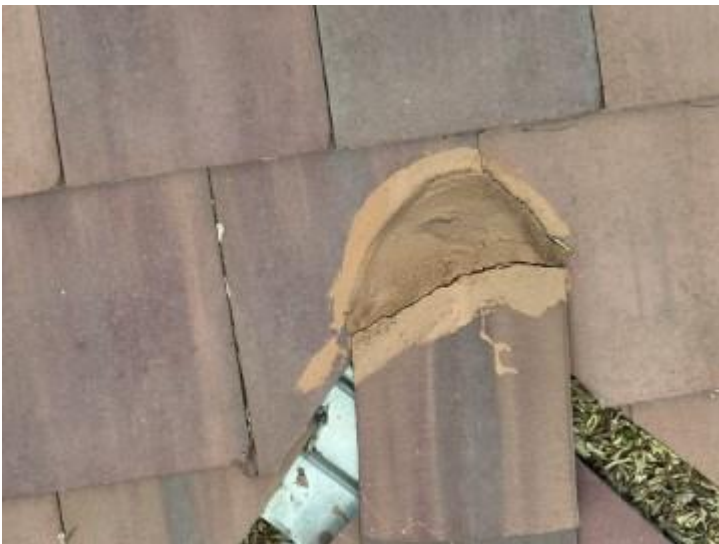
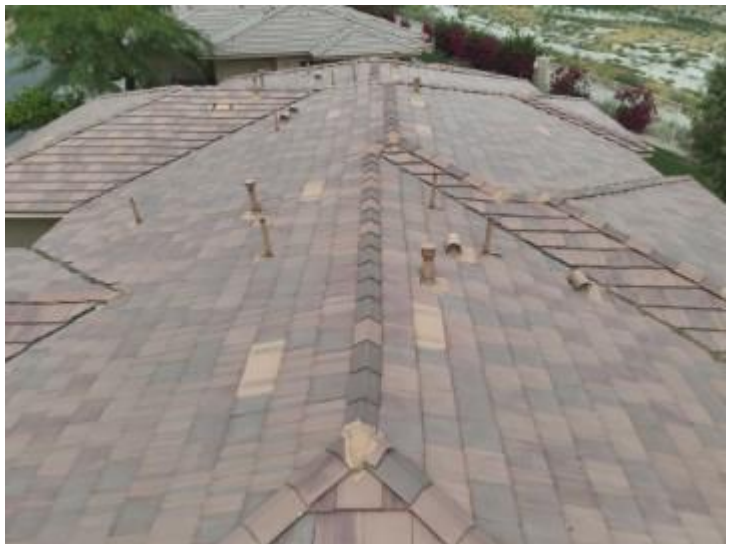
**Building 15 -**

ITEM	Good	Fair	Poor	N/A	COMMENTS
A - Perimeter details		X			
B - Drainage		X			Some debris noted in the valleys.
C - Penetration flashings		X			
D - Overall Tile condition		X			Some isolated chipped tiles noted. Some cracking noted at mortar. Some isolated slipping tiles noted.
E - Wall/Curb flashings				X	
F - Insulation				X	
G - Other				X

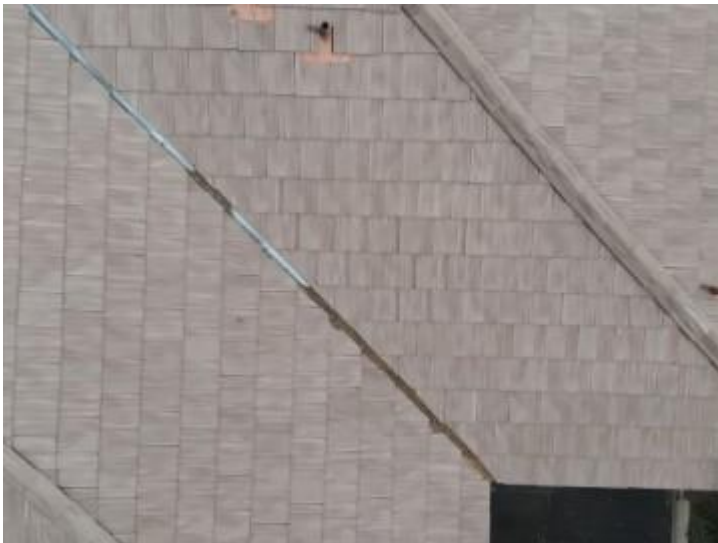
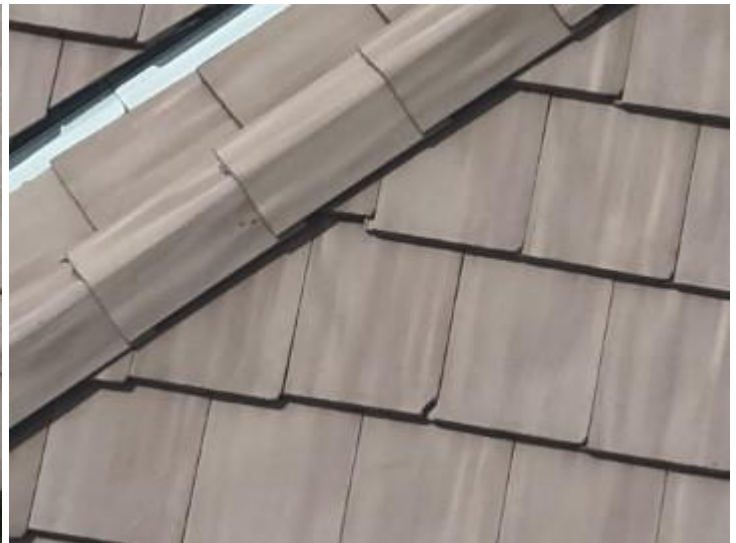
**Building 16 –**

ITEM	Good	Fair	Poor	N/A	COMMENTS
A - Perimeter details		X			
B - Drainage		X			Some debris noted in the valleys.
C - Penetration flashings		X			
D - Overall Tile condition		X			Some isolated chipped tiles noted.
E - Wall/Curb flashings				X	
F - Insulation				X	
G – Other				X

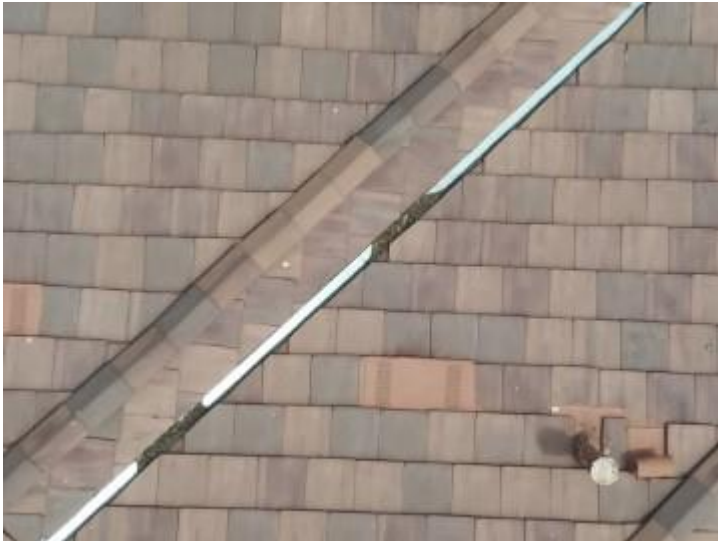
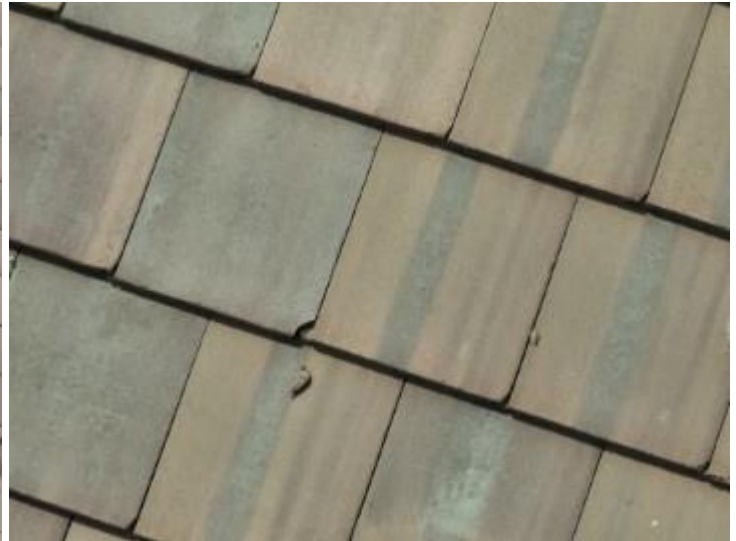
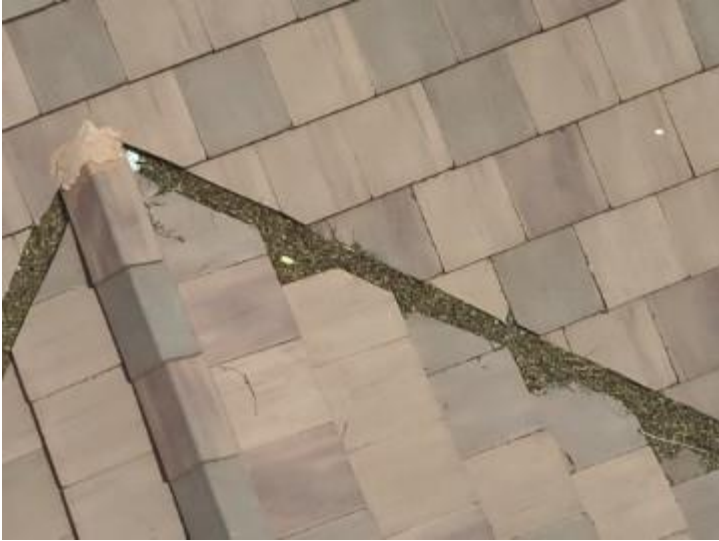
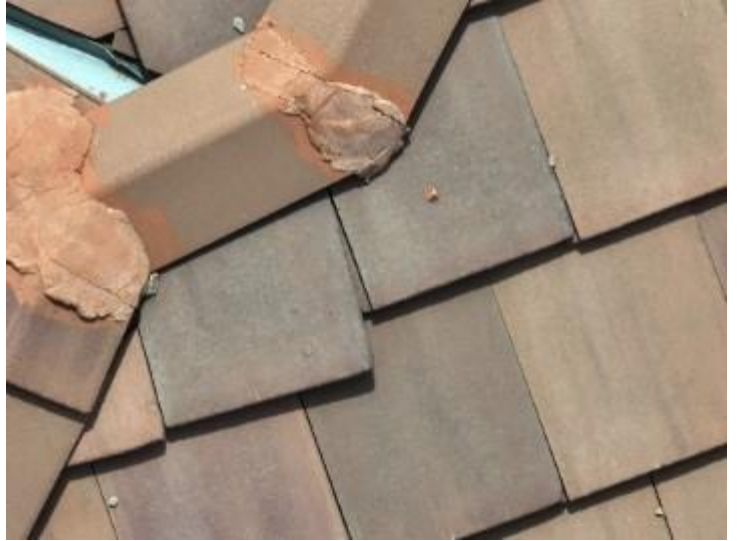
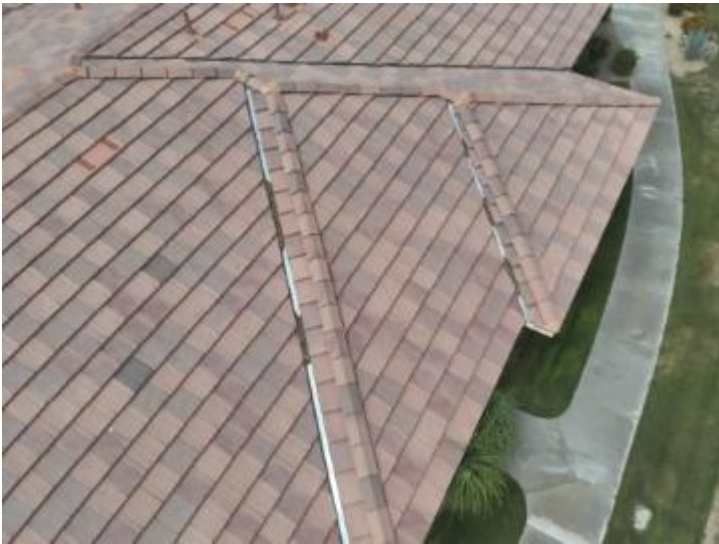
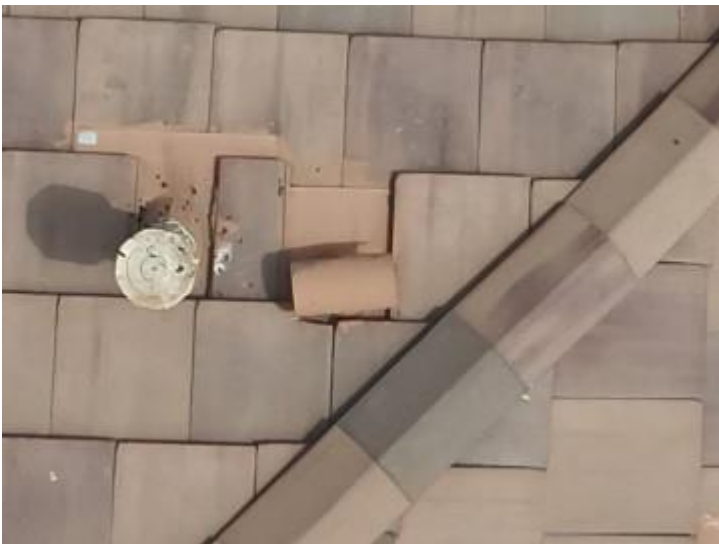
**Building 17 -**

ITEM	Good	Fair	Poor	N/A	COMMENTS
A - Perimeter details		X			
B - Drainage		X			Some debris noted in the valleys.
C - Penetration flashings		X			
D - Overall Tile condition		X			Some isolated chipped tiles noted. Some cracking noted at mortar.
E - Wall/Curb flashings				X	
F - Insulation				X	
G - Other				X
