## HOUSING AUTHORITY Meeting Agenda

Thursday, November 7, 2024

Re: **Roof Consulting**  
Indian Wells Villas  
74800 Village Center Drive  
Indian Wells, CA 92210

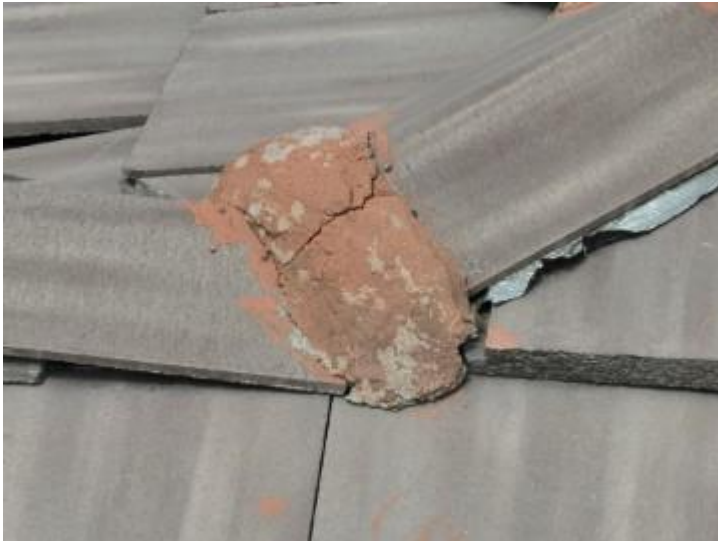
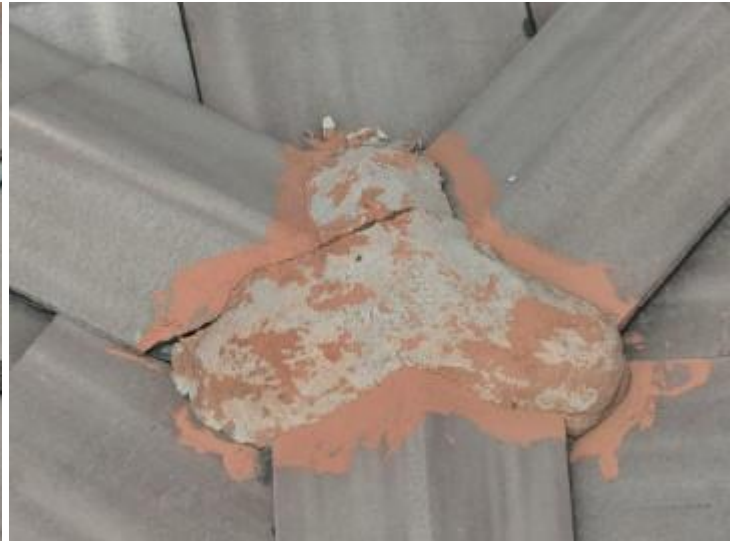
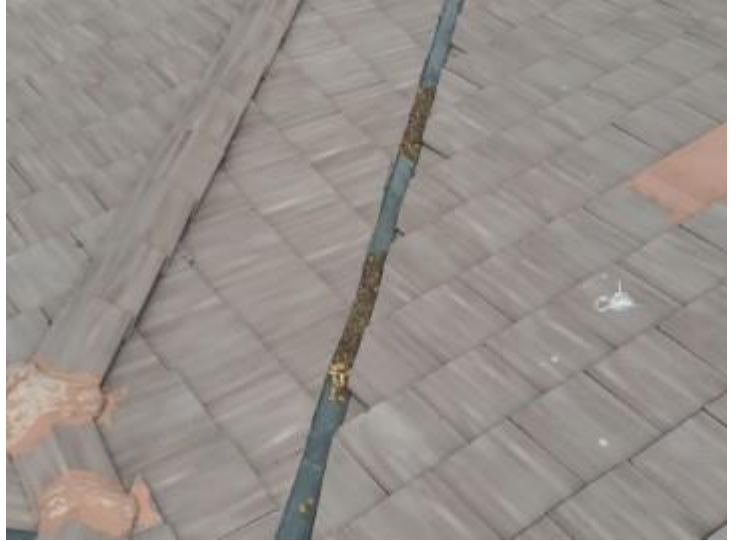
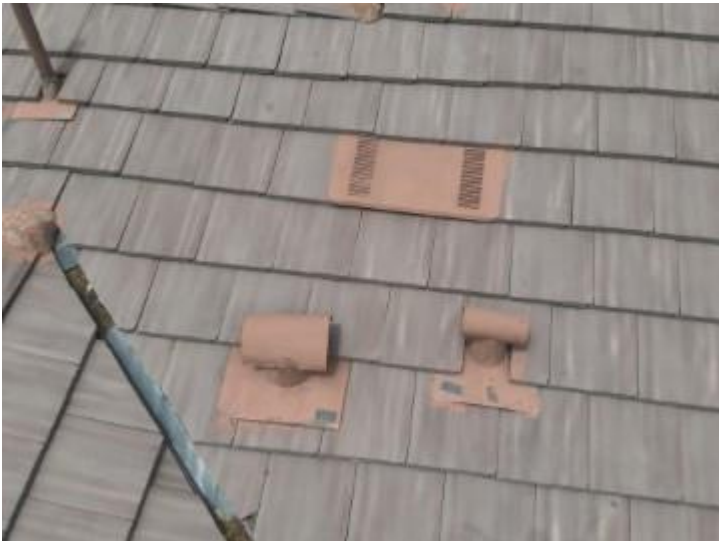
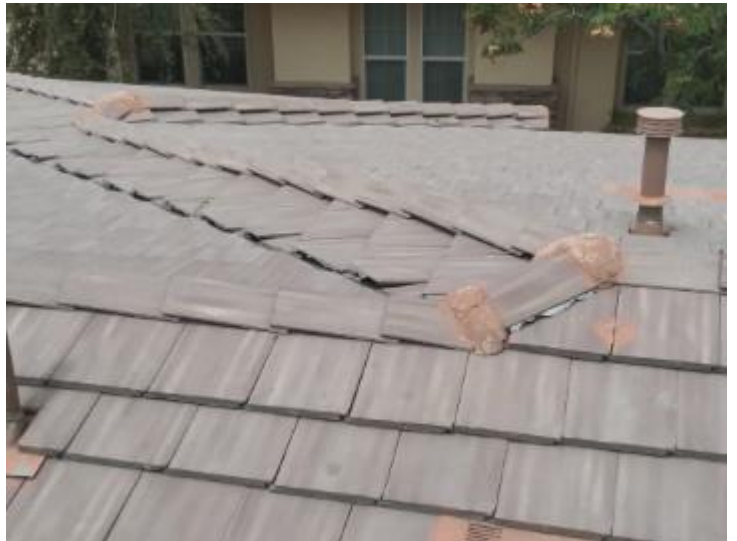
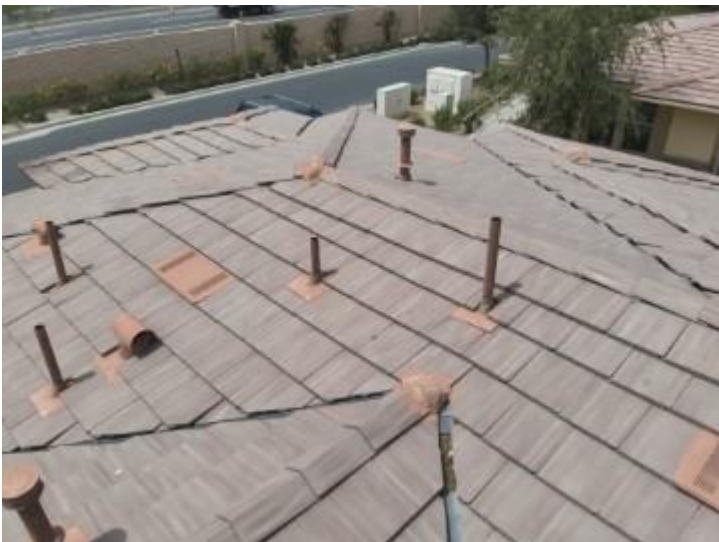
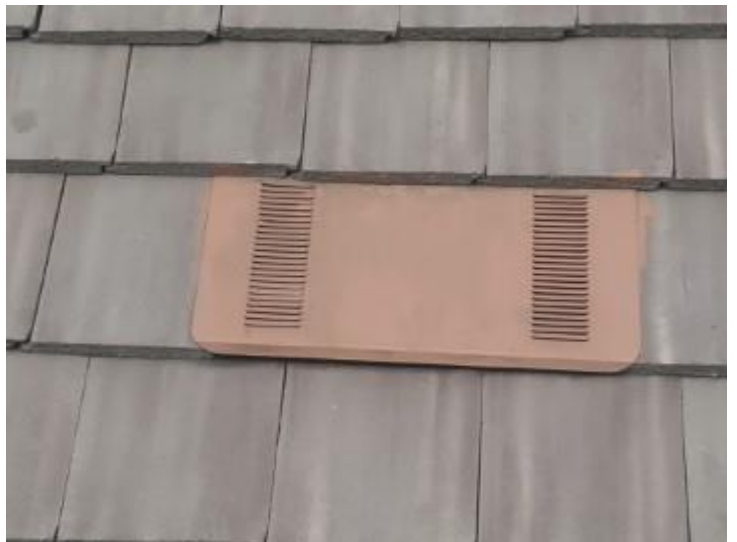
**Building 18 -**

ITEM	Good	Fair	Poor	N/A	COMMENTS
A - Perimeter details		X			
B - Drainage		X			Some debris noted in the valleys.
C - Penetration flashings		X			
D - Overall Tile condition		X			Some cracking noted at mortar.
E - Wall/Curb flashings				X	
F - Insulation				X	
G - Other				X

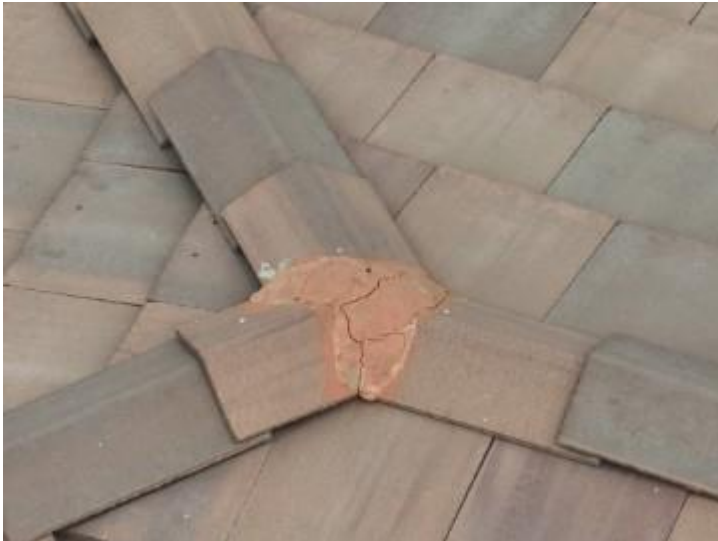
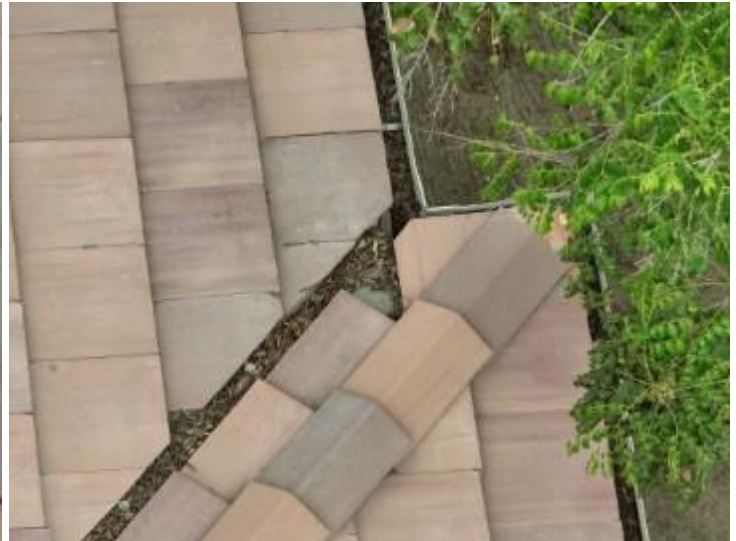
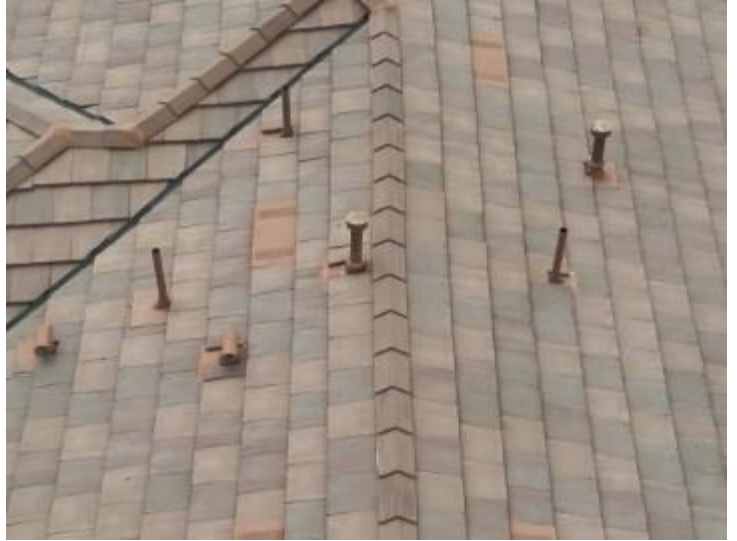
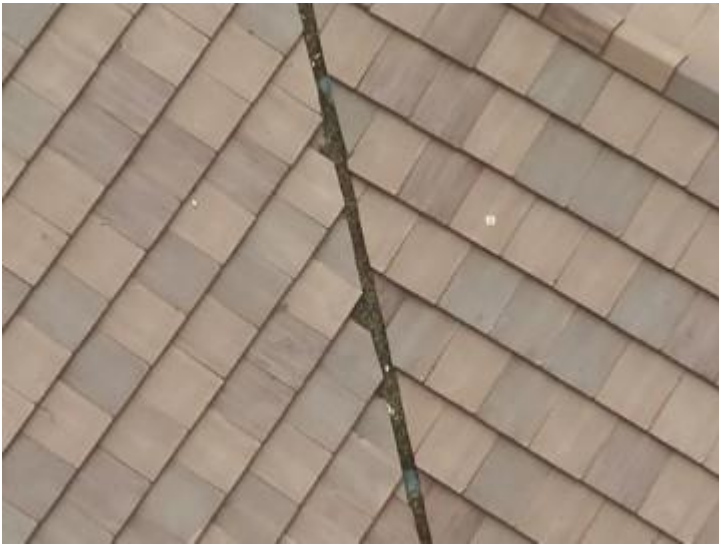
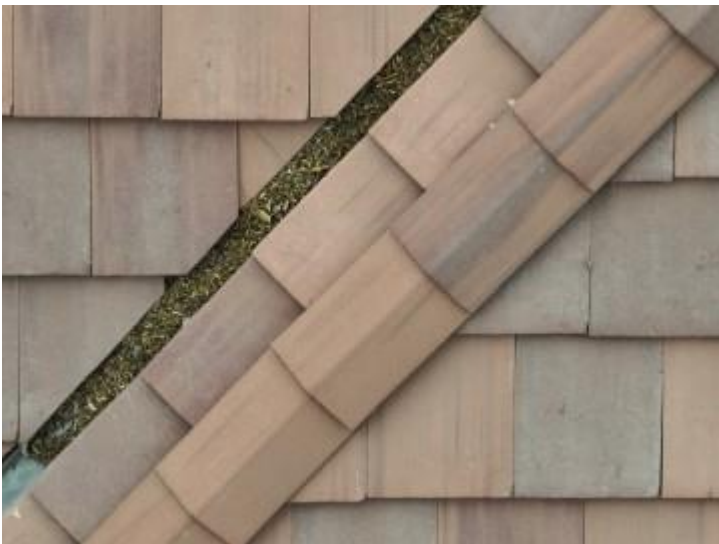
**Building 19 -**

ITEM	Good	Fair	Poor	N/A	COMMENTS
A - Perimeter details		X			
B - Drainage		X			Some debris noted in the valleys.
C - Penetration flashings		X			
D - Overall Tile condition		X			Some cracking noted at mortar. A missing tile notes at valley.
E - Wall/Curb flashings				X	
F - Insulation				X	
G - Other				X

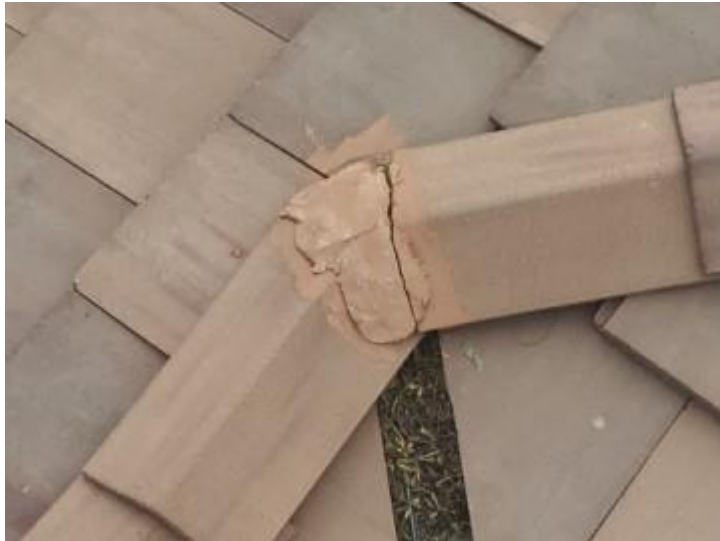
**Building 21 -**

ITEM	Good	Fair	Poor	N/A	COMMENTS
A - Perimeter details		X			
B - Drainage		X			Some debris noted in the valleys.
C - Penetration flashings		X			
D - Overall Tile condition		X			Some isolated chipped tiles noted. Some cracking noted at mortar.
E - Wall/Curb flashings				X	
F - Insulation				X	
G - Other				X

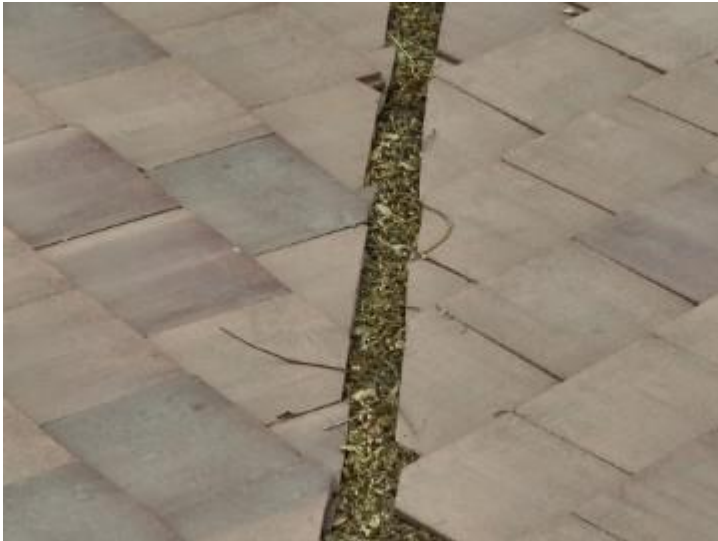
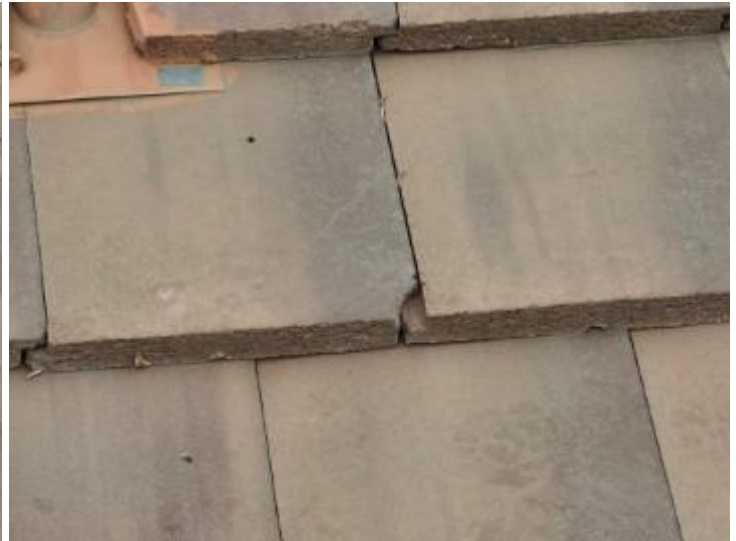
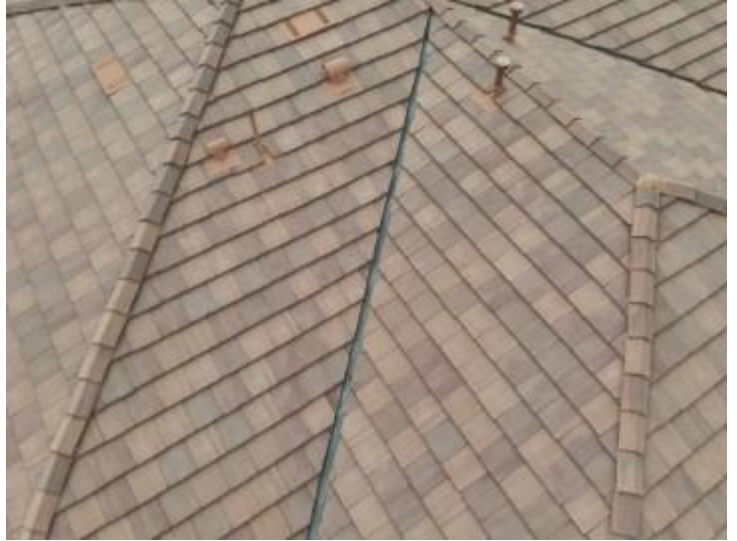
**Building 22 -**

ITEM	Good	Fair	Poor	N/A	COMMENTS
A - Perimeter details		X			
B - Drainage		X			Some debris noted in the valleys.
C - Penetration flashings		X			
D - Overall Tile condition		X			Some isolated chipped tiles noted. Some cracking noted at mortar.
E - Wall/Curb flashings				X	
F - Insulation				X	
G - Other				X

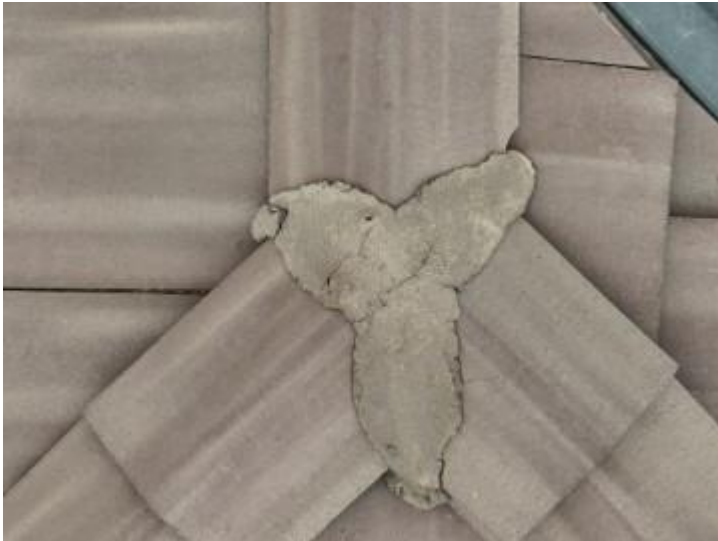
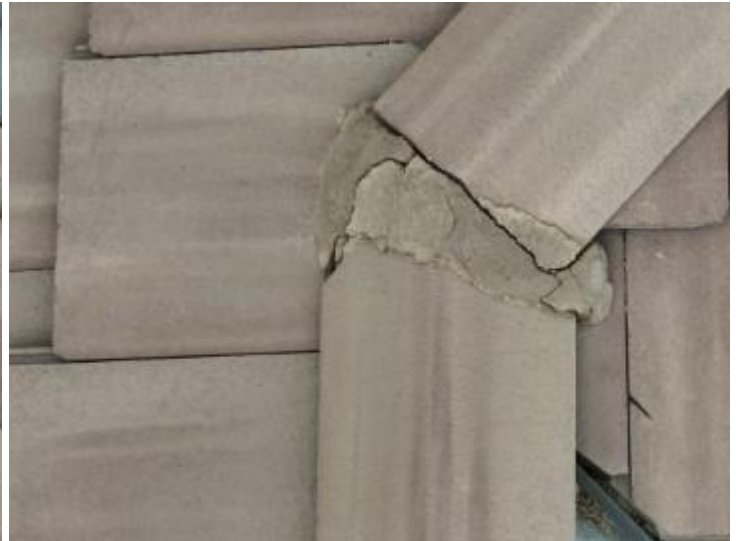
**Building 23 -**

ITEM	Good	Fair	Poor	N/A	COMMENTS
A - Perimeter details		X			
B - Drainage		X			Some debris noted in the valleys.
C - Penetration flashings		X			
D - Overall Tile condition		X			Some isolated chipped tiles noted. Some cracking noted at mortar.
E - Wall/Curb flashings				X	
F - Insulation				X	
G - Other				X

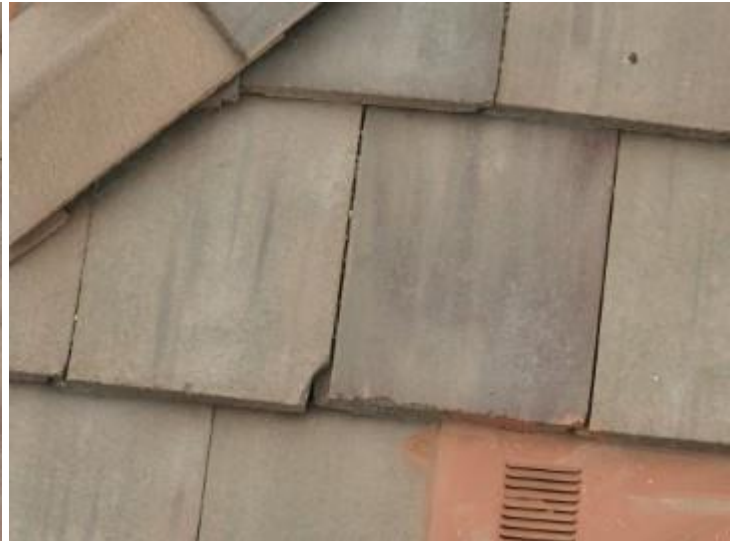
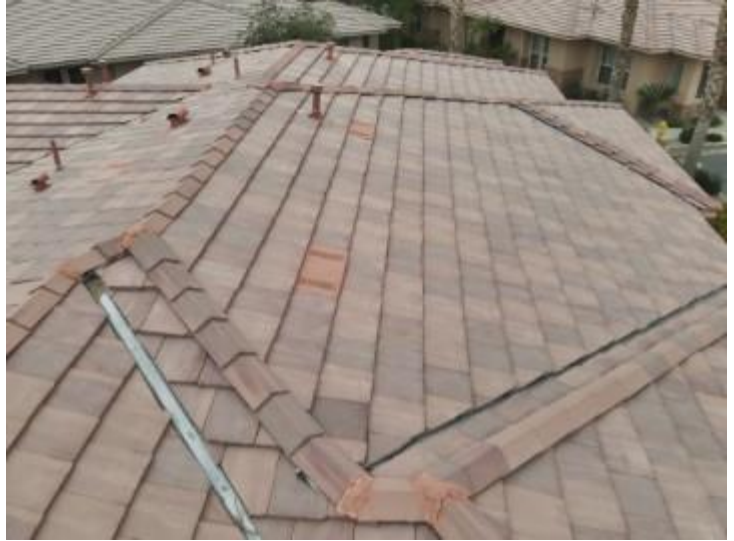
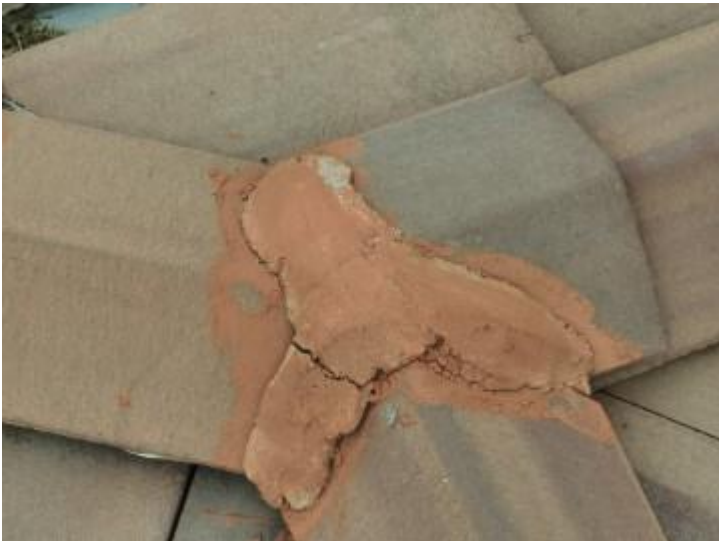
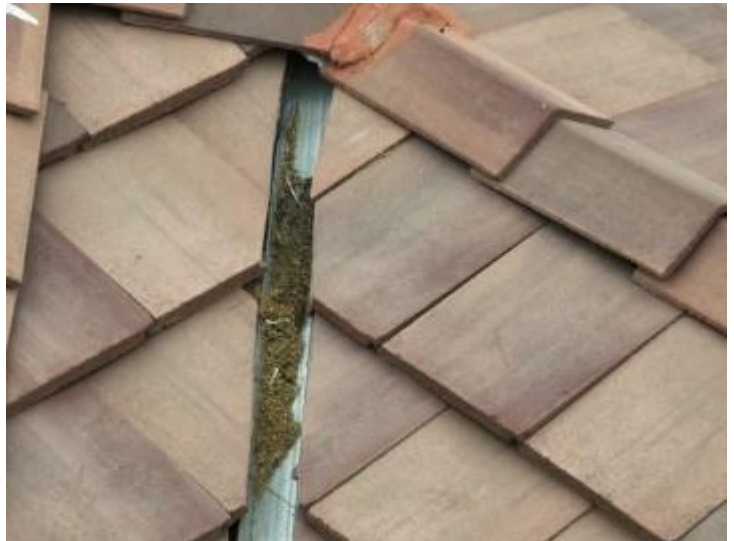
**Building 24 -**

ITEM	Good	Fair	Poor	N/A	COMMENTS
A - Perimeter details		X			
B - Drainage		X			Some debris noted in the valleys.
C - Penetration flashings		X			
D - Overall Tile condition		X			Some isolated chipped tiles noted. Some cracking noted at mortar.
E - Wall/Curb flashings				X	
F - Insulation				X	
G - Other				X

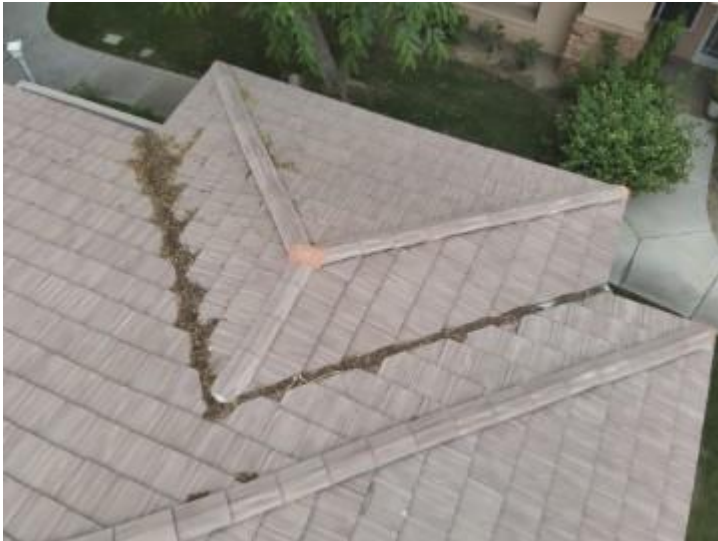
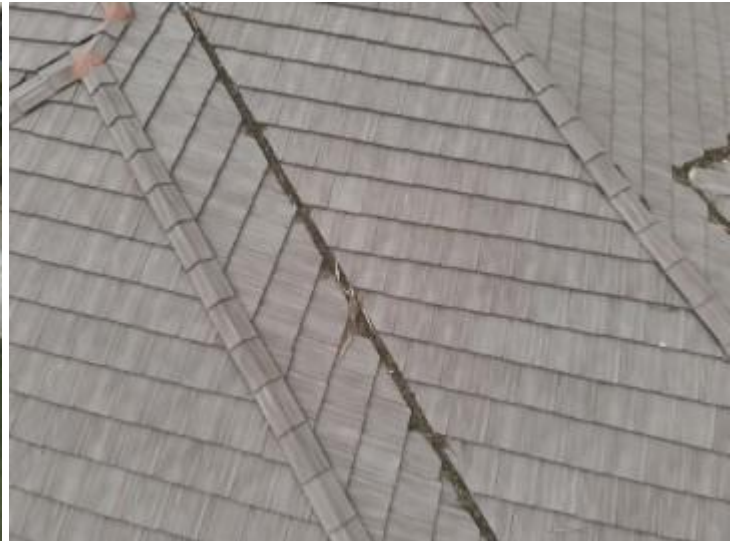
**Building 25 -**

ITEM	Good	Fair	Poor	N/A	COMMENTS
A - Perimeter details		X			
B - Drainage		X			Some debris noted in the valleys.
C - Penetration flashings		X			
D - Overall Tile condition		X			Some isolated chipped tiles noted. Some cracking noted at mortar.
E - Wall/Curb flashings				X	
F - Insulation				X	
G - Other				X

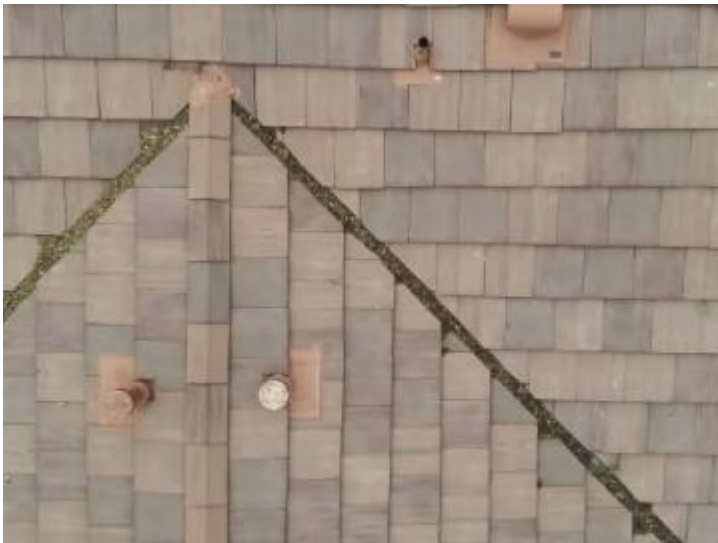
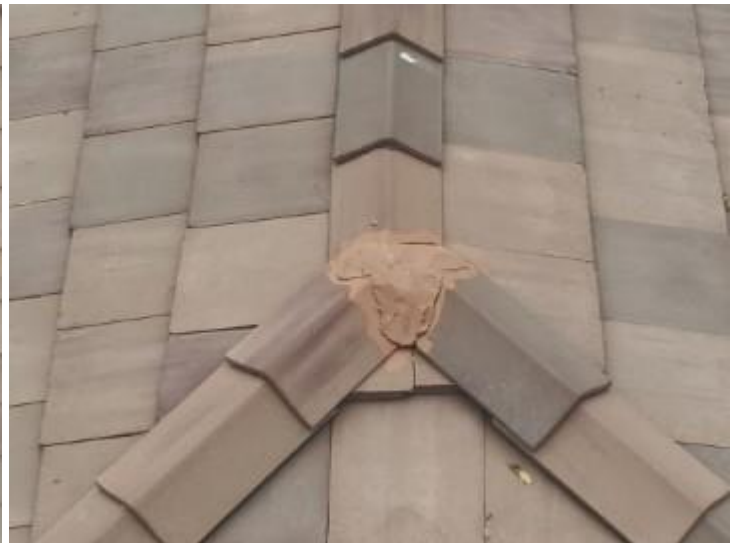
**Building 26 -**

ITEM	Good	Fair	Poor	N/A	COMMENTS
A - Perimeter details		X			
B - Drainage		X			Some debris noted in the valleys.
C - Penetration flashings		X			
D - Overall Tile condition		X			Some isolated chipped tiles noted. Some cracking noted at mortar.
E - Wall/Curb flashings				X	
F - Insulation				X	
G - Other				X

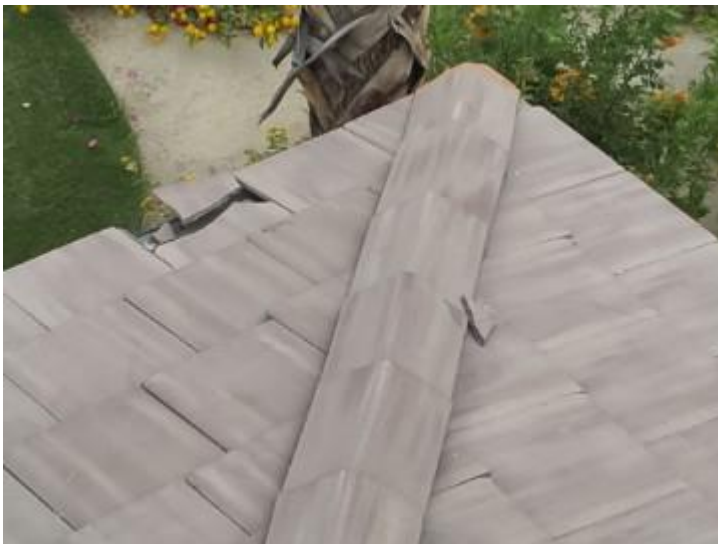
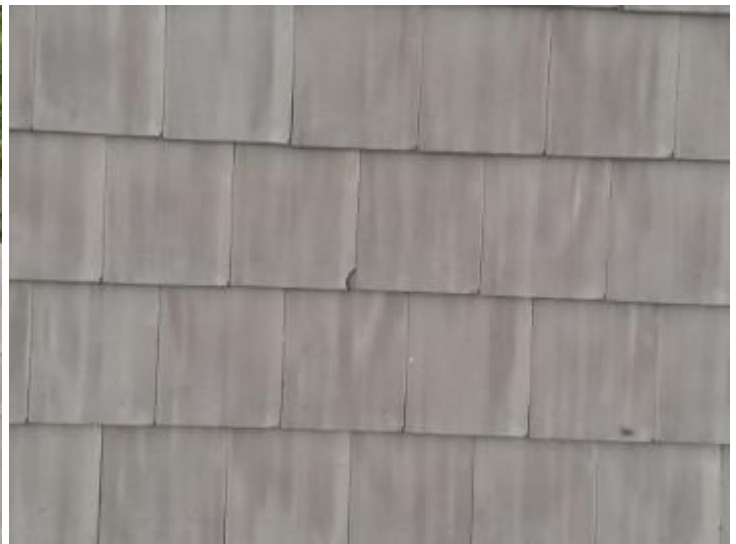
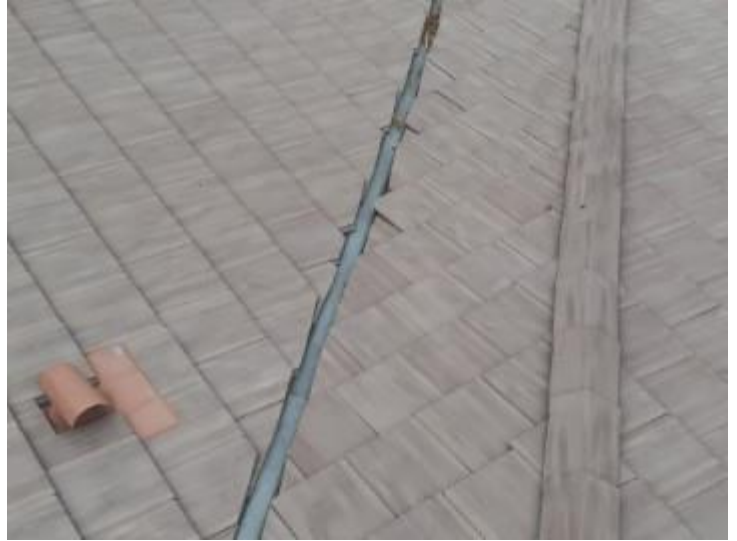
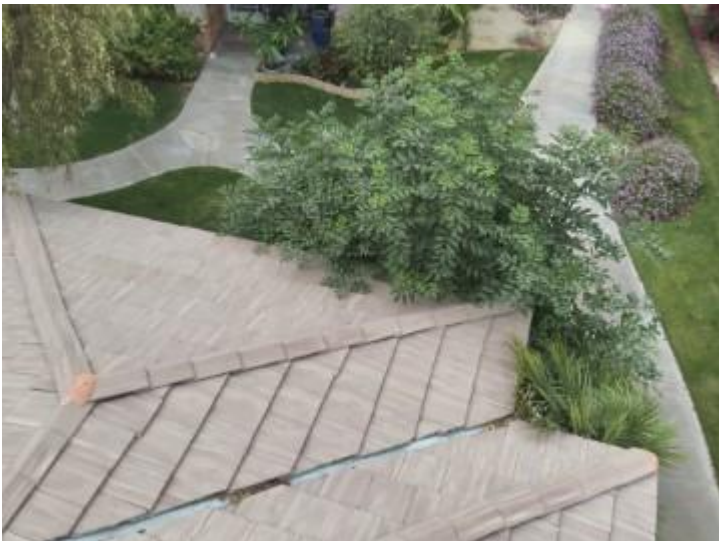
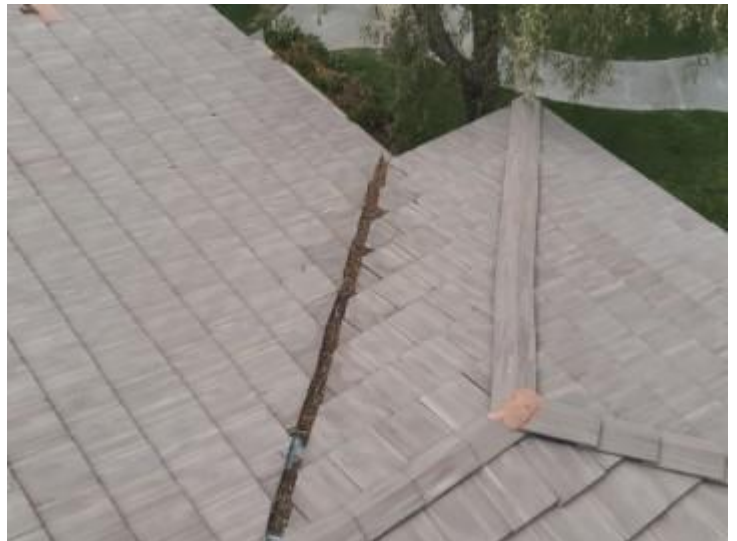
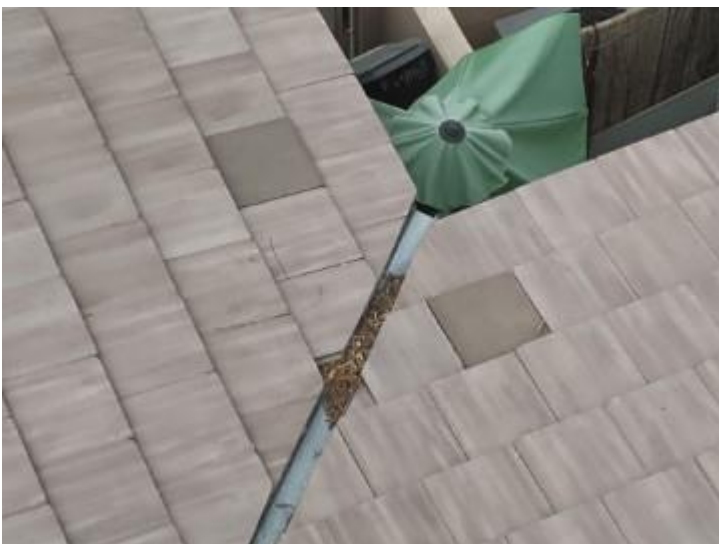
**Building 27 -**

ITEM	Good	Fair	Poor	N/A	COMMENTS
A - Perimeter details		X			
B - Drainage		X			Some debris noted in the valleys.
C - Penetration flashings		X			
D - Overall Tile condition		X			Some isolated broken tiles noted. Some isolated chipped tiles noted. Some cracking noted at mortar.
E - Wall/Curb flashings				X	
F - Insulation				X	
G - Other				X

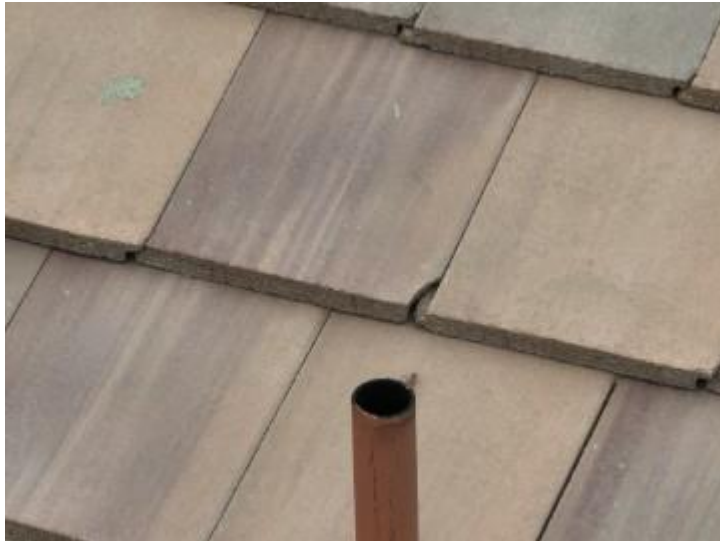
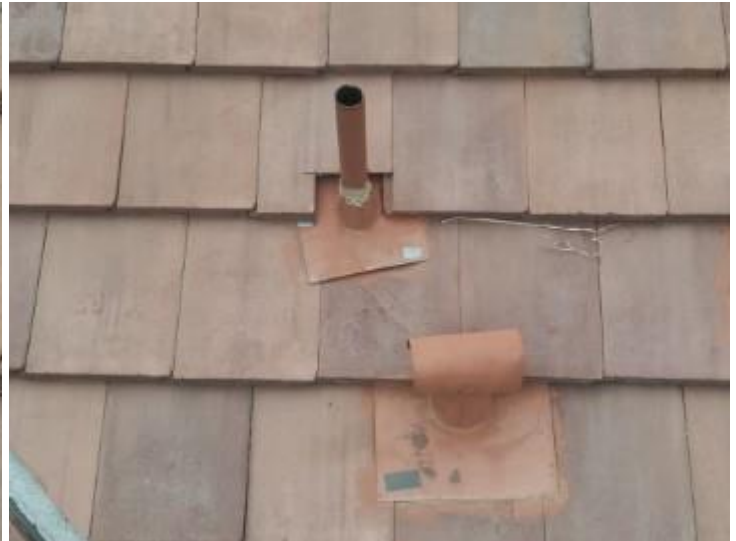
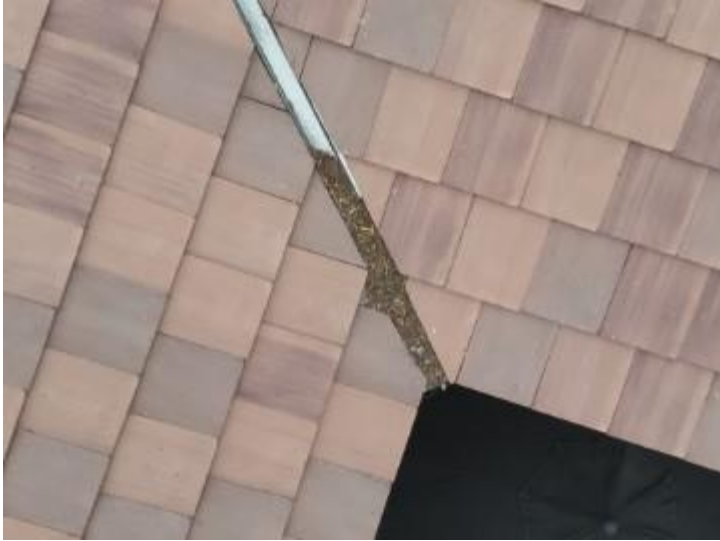
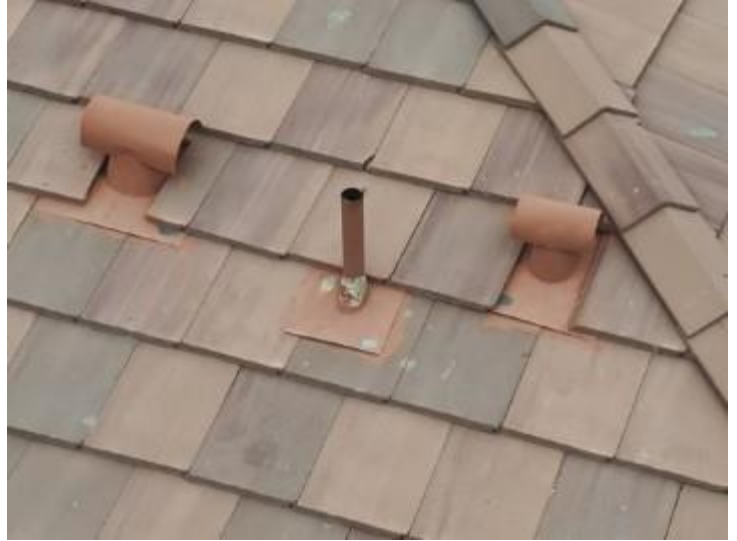
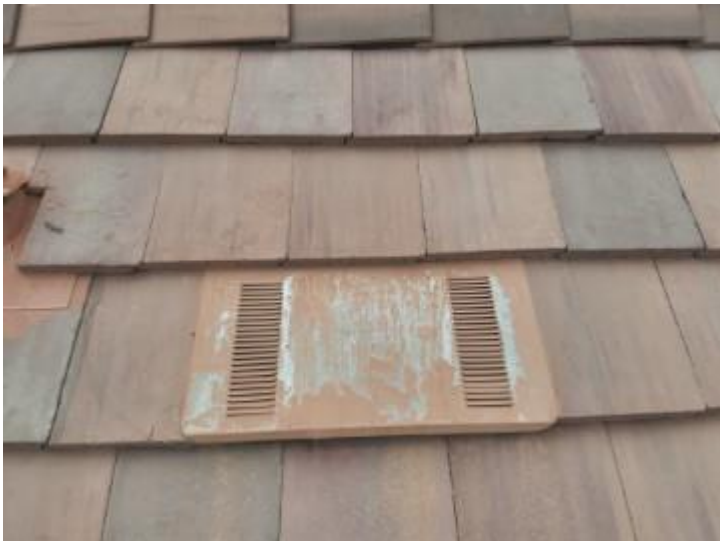
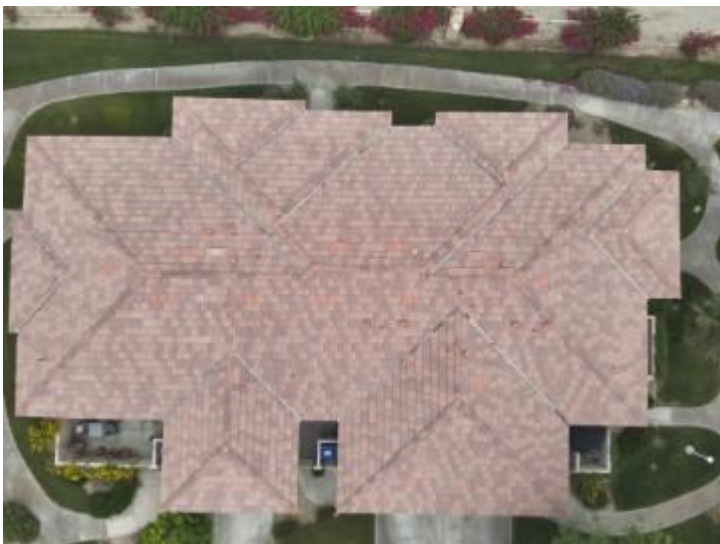
**Building 28 -**

ITEM	Good	Fair	Poor	N/A	COMMENTS
A - Perimeter details		X			
B - Drainage		X			Some debris noted in the valleys.
C - Penetration flashings		X			A loose flashing was noted at a plumbing vent.
D - Overall Tile condition		X			Some isolated chipped tiles noted. Some cracking noted at mortar.
E - Wall/Curb flashings				X	
F - Insulation				X	
G - Other				X

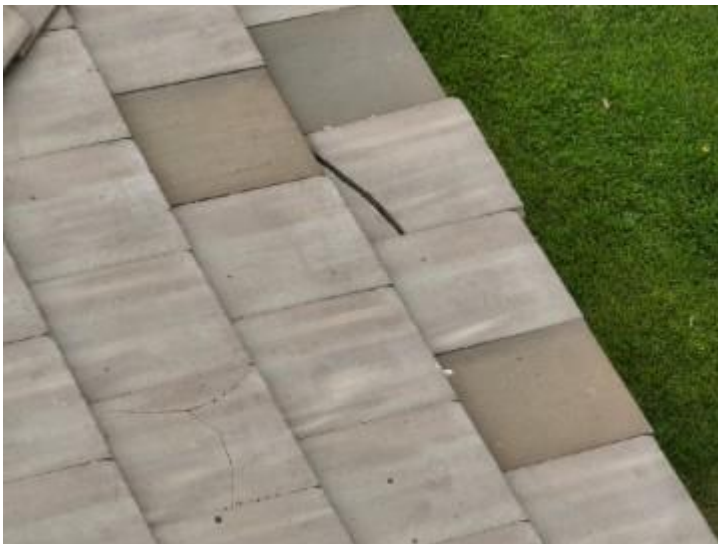
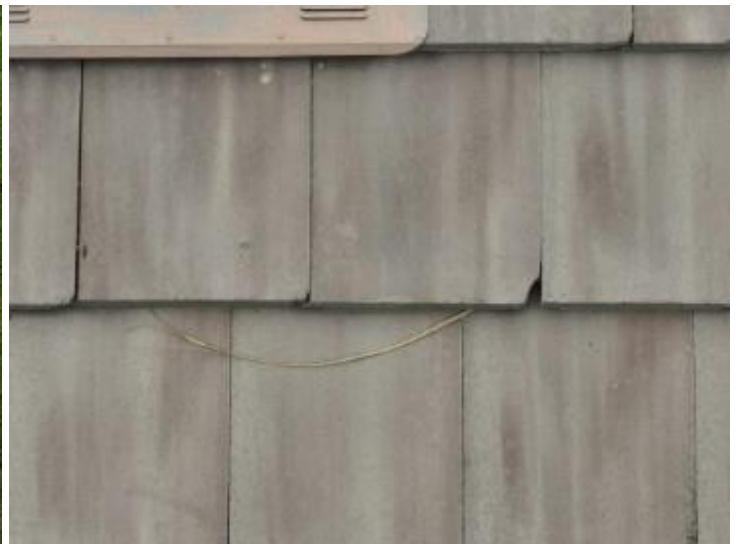
**Building 29 -**

ITEM	Good	Fair	Poor	N/A	COMMENTS
A - Perimeter details		X			
B - Drainage		X			Some debris noted in the valleys.
C - Penetration flashings		X			
D - Overall Tile condition		X			Some isolated cracked tiles noted. Some isolated chipped tiles noted. Some cracking noted at mortar.
E - Wall/Curb flashings				X	
F - Insulation				X	
G - Other				X

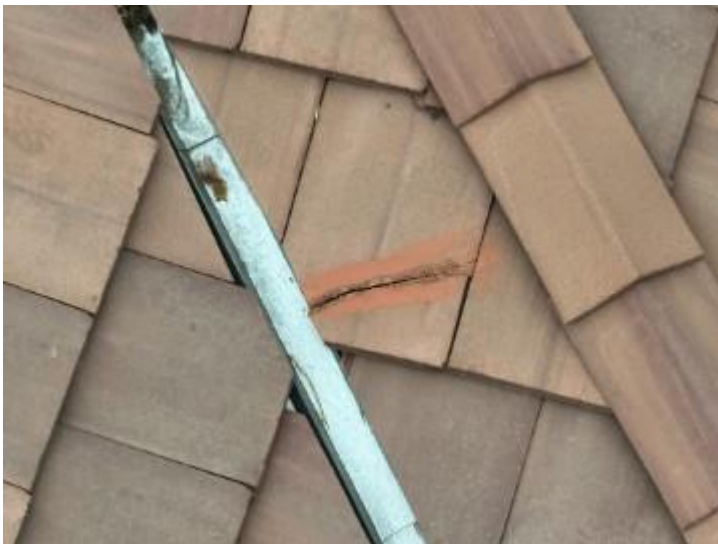
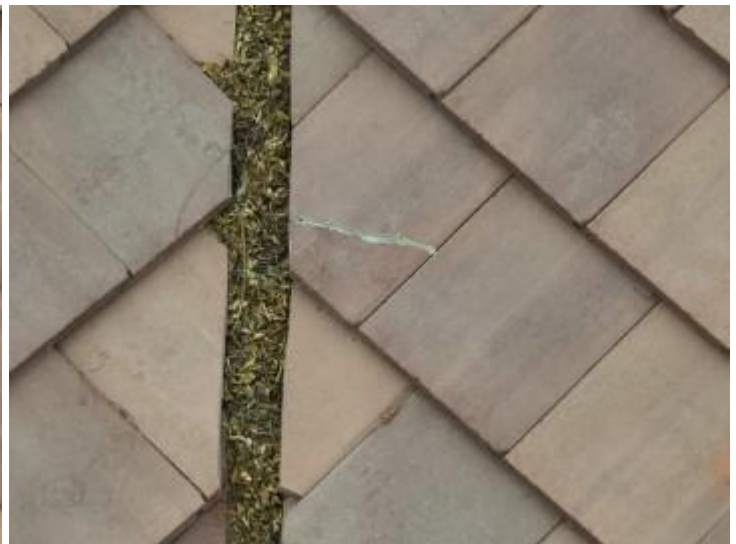
**Building 30 -**

ITEM	Good	Fair	Poor	N/A	COMMENTS
A - Perimeter details		X			
B - Drainage		X			Some debris noted in the valleys.
C - Penetration flashings		X			
D - Overall Tile condition		X			Some isolated cracked tiles noted. Some isolated chipped tiles noted. Some cracking noted at mortar.
E - Wall/Curb flashings				X	
F - Insulation				X	
G - Other				X

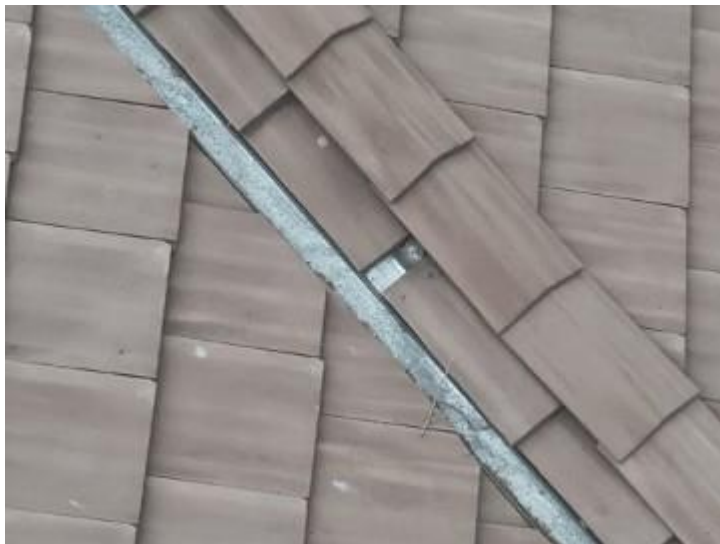
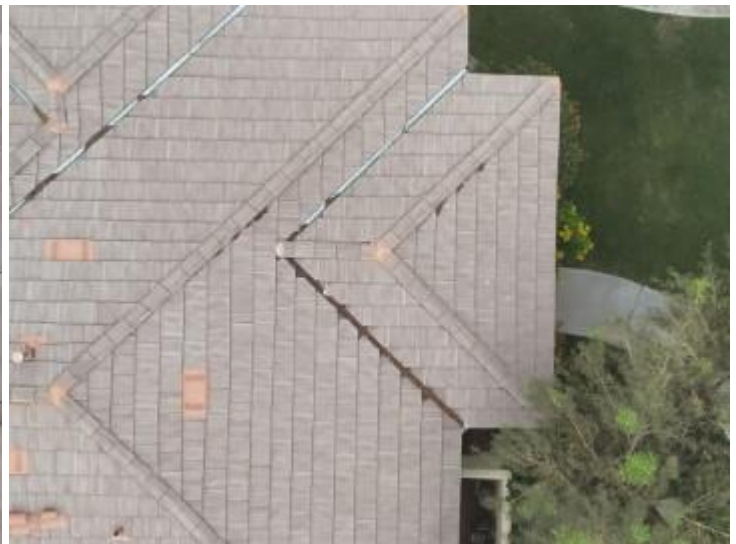
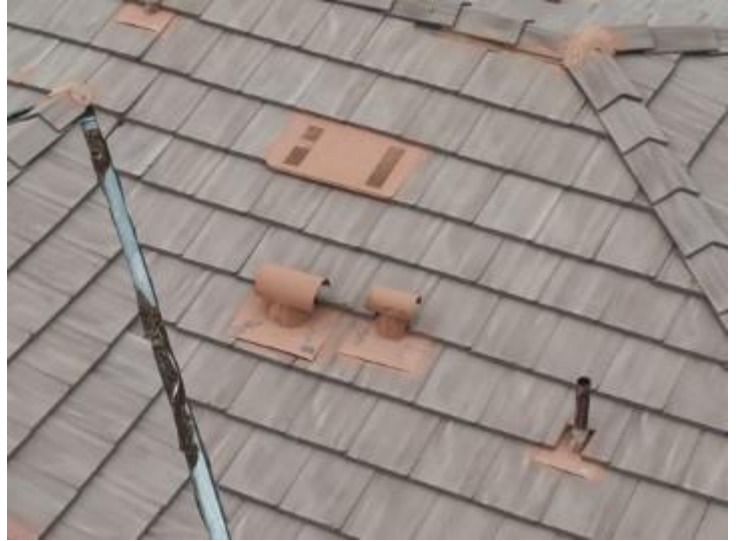
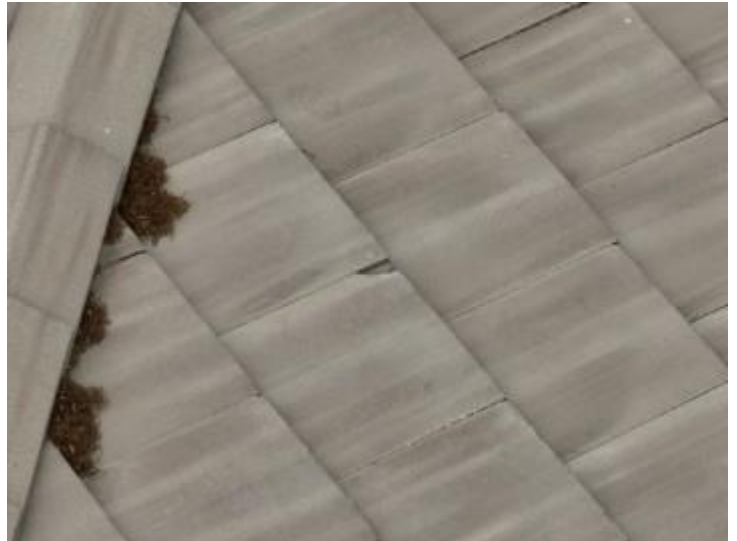
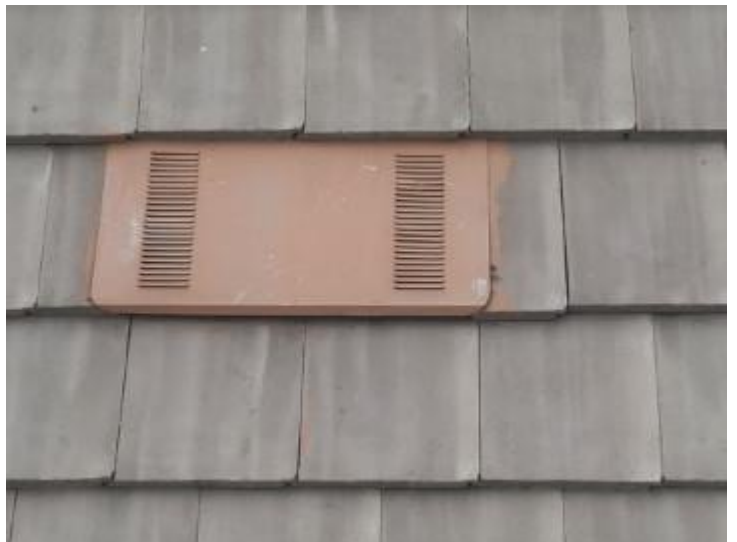
**Building 31 -**

ITEM	Good	Fair	Poor	N/A	COMMENTS
A - Perimeter details		X			
B - Drainage		X			Some debris noted in the valleys.
C - Penetration flashings		X			
D - Overall Tile condition		X			A slipped tile noted at a valley. Some isolated chipped tiles noted. Some cracking noted at mortar.
E - Wall/Curb flashings				X	
F - Insulation				X	
G - Other				X

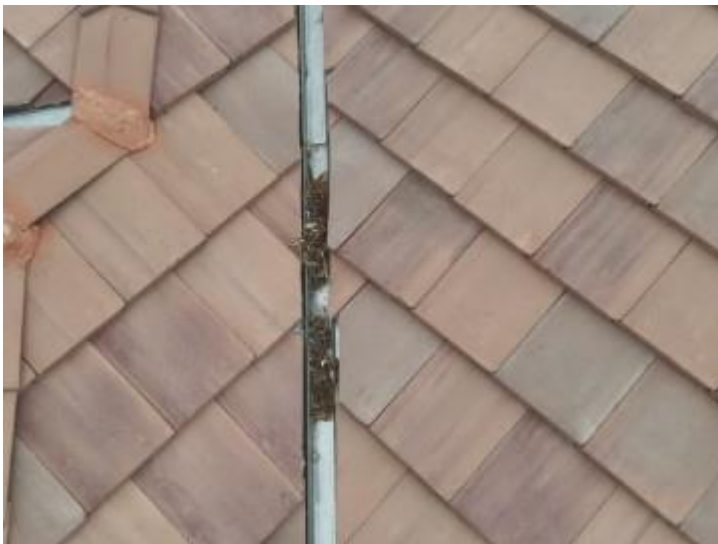
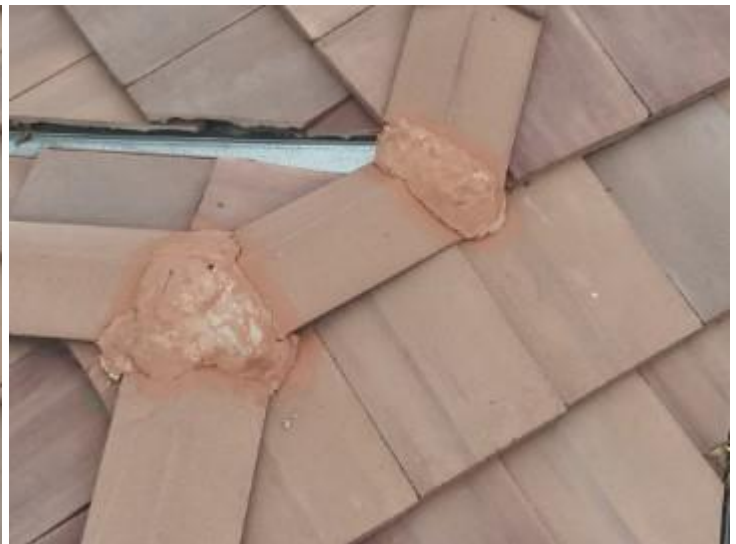
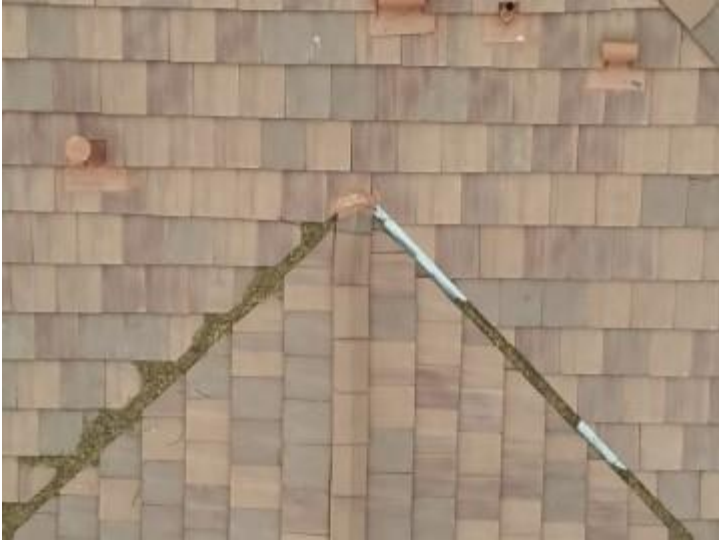
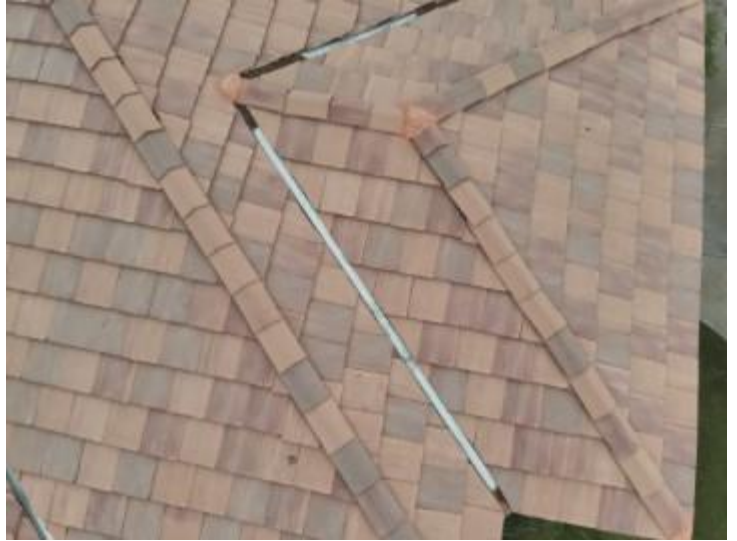
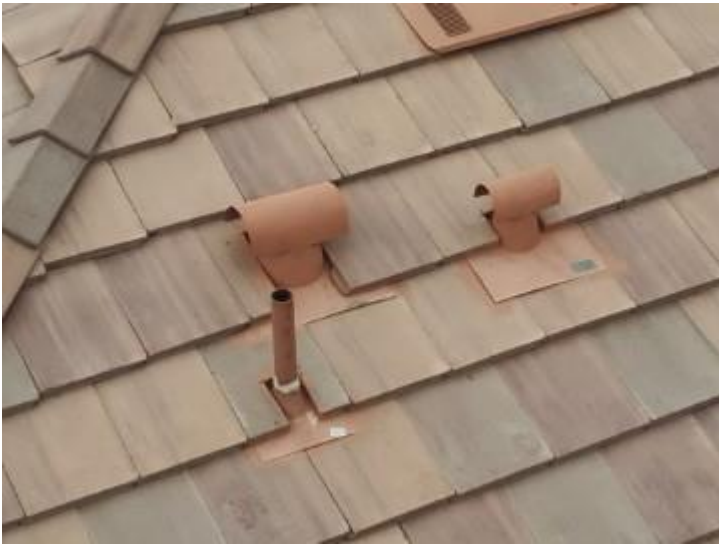
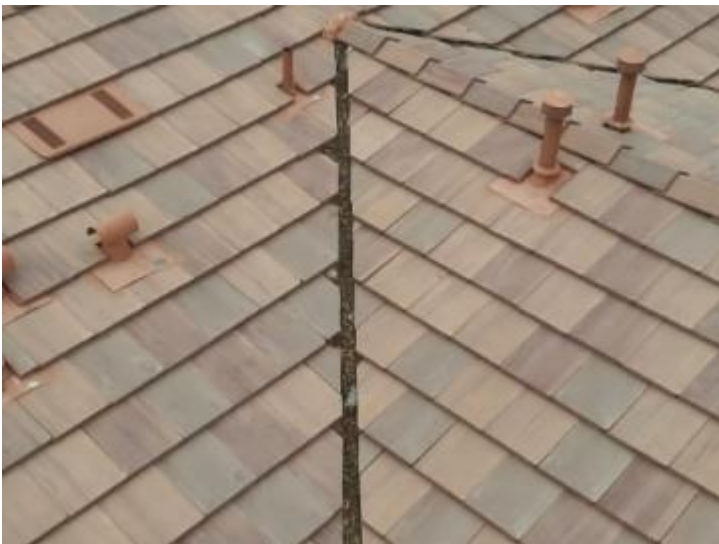
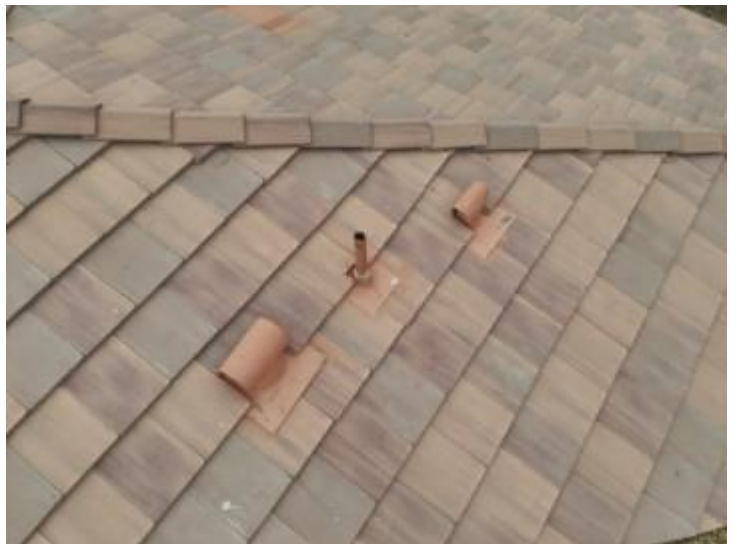
**GENERAL PHOTOS**

ITEM	Good	Fair	Poor	N/A	COMMENTS
A - Perimeter details		X			
B - Drainage		X			Some debris noted in the valleys.
C - Penetration flashings		X			
D - Overall Tile condition		X			Some cracking noted at mortar. A slipped tile noted at hip.
E - Wall/Curb flashings				X	
F - Insulation				X	
G - Other				X
