## HOUSING AUTHORITY Meeting Agenda

Thursday, November 7, 2024

Re: **Roof Consulting**  
Indian Wells Villas  
74800 Village Center Drive  
Indian Wells, CA 92210

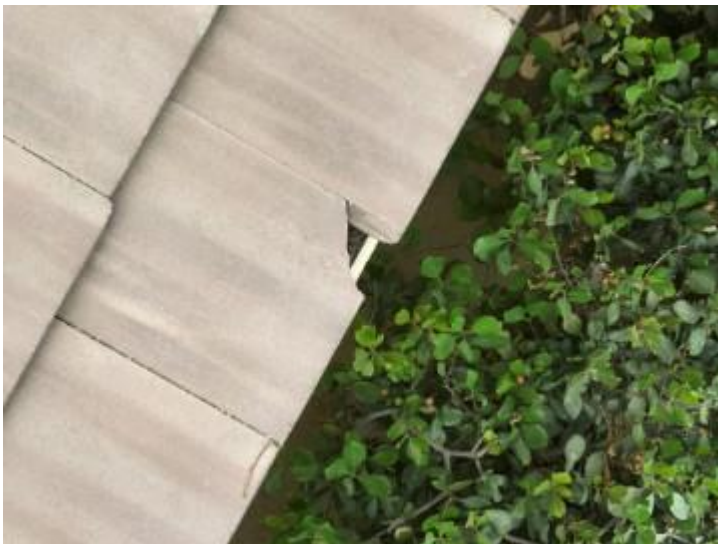
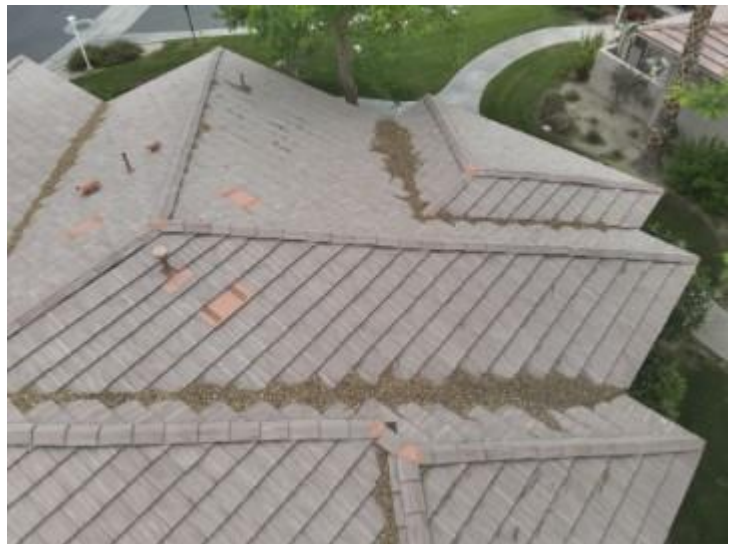
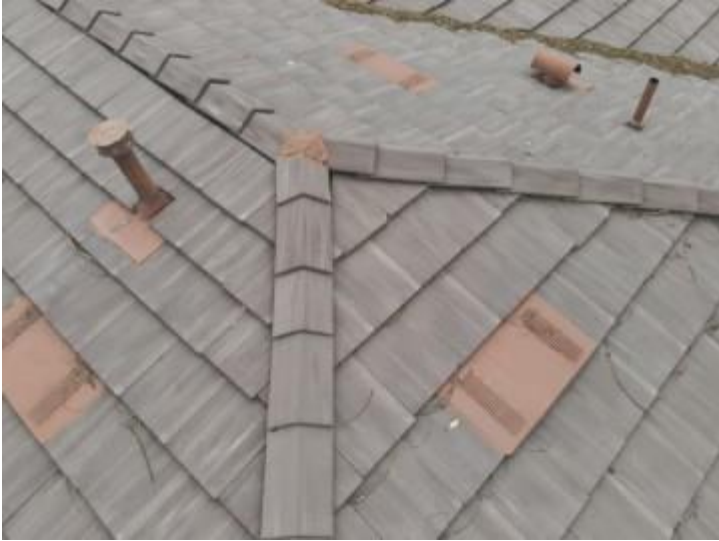
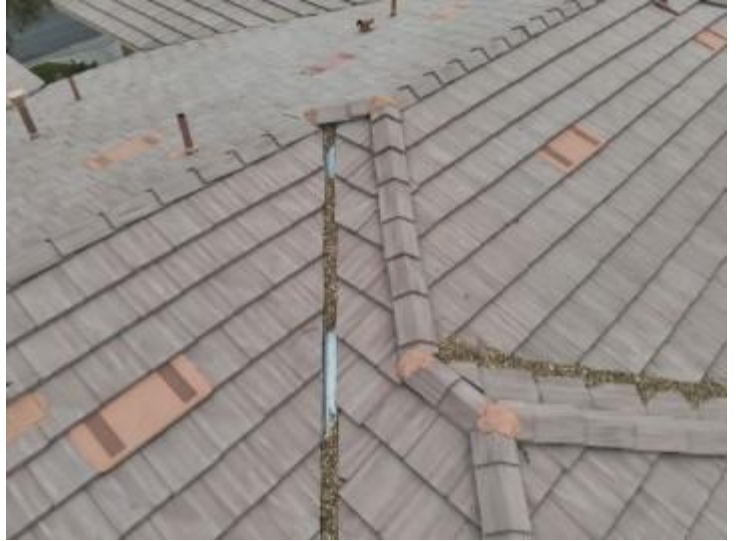
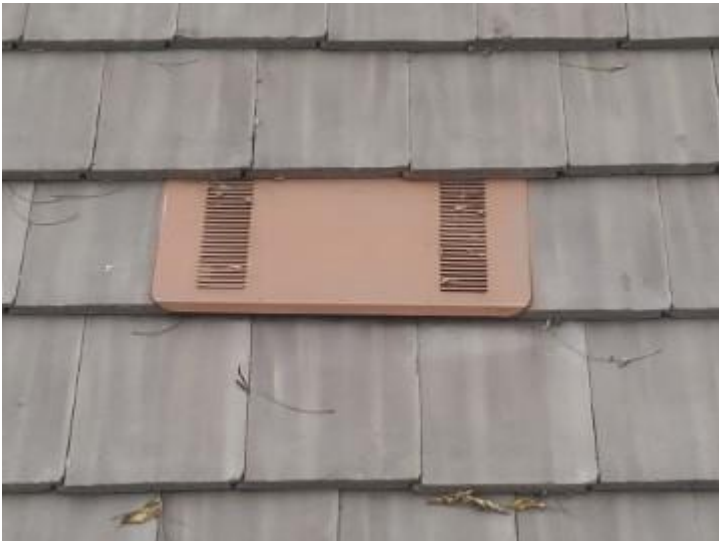
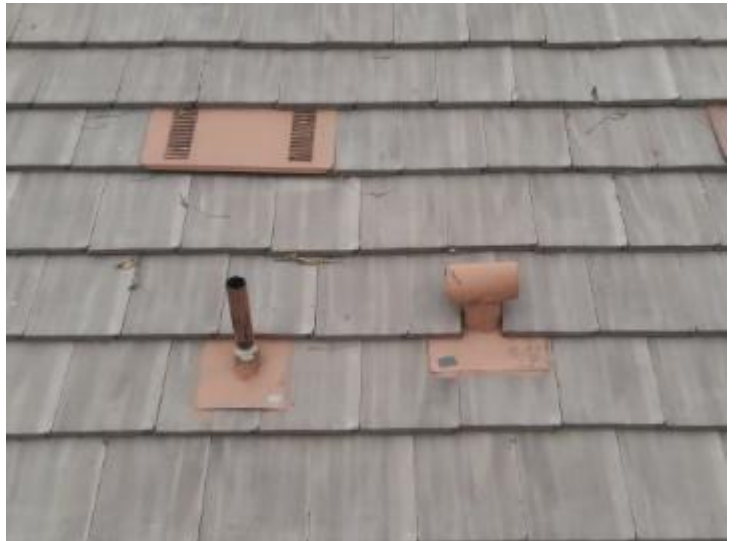
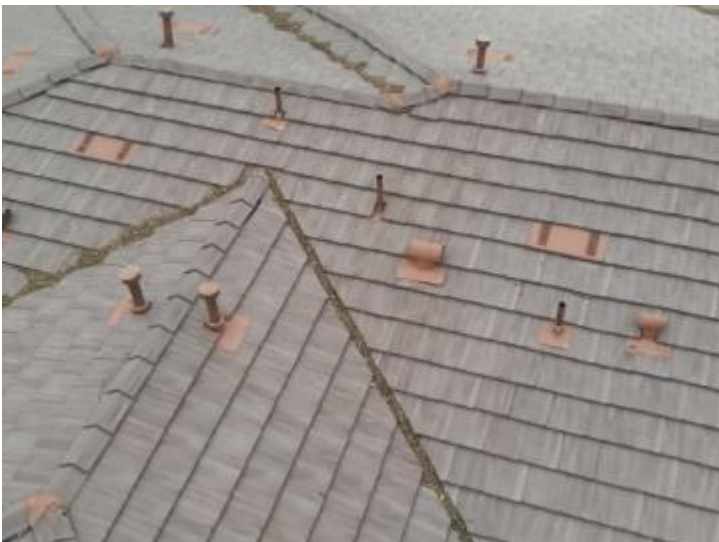
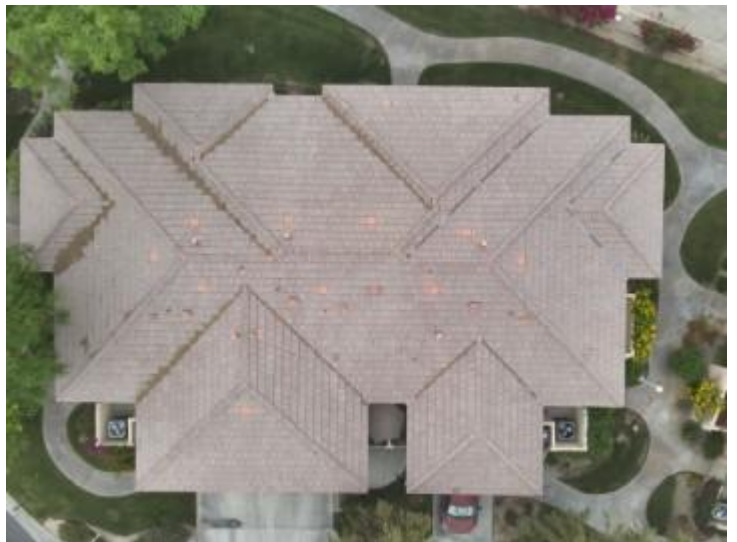
**Building 33 -**

ITEM	Good	Fair	Poor	N/A	COMMENTS
A - Perimeter details		X			
B - Drainage		X			Some debris noted in the valleys.
C - Penetration flashings		X			
D - Overall Tile condition		X			Some isolated cracked tiles noted. Some isolated chipped tiles noted. Some cracking noted at mortar.
E - Wall/Curb flashings				X	
F - Insulation				X	
G - Other				X

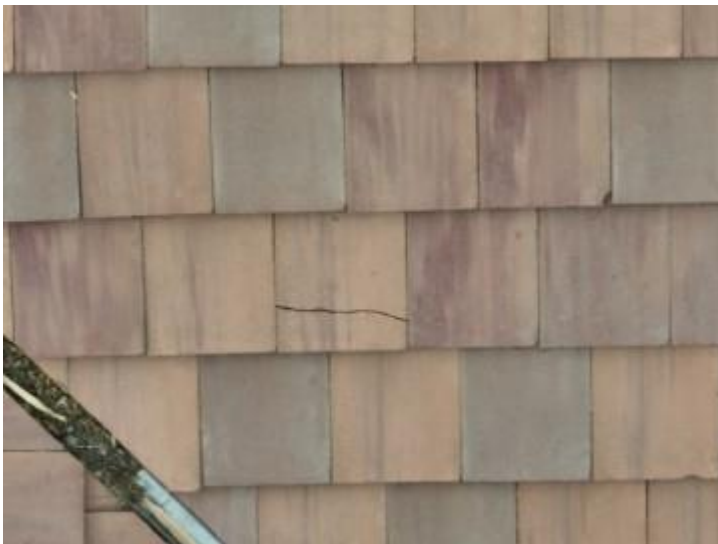
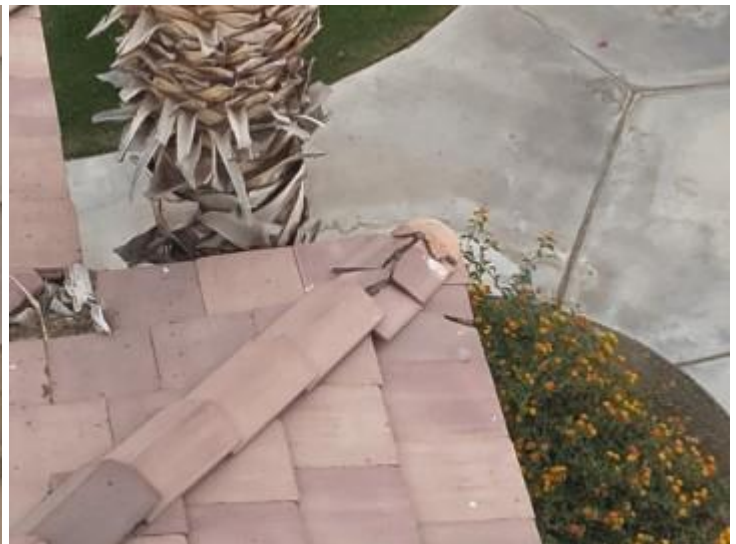
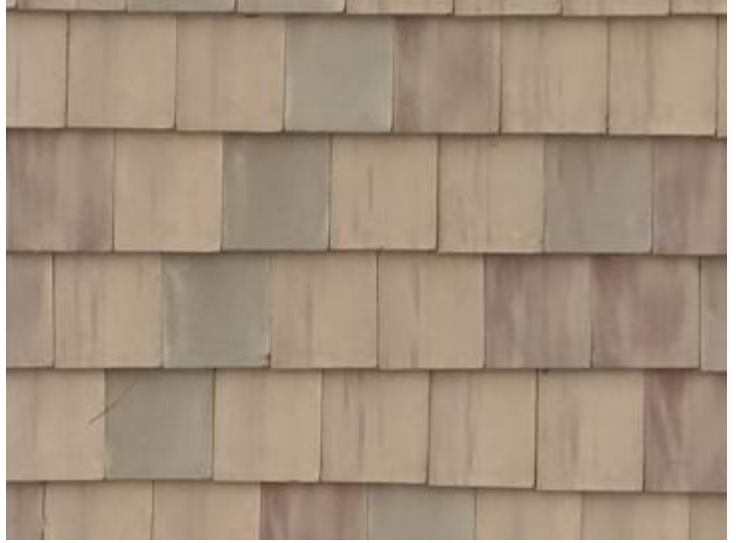
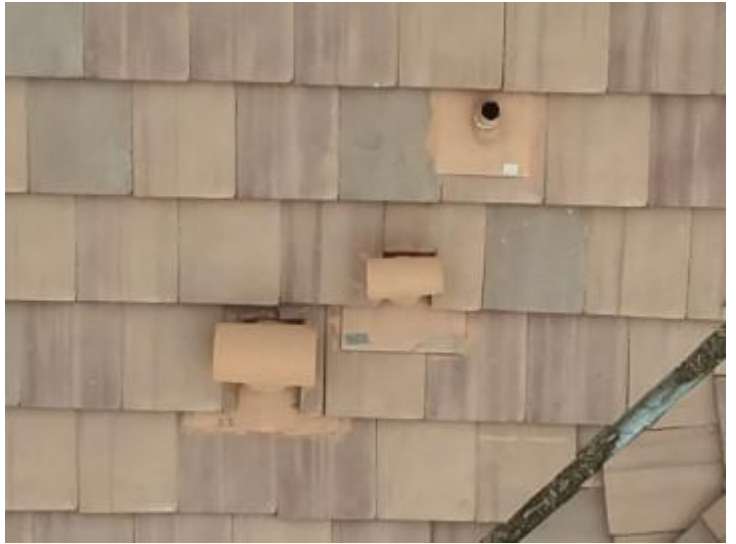
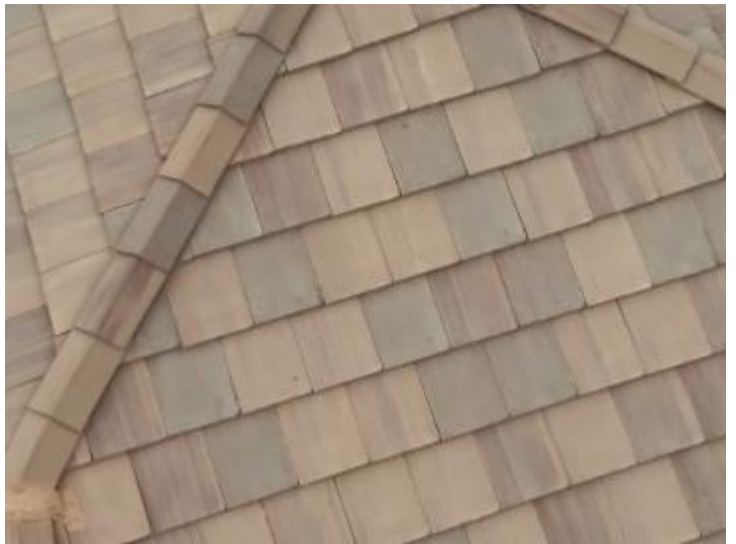
**Building 34 -**

ITEM	Good	Fair	Poor	N/A	COMMENTS
A - Perimeter details		X			
B - Drainage		X			Some debris noted in the valleys.
C - Penetration flashings		X			
D - Overall Tile condition		X			Some isolated cracked/ broken tiles noted. Some isolated chipped tiles noted. Some cracking noted at mortar.
E - Wall/Curb flashings				X	
F - Insulation				X	
G - Other				X

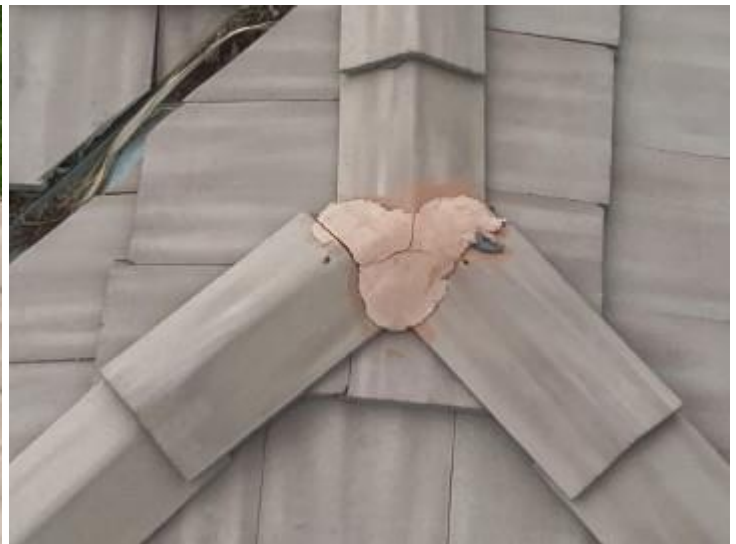
**Building 35 -**

ITEM	Good	Fair	Poor	N/A	COMMENTS
A - Perimeter details		X			
B - Drainage		X			Some debris noted in the valleys.
C - Penetration flashings		X			
D - Overall Tile condition		X			Some isolated cracked/broken tiles noted. Some isolated chipped tiles noted. Some cracking noted at mortar.
E - Wall/Curb flashings				X	
F - Insulation				X	
G - Other				X

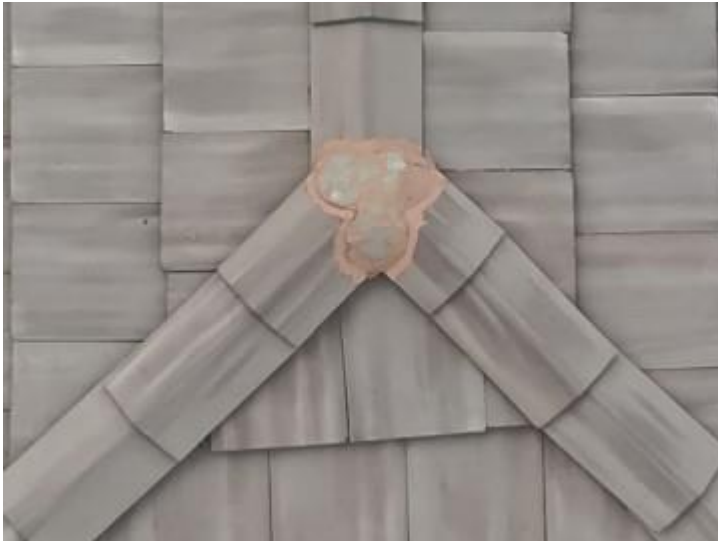
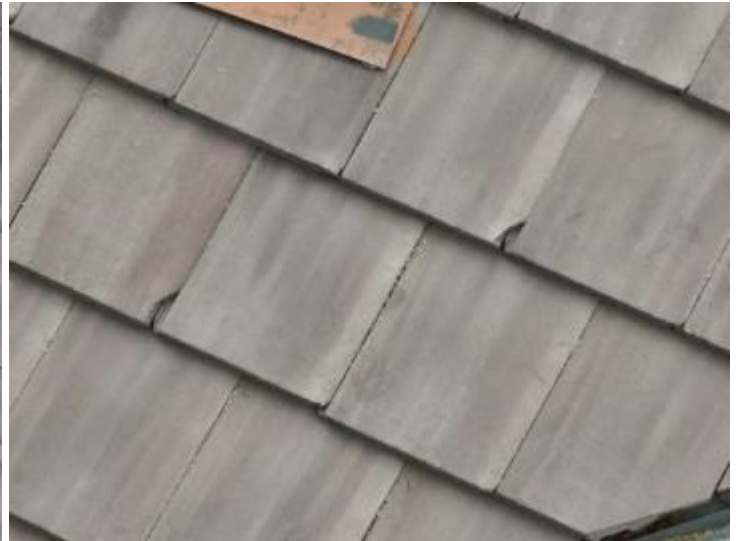
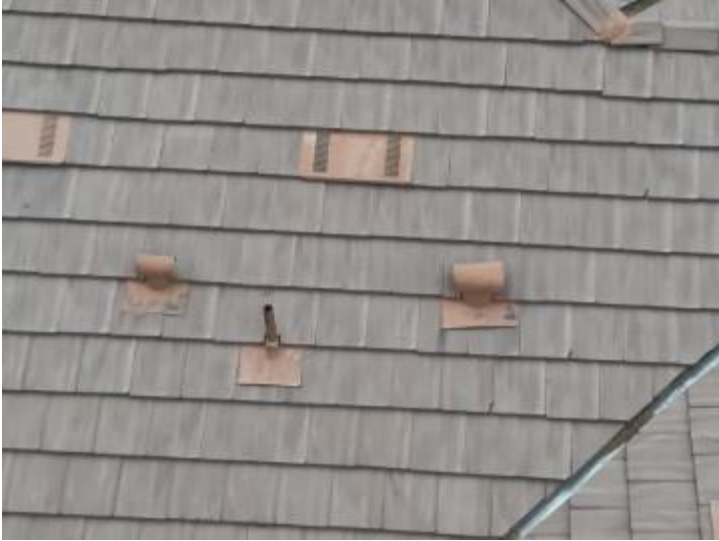
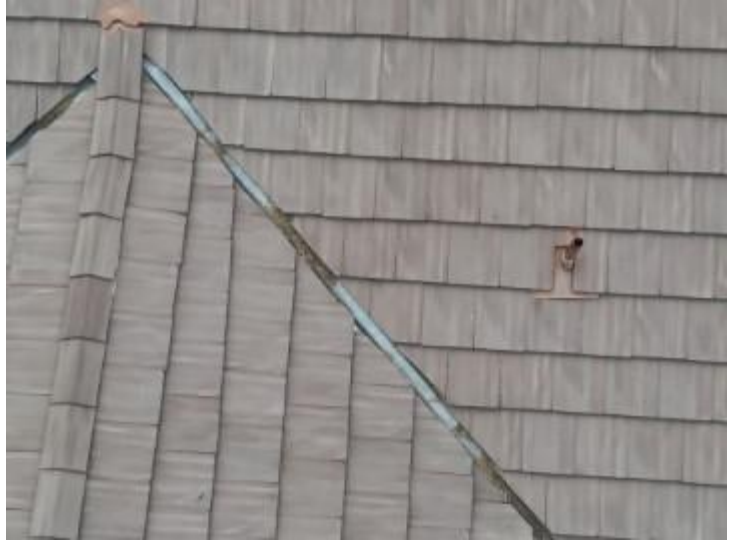
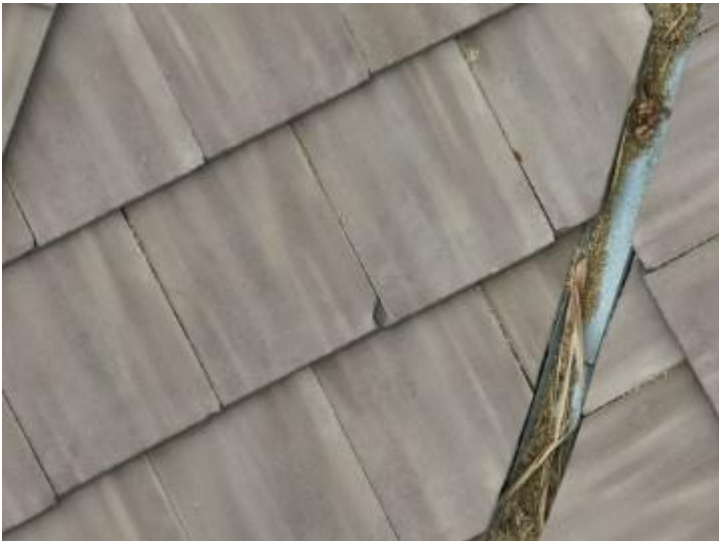
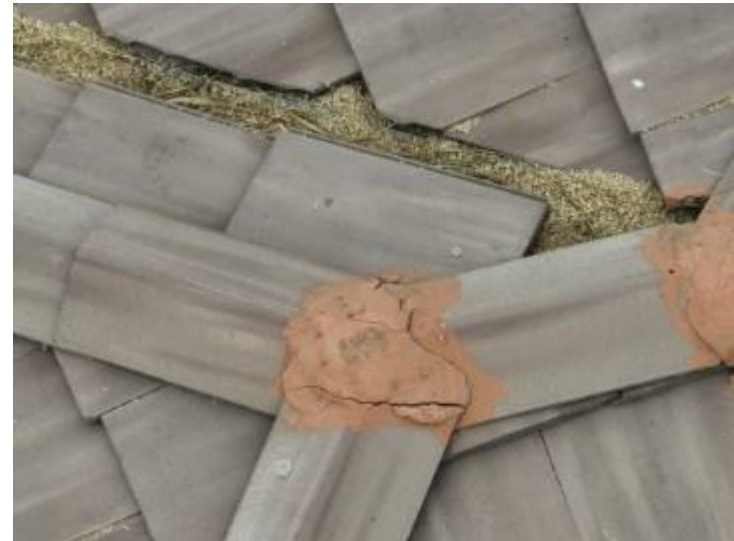
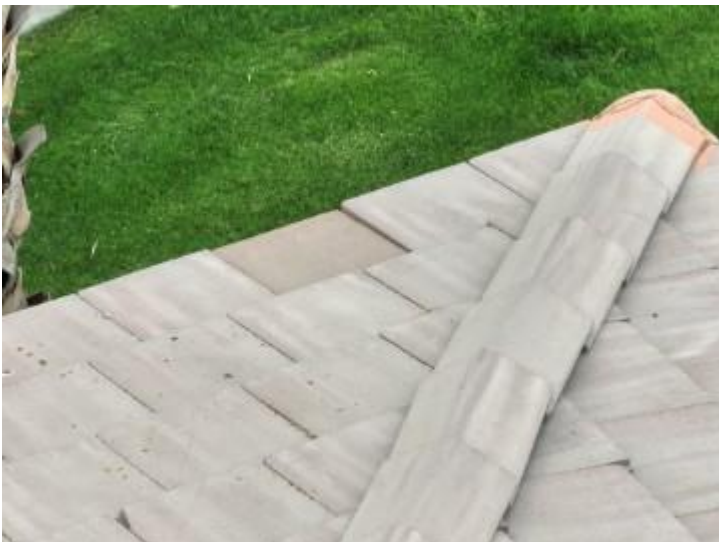
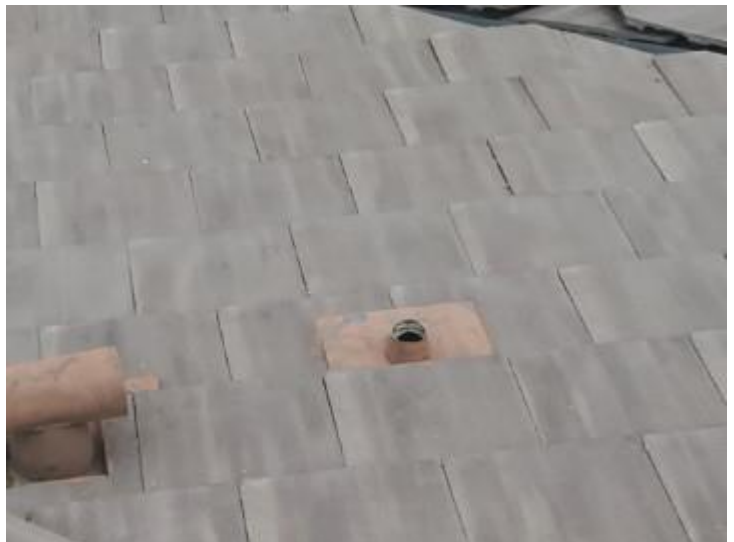
**Building 36 -**

ITEM	Good	Fair	Poor	N/A	COMMENTS
A - Perimeter details		X			
B - Drainage		X			Some debris noted in the valleys.
C - Penetration flashings		X			
D - Overall Tile condition		X			Some isolated chipped tiles noted. Some cracking noted at mortar.
E - Wall/Curb flashings		X			
F - Insulation				X	
G - Other				X

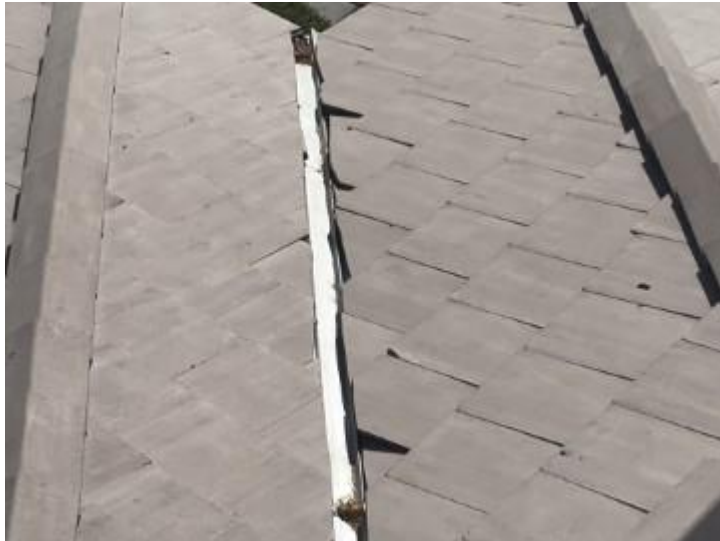
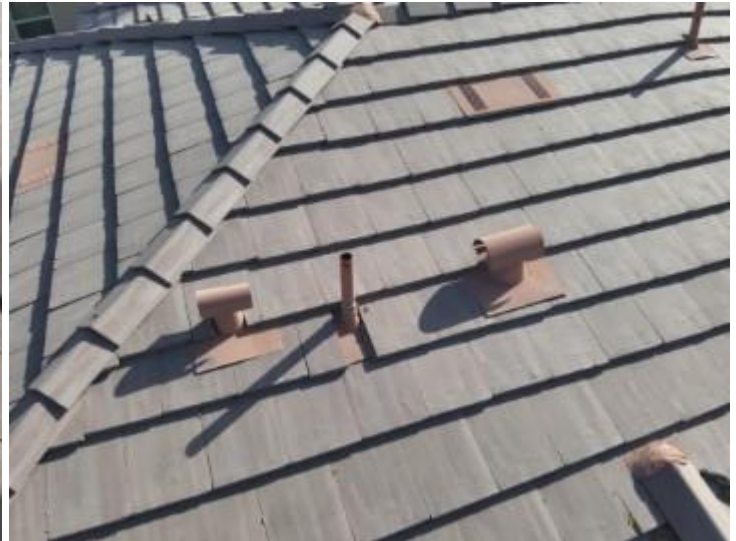
**Building 37 -**

ITEM	Good	Fair	Poor	N/A	COMMENTS
A - Perimeter details		X			
B - Drainage		X			Some debris noted in the valleys.
C - Penetration flashings		X			
D - Overall Tile condition		X			Some isolated chipped tiles noted. Some cracking noted at mortar.
E - Wall/Curb flashings				X	
F - Insulation				X	
G - Other				X

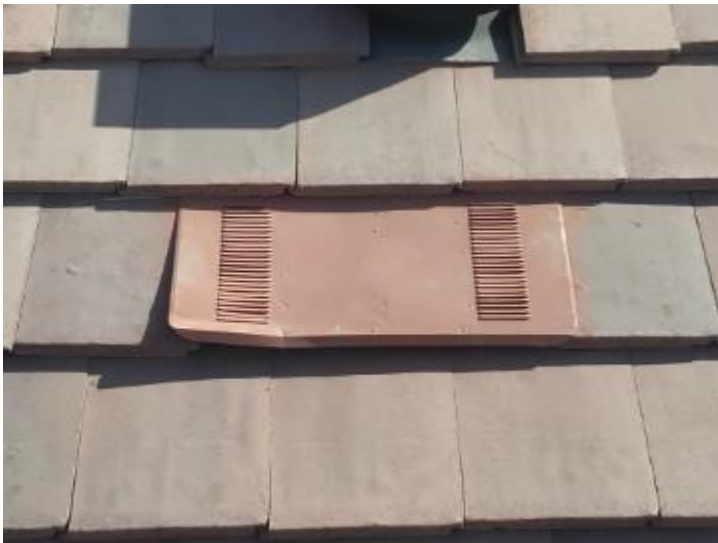
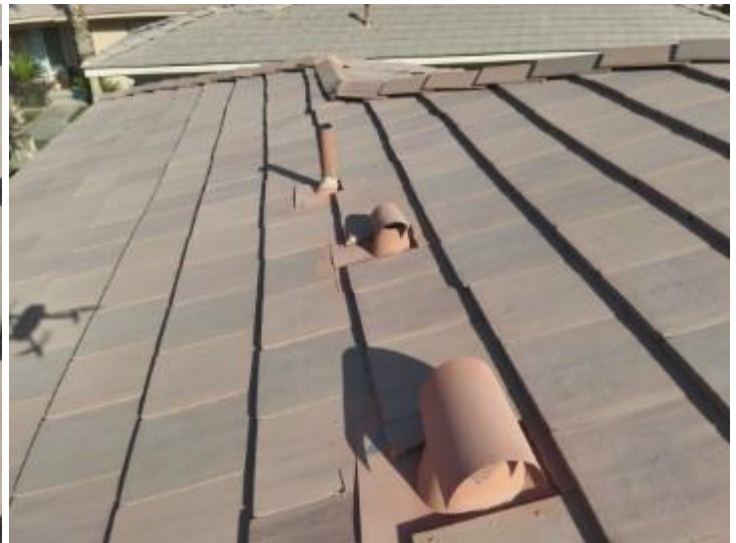
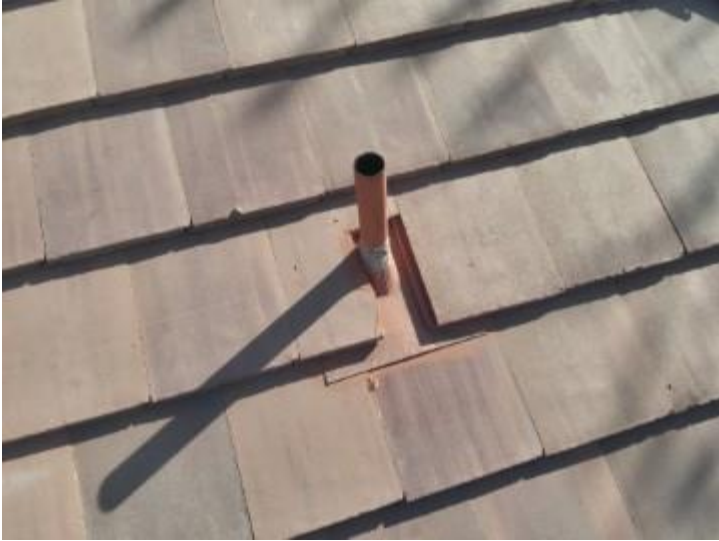
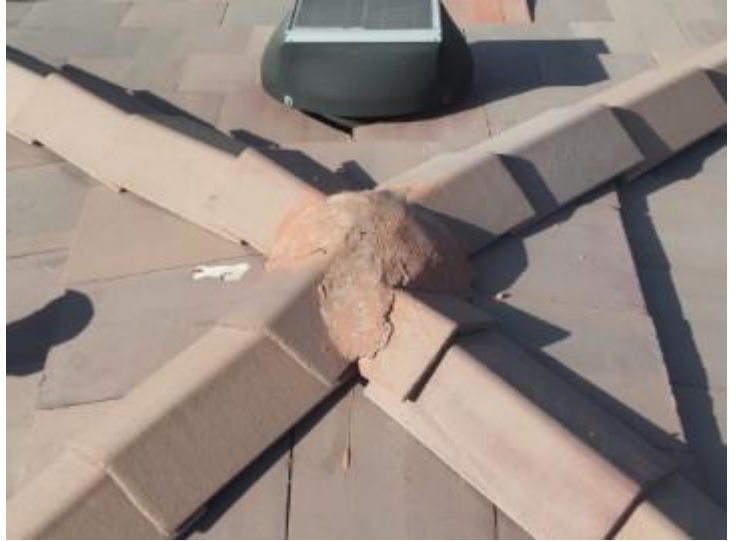
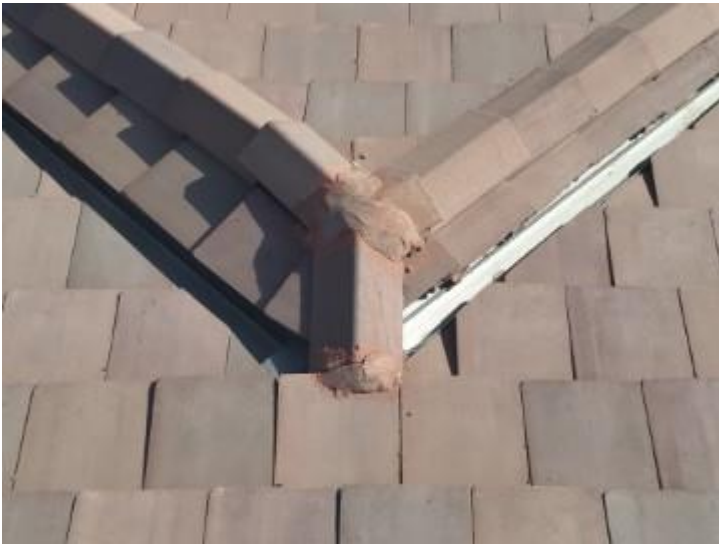
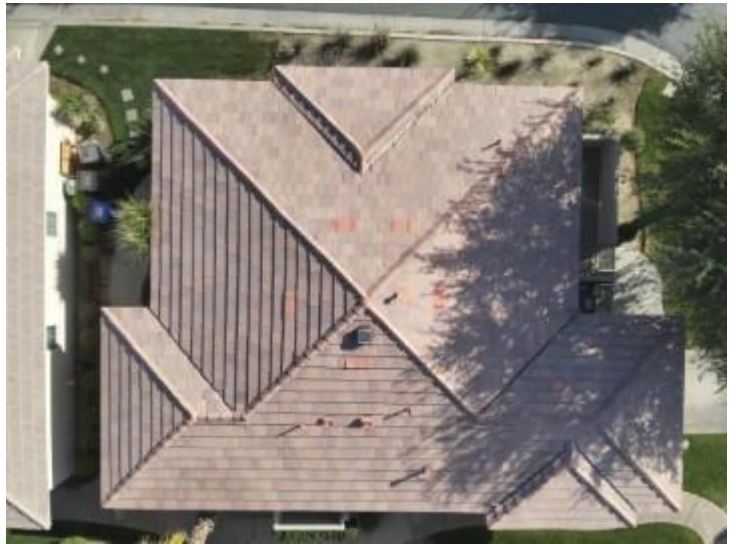
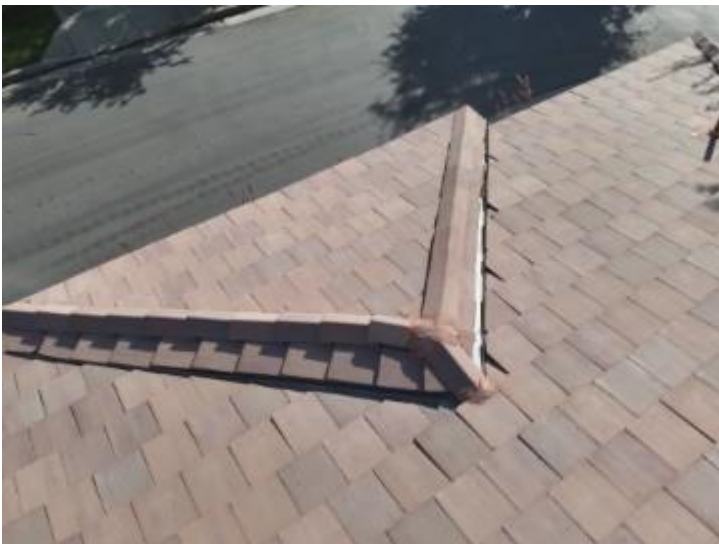
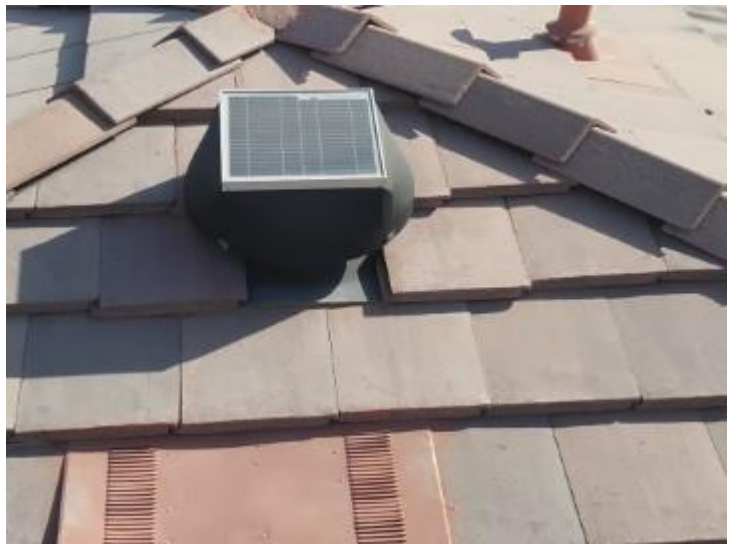
**Building 38 -**

ITEM	Good	Fair	Poor	N/A	COMMENTS
A - Perimeter details		X			
B - Drainage		X			Some debris noted in the valleys.
C - Penetration flashings		X			A bent attic vent noted.
D - Overall Tile condition		X			Some cracking noted at mortar.
E - Wall/Curb flashings				X	
F - Insulation				X	
G - Other				X

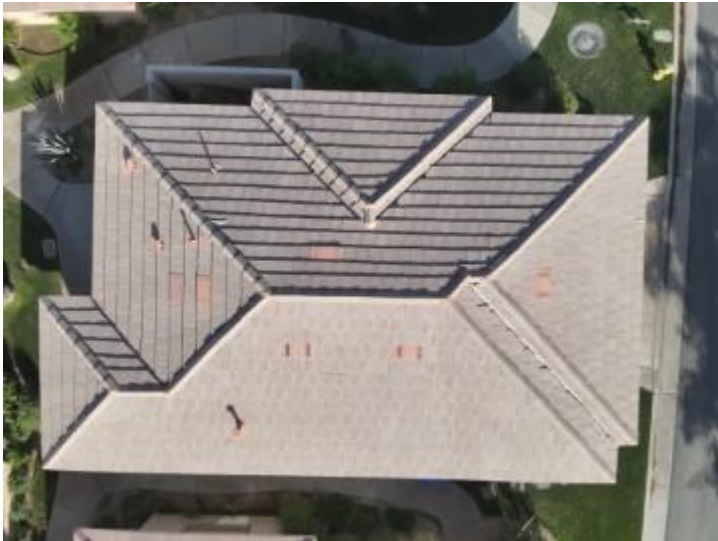
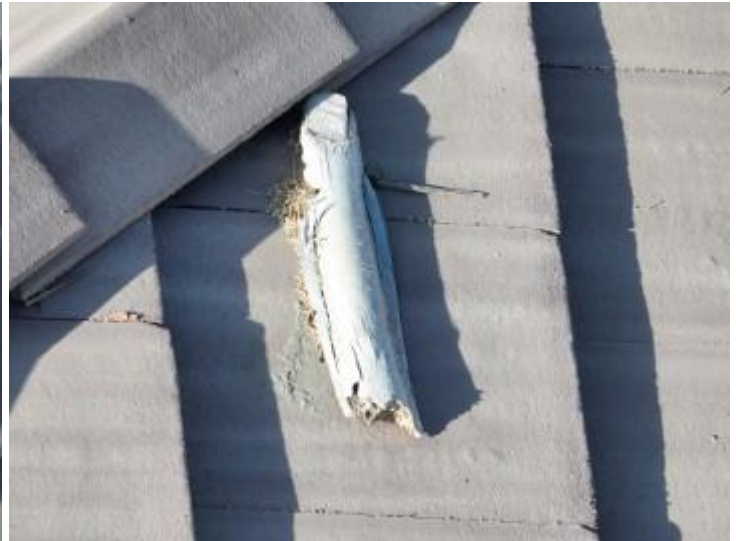
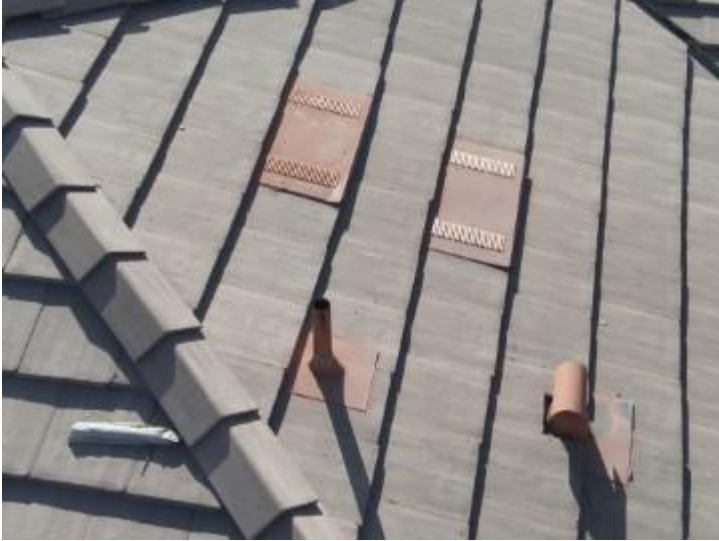
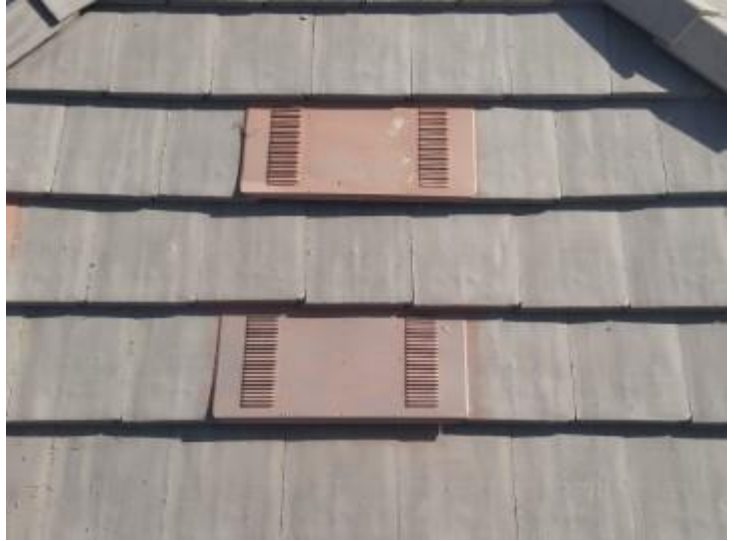
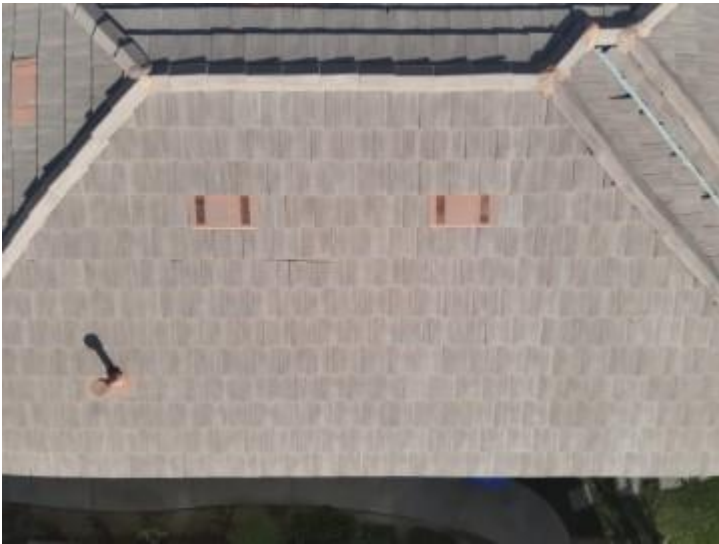
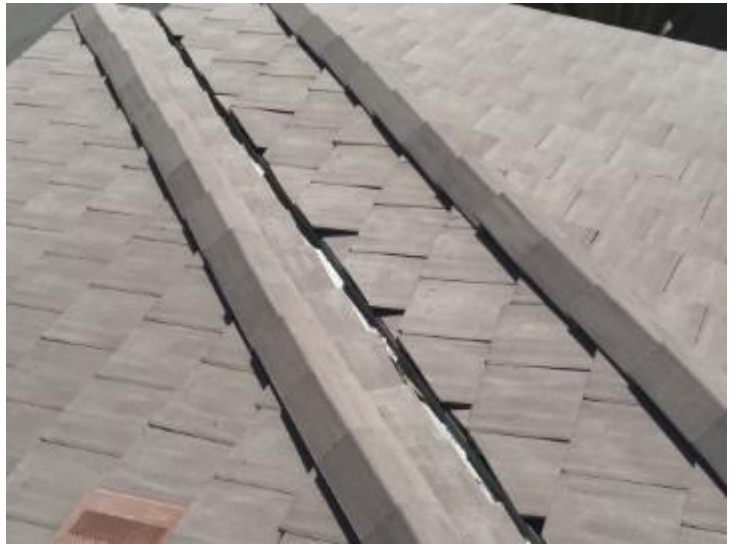
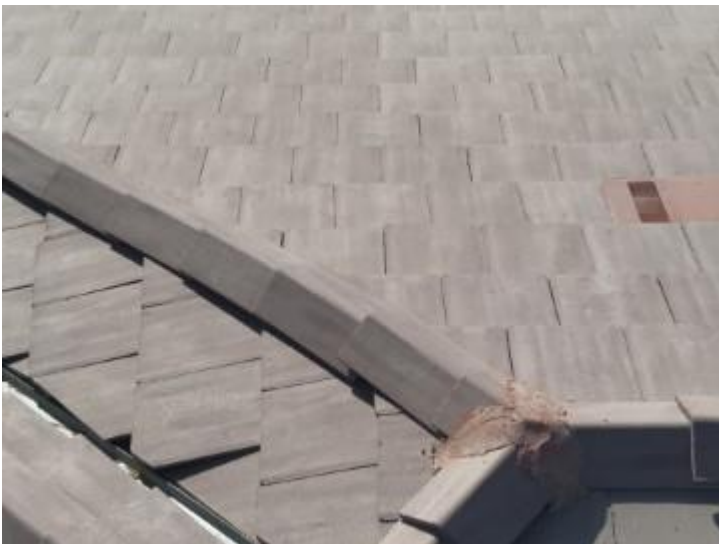
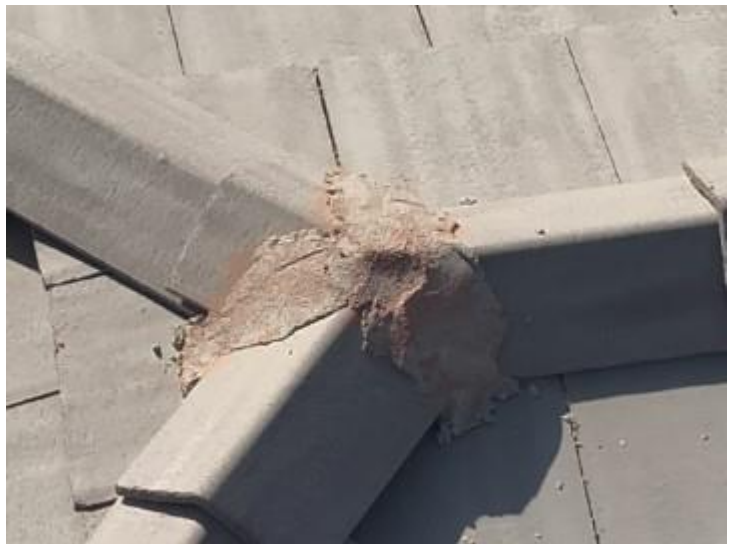
**Building 39 -**

ITEM	Good	Fair	Poor	N/A	COMMENTS
A - Perimeter details		X			
B - Drainage		X			Some debris noted in the valleys.
C - Penetration flashings		X			
D - Overall Tile condition		X			
E - Wall/Curb flashings		X			
F - Insulation				X	
G - Other				X

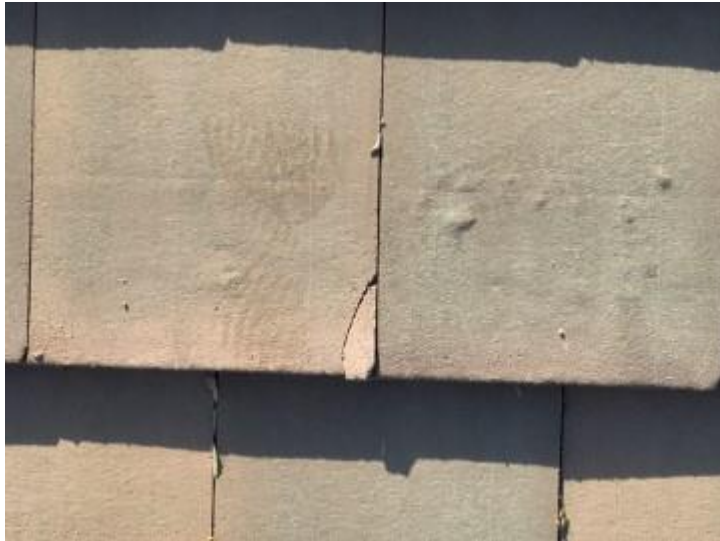
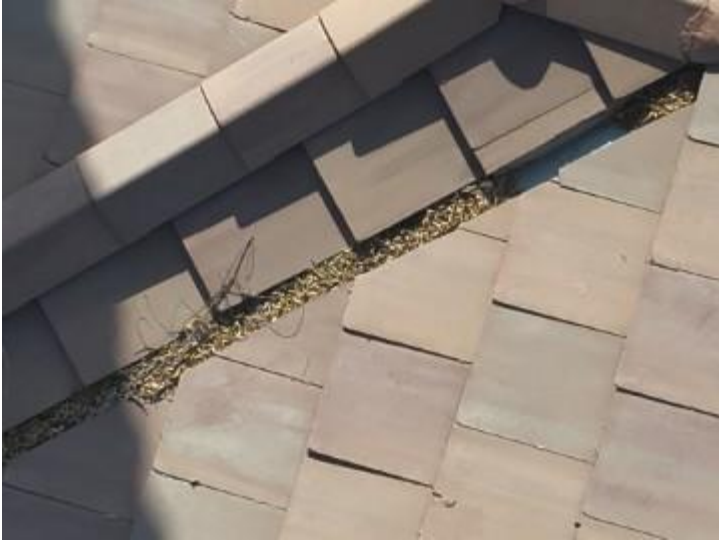
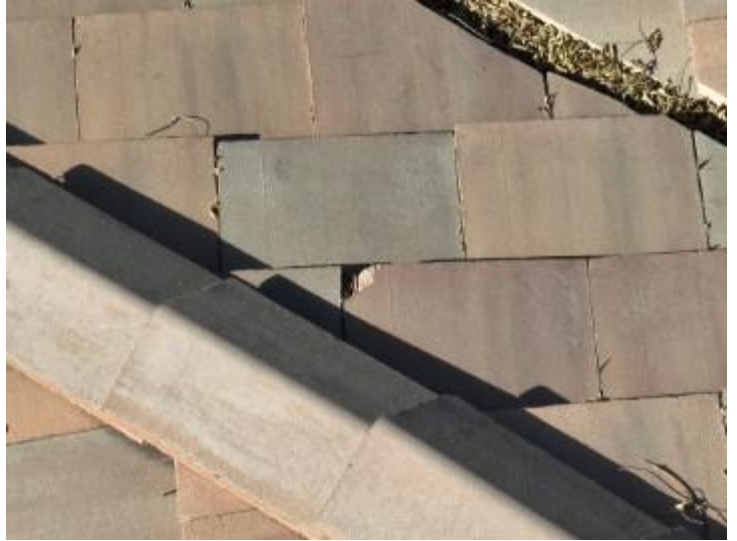
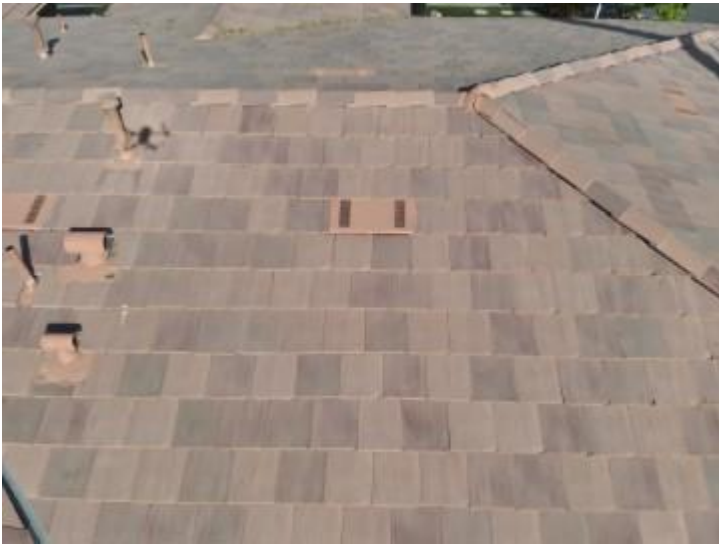
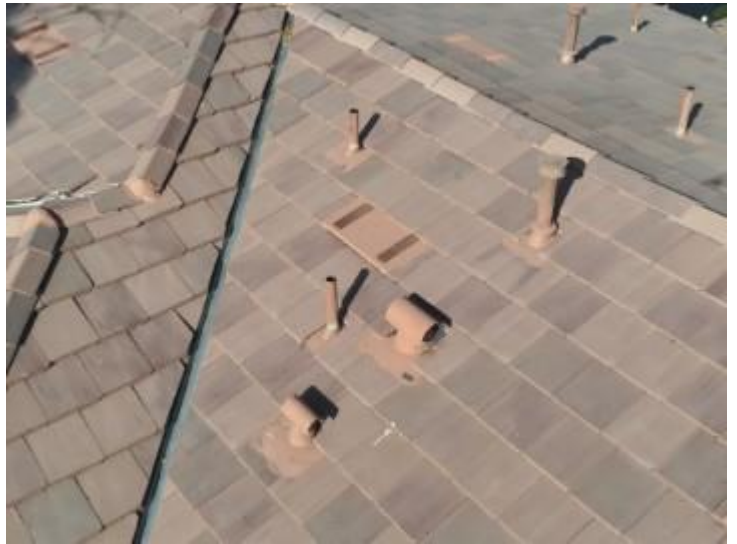
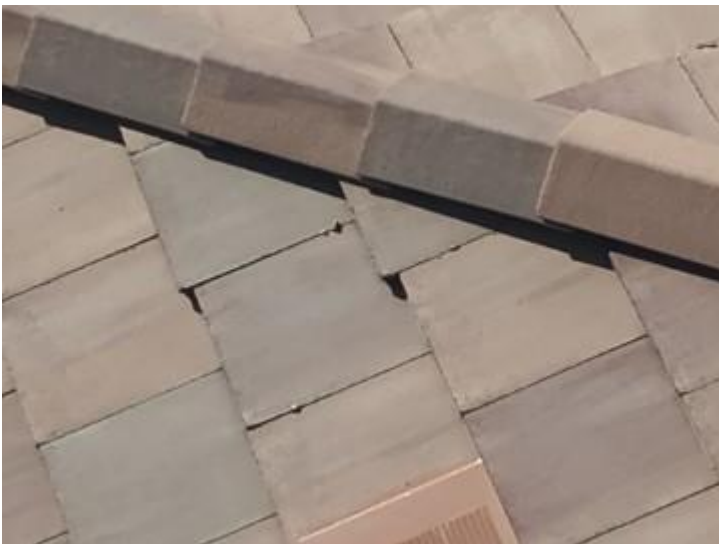
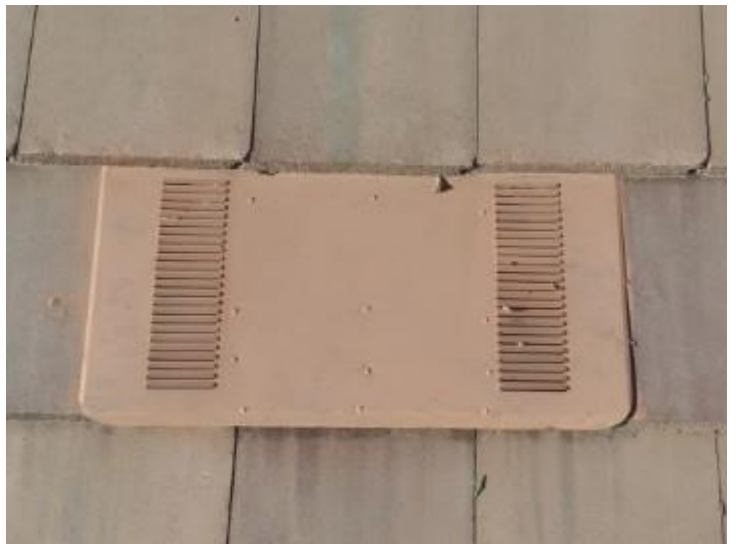
**Building 40 -**

ITEM	Good	Fair	Poor	N/A	COMMENTS
A - Perimeter details		X			
B - Drainage		X			Some debris noted in the valleys.
C - Penetration flashings		X			
D - Overall Tile condition		X			Some isolated chipped tiles noted. Some cracking noted at mortar.
E - Wall/Curb flashings				X	
F - Insulation				X	
G - Other				X

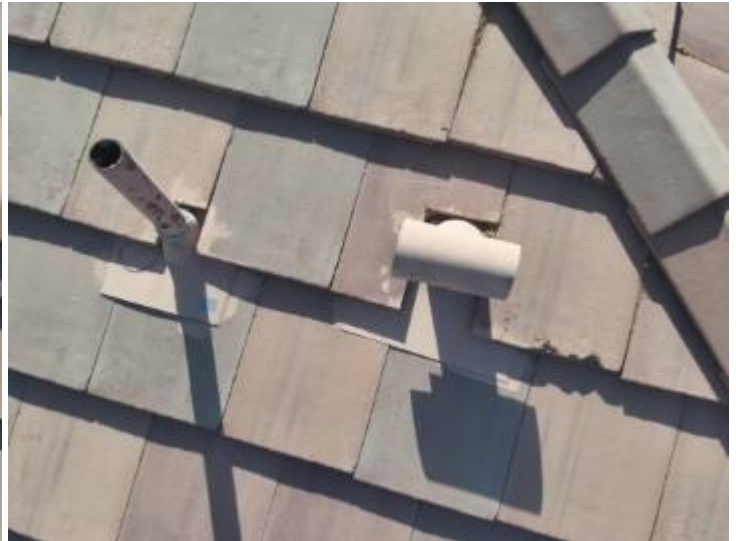
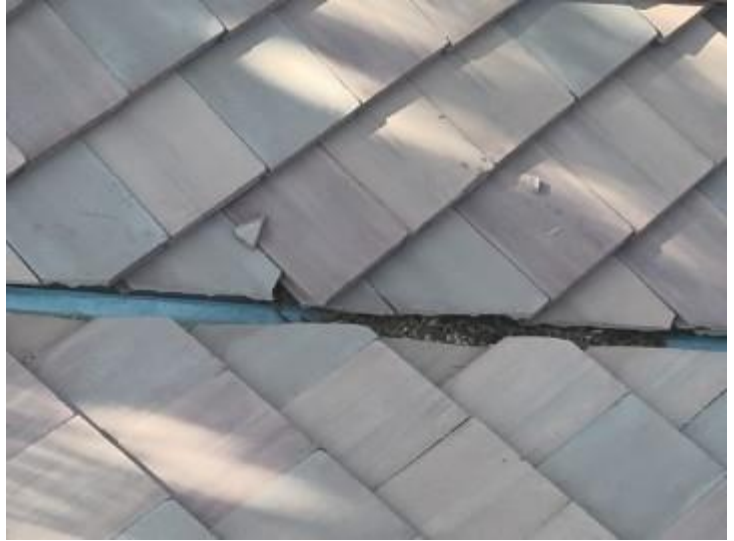
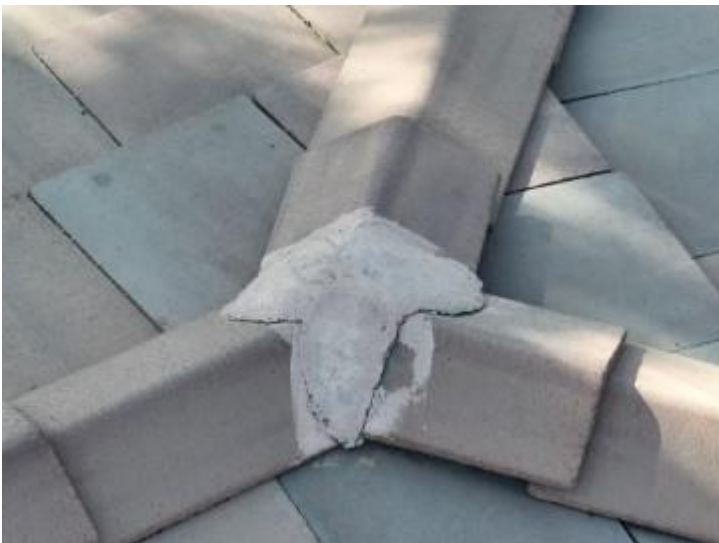
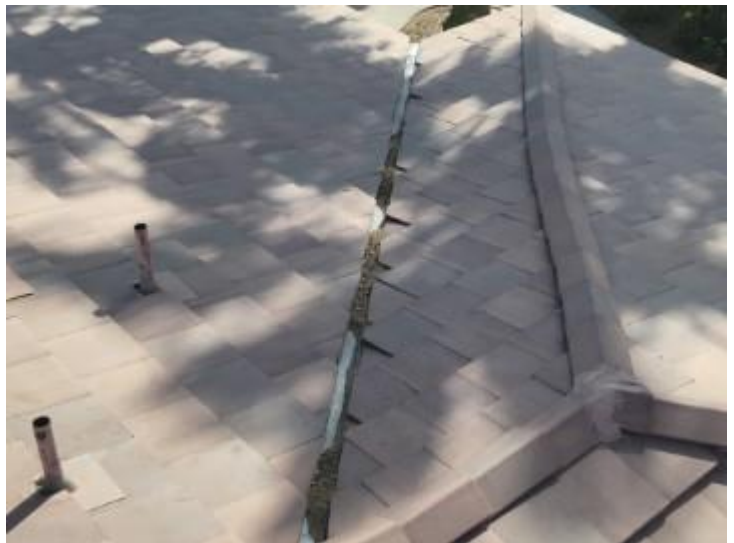
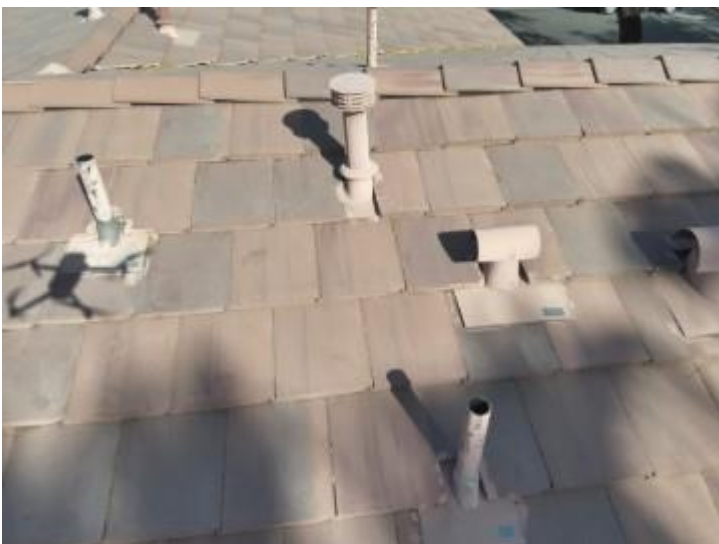
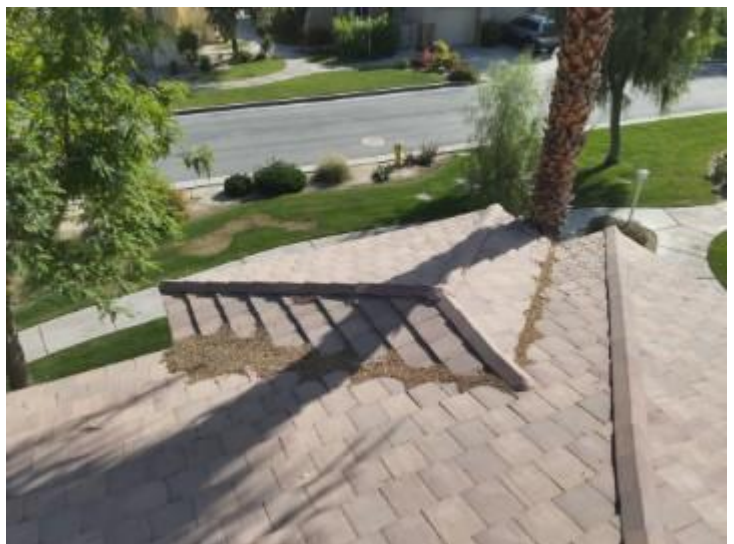
**Building 41 -**

ITEM	Good	Fair	Poor	N/A	COMMENTS
A - Perimeter details		X			
B - Drainage		X			Some debris noted in the valleys.
C - Penetration flashings		X			
D - Overall Tile condition		X			Some isolated chipped tiles noted. Some cracking noted at mortar.
E - Wall/Curb flashings				X	
F - Insulation				X	
G - Other				X

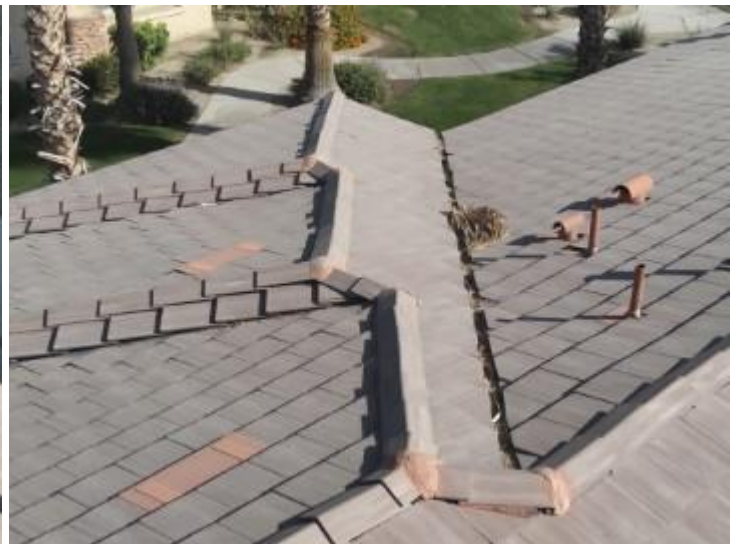
**Building 42 -**

ITEM	Good	Fair	Poor	N/A	COMMENTS
A - Perimeter details		X			
B - Drainage		X			Some debris noted in the valleys.
C - Penetration flashings		X			
D - Overall Tile condition		X			Some isolated cracked/broken tiles noted. Some isolated chipped tiles noted. Some cracking noted at mortar.
E - Wall/Curb flashings				X	
F - Insulation				X	
G - Other				X
