## HOUSING AUTHORITY Meeting Agenda

Thursday, November 7, 2024

Re: **Roof Consulting**  
Indian Wells Villas  
74800 Village Center Drive  
Indian Wells, CA 92210

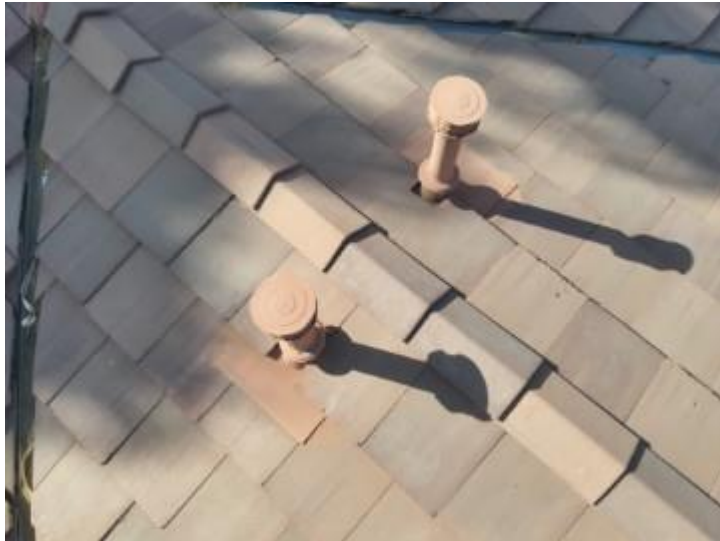
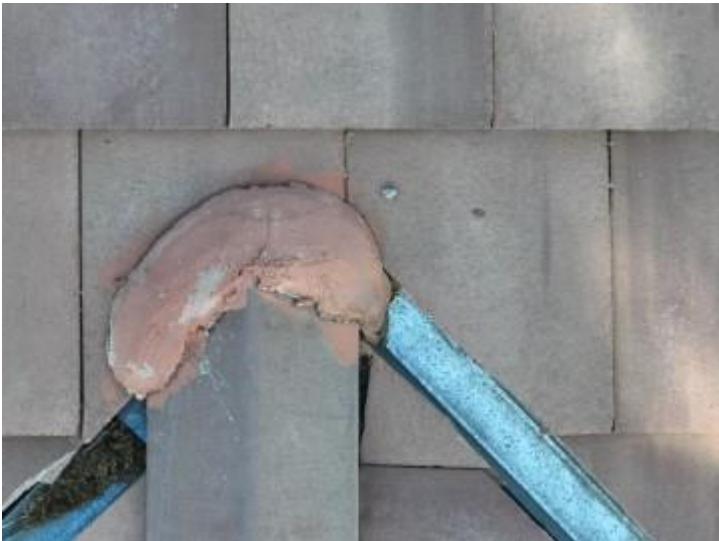
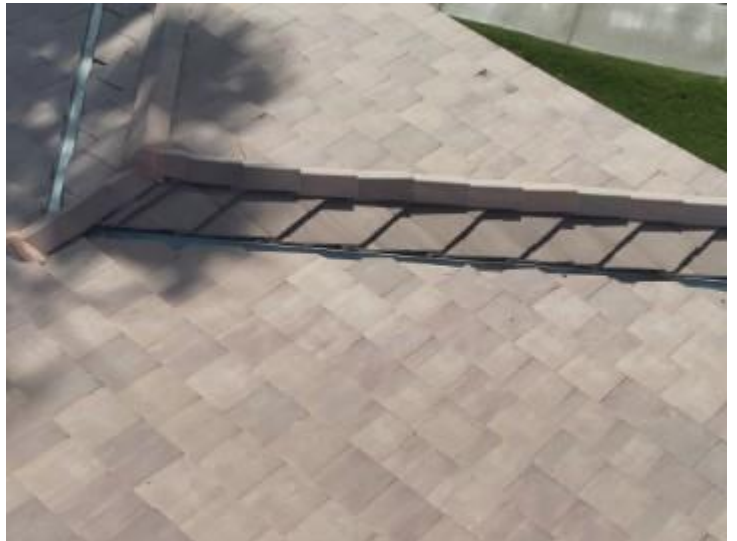
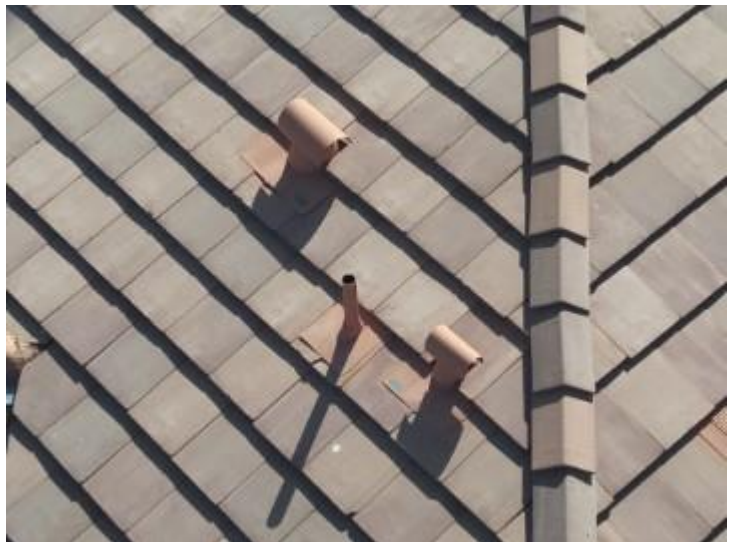
**Building 43 -**

ITEM	Good	Fair	Poor	N/A	COMMENTS
A - Perimeter details		X			
B - Drainage		X			Some debris noted in the valleys.
C - Penetration flashings		X			
D - Overall Tile condition		X			Some cracking noted at mortar.
E - Wall/Curb flashings		X\		X	
F - Insulation				X	
G - Other				X

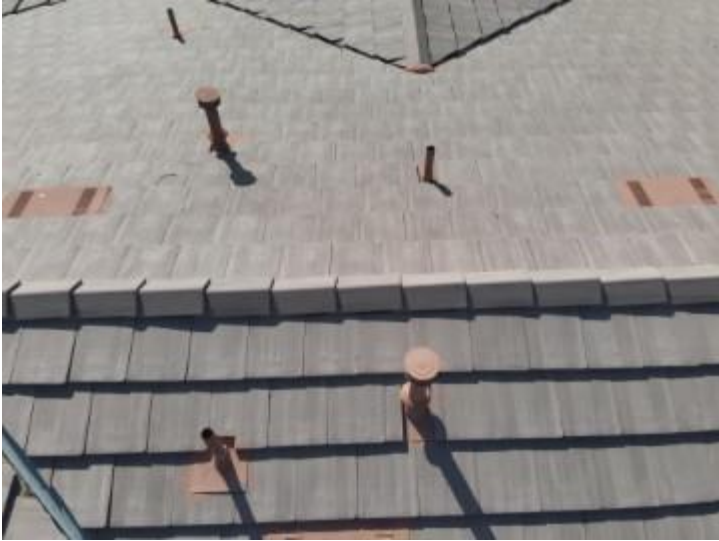
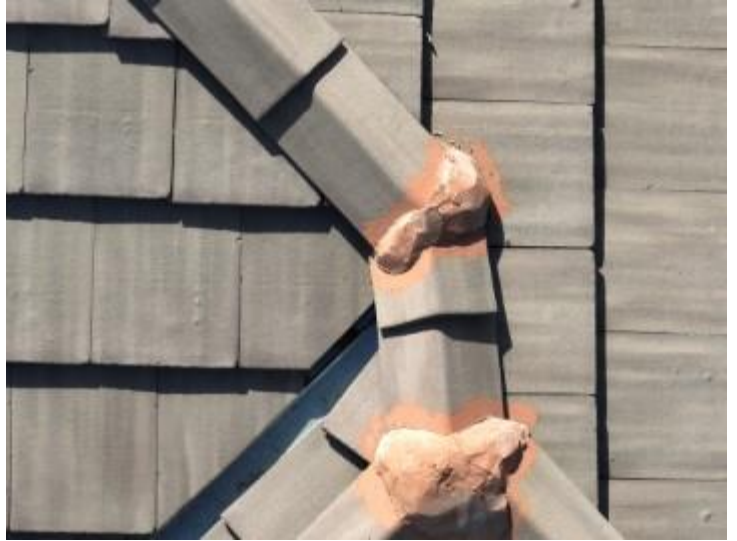
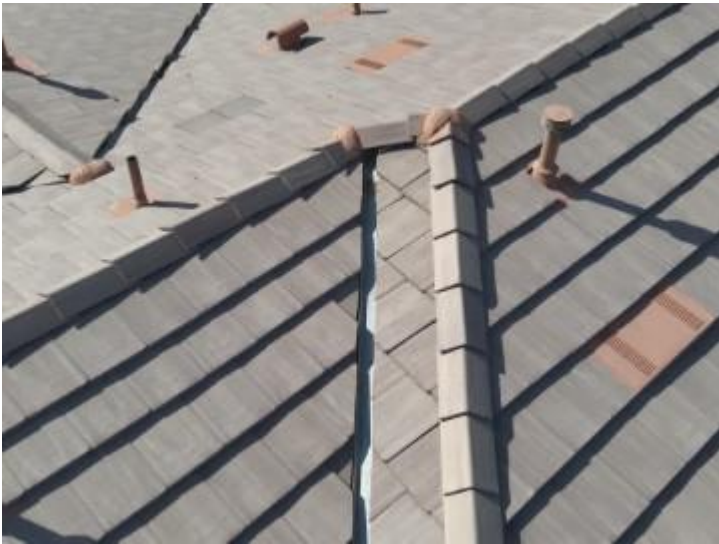
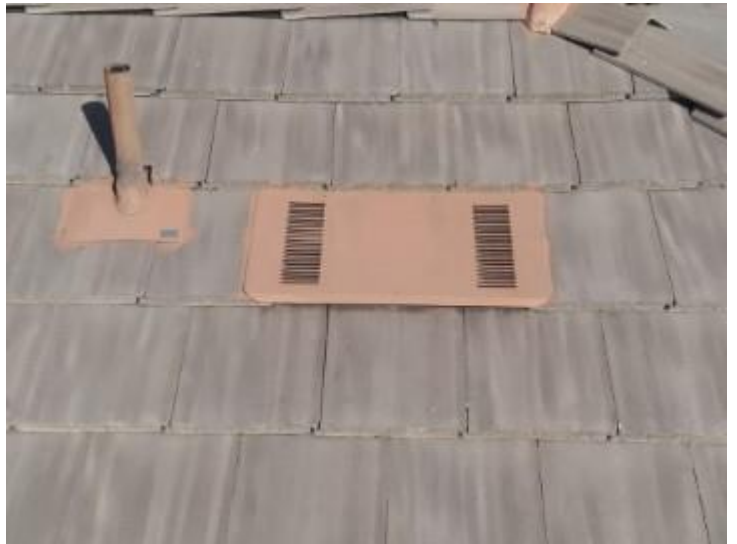
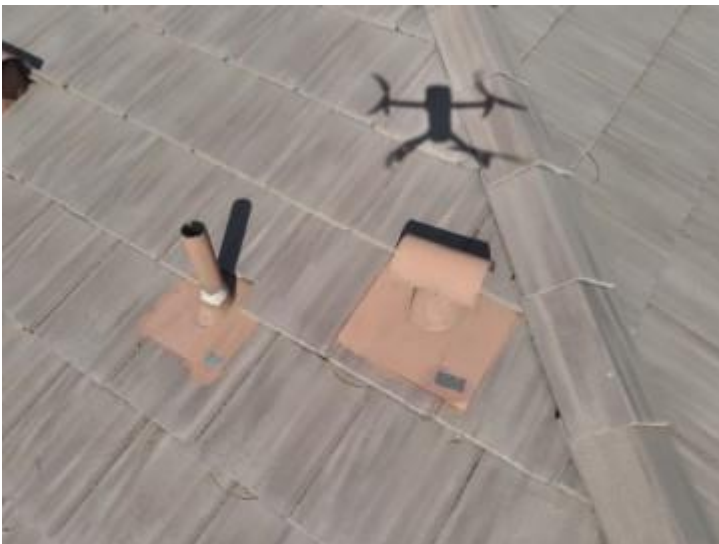
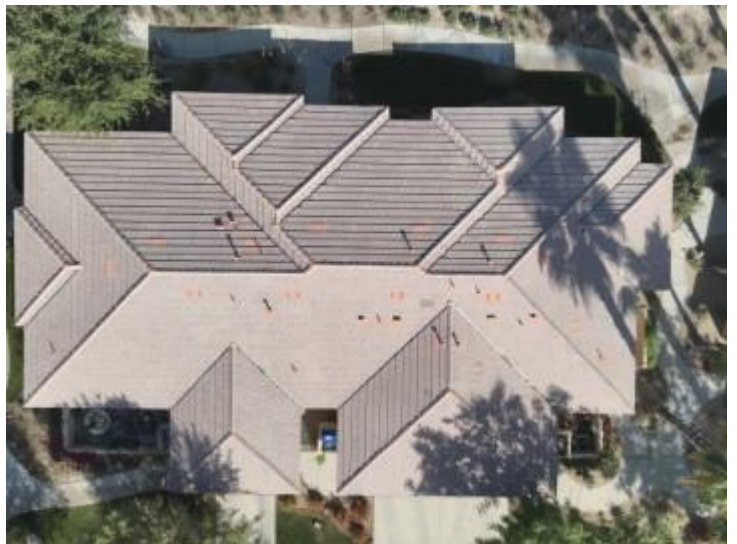
**Building 44 -**

ITEM	Good	Fair	Poor	N/A	COMMENTS
A - Perimeter details		X			
B - Drainage		X			Some debris noted in the valleys.
C - Penetration flashings		X			
D - Overall Tile condition		X			Some cracking noted at mortar.
E - Wall/Curb flashings				X	
F - Insulation				X	
G - Other				X

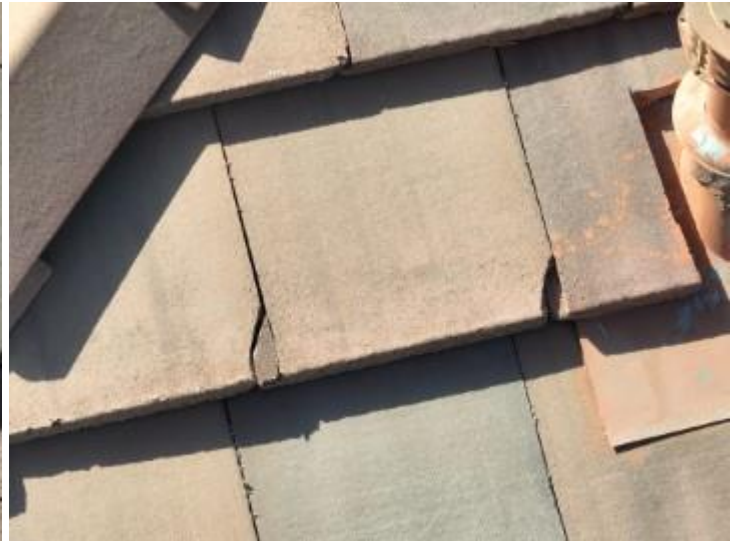
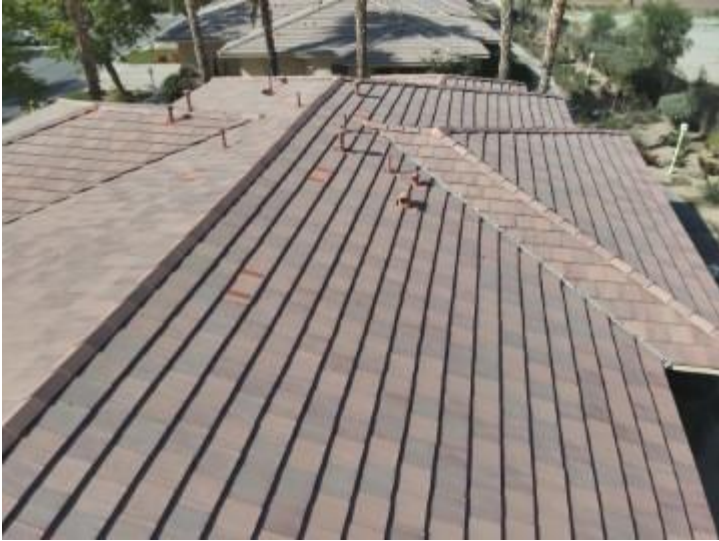
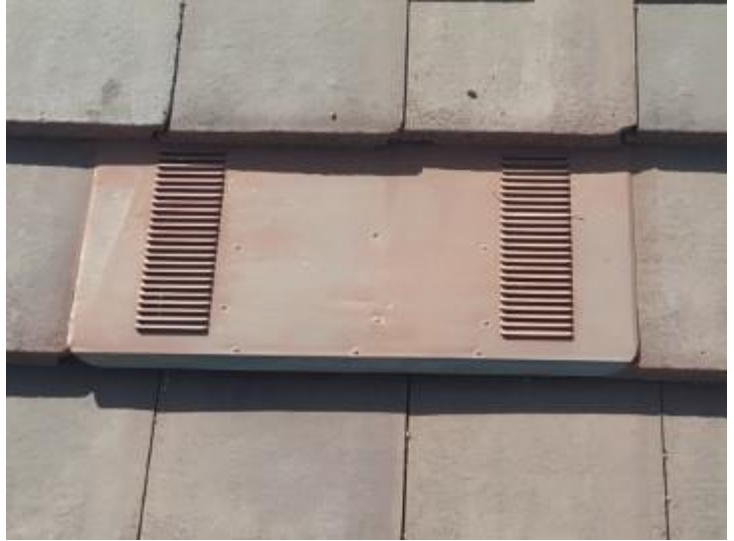
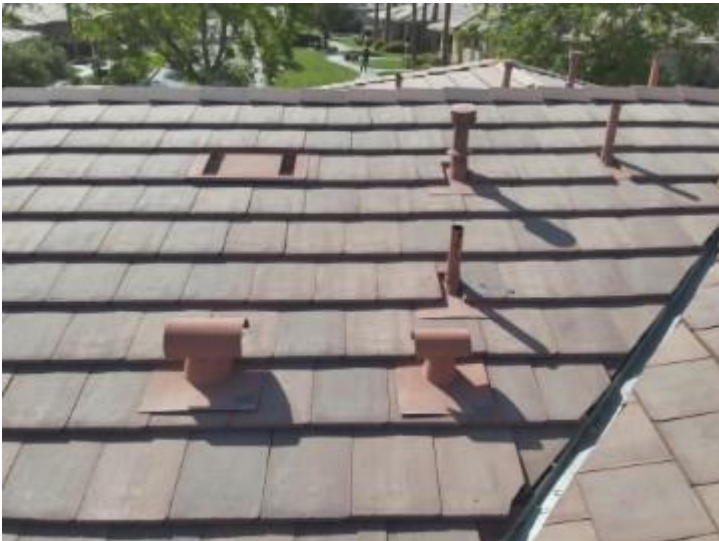
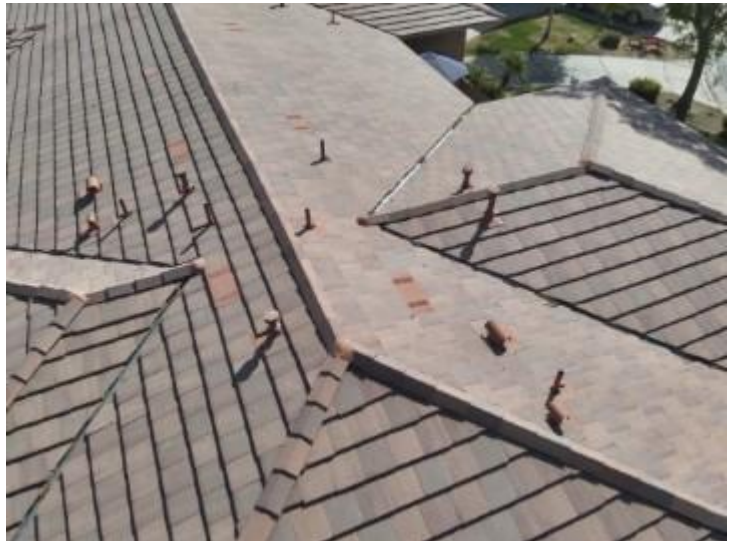
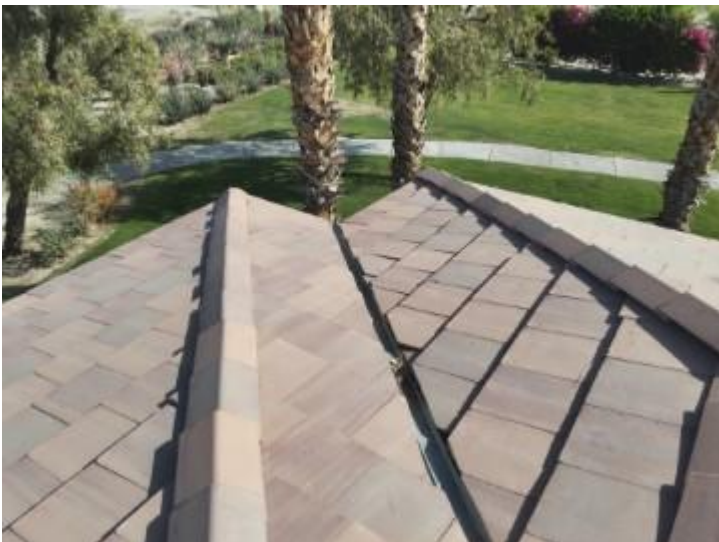
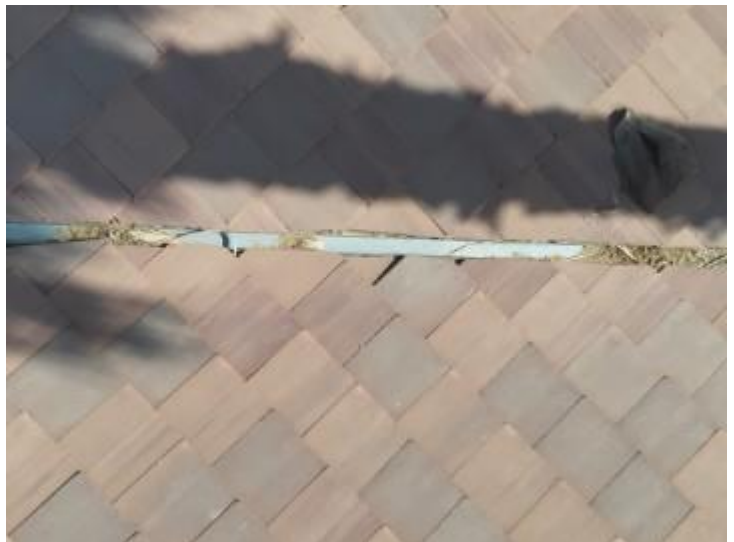
**Building 45 -**

ITEM	Good	Fair	Poor	N/A	COMMENTS
A - Perimeter details		X			
B - Drainage		X			Some debris noted in the valleys.
C - Penetration flashings		X			
D - Overall Tile condition		X			Some isolated chipped tiles noted. Some cracking noted at mortar.
E - Wall/Curb flashings				X	
F - Insulation				X	
G - Other				X

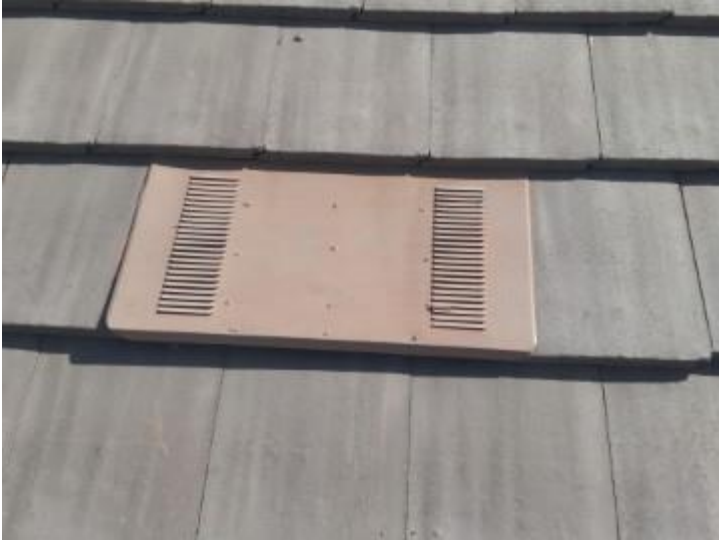
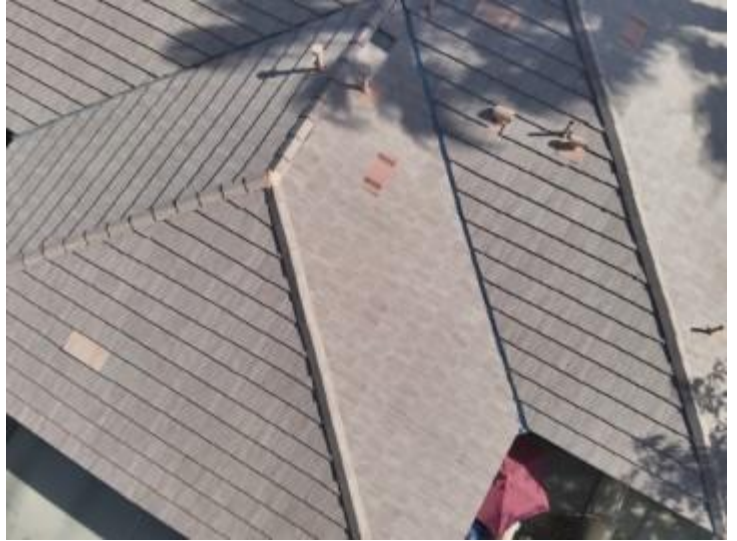
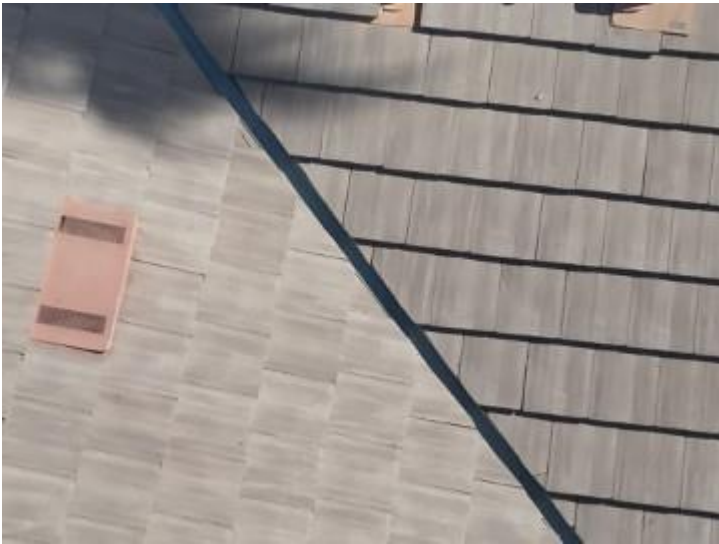
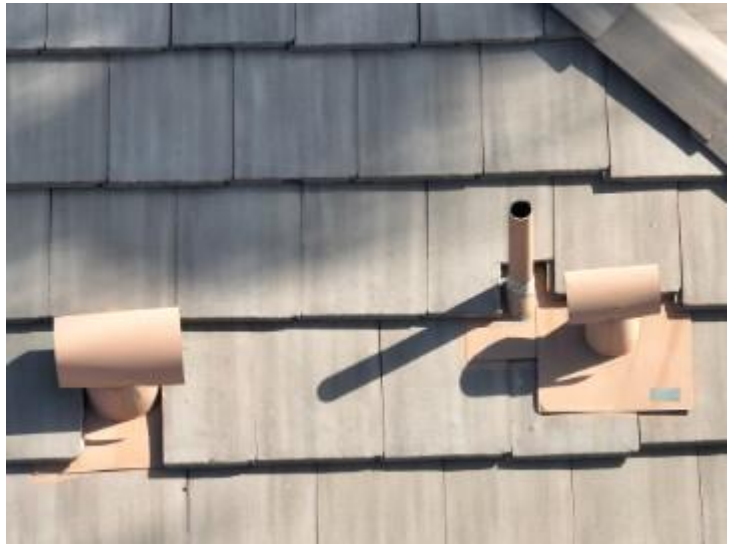
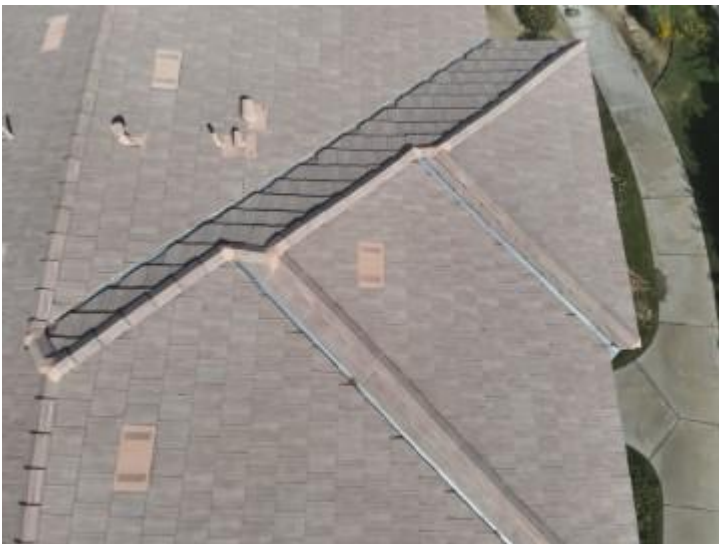
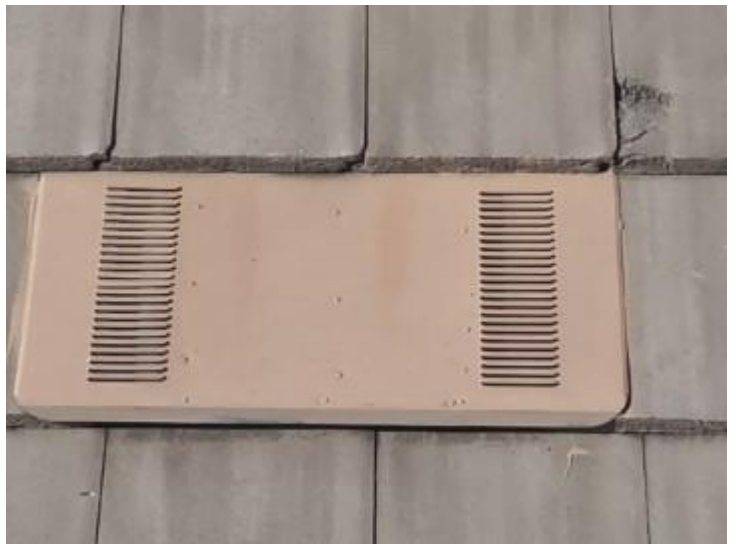
**Building 46 -**

ITEM	Good	Fair	Poor	N/A	COMMENTS
A - Perimeter details		X			
B - Drainage		X			Some debris noted in the valleys.
C - Penetration flashings		X			
D - Overall Tile condition		X			Some isolated cracked/broken tiles noted. Some isolated chipped tiled noted. Some cracking noted at mortar.
E - Wall/Curb flashings				X	
F - Insulation				X	
G - Other				X

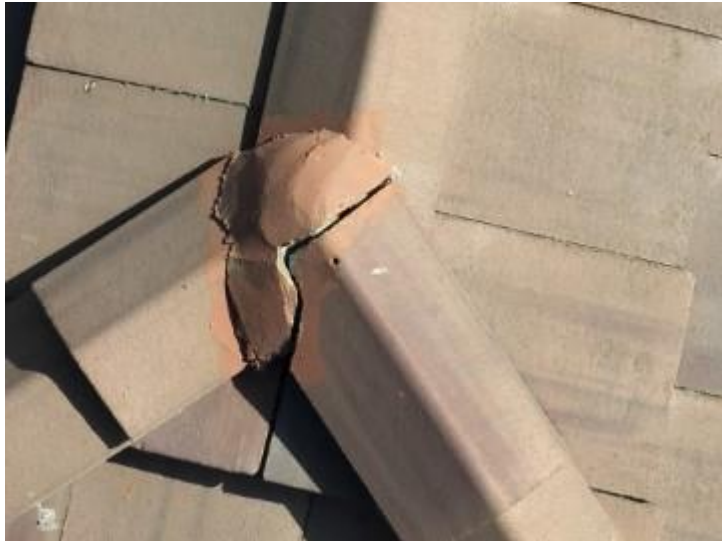
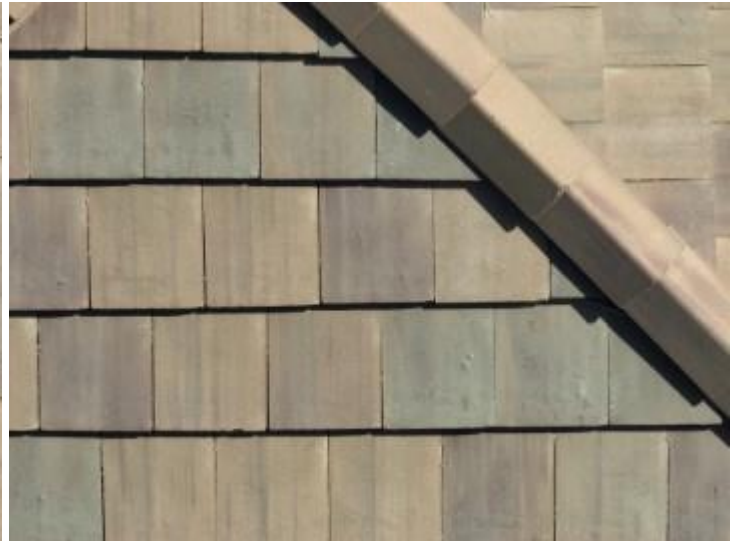
**Building 47 -**

ITEM	Good	Fair	Poor	N/A	COMMENTS
A - Perimeter details		X			
B - Drainage		X			Some debris noted in the valleys.
C - Penetration flashings		X			
D - Overall Tile condition		X			Some cracking noted at mortar.
E - Wall/Curb flashings				X	
F - Insulation				X	
G - Other				X

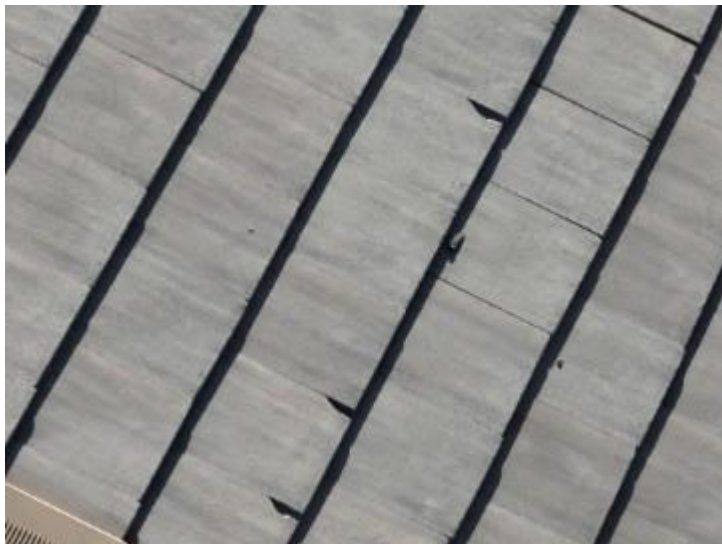
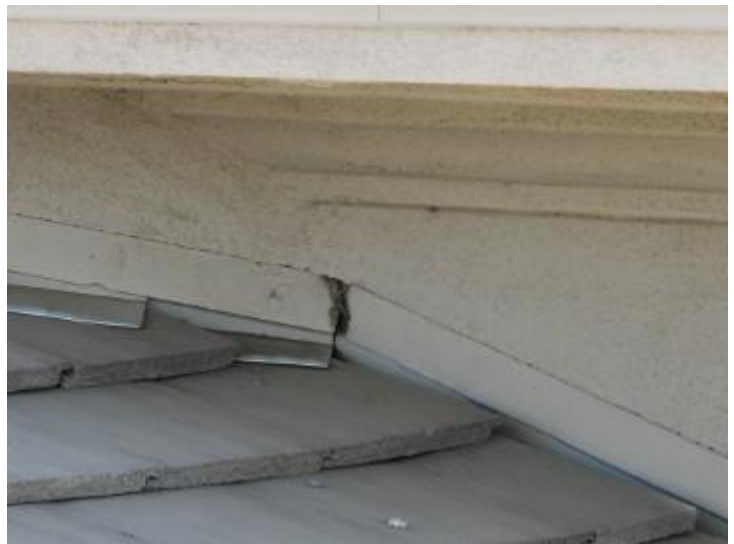
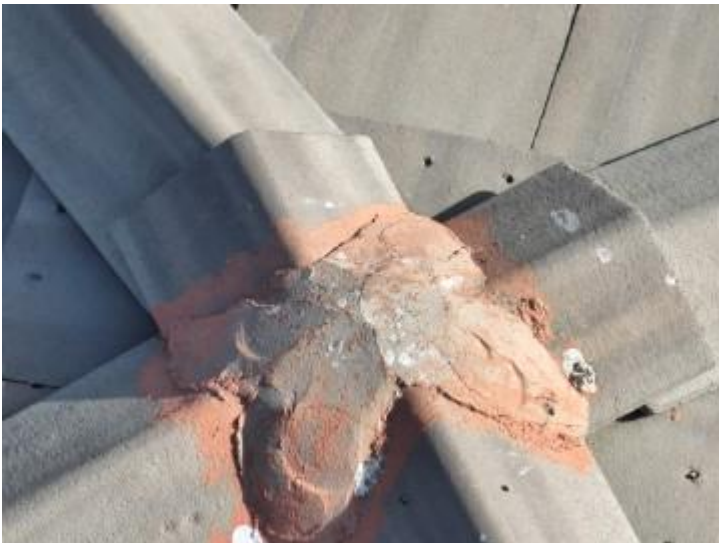
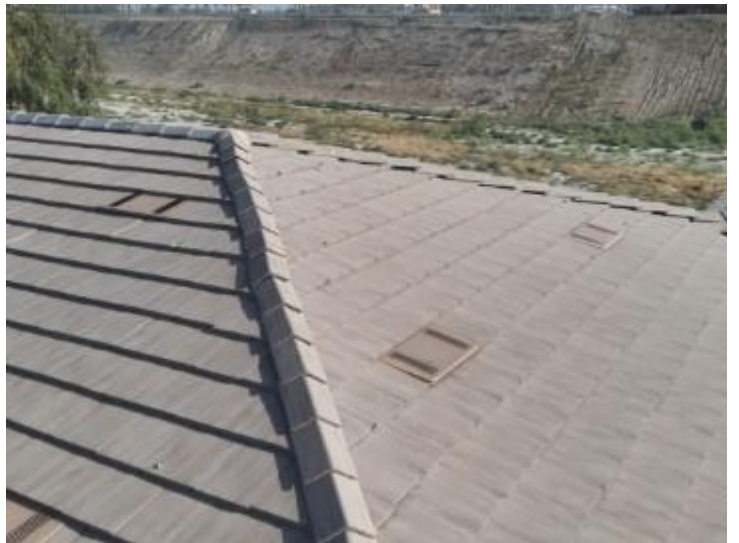
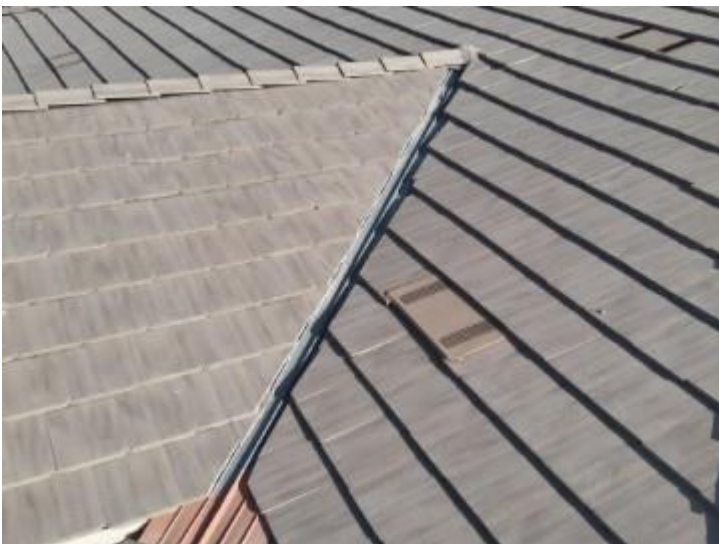
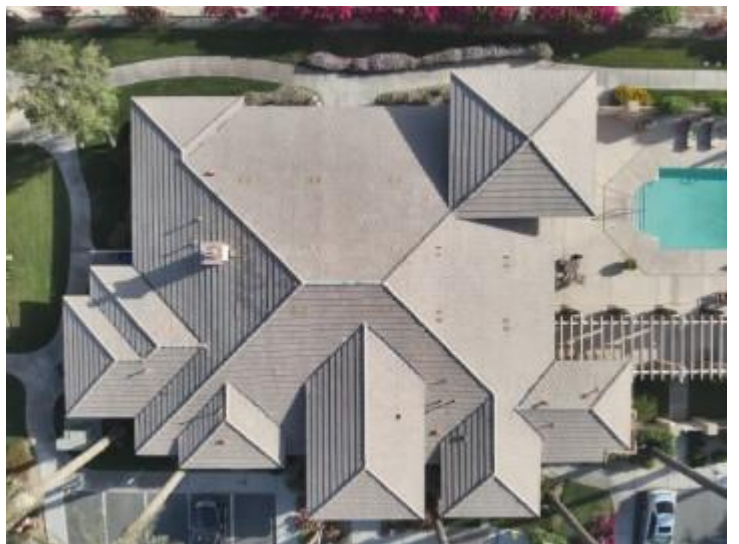
**Building Community Center -**

ITEM	Good	Fair	Poor	N/A	COMMENTS
A - Perimeter details		X			
B - Drainage		X			Some debris noted in the valleys.
C - Penetration flashings		X			
D - Overall Tile condition		X			Some isolated cracked tiles noted. Some isolated chipped tiles noted. Some cracking noted at mortar.
E - Wall/Curb flashings		X			Some possible rot noted at the wall trim.
F - Insulation				X	
G - Other				X
