SITE INSPECTION REPORT

Indian Wells Villas

74-800 Village Center Drive
Indian Wells, CA 92210

May 14, 2024.

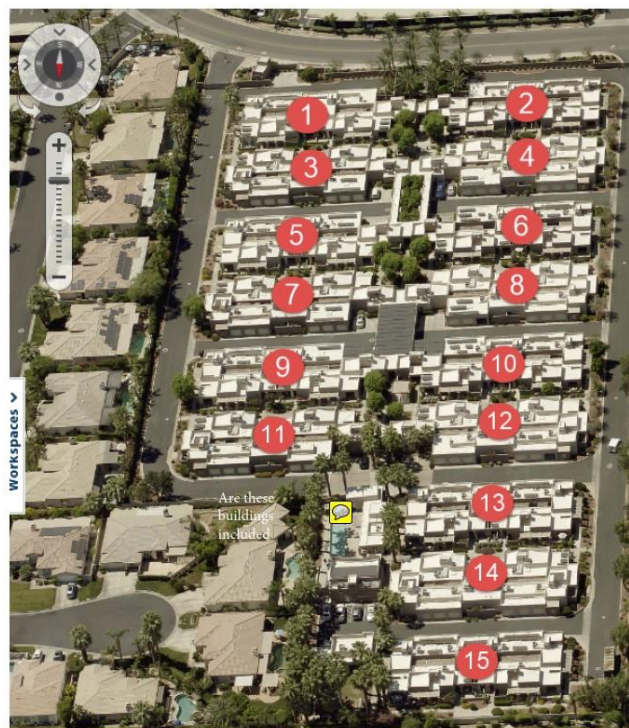
Partner used the numbering provided by the client, as shown below for preparation of this report:

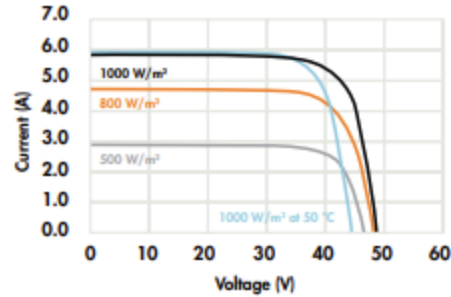
IV Curve

Current/voltage characteristics with dependence on irradiance and module temperature.

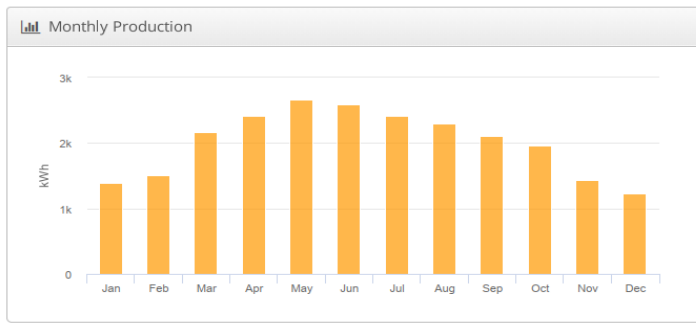
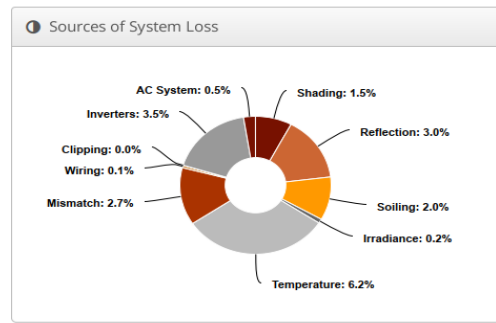
System Metrics	
Design	Typical Building with 56 Modules
Module DC Nameplate	12.9 kW
Inverter AC Nameplate	12.0 kW Load Ratio: 1.07
Annual Production	24.16 MWh
Performance Ratio	81.8%
kWh/kWp	1,875.5
Weather Dataset	TMY, 10km grid (33.75,-116.35), NREL (prospector)
Simulator Version	8bf5d16c4c-3987ccdd1a-3fcd90ee4d-f7c132eac

Specific production of system based on modeling software = **1875 kWh ac / kW dc / Year** for a new built system.

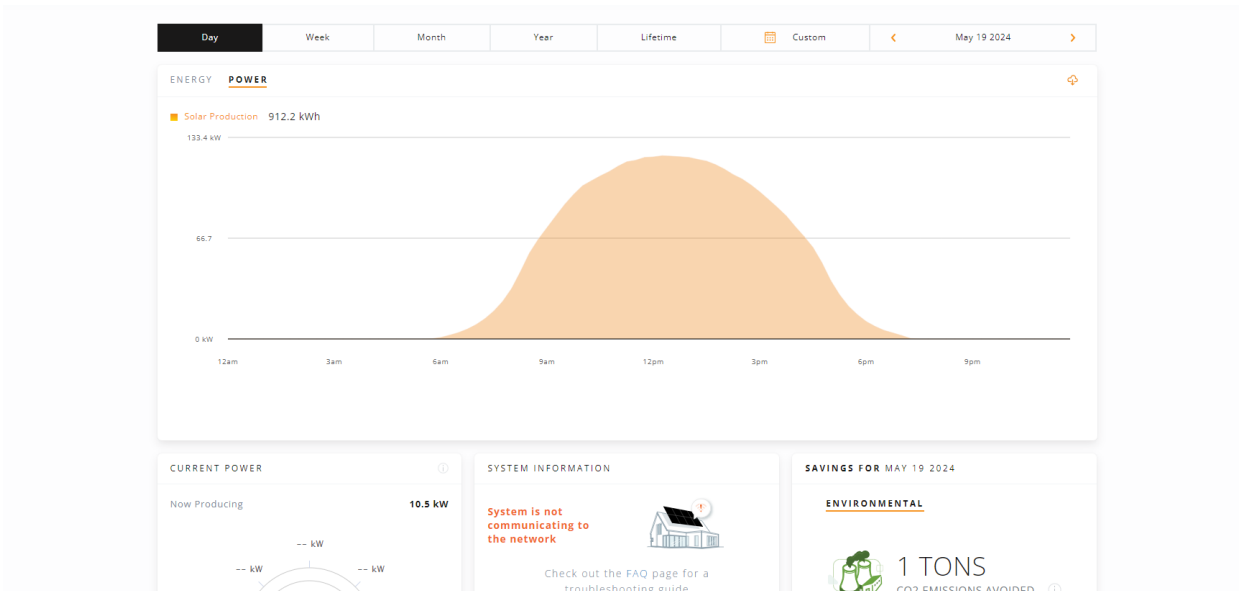
January	16000	kWh AC
February	18000	kWh AC
March	24,500	kWh AC
April	30,000	kWh AC

Based on above calculations, the performance of the system is estimated to be at **1113.2/1792 = 62%.**

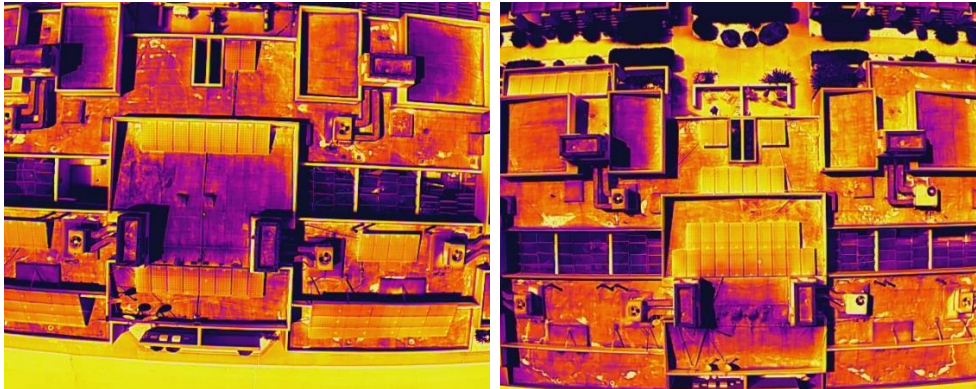
Partner conducted a complete site drone videography, imagery, and infrared inspection to locate malfunctioning solar modules with hotspots. Hotspots were detected on some of the solar modules.

The total number of modules with hot spots is estimated to be 25 which is about 2.41% of the modules.

Scenario 1 analysis replaces the inverters and modules with hot spots, cleaning of existing modules to generate an increase in production with an approximate 3 year payback to break even with cost of upgrade.

Based on above analysis, Partner suggests considering scenario 1.

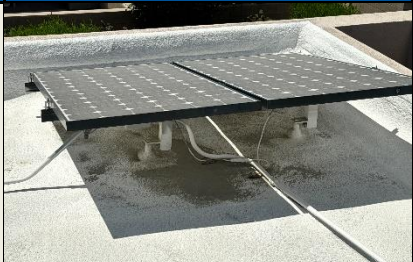
No.	Observation	Photo
3.	DC wires and module labels were painted.

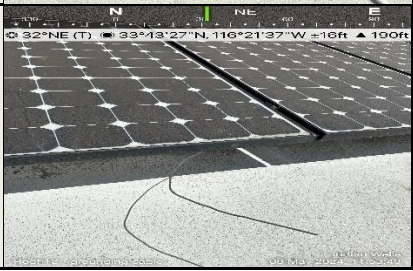
4.	Grounding cable was loose and not attached.

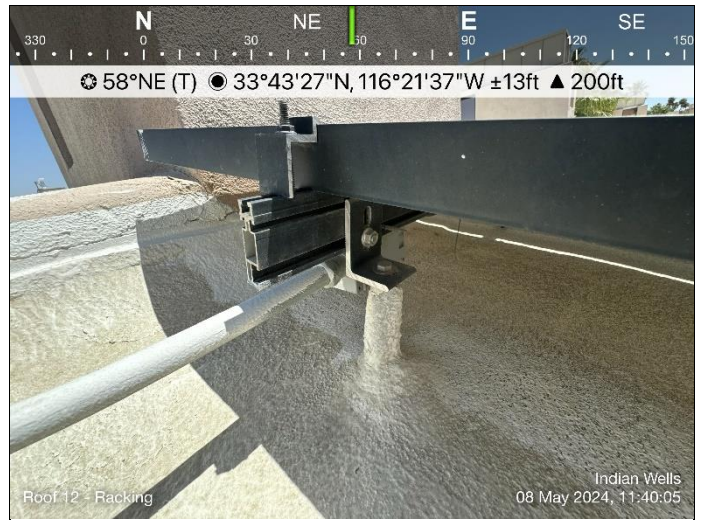
3. Soiling

- b) Soiling was observed on the modules. Additionally, bird droppings were observed on certain solar modules which raises concerns as their acidic nature can impact the lifespan and performance of photovoltaic cells.
- c) DC wiring was completed; however, it was all painted and no labels were showing. Additionally, some DC wires were touching the roof surface. This issue can be addressed by operation and maintenance team.

- a) Soiling observed on solar modules.
- b) Connections were missing torque marks.
- c) Grounding wire was observed to be loose and not connected.
- d) DC wires and module labels were painted.
- e) PV wires need to be properly managed off the roof.

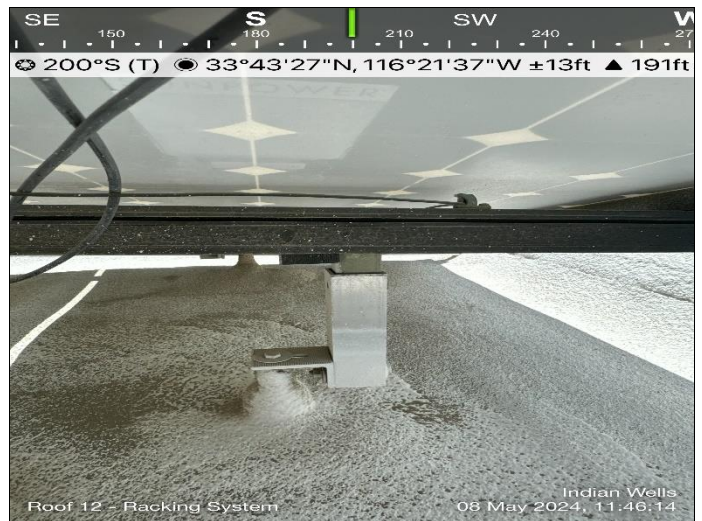
9. Grounding

- Racking system is a fixed-tilt roof mount securely anchored to the roof.
- No issues or red flag observed on the racking system.
- Modules maintained appropriate clearance for typical roof mounts.
- System grounding was observed to be disconnected in some locations.
- Racking connections were not torque marked.
