Re: **Roof Consulting**  
Indian Wells Villas  
74800 Village Center Drive  
Indian Wells, CA 92210

Alliance Consulting & Testing Inc. has completed our initial roof surveys and we have the following report of our findings and opinions regarding the roofing systems on this property. We understand the purpose of the surveys was to determine the overall condition of the roofing systems including past repairs, what repairs still need to be made, the remaining service life of the systems and/or does the roofing systems need to be replaced.

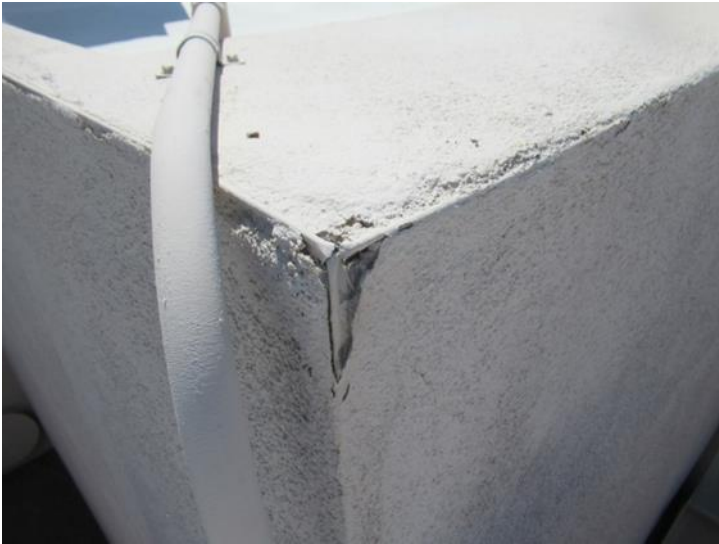
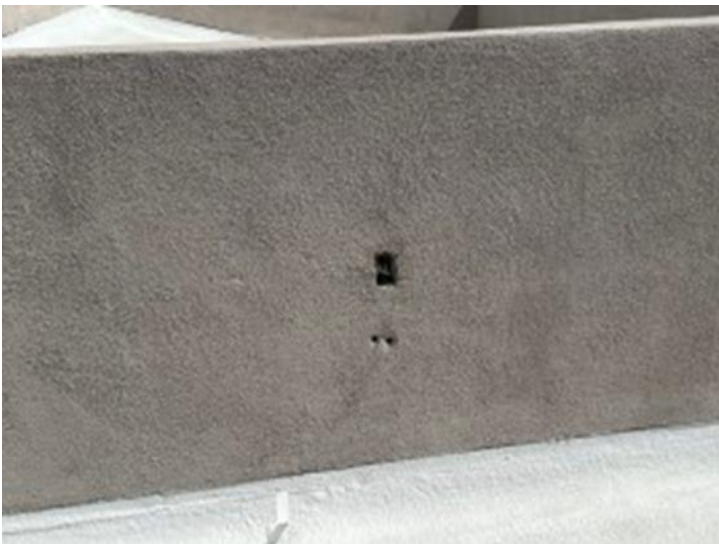
Walls show signs of cracking and minor to moderate deterioration especially at corners, windows, wall tops and roof to wall intersections.

Several penetrations at the walls both active and abandoned are not properly sealed.

A variety of issues noted at the drains including: clogged, coated over and broken/missing baskets.

The foam at the curtain walls is deteriorated likely due to animals.

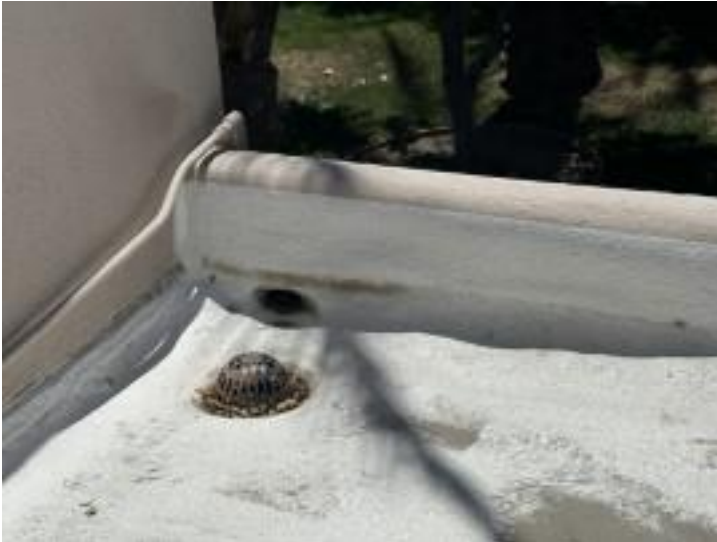
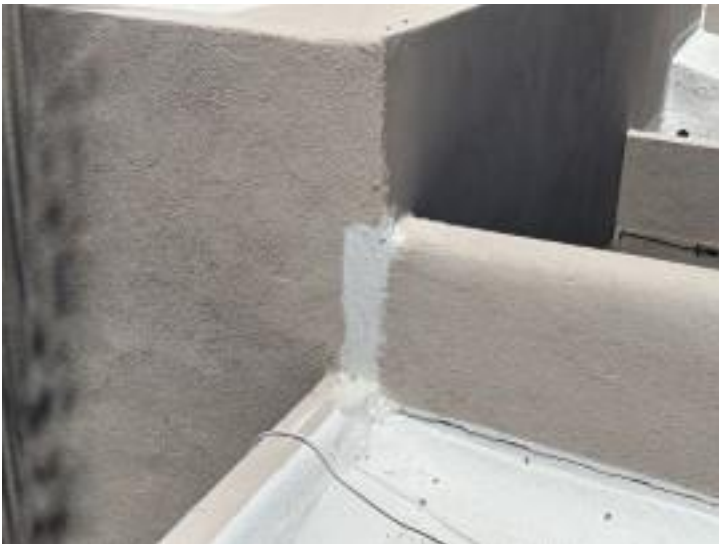
**GENERAL PHOTOS**

ITEM	Good	Fair	Poor	N/A	COMMENTS
A - Perimeter details		X			Deteriorated foam noted at curtain walls. Dish wires preventing curtain wall door from opening.
B - Drainage		X			Missing covers noted at drains. Debris(leaves) noted at drains.
C - Penetration flashings	X				
D - Overall membrane condition	X				
E - Walls/Curbs		X			Cracking and deterioration noted at walls.
F - Insulation				X	
G - Other				X	Wall penetrations both active and abandoned are not properly sealed.

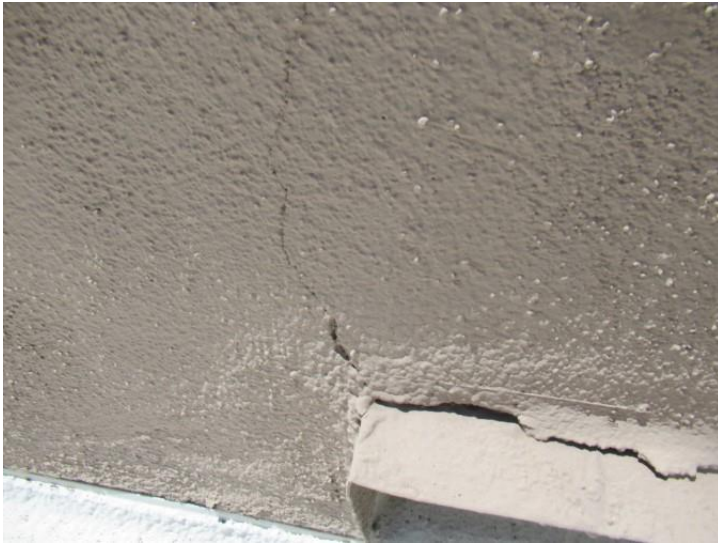
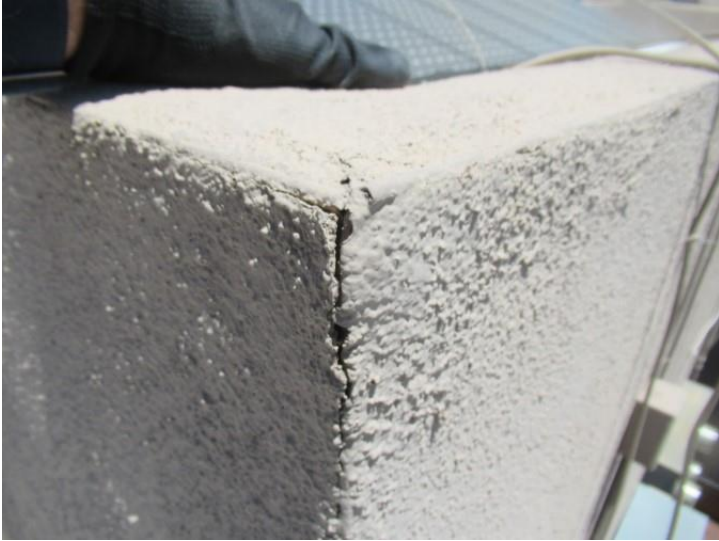
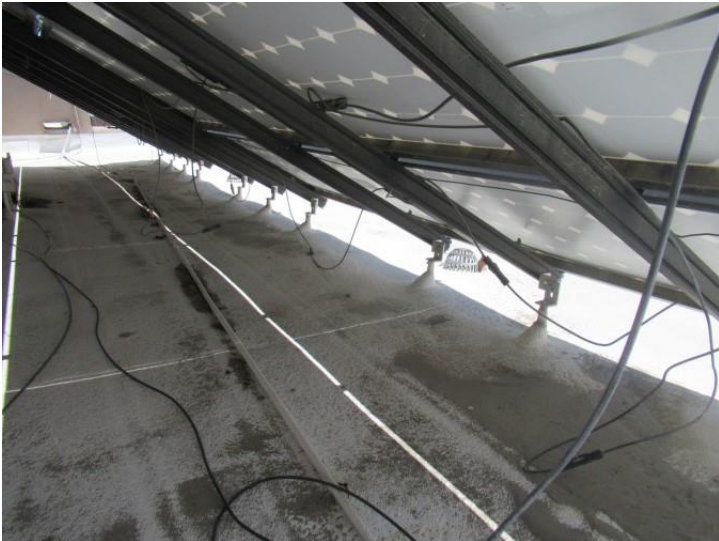
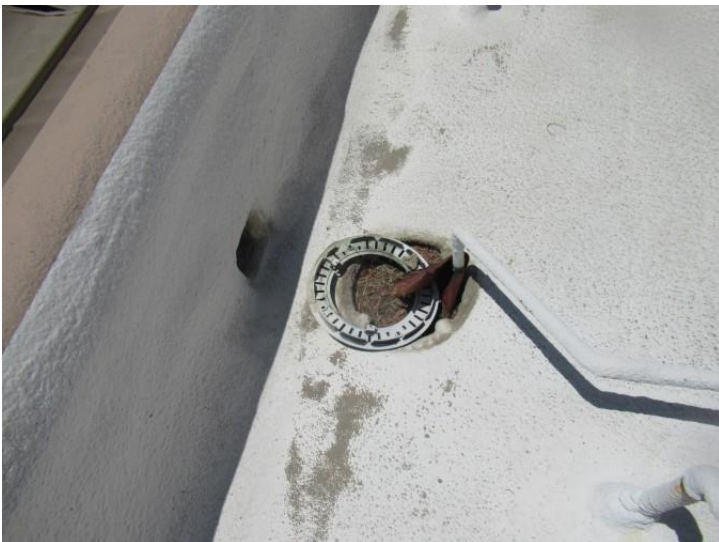
**GENERAL PHOTOS**

ITEM	Good	Fair	Poor	N/A	COMMENTS
A - Perimeter details		X			Deteriorated foam noted at curtain walls.
B - Drainage		X			Missing covers noted at drains. Debris(leaves) noted at drains.
C - Penetration flashings	X				
D - Overall membrane condition	X				
E - Walls/Curbs		X			Cracking and deterioration noted at walls.
F - Insulation				X	
G - Other				X	Wall penetrations both active and abandoned are not properly sealed.

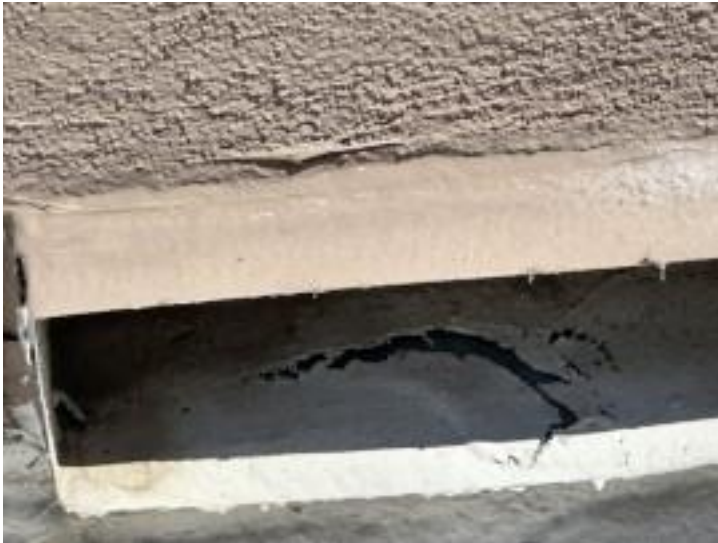
**GENERAL PHOTOS**

ITEM	Good	Fair	Poor	N/A	COMMENTS
A - Perimeter details		X			Deteriorated foam noted at curtain walls.
B - Drainage		X			Missing covers noted at drains. Debris(leaves) noted at drains.  Some deterioration noted at scupper coating.
C - Penetration flashings	X				
D - Overall membrane condition	X				
E - Walls/Curbs		X			Cracking and deterioration noted at walls.
F - Insulation				X	
G - Other				X	Wall penetrations both active and abandoned are not properly sealed.

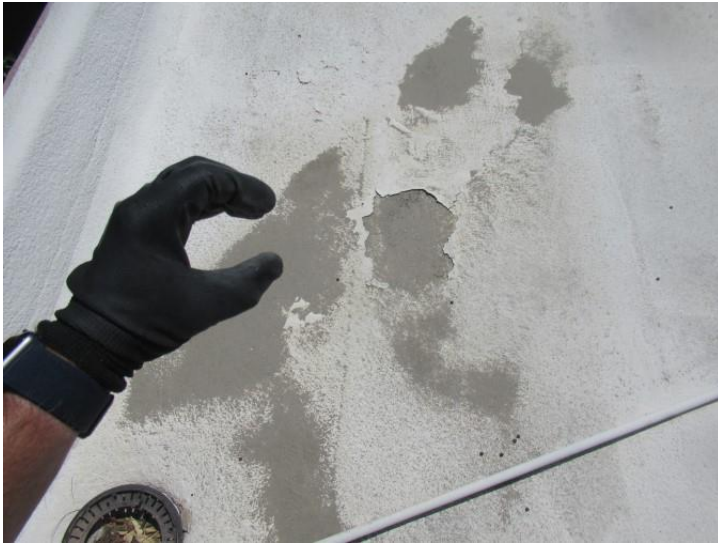
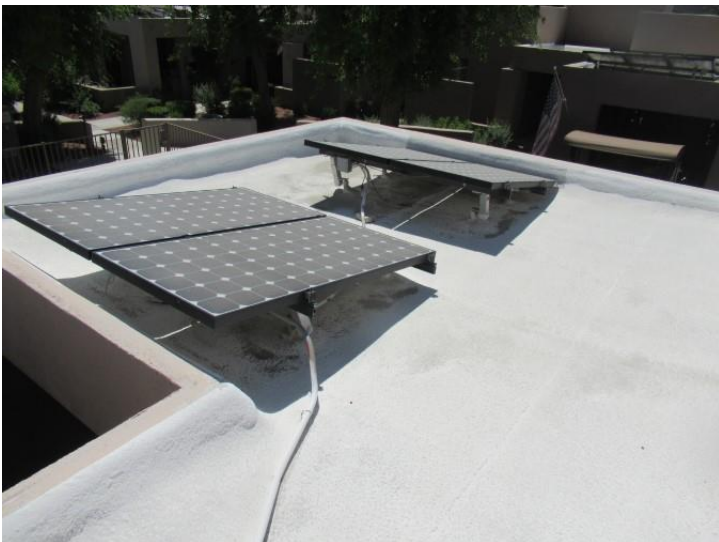
**GENERAL PHOTOS**

ITEM	Good	Fair	Poor	N/A	COMMENTS
A - Perimeter details		X			Deteriorated foam noted at curtain walls.
B - Drainage		X			Missing covers noted at drains. Debris(leaves) noted at drains.
C - Penetration flashings	X				
D - Overall membrane condition	X				Some coating deterioration noted in isolated locations.
E - Walls/Curbs		X			Cracking and deterioration noted at walls.
F - Insulation				X	
G - Other				X	Wall penetrations both active and abandoned are not properly sealed.

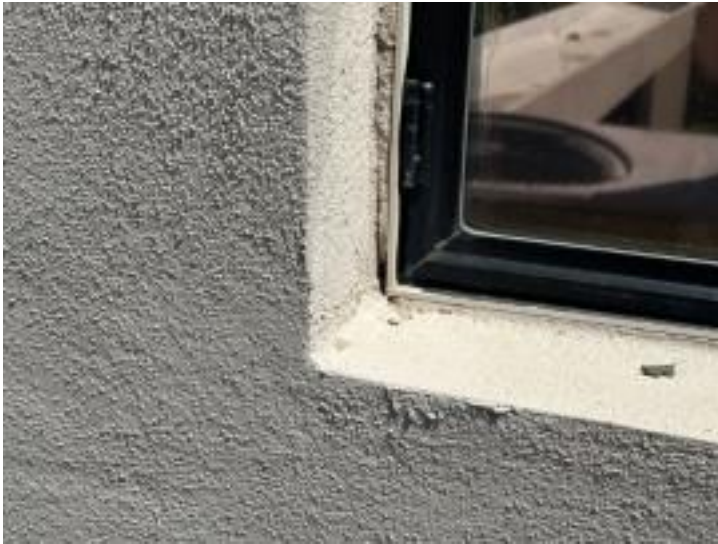
## GENERAL PHOTOS

ITEM	Good	Fair	Poor	N/A	COMMENTS
A - Perimeter details		X			Deteriorated foam noted at curtain walls.
B - Drainage		X			Missing covers noted at drains. Debris(leaves) noted at drains.
C - Penetration flashings	X				
D - Overall membrane condition	X				
E - Walls/Curbs		X			Cracking and deterioration noted at walls.
F - Insulation				X	
G - Other				X	Wall penetrations both active and abandoned are not properly sealed.

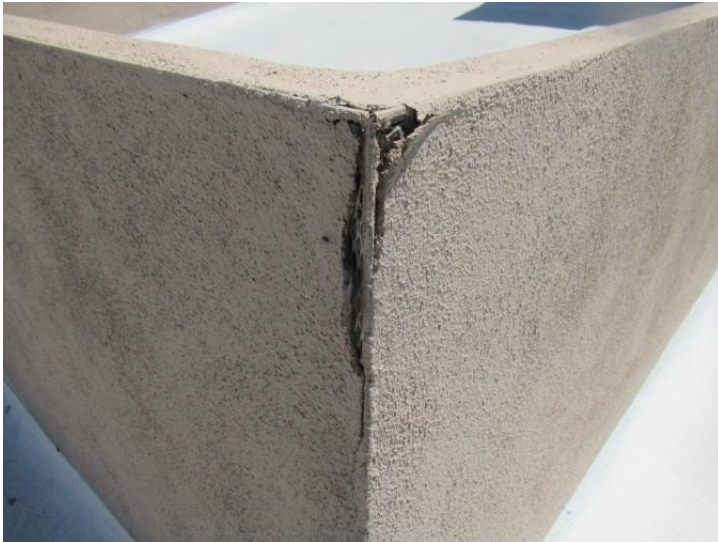
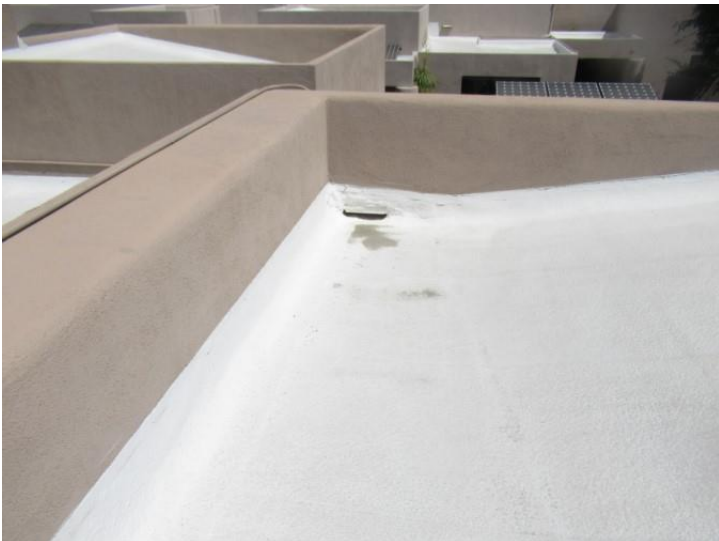
**GENERAL PHOTOS**

ITEM	Good	Fair	Poor	N/A	COMMENTS
A - Perimeter details		X			Deteriorated foam noted at curtain walls.
B - Drainage		X			Missing covers noted at drains. Debris(leaves) noted at drains.
C - Penetration flashings	X				
D - Overall membrane condition	X				
E - Walls/Curbs		X			Cracking and deterioration noted at walls.
F - Insulation				X	
G - Other				X	Wall penetrations both active and abandoned are not properly sealed.

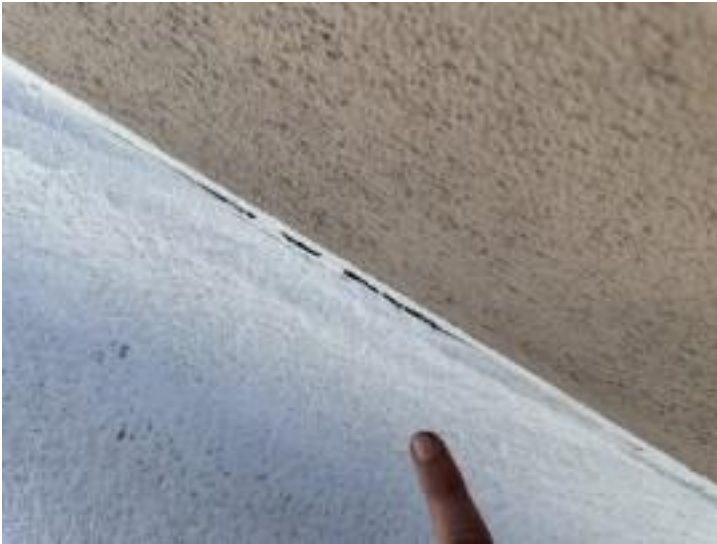
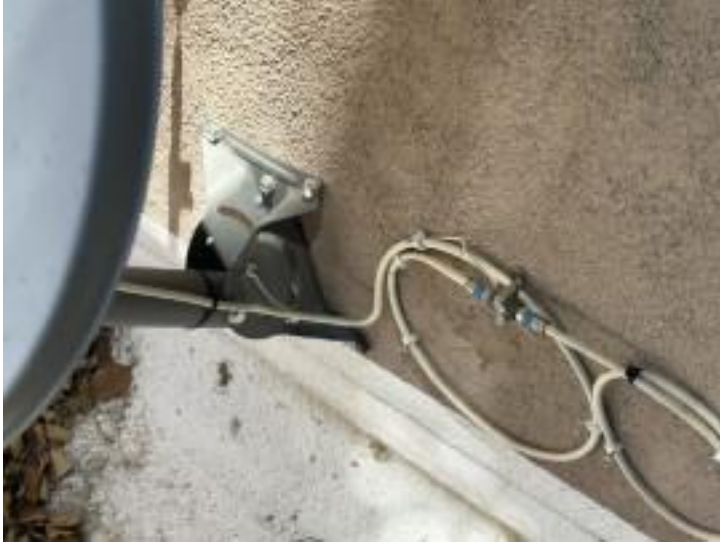
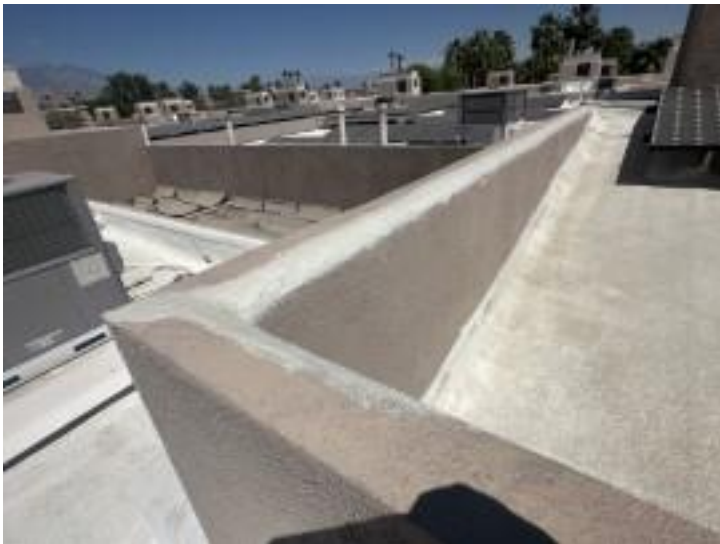
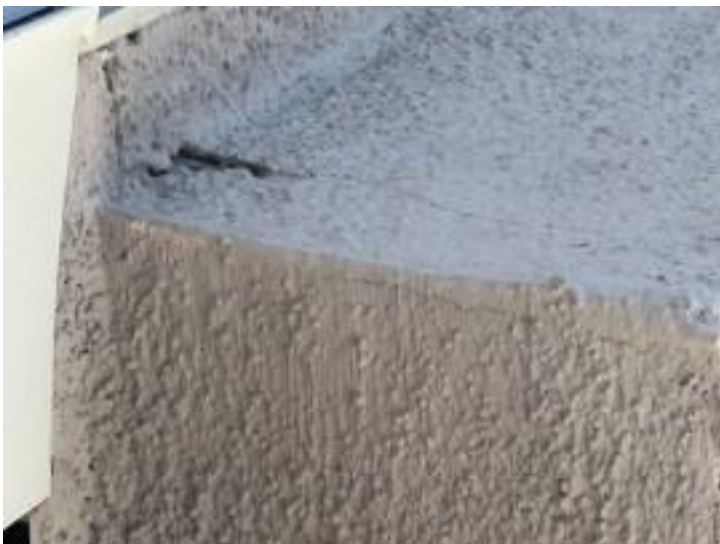
**GENERAL PHOTOS**

ITEM	Good	Fair	Poor	N/A	COMMENTS
A - Perimeter details		X			Deteriorated foam noted at curtain walls.
B - Drainage		X			Missing covers noted at drains. Debris(leaves) noted at drains.
C - Penetration flashings	X				
D - Overall membrane condition	X				
E - Walls/Curbs		X			Cracking and deterioration noted at walls.
F - Insulation				X	
G - Other				X	Wall penetrations both active and abandoned are not properly sealed.

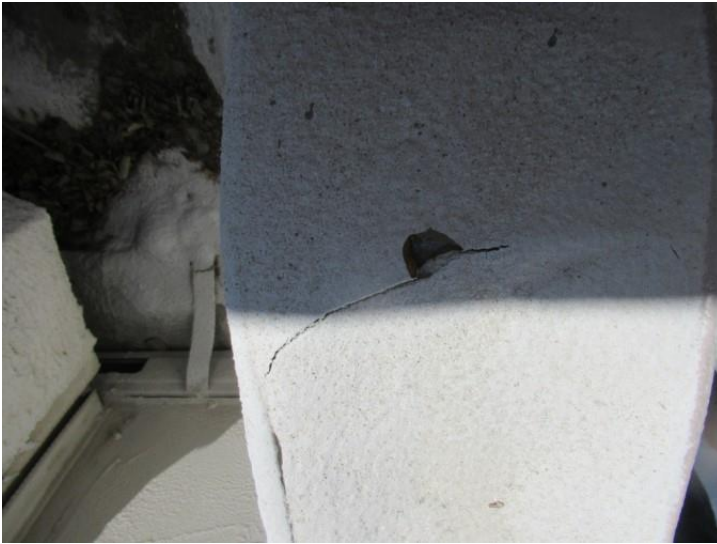
**GENERAL PHOTOS**

ITEM	Good	Fair	Poor	N/A	COMMENTS
A - Perimeter details		X			Deteriorated foam noted at curtain walls.
B - Drainage		X			Missing covers noted at drains. Debris(leaves) noted at drains.
C - Penetration flashings	X				
D - Overall membrane condition	X				
E - Walls/Curbs		X			Cracking and deterioration noted at walls.
F - Insulation				X	
G - Other				X	Wall penetrations both active and abandoned are not properly sealed.

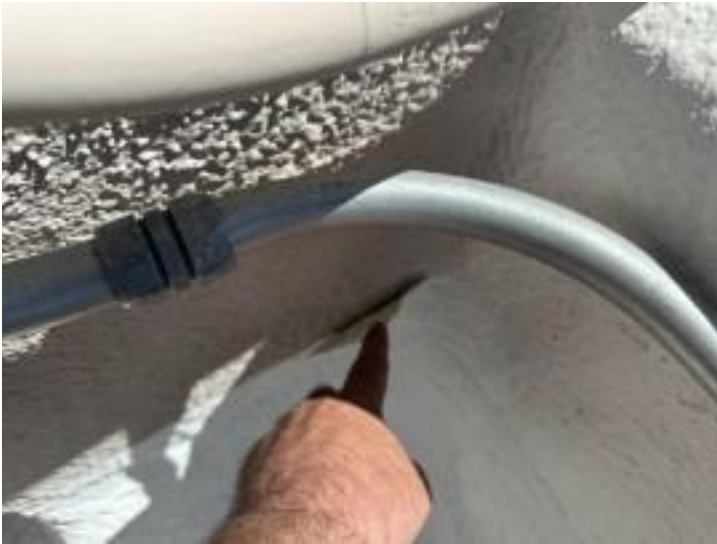
## GENERAL PHOTOS

ITEM	Good	Fair	Poor	N/A	COMMENTS
A - Perimeter details		X			Deteriorated foam noted at curtain walls.
B - Drainage		X			Missing covers noted at drains. Debris(leaves) noted at drains.
C - Penetration flashings		X			Deterioration noted at the copper line penetration flashing.
D - Overall membrane condition	X				
E - Walls/Curbs		X			Cracking and deterioration noted at walls.
F - Insulation				X	
G - Other				X	Wall penetrations both active and abandoned are not properly sealed.

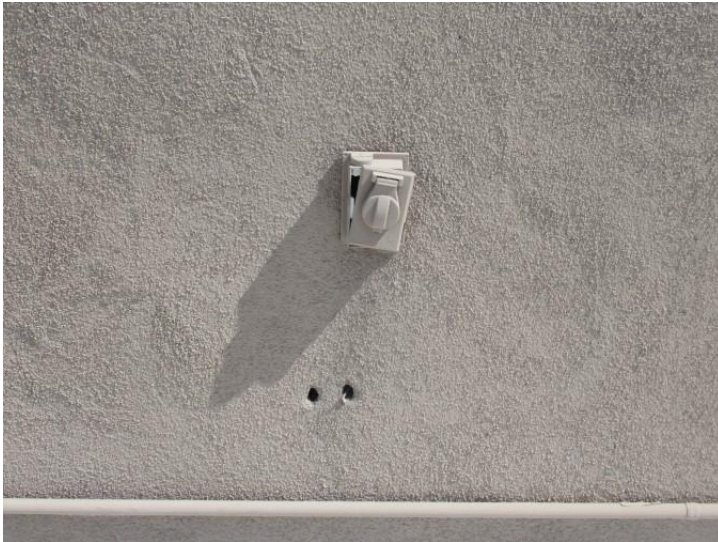
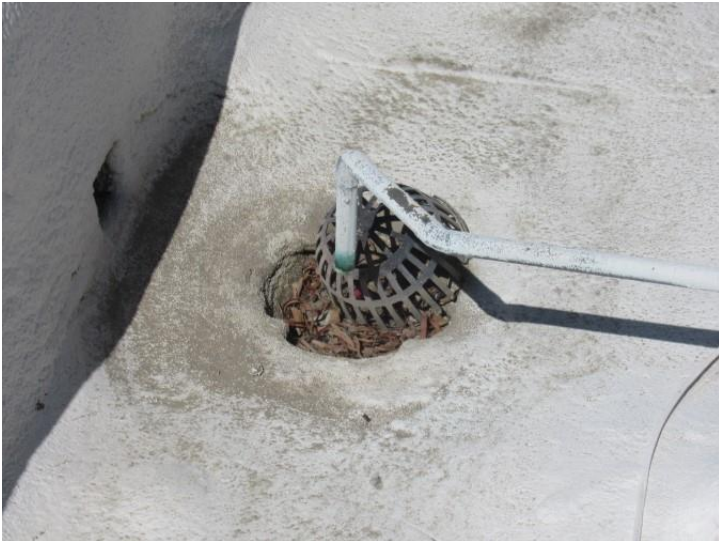
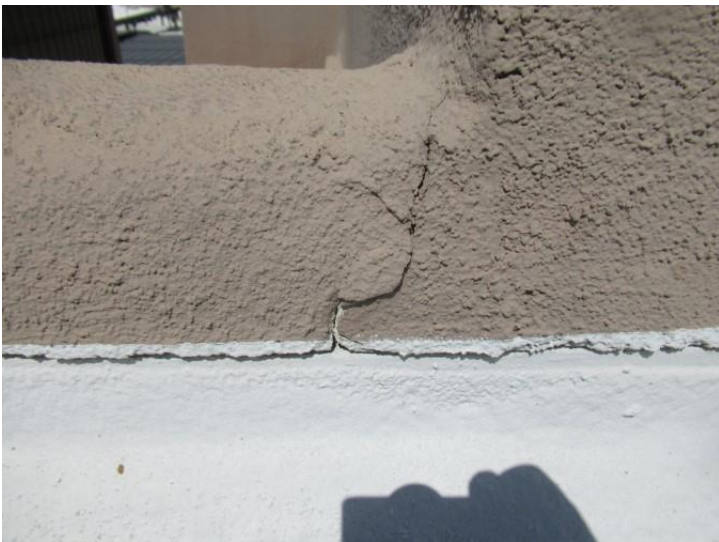
**GENERAL PHOTOS**

ITEM	Good	Fair	Poor	N/A	COMMENTS
A - Perimeter details		X			Deteriorated foam noted at curtain walls.
B - Drainage		X			Missing covers noted at drains. Debris(leaves) noted at drains.
C - Penetration flashings	X				
D - Overall membrane condition	X				
E - Walls/Curbs		X			Cracking and deterioration noted at walls.
F - Insulation				X	
G - Other				X	Wall penetrations both active and abandoned are not properly sealed.

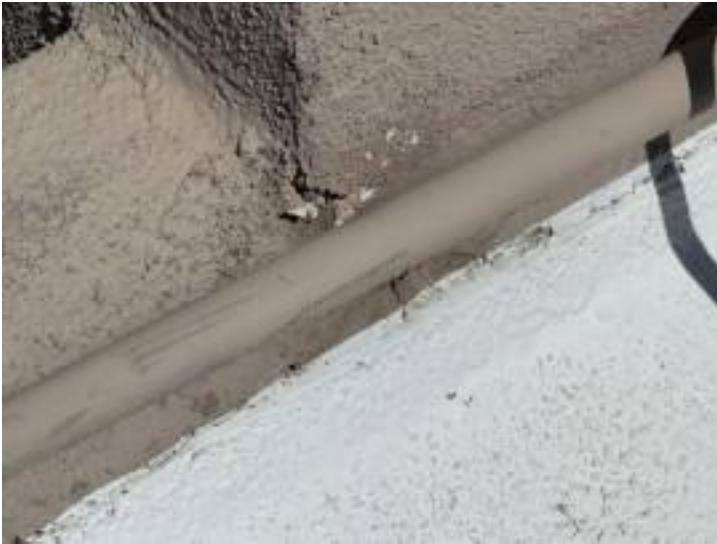
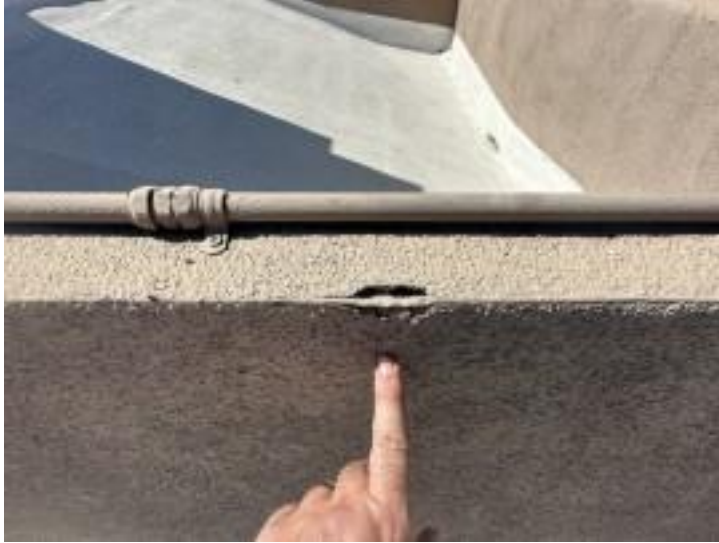
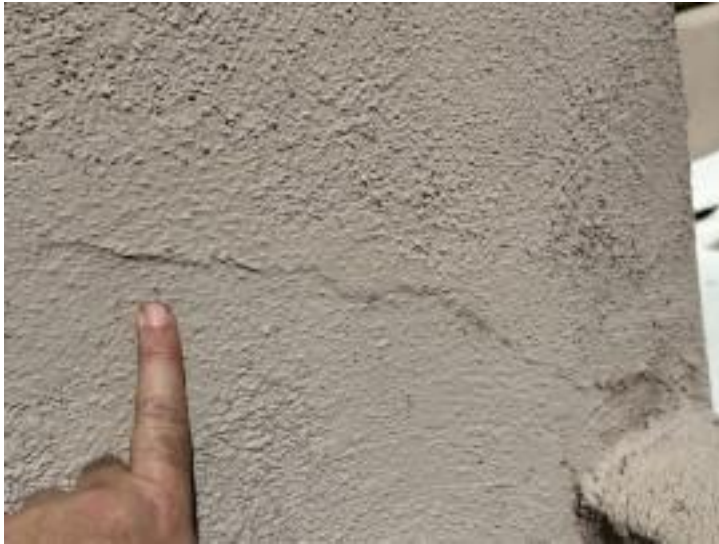
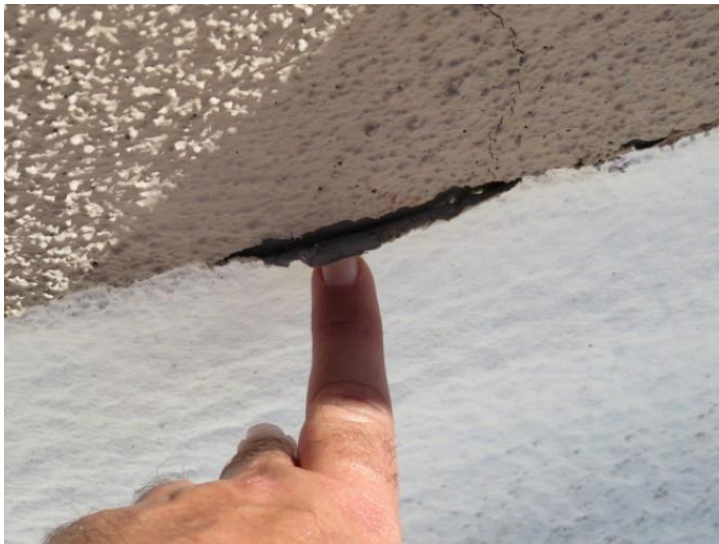
ITEM	Good	Fair	Poor	N/A	COMMENTS
A - Perimeter details		X			Deteriorated foam noted at curtain walls.
B - Drainage		X			Missing covers noted at drains. Debris(leaves) noted at drains.
C - Penetration flashings	X				
D - Overall membrane condition	X				
E - Walls/Curbs		X			Cracking and deterioration noted at walls.
F - Insulation				X	
G - Other				X	Wall penetrations both active and abandoned are not properly sealed.

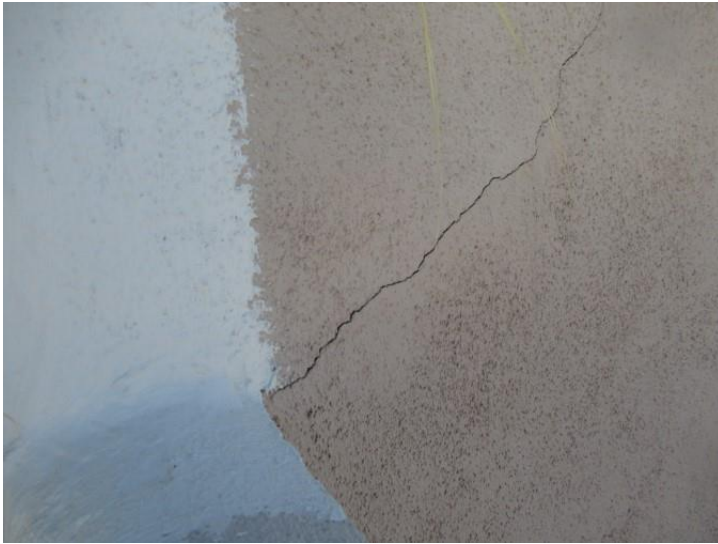
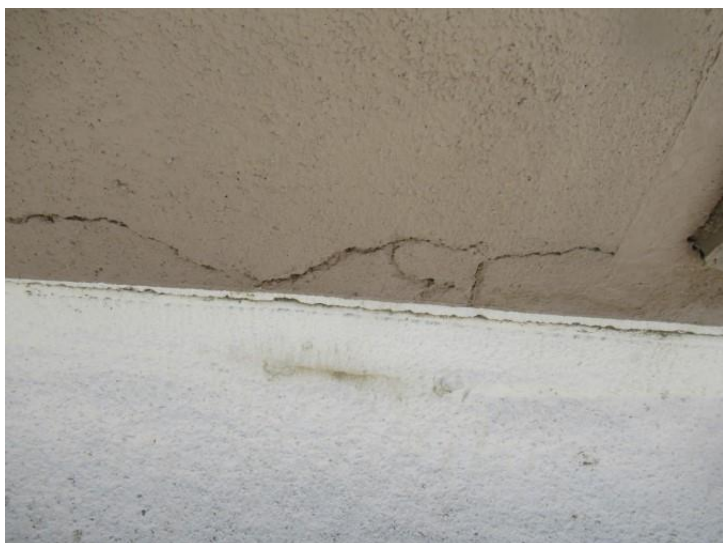
**Building 12 -**

ITEM	Good	Fair	Poor	N/A	COMMENTS
A - Perimeter details		X			Deteriorated foam noted at curtain walls.
B - Drainage		X			Missing covers noted at drains. Debris(leaves) noted at drains.
C - Penetration flashings	X				
D - Overall membrane condition	X				
E - Walls/Curbs		X			Cracking and deterioration noted at walls.
F - Insulation				X	
G - Other				X	Wall penetrations both active and abandoned are not properly sealed.

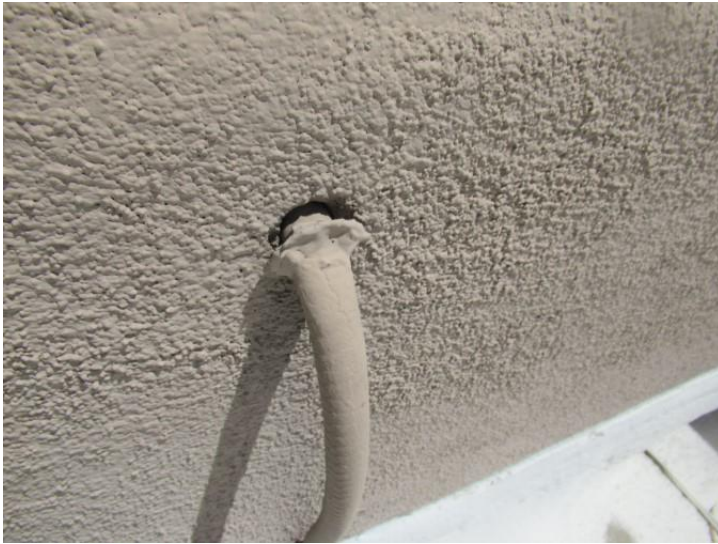
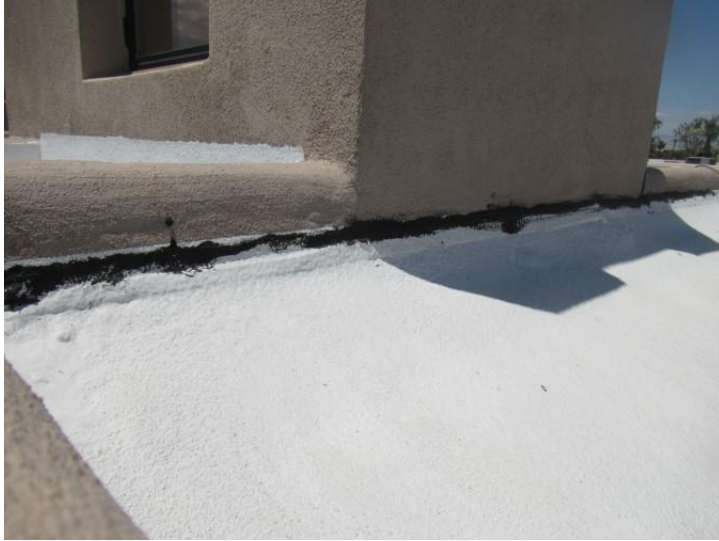
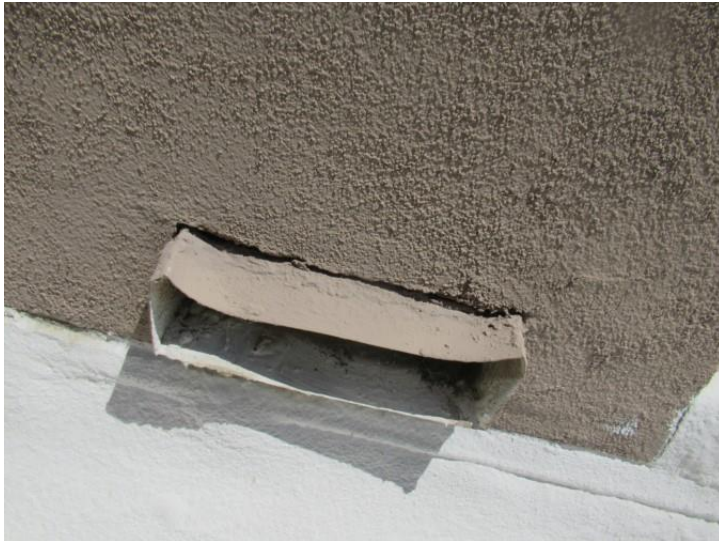
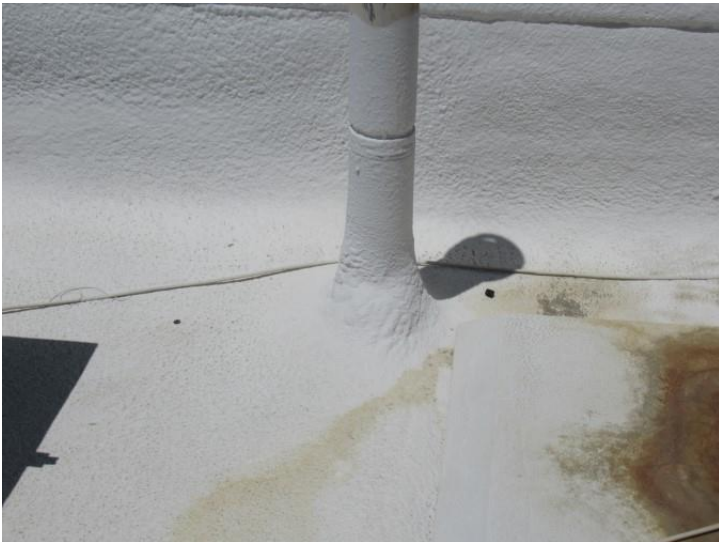
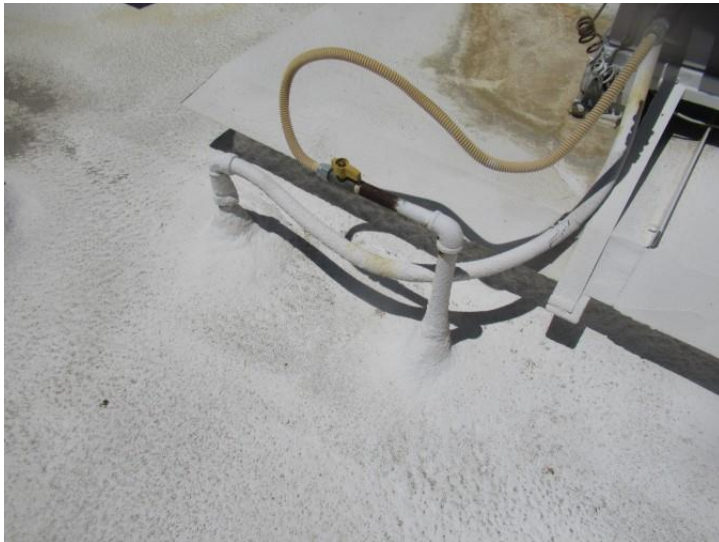
**Building 13 -**

ITEM	Good	Fair	Poor	N/A	COMMENTS
A - Perimeter details		X			Deteriorated foam noted at curtain walls.
B - Drainage		X			Missing covers noted at drains. Debris(leaves) noted at drains.
C - Penetration flashings	X				
D - Overall membrane condition	X				
E - Walls/Curbs		X			Cracking and deterioration noted at walls.
F - Insulation				X	
G - Other				X	Wall penetrations both active and abandoned are not properly sealed.

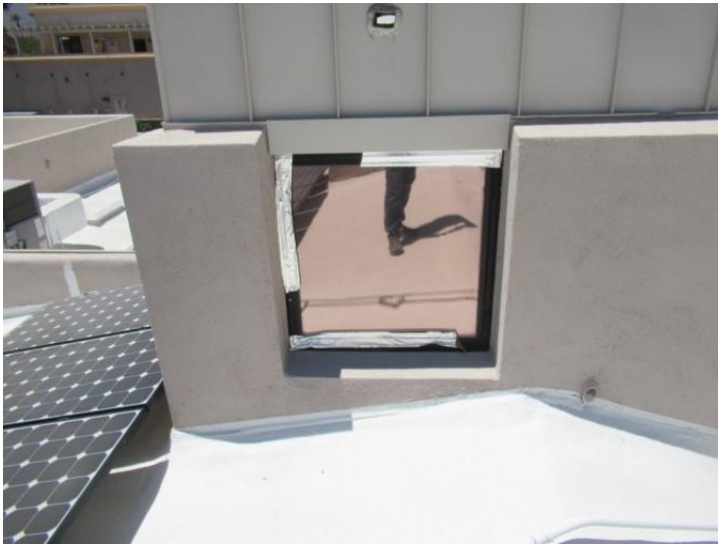
**Building 14 -**

ITEM	Good	Fair	Poor	N/A	COMMENTS
A - Perimeter details		X			Deteriorated foam noted at curtain walls.
B - Drainage		X			Missing covers noted at drains. Debris(leaves) noted at drains.
C - Penetration flashings	X				
D - Overall membrane condition	X				
E - Walls/Curbs		X			Cracking and deterioration noted at walls.
F - Insulation				X	
G - Other				X	Wall penetrations both active and abandoned are not properly sealed.  Tape noted at window, likely temporary repair.

ACTION/MONITORING ITEMS	
<b>Specific Action Items</b>	
Building 1 – Reroute Dish wires to ensure curtain wall access door properly opens. Building 3 – Reseal deteriorated coating in scupper. Building 14 – Further investigate and properly repair and seal window with temporary tape repair. Building 15 – Repair/seal large gap noted at membrane in back corner.	
<b>General Action Items</b>	
Further evaluate and repair walls where needed as cracking and deterioration noted at several locations of all buildings. Recoat/repair deterioration at roof to wall intersections (Wall Flashings.) Ensure all wall penetrations are properly sealed. Several holes where noted where items have been removed from the walls (Satellite dishes?). Ensure windows at penthouses are regularly maintained and sealed. Remove debris from roofs and drains where needed. Replace broken and missing drain covers. Ensure sleepers blocks and slip sheets installed where needed. Replace/repair damaged curtain wall foam tops.

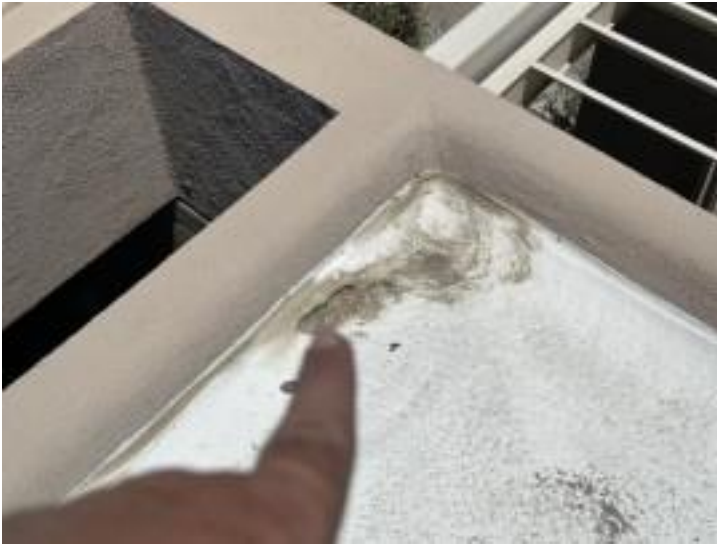
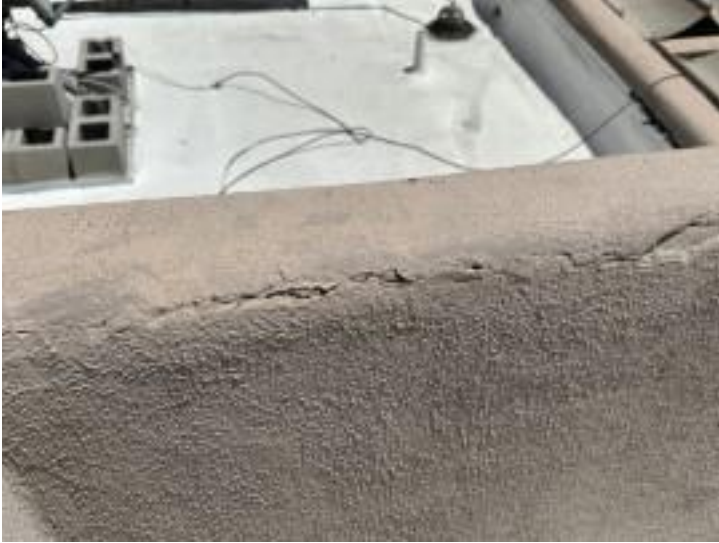
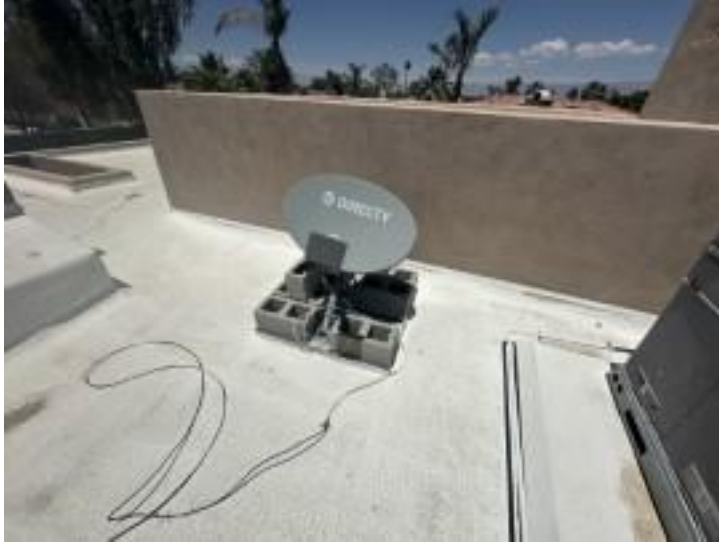
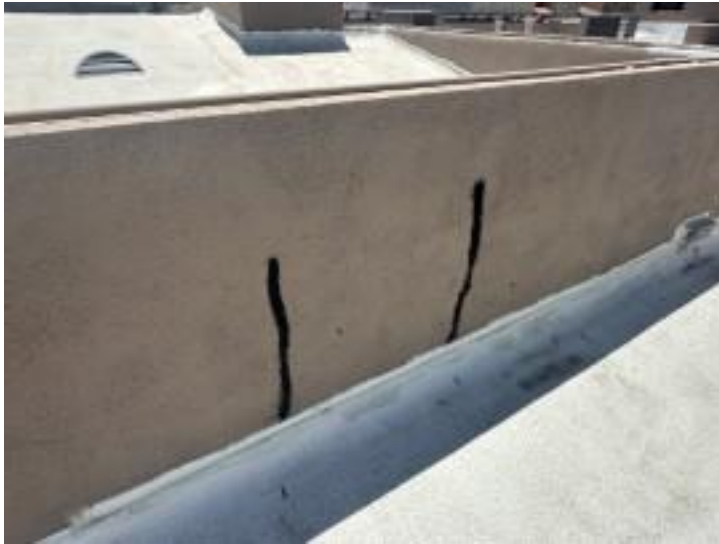
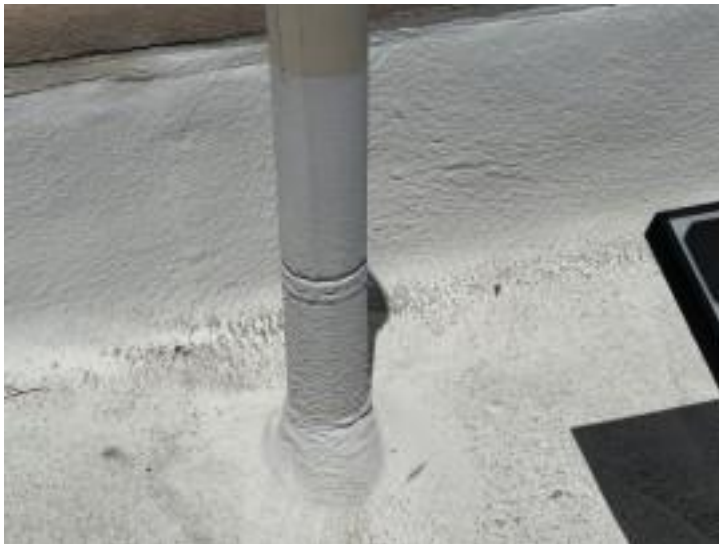
**Building 15 -**

ITEM	Good	Fair	Poor	N/A	COMMENTS
A - Perimeter details		X			Deteriorated foam noted at curtain walls.
B - Drainage		X			Missing covers noted at drains. Debris(leaves) noted at drains.
C - Penetration flashings	X				
D - Overall membrane condition		X			Large gap noted at membrane in back corner.
E - Walls/Curbs		X			Cracking and deterioration noted at walls.
F - Insulation				X	
G - Other				X	Wall penetrations both active and abandoned are not properly sealed.  Ensure satellite dishes have slip sheets.

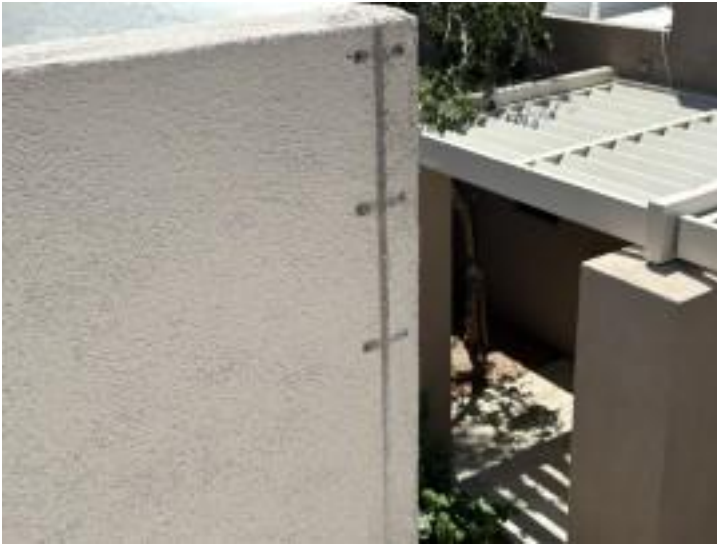
**Building 16 -**

ITEM	Good	Fair	Poor	N/A	COMMENTS
A - Perimeter details		X			Deteriorated foam noted at curtain walls.
B - Drainage		X			Missing covers noted at drains. Debris(leaves) noted at drains.
C - Penetration flashings	X				
D - Overall membrane condition	X				
E - Walls/Curbs		X			Cracking and deterioration noted at walls.
F - Insulation				X	
G - Other				X	Wall penetrations both active and abandoned are not properly sealed.

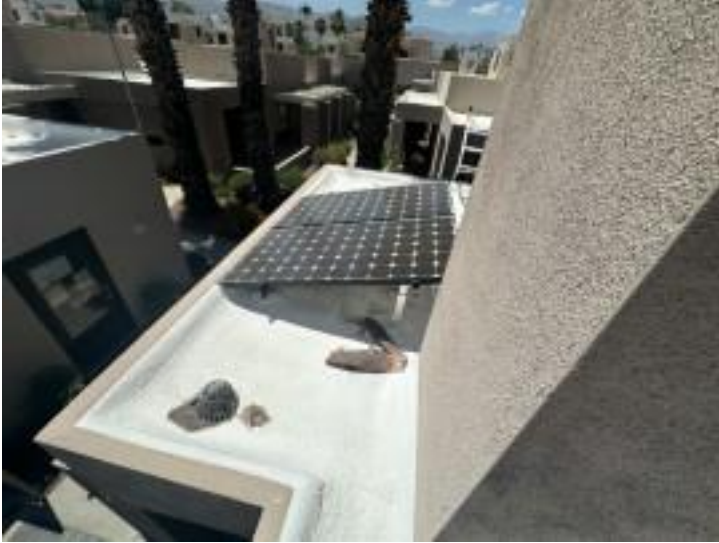
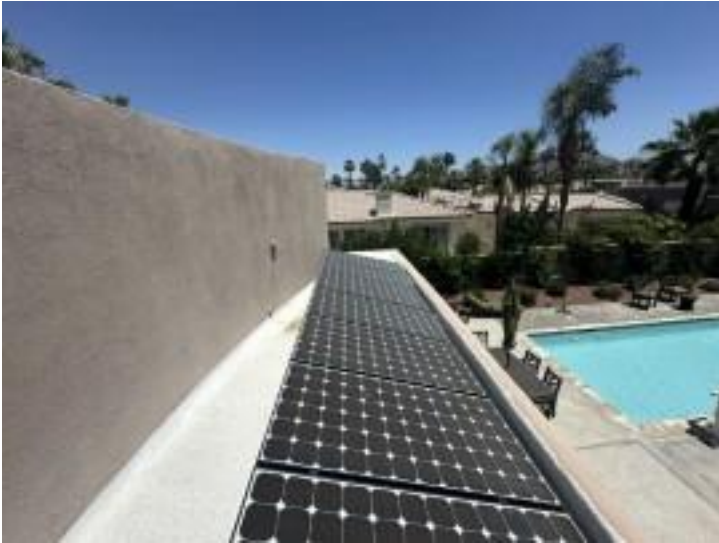
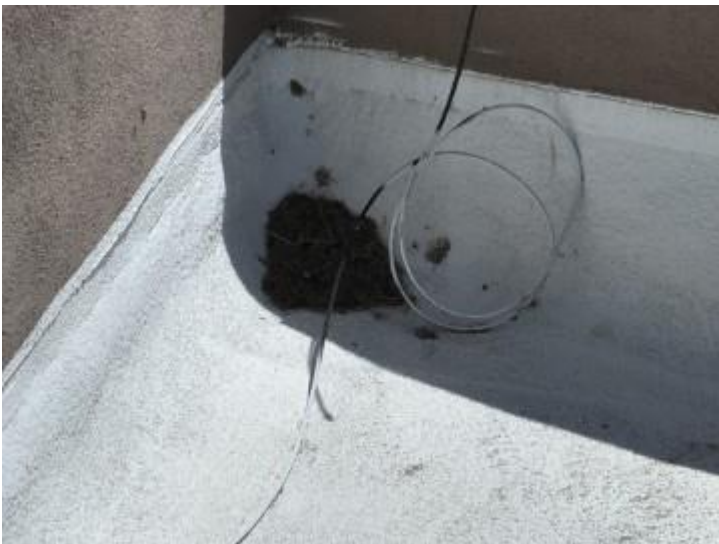
**Building 17 -**

ITEM	Good	Fair	Poor	N/A	COMMENTS
A - Perimeter details		X			Deteriorated foam noted at curtain walls.
B - Drainage		X			Missing covers noted at drains. Debris(leaves) noted at drains.
C - Penetration flashings	X				
D - Overall membrane condition	X				
E - Walls/Curbs		X			Cracking and deterioration noted at walls.
F - Insulation				X	
G - Other				X	Wall penetrations both active and abandoned are not properly sealed.

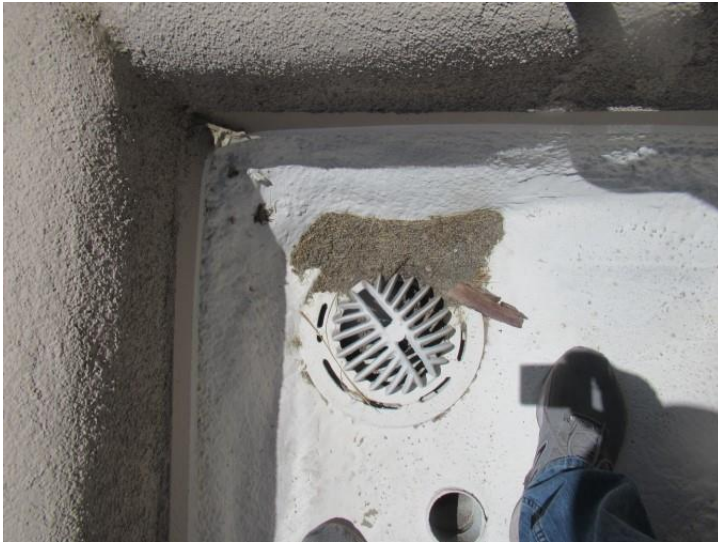
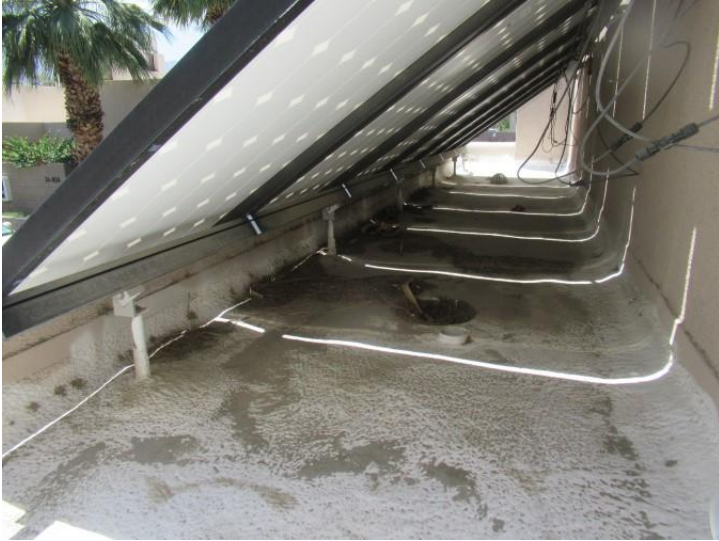
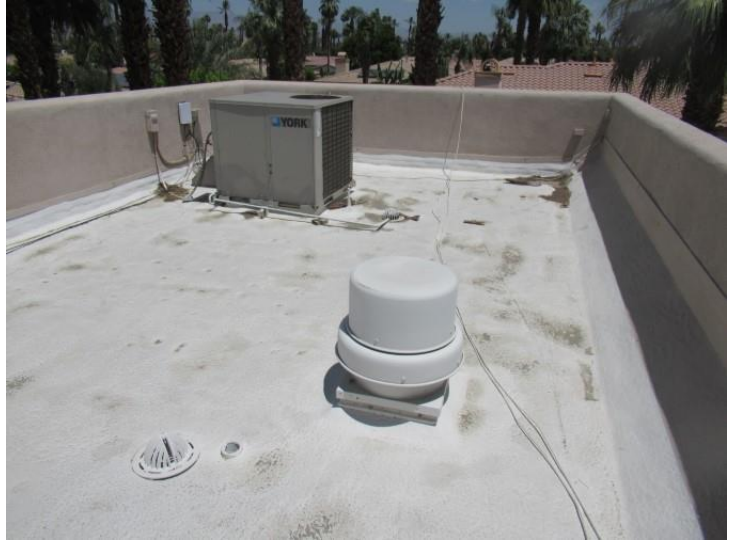
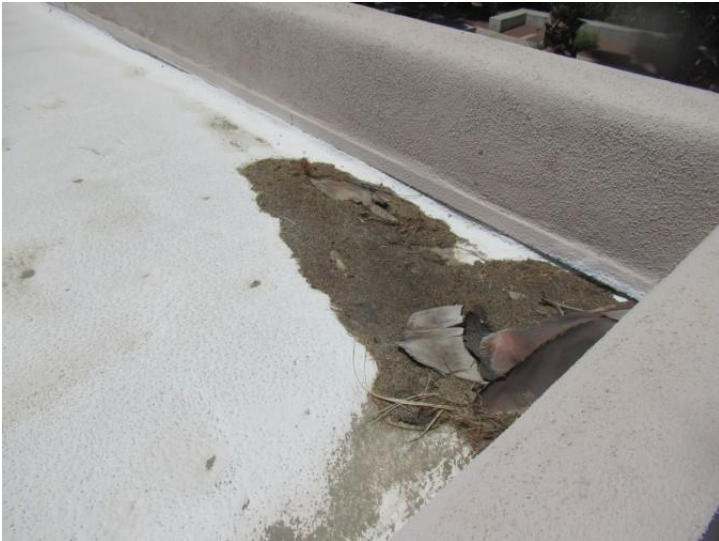
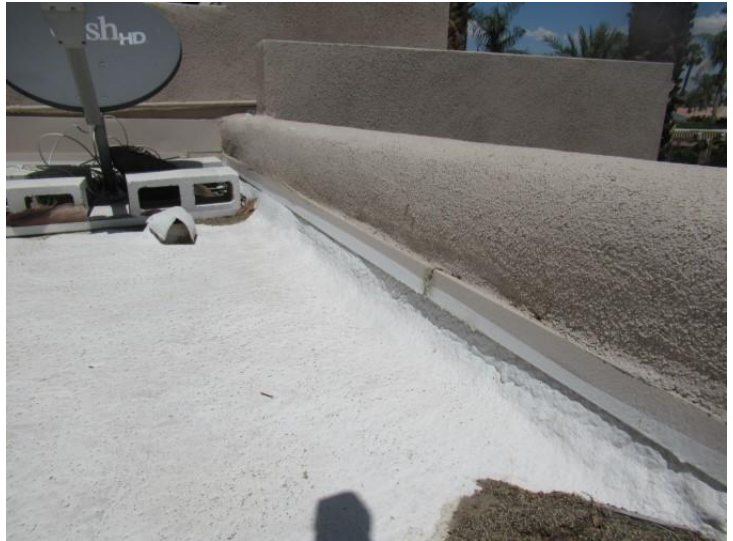
**Building 18 -**

ITEM	Good	Fair	Poor	N/A	COMMENTS
A - Perimeter details		X			Deteriorated foam noted at curtain walls.
B - Drainage		X			Missing covers noted at drains. Debris(leaves) noted at drains.
C - Penetration flashings	X				
D - Overall membrane condition	X				
E - Walls/Curbs		X			Cracking and deterioration noted at walls.
F - Insulation				X	
G - Other				X	Wall penetrations both active and abandoned are not properly sealed.
