June 13th, 2024

Re: Roof Consulting
Mountain View Villas
78000 Betty Barker Way
Indian Wells, CA 92210

Alliance Consulting & Testing Inc. has completed our initial roof surveys and we have the following report of our findings and opinions regarding the roofing systems on this property. We understand the purpose of the surveys was to determine the overall condition of the roofing systems including past repairs, what repairs still need to be made, the remaining service life of the systems and/or does the roofing systems need to be replaced.

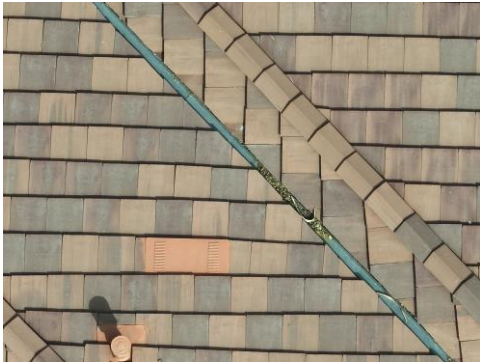
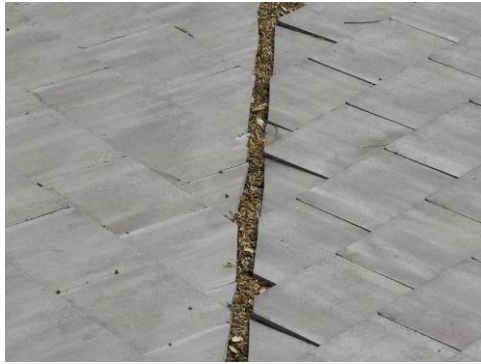
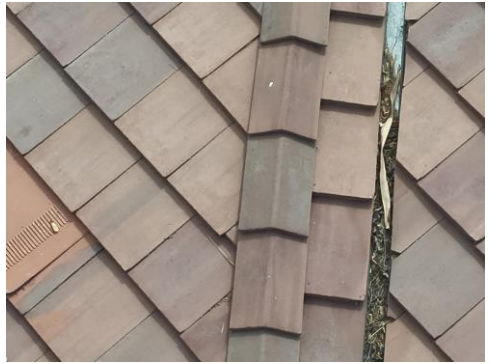
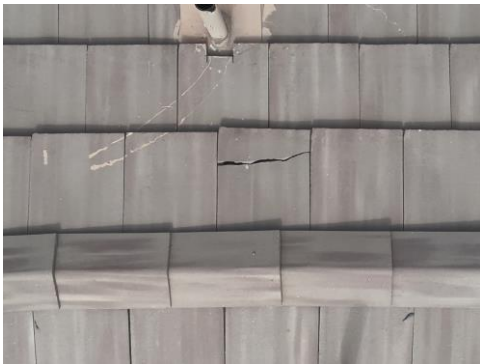
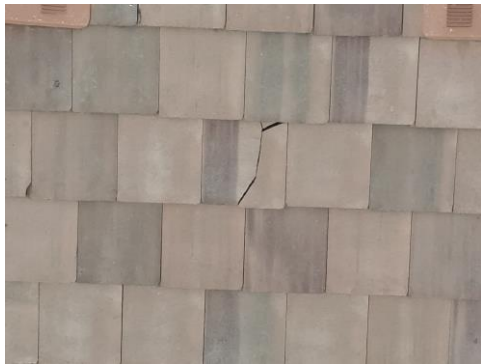
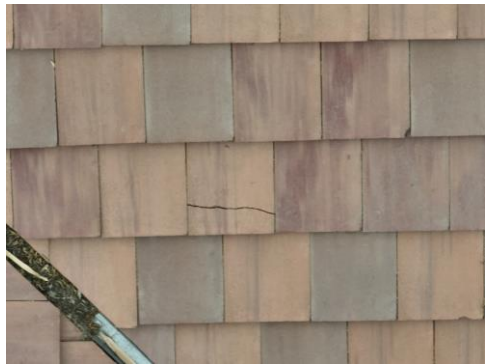
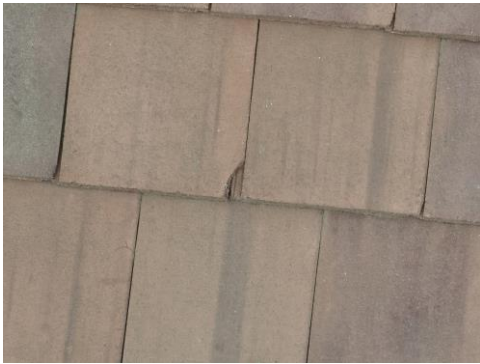
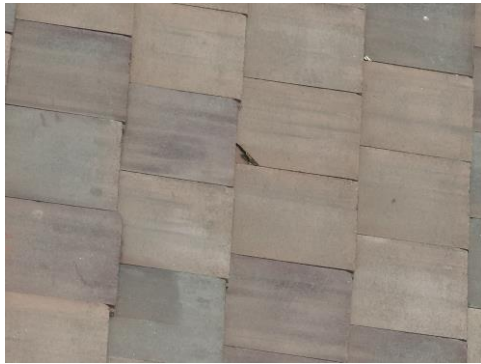
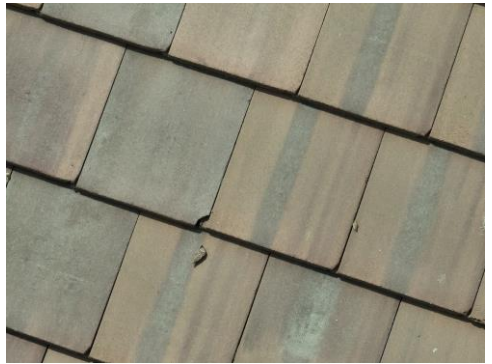
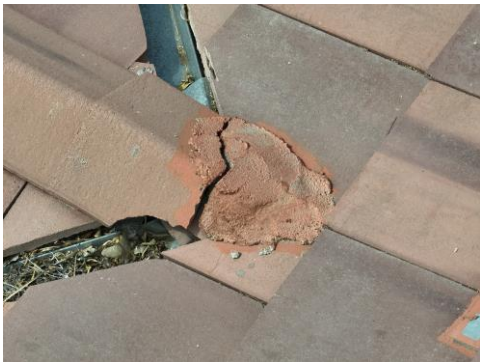
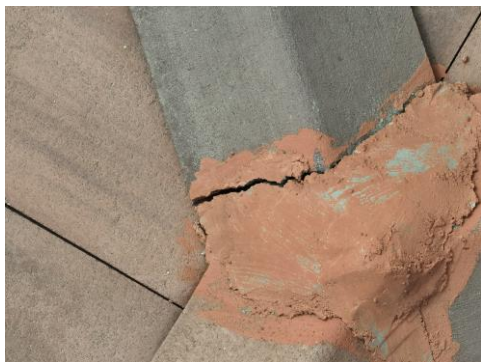
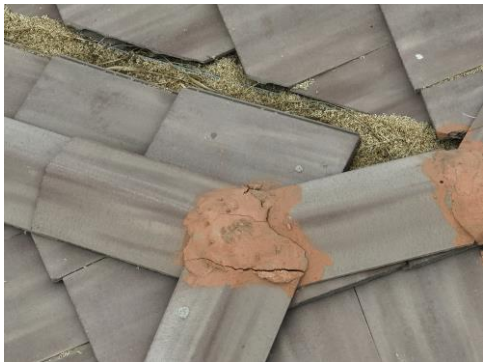
GENERAL ACTION ITEM PHOTOS

- 1 – Debris on Roof (Leaves)
- 2 – Cracked Tiles
- 3 – Chipped Corners of Tiles
- 4 – Cracked Mortar

- Replace broken/cracked tiles where needed throughout the property (This does not include chipped tiles)
- Repair/seal/regROUT mortar areas that have wide cracks.
- Ensure trees are regularly cut back away from roof structures to reduce related limb damage.
- Ensure Valleys are regularly cleaned/cleared to ensure proper drainage.

Monitor chipped tiles for chips that expose the underlayment or are large enough to cause potential water intrusion.

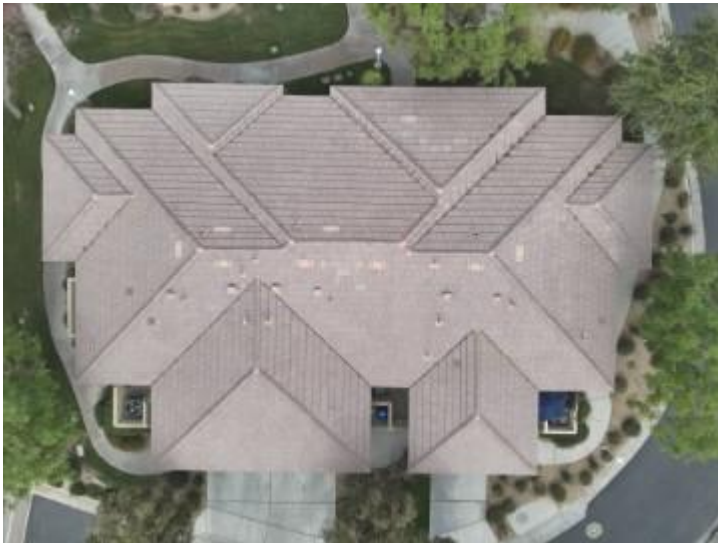
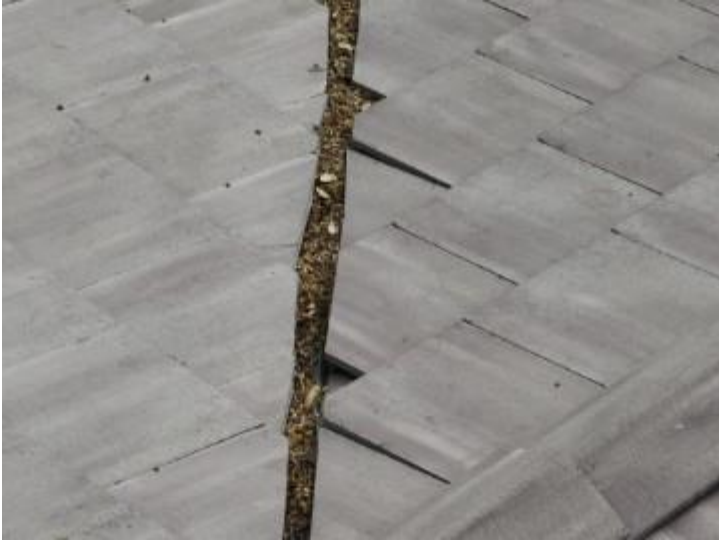
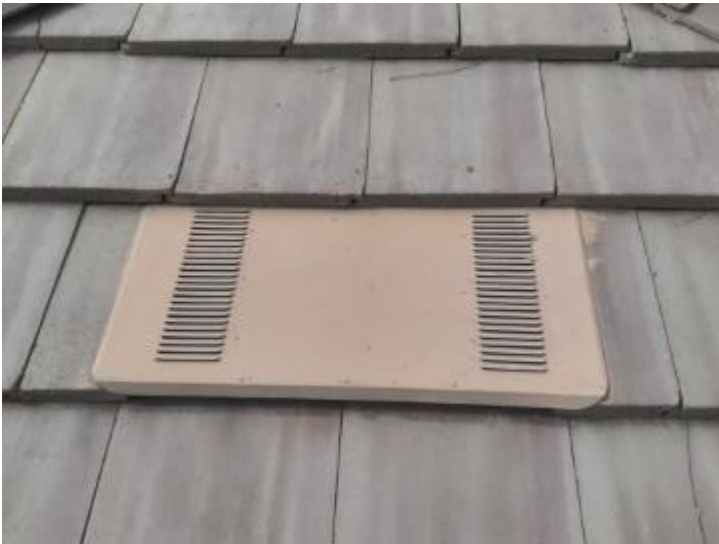
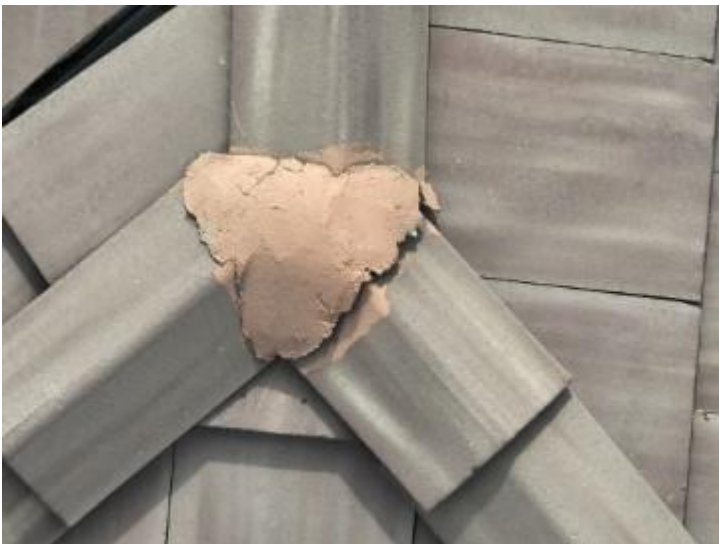
Building 1 -

ITEM	Good	Fair	Poor	N/A	COMMENTS
A - Perimeter details	X				
B - Drainage		X			Some debris noted in the valleys.
C - Penetration flashings		X			
D - Overall Tile condition		X			Some isolated cracked tiles noted. Some isolated chipped tiles noted.
E - Wall/Curb flashings				X	
F - Insulation				X	
G - Other				X

- Building 1 – Replace cracked tile where needed.
- Building 2 – Replace cracked tile where needed.
- Building 4 – Remove unused tiles from rooftop.
- Building 6 – Replace cracked/broken tile where needed.

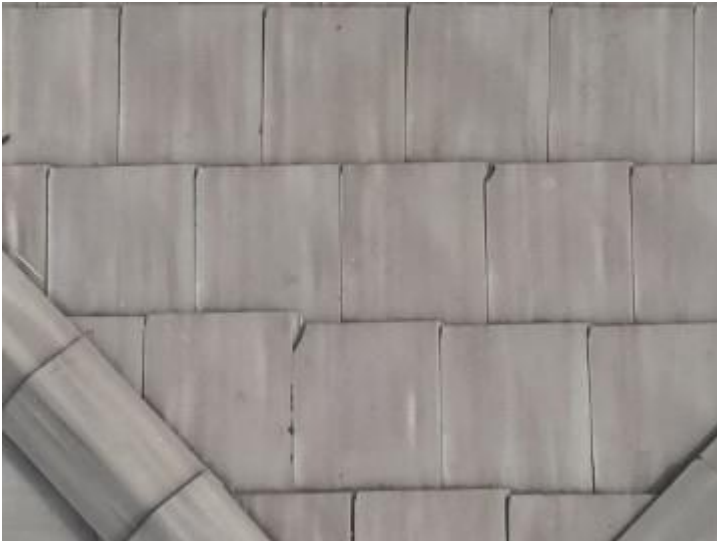
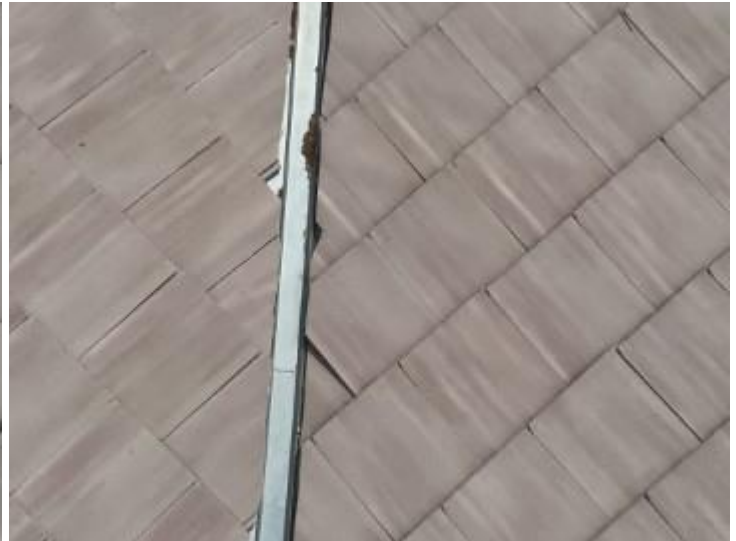
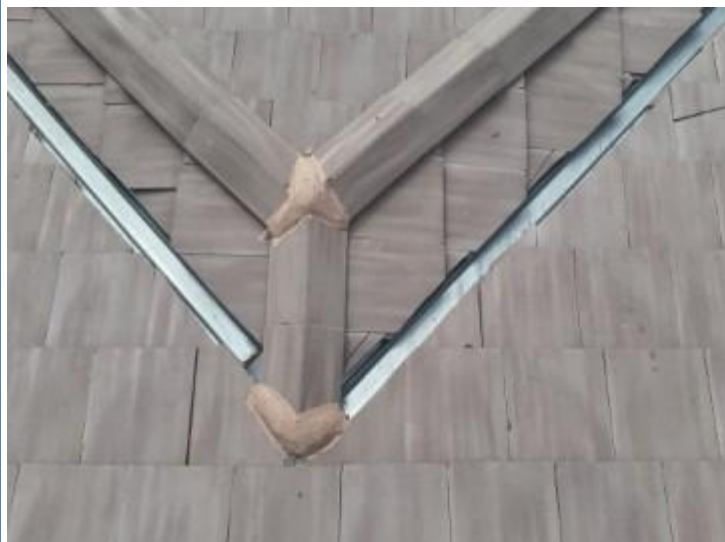
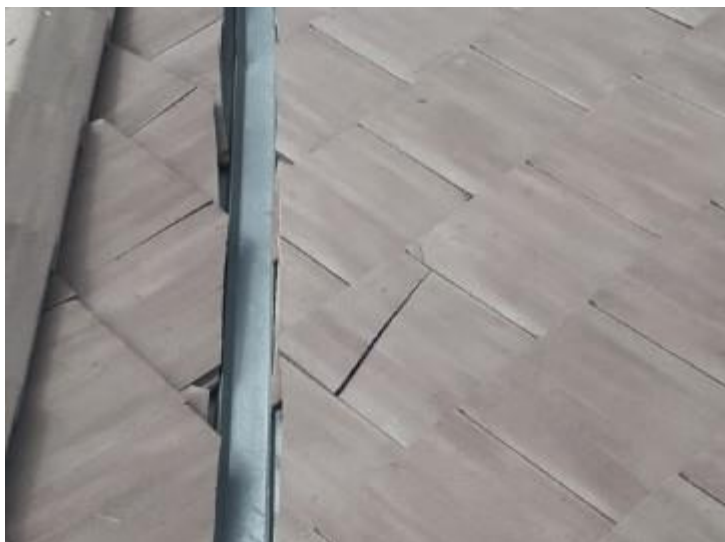
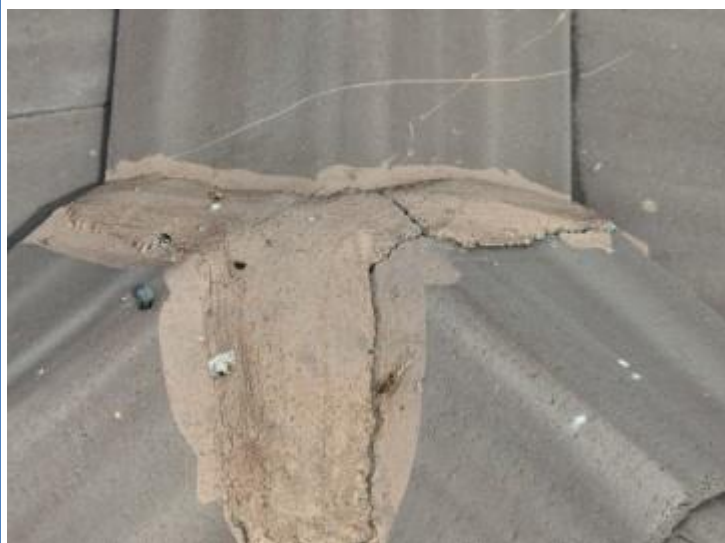
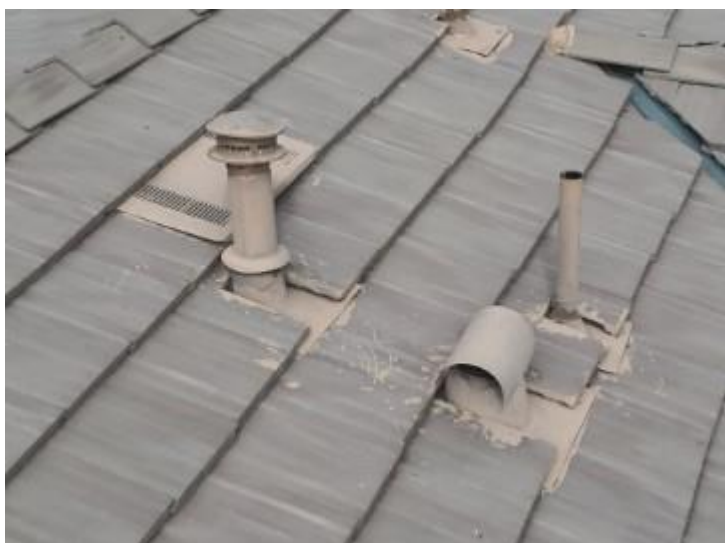
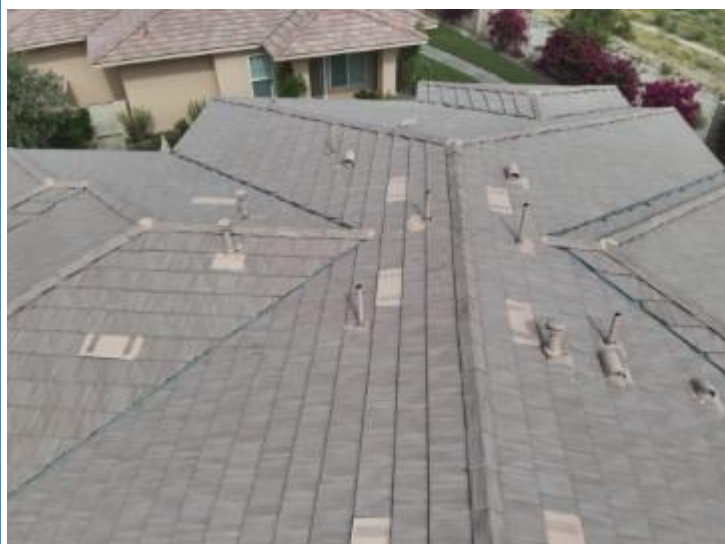
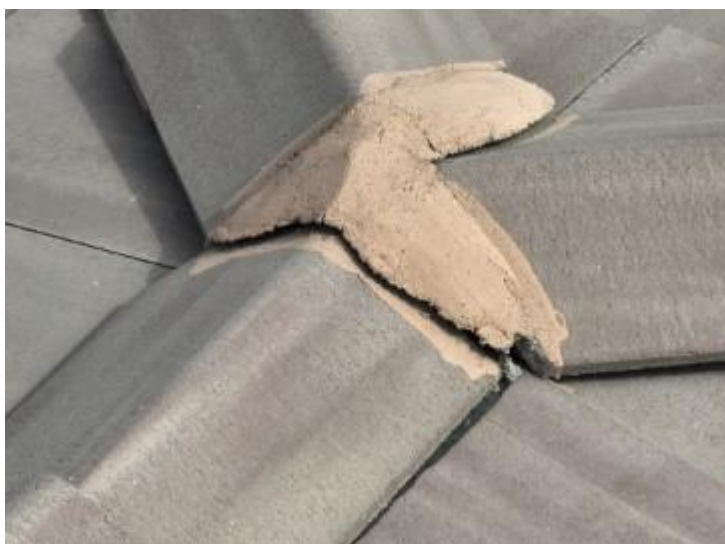
Building 2 -

ITEM	Good	Fair	Poor	N/A	COMMENTS
A - Perimeter details	X				
B - Drainage		X			Some debris noted in the valleys.
C - Penetration flashings	X				
D - Overall Tile condition		X			Some isolated cracked tiles noted. Some isolated chipped tiles noted. Some cracking noted at mortar.
E - Wall/Curb flashings				X	
F - Insulation				X	
G - Other				X

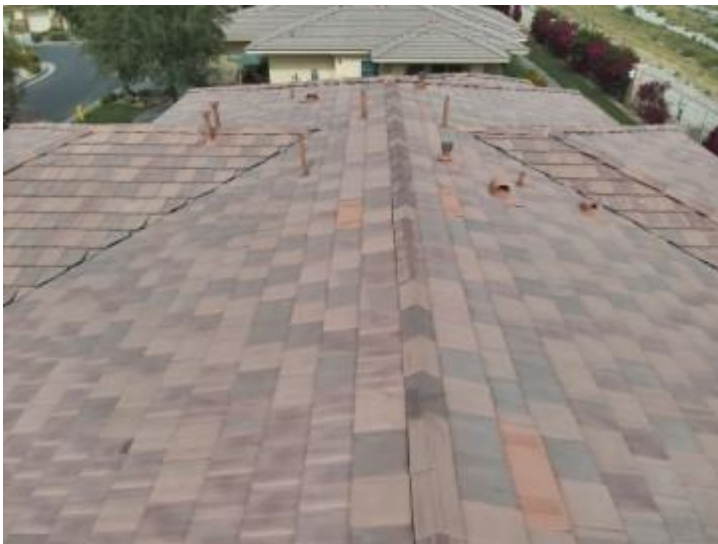
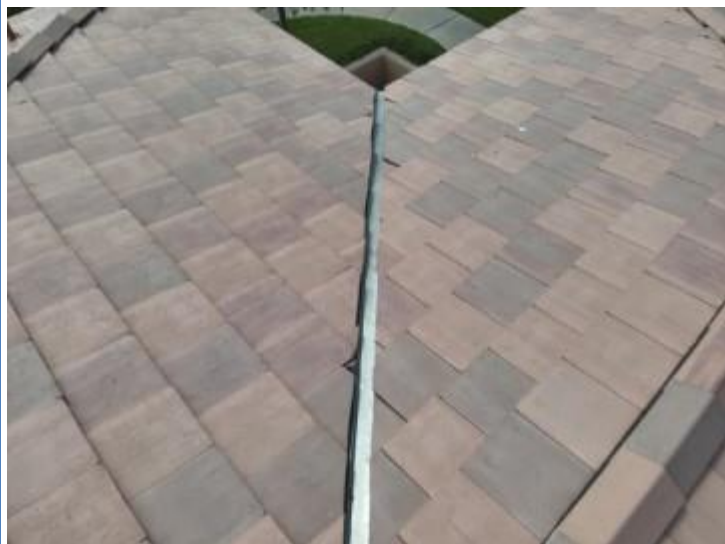
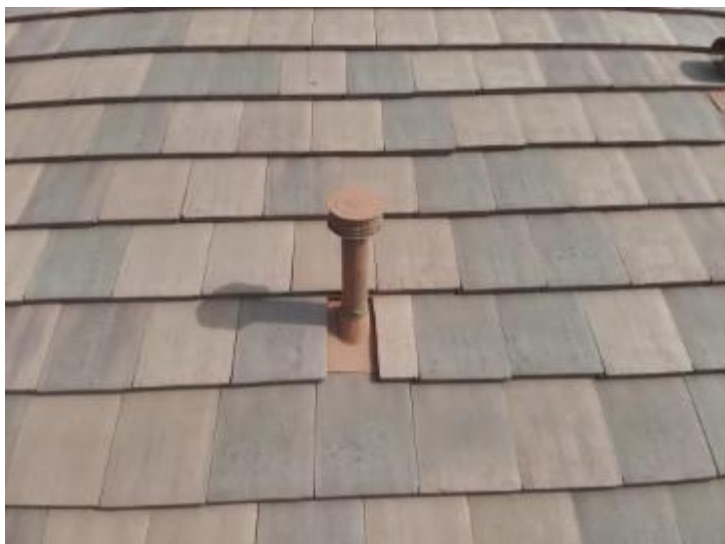
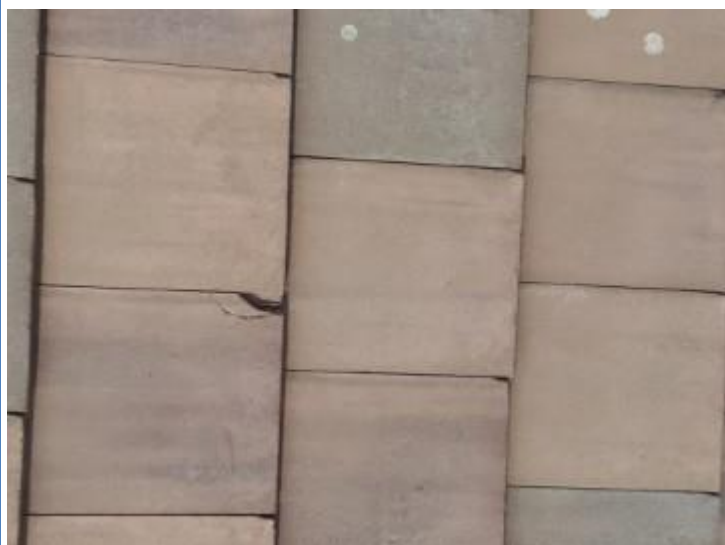
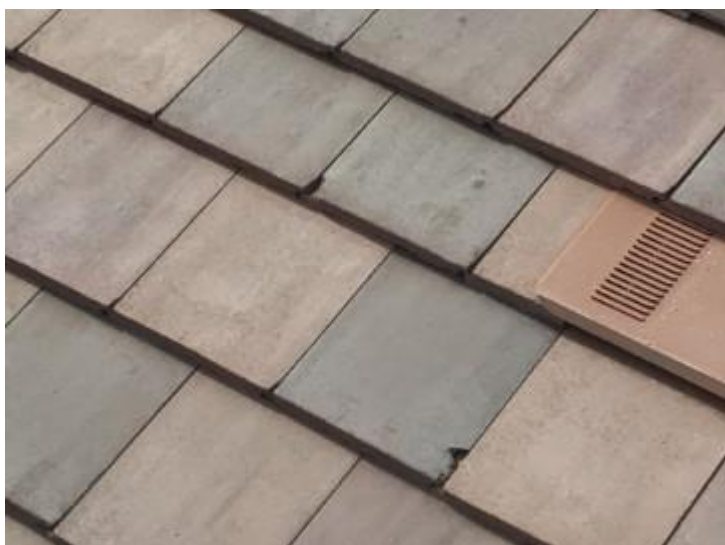
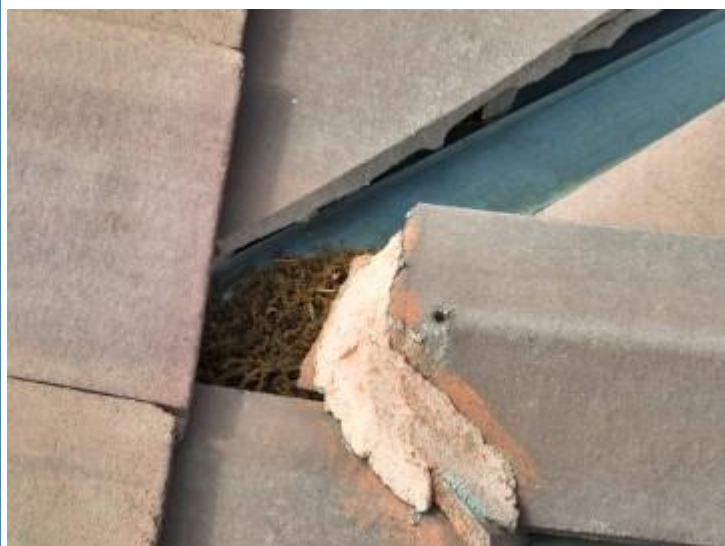
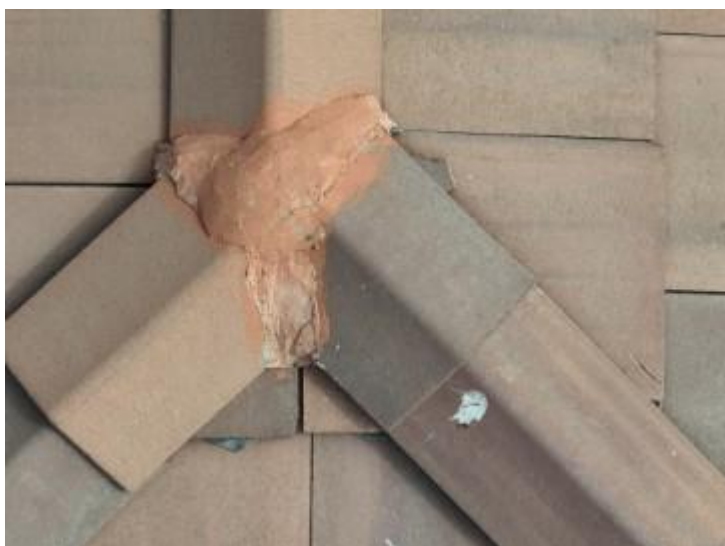
Building 3 -

ITEM	Good	Fair	Poor	N/A	COMMENTS
A - Perimeter details	X				
B - Drainage		X			
C - Penetration flashings		X			
D - Overall Tile condition		X			Some isolated cracked tiles noted. Some isolated chipped tiles noted. Some cracking noted at mortar.
E - Wall/Curb flashings				X	
F - Insulation				X	
G - Other				X

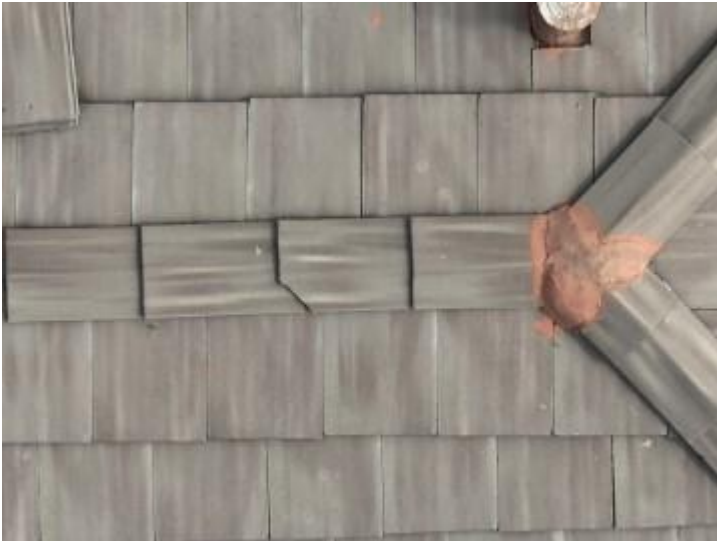
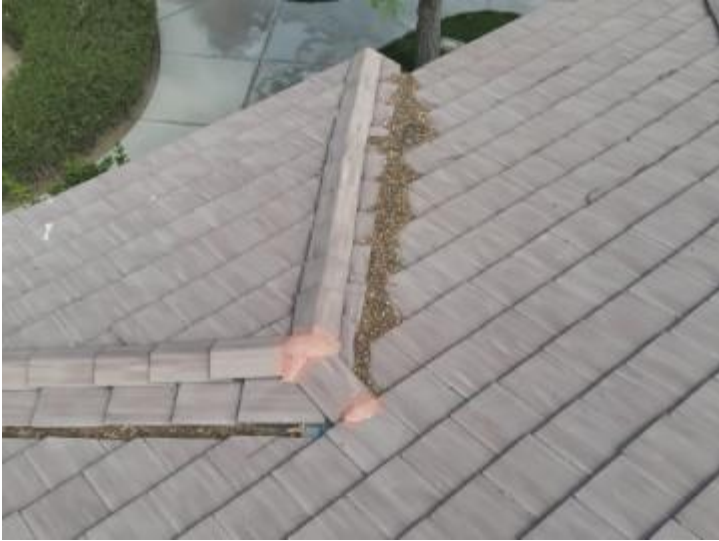
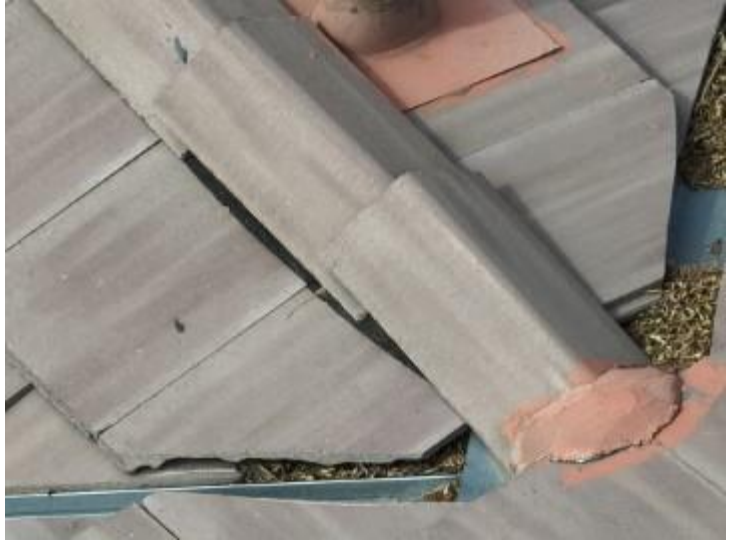
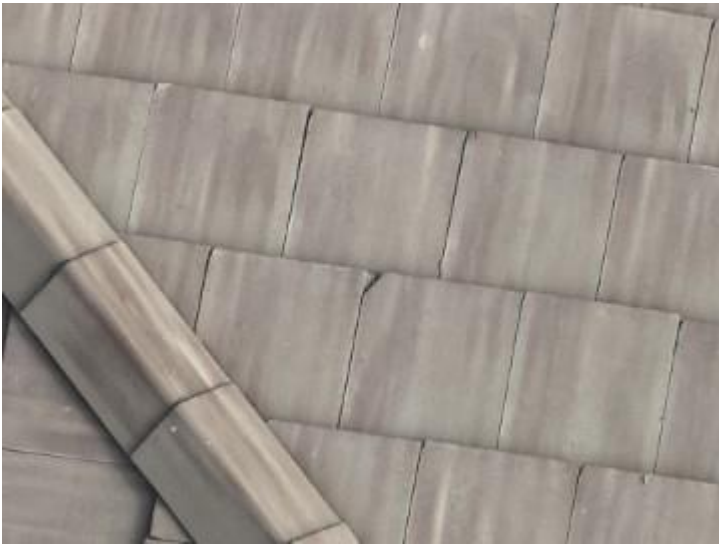
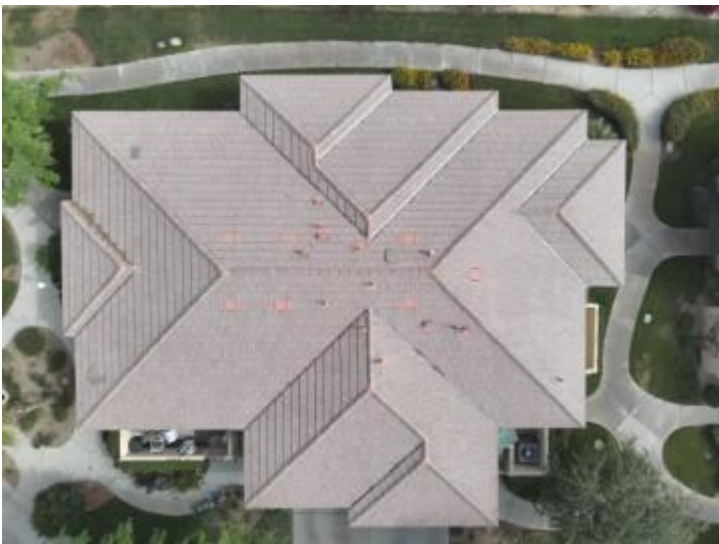
Building 4 -

ITEM	Good	Fair	Poor	N/A	COMMENTS
A - Perimeter details	X				
B - Drainage		X			Some debris noted in the valleys.
C - Penetration flashings		X			
D - Overall Tile condition		X			A broken cap tile noted. Some isolated chipped tiles noted. Some cracking noted at mortar.
E - Wall/Curb flashings				X	
F - Insulation				X	
G - Other				X	Some loose tiles left on the roof, likely from a past repair.

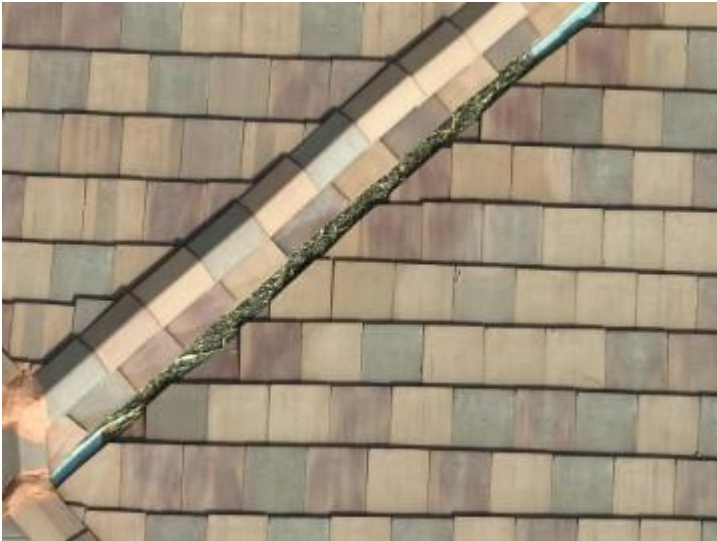
Building 5 -

ITEM	Good	Fair	Poor	N/A	COMMENTS
A - Perimeter details		X			
B - Drainage		X			Some debris noted in the valleys.
C - Penetration flashings		X			
D - Overall Tile condition		X			Some cracking noted at mortar.
E - Wall/Curb flashings				X	
F - Insulation				X	
G - Other				X

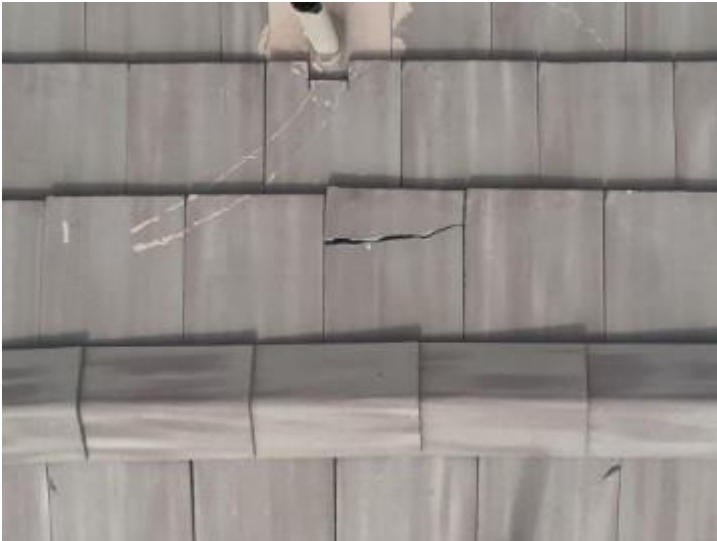
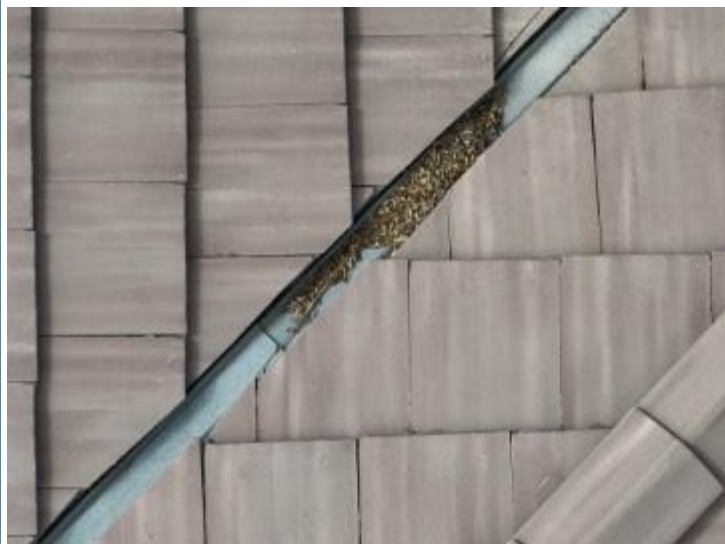
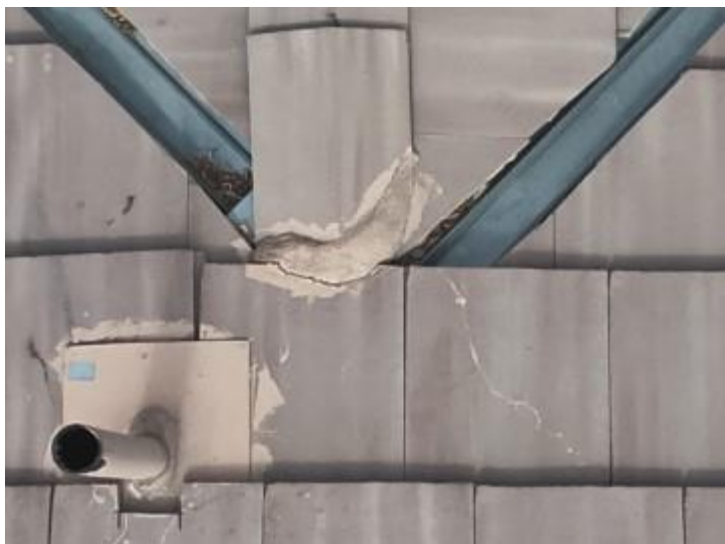
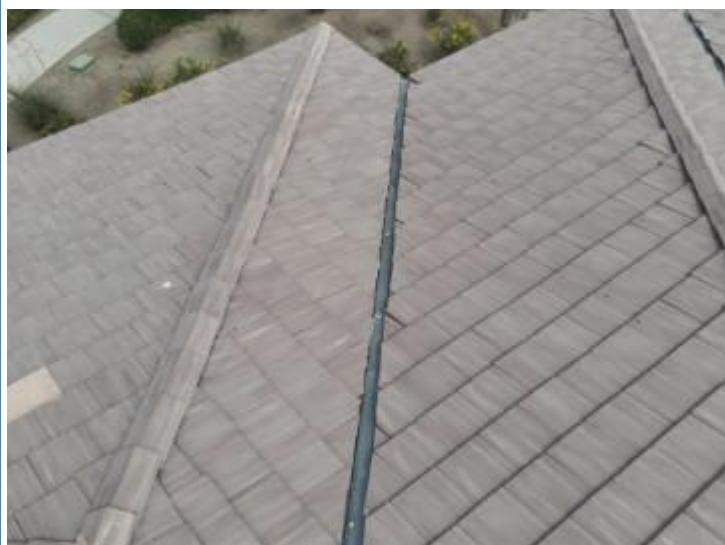
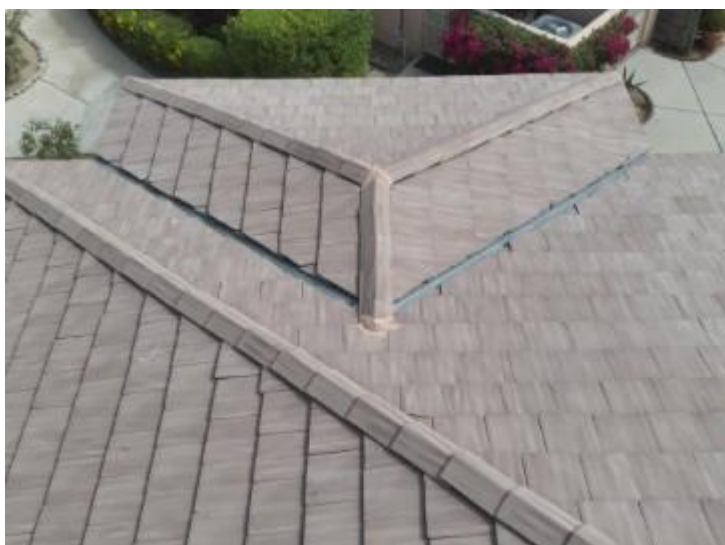
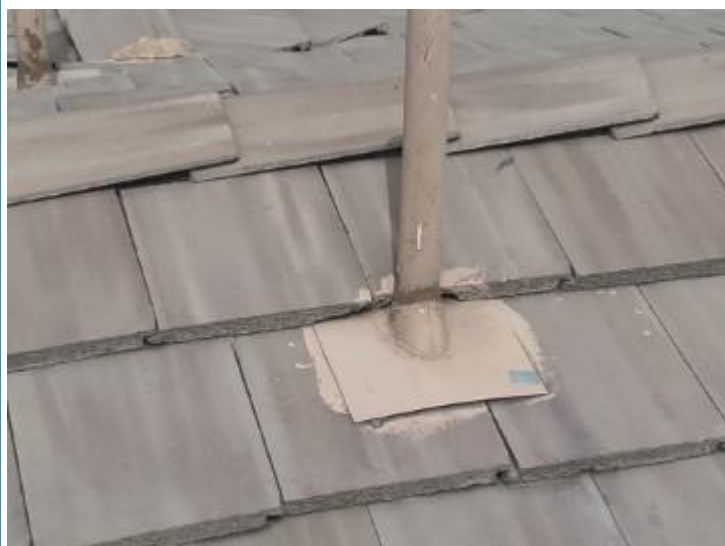
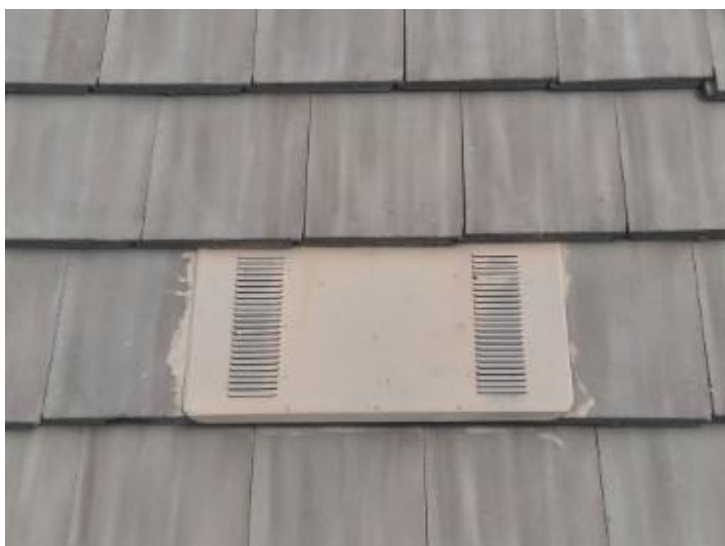
Building 6 -

ITEM	Good	Fair	Poor	N/A	COMMENTS
A - Perimeter details		X			
B - Drainage		X			Some debris noted in the valleys.
C - Penetration flashings		X			
D - Overall Tile condition		X			Some isolated cracked tiles noted. Some cracking noted at mortar. Some isolated slipping tiles noted.
E - Wall/Curb flashings				X	
F - Insulation				X	
G - Other				X

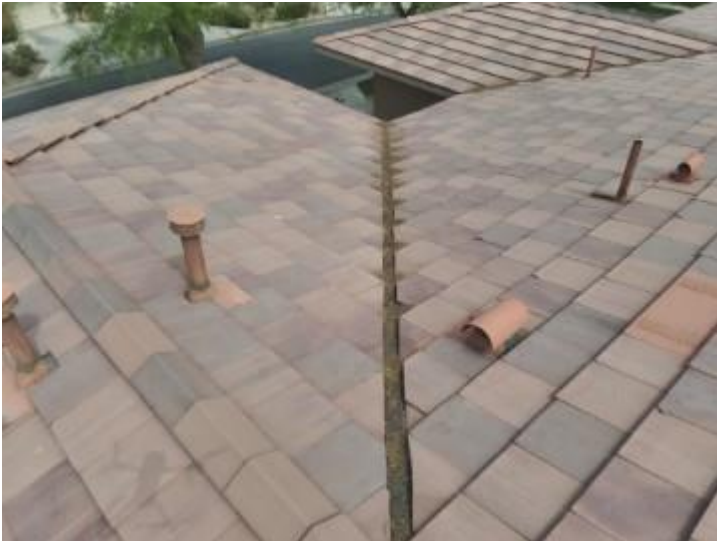
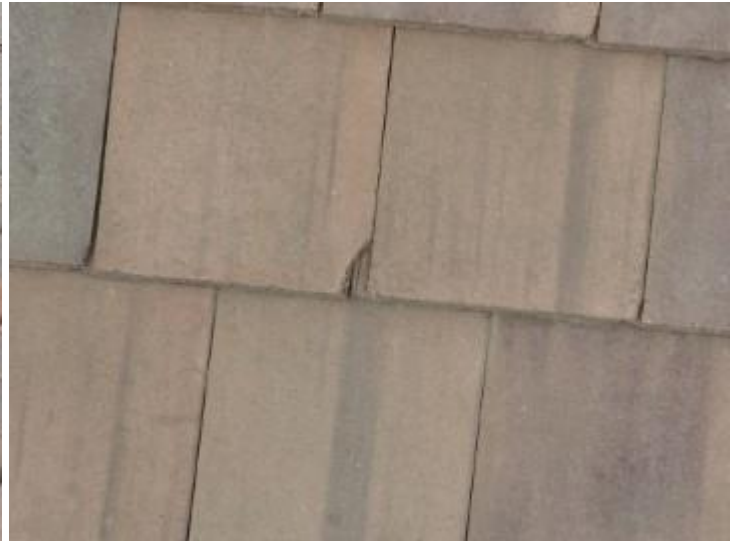
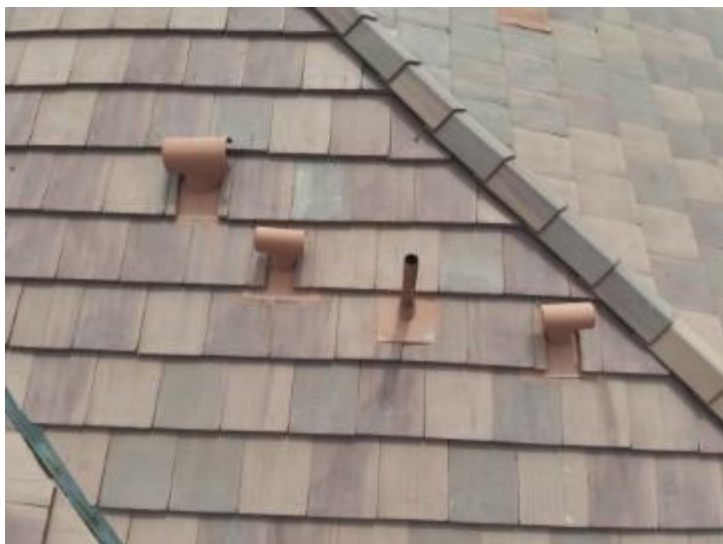
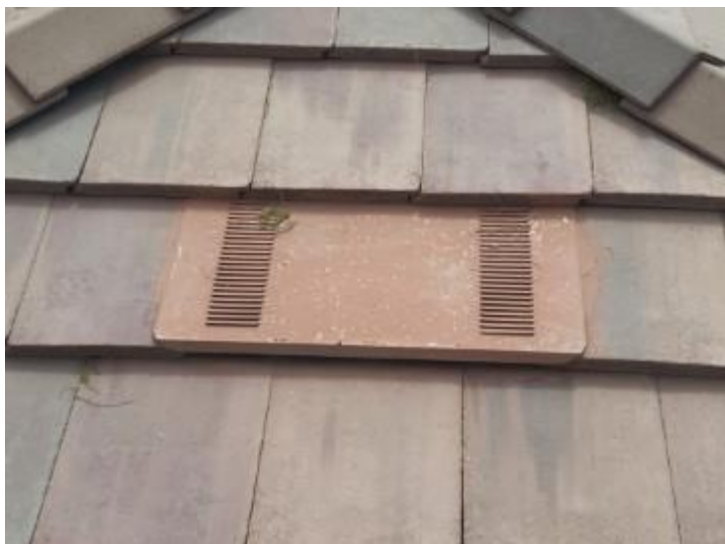
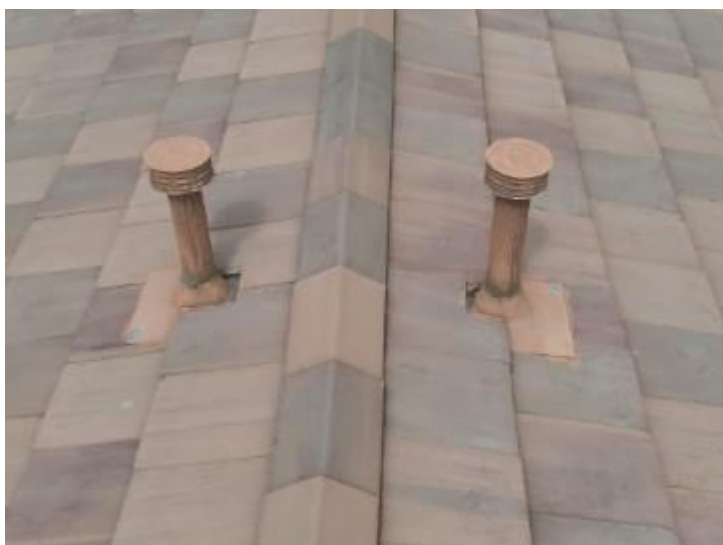
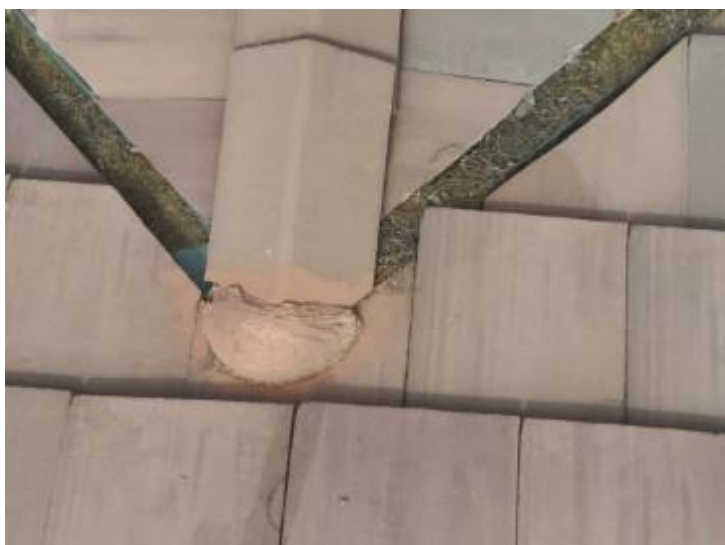
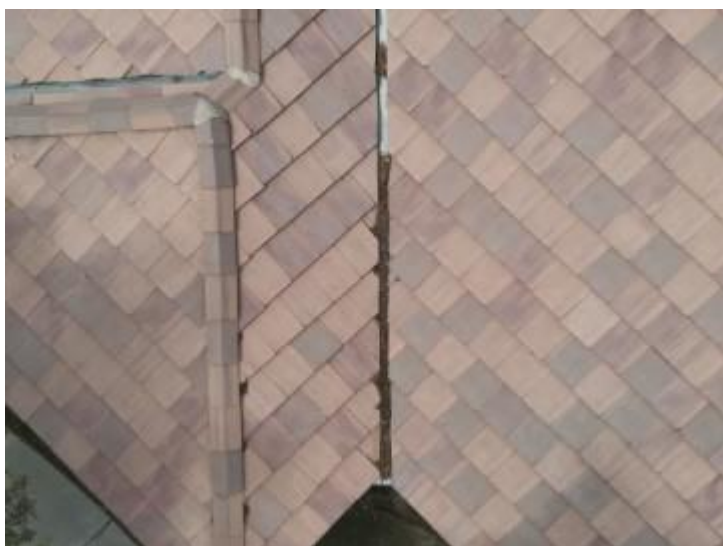
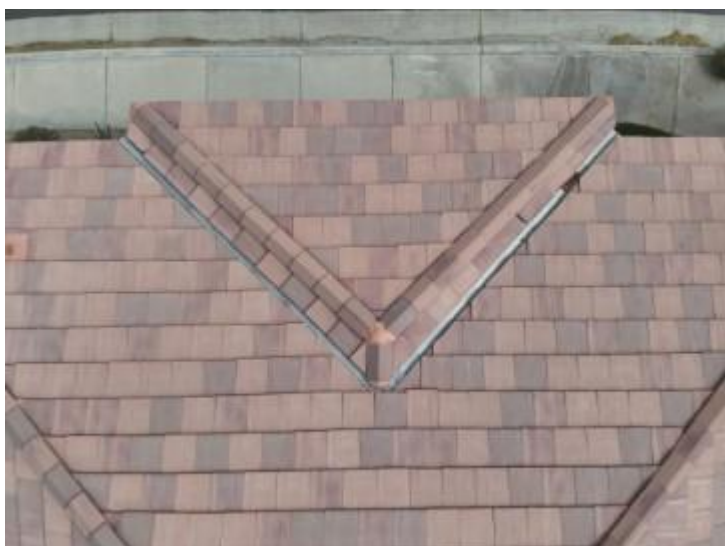
Building 7 -

ITEM	Good	Fair	Poor	N/A	COMMENTS
A - Perimeter details		X			
B - Drainage		X			Some debris noted in the valleys.
C - Penetration flashings		X			
D - Overall Tile condition		X			Some isolated chipped tiles noted.
E - Wall/Curb flashings				X	
F - Insulation				X	
G - Other				X

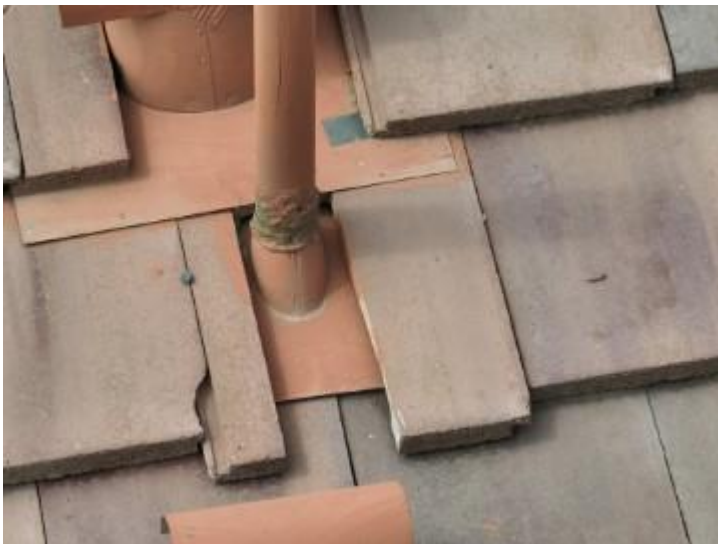
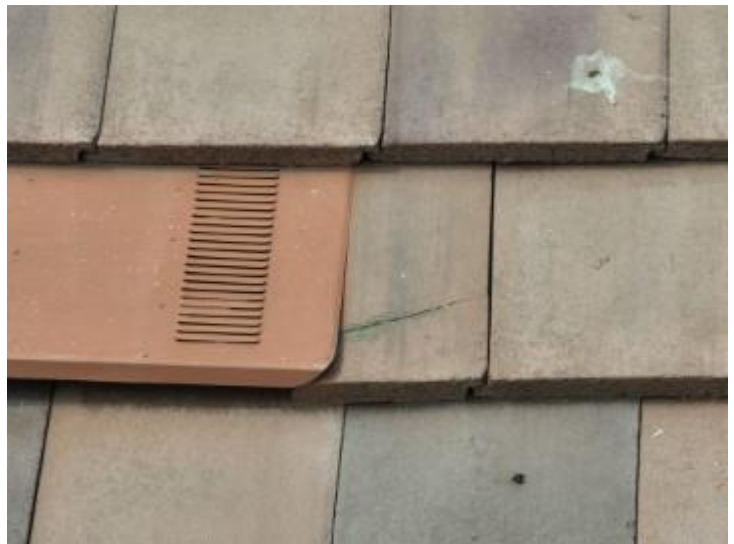
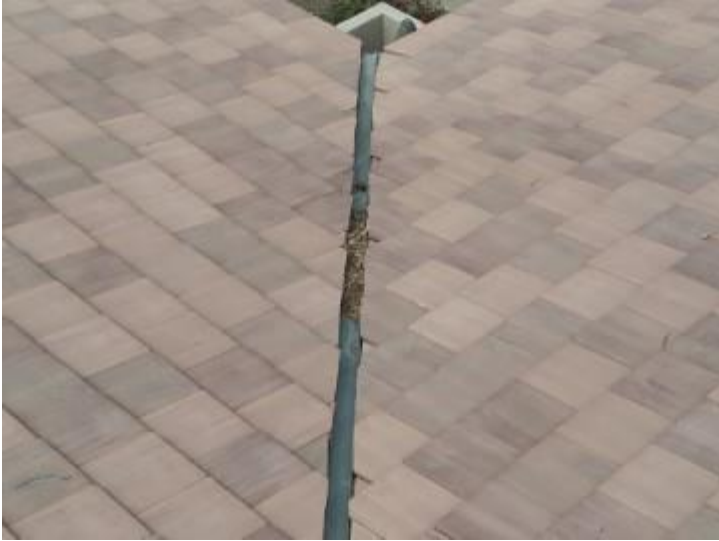
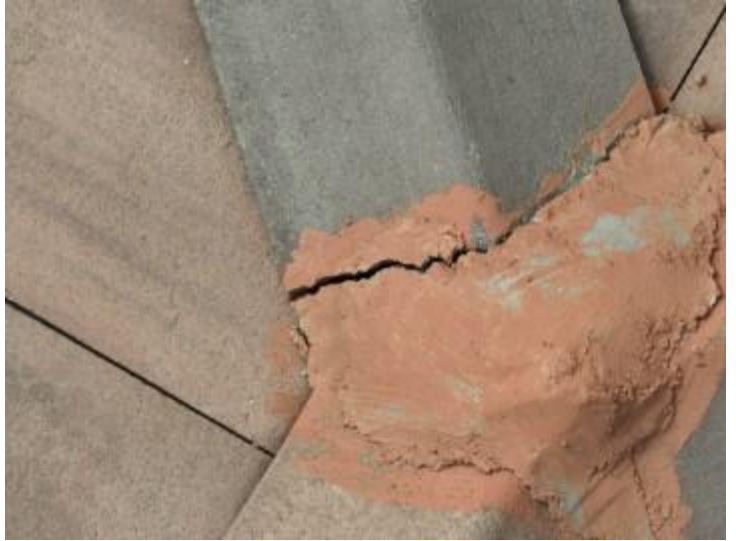
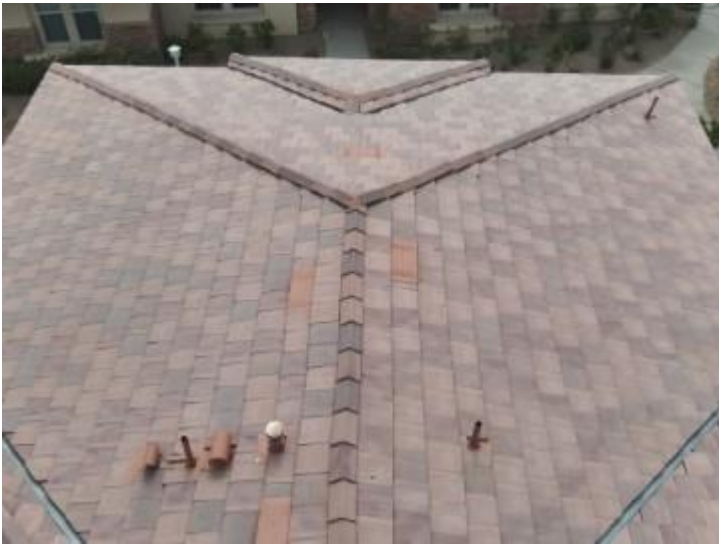
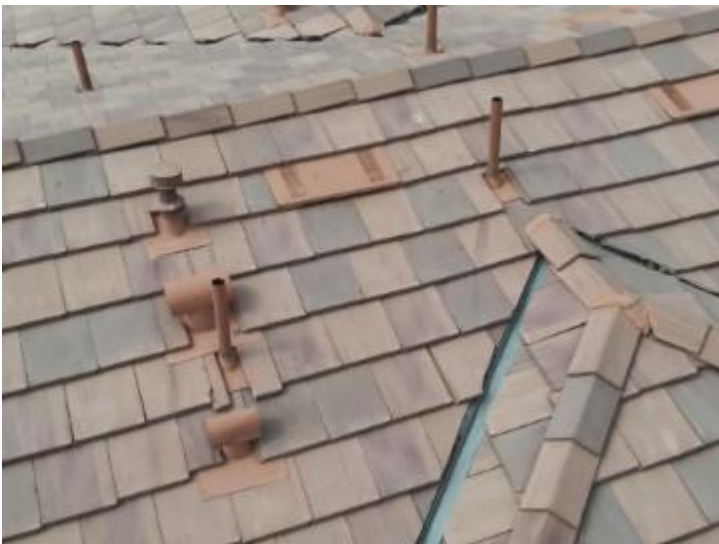
Building 8 -

ITEM	Good	Fair	Poor	N/A	COMMENTS
A - Perimeter details		X			
B - Drainage		X			Some debris noted in the valleys.
C - Penetration flashings		X			
D - Overall Tile condition		X			Some isolated cracked tiles noted. Some isolated chipped tiles noted. Some cracking noted at mortar.
E - Wall/Curb flashings				X	
F - Insulation				X	
G - Other				X
