June 13th, 2024

Re: Roof Consulting
Mountain View Villas
78000 Betty Barker Way
Indian Wells, CA 92210

Alliance Consulting & Testing Inc. has completed our initial roof surveys and we have the following report of our findings and opinions regarding the roofing systems on this property. We understand the purpose of the surveys was to determine the overall condition of the roofing systems including past repairs, what repairs still need to be made, the remaining service life of the systems and/or does the roofing systems need to be replaced.

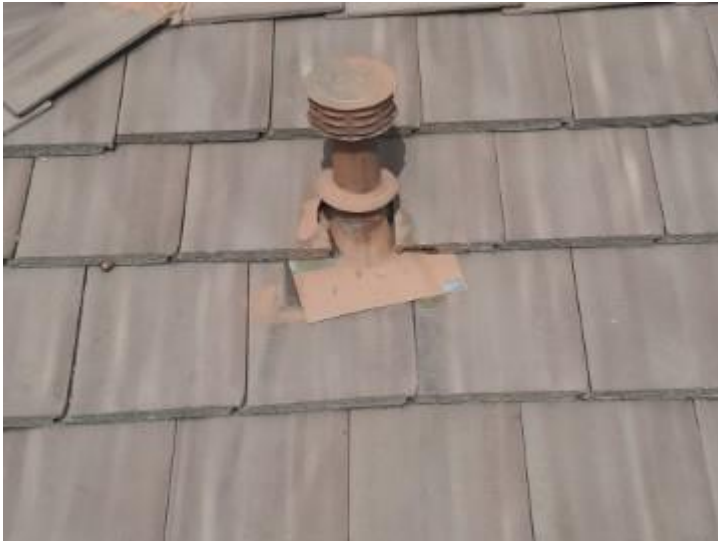
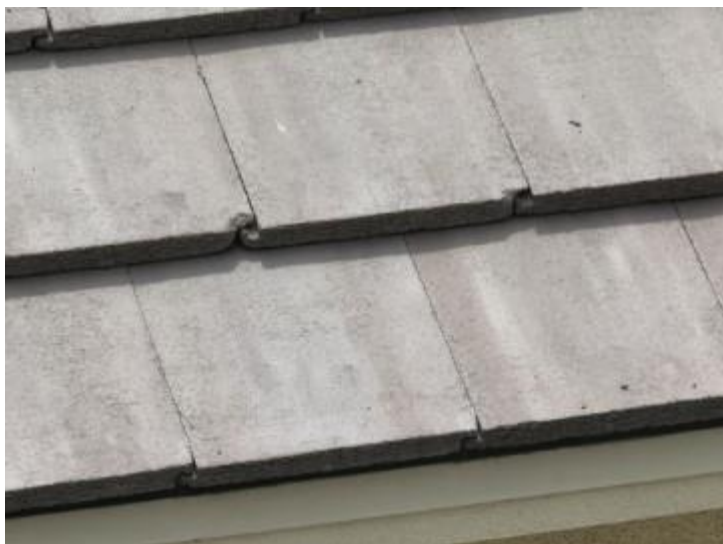
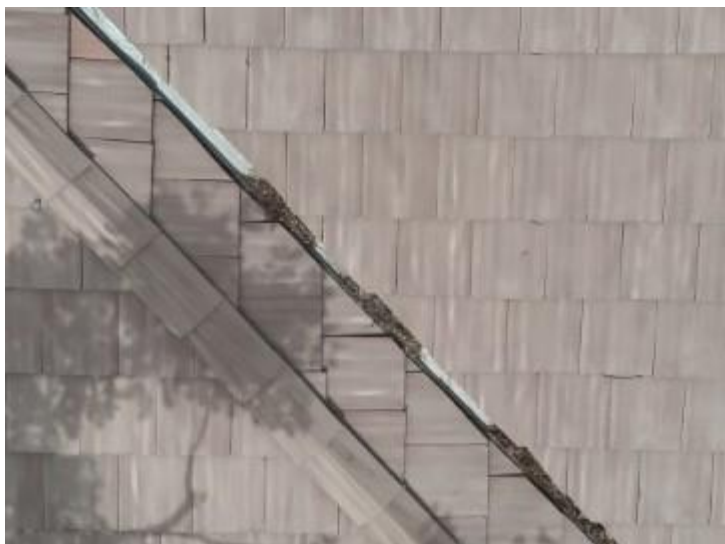
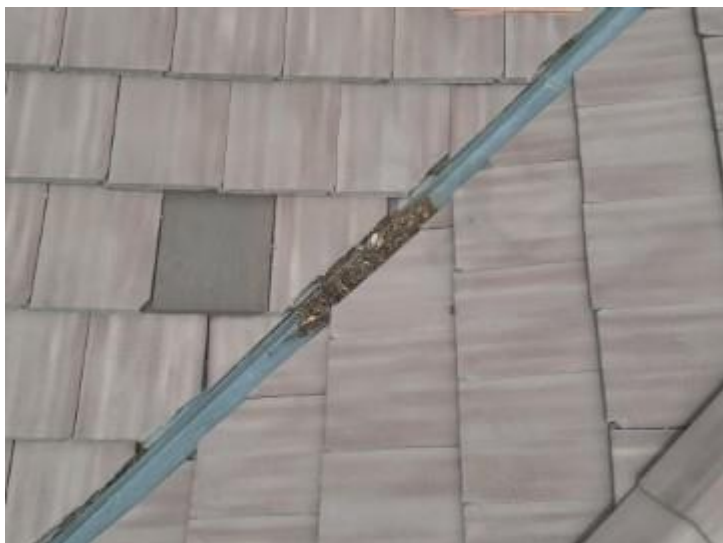
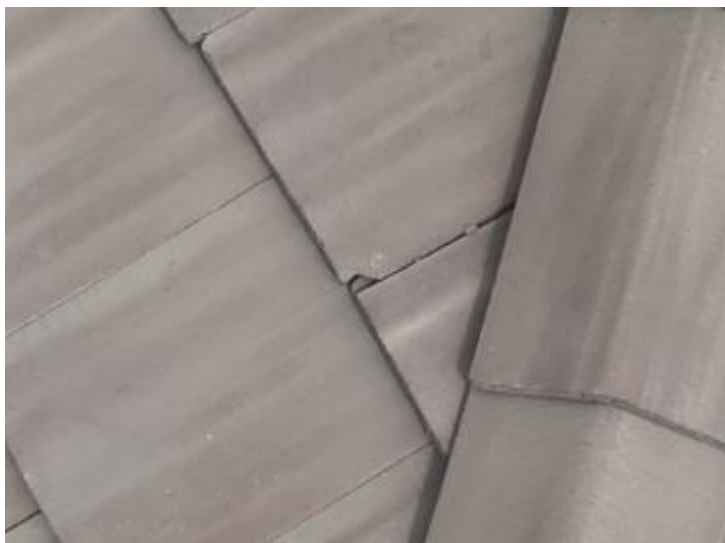
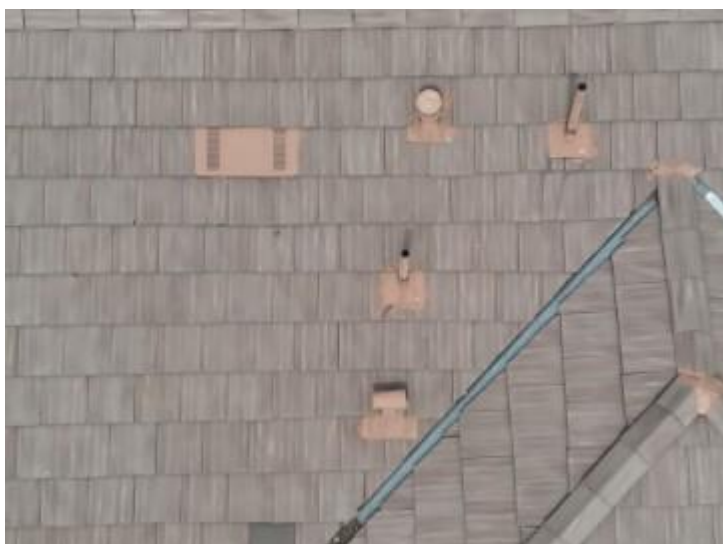
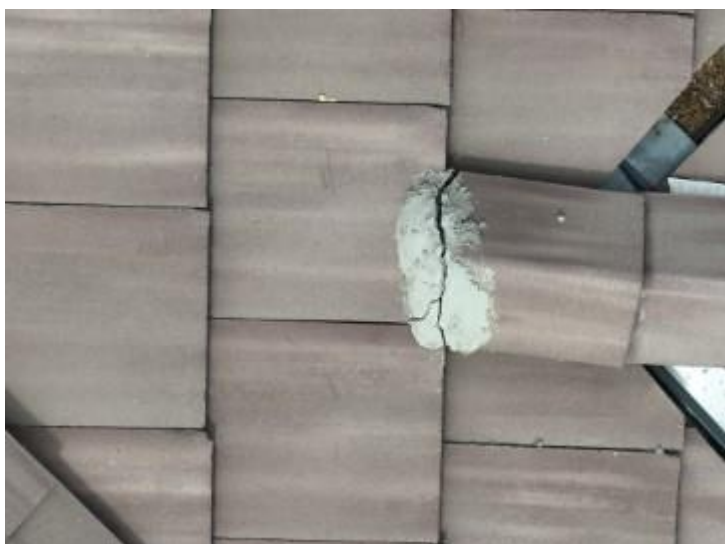
Building 9 -

ITEM	Good	Fair	Poor	N/A	COMMENTS
A - Perimeter details		X			
B - Drainage		X			Some debris noted in the valleys.
C - Penetration flashings		X			A loose pipe flashing noted.
D - Overall Tile condition		X			Some isolated cracked tiles noted. Some isolated chipped tiles noted. Some cracking noted at mortar.
E - Wall/Curb flashings				X	
F - Insulation				X	
G - Other				X	Areas of past repairs noted including replacement of tiles and sealing of a crack.

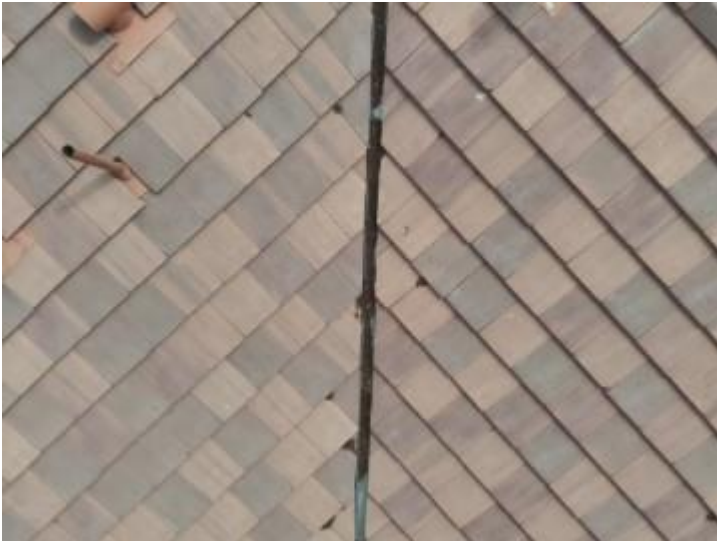
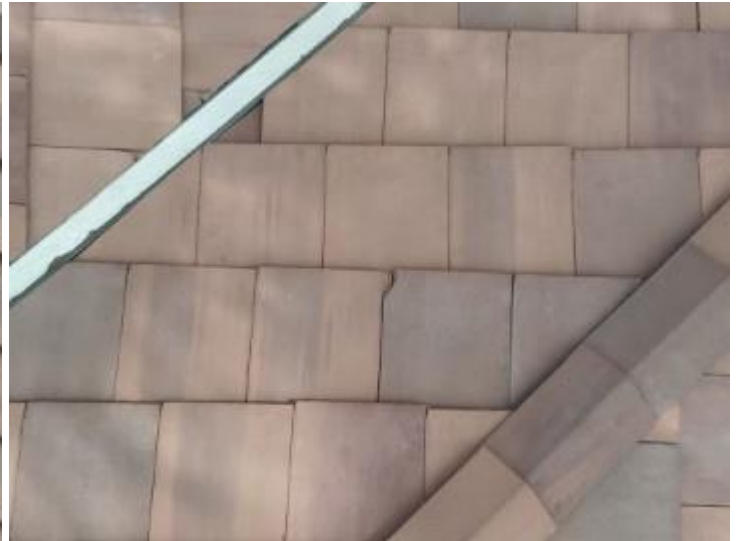
Building 10 -

ITEM	Good	Fair	Poor	N/A	COMMENTS
A - Perimeter details		X			
B - Drainage		X			Some debris noted in the valleys.
C - Penetration flashings		X			
D - Overall Tile condition		X			Some isolated chipped tiles noted.
E - Wall/Curb flashings				X	
F - Insulation				X	
G - Other				X

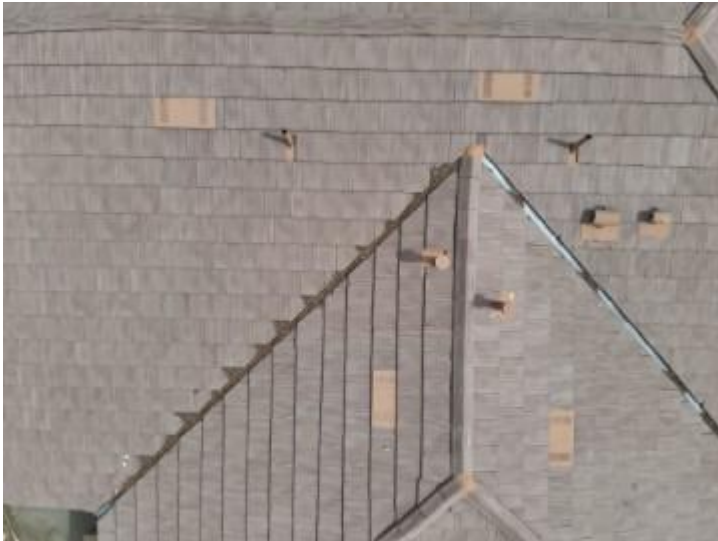
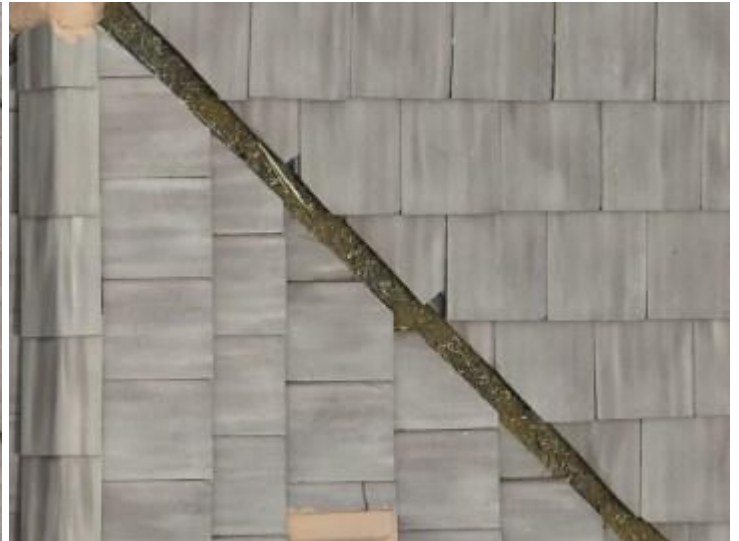
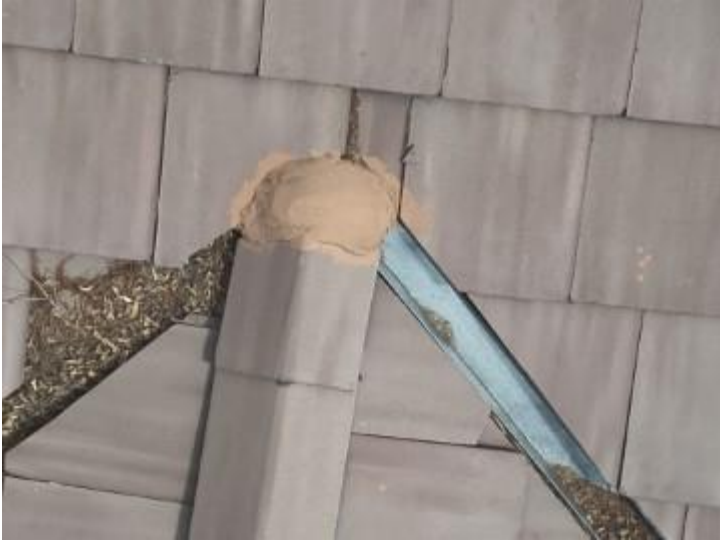
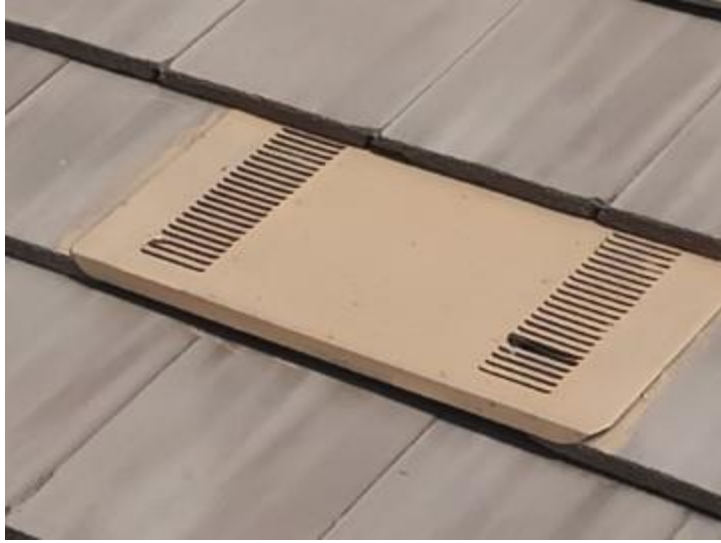
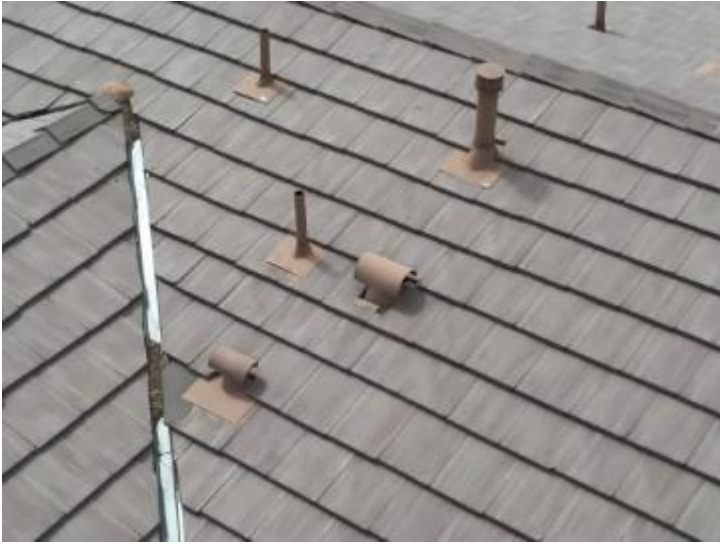
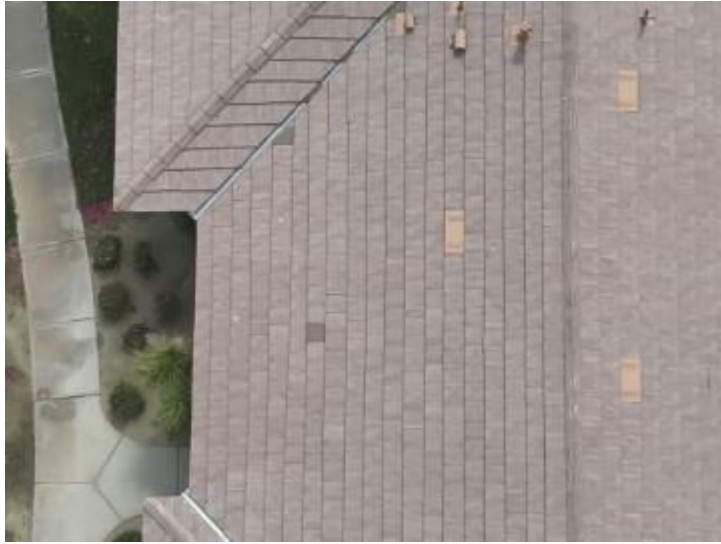
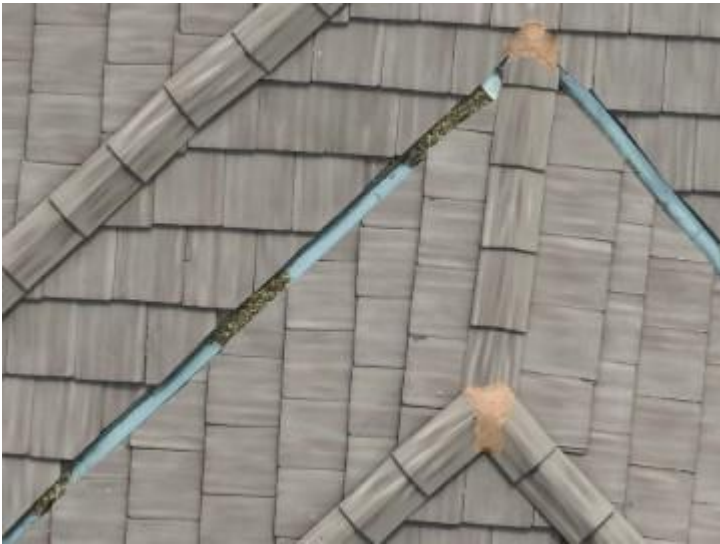
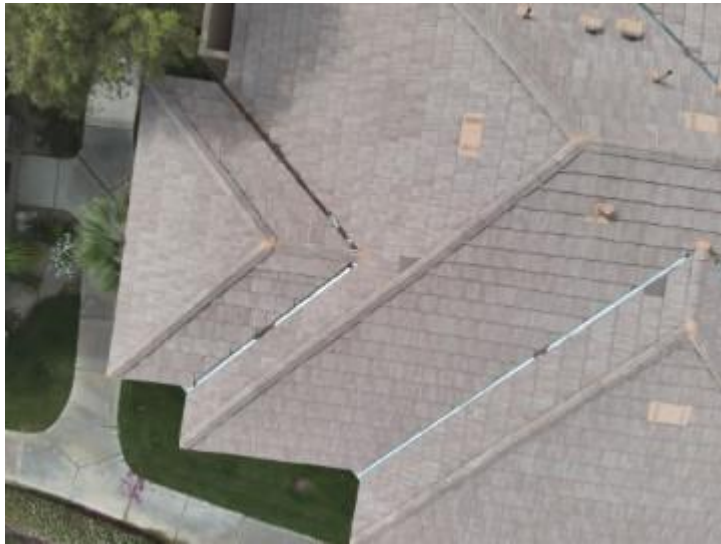
Building 11 -

ITEM	Good	Fair	Poor	N/A	COMMENTS
A - Perimeter details		X			
B - Drainage		X			Some debris noted in the valleys.
C - Penetration flashings		X			
D - Overall Tile condition		X			Some isolated chipped tiles noted.
E - Wall/Curb flashings				X	
F - Insulation				X	
G - Other				X

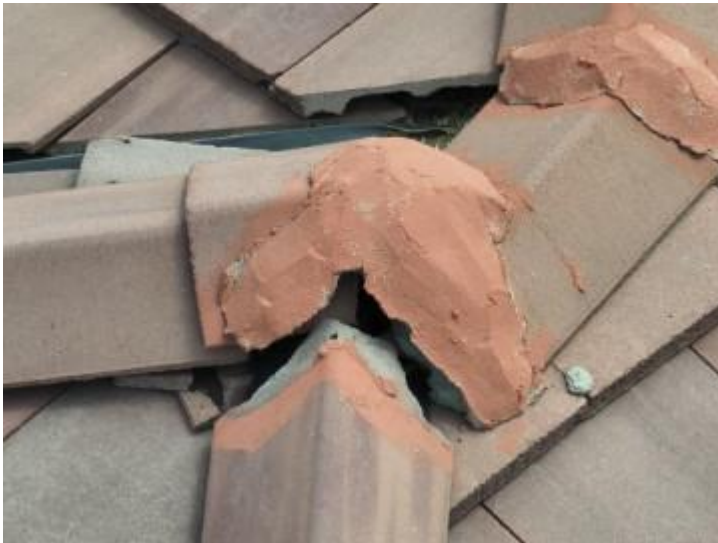
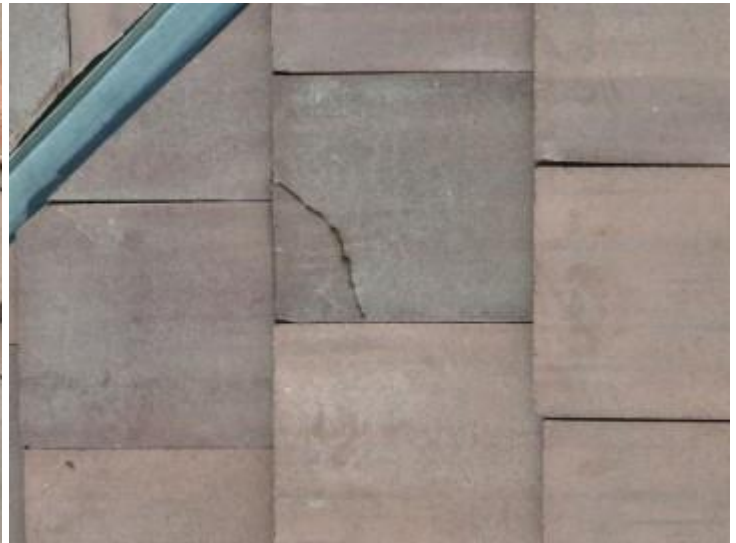
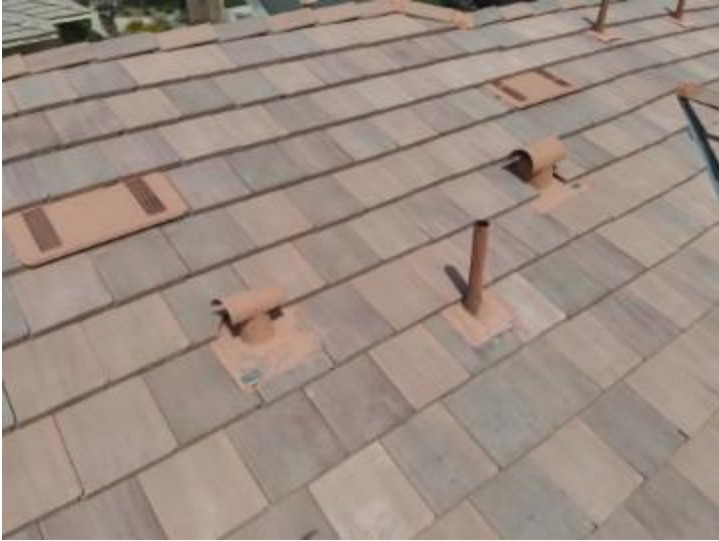
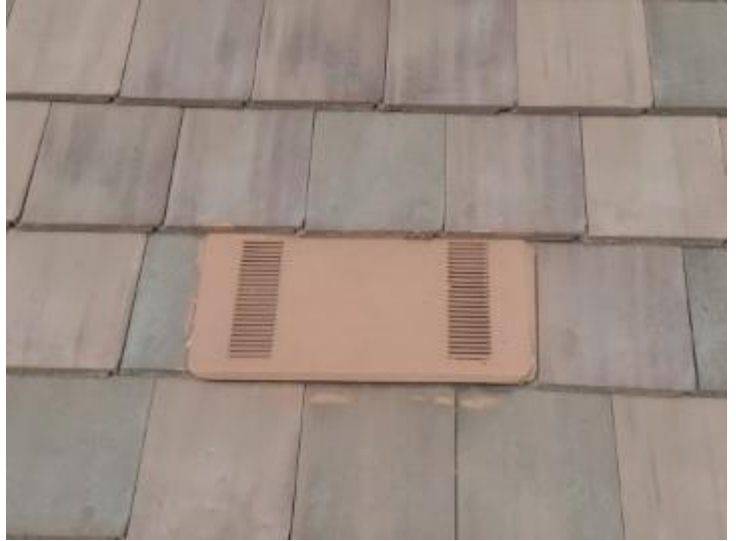
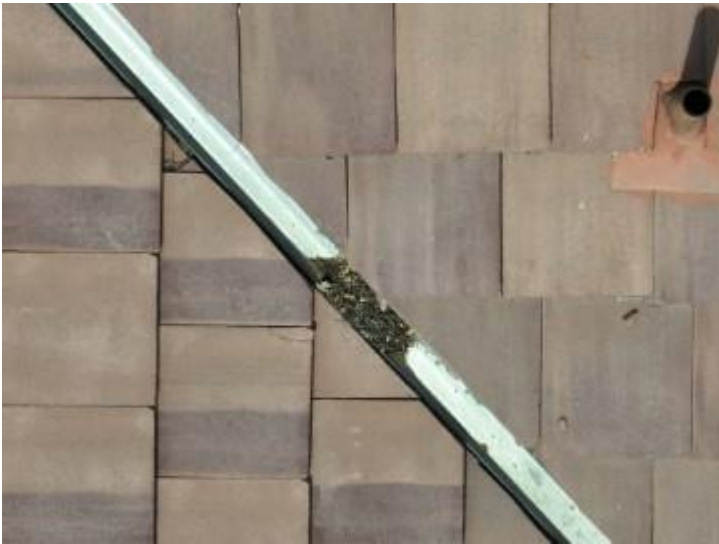
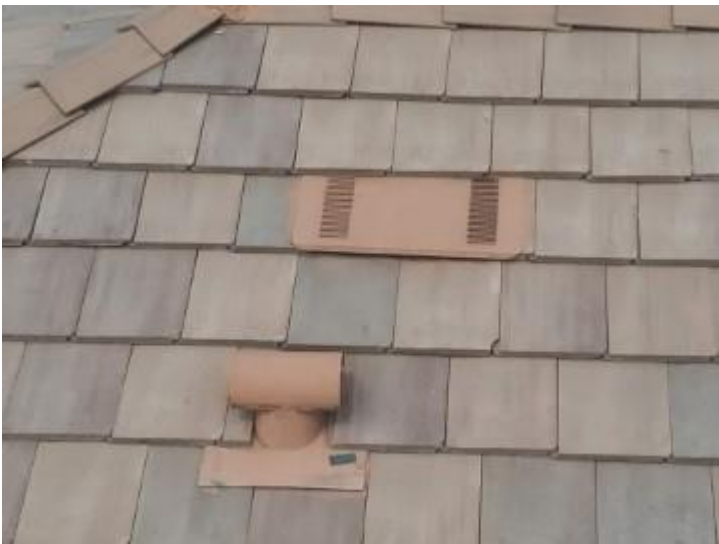
Building 12 -

ITEM	Good	Fair	Poor	N/A	COMMENTS
A - Perimeter details		X			
B - Drainage		X			Some debris noted in the valleys.
C - Penetration flashings		X			
D - Overall Tile condition		X			Some isolated cracked tiles noted. Some isolated chipped tiled noted. Some cracking noted at mortar. Some dislodged tiles noted.
E - Wall/Curb flashings				X	
F - Insulation				X	
G - Other				X	Damaged and dislodged tiles may be allowing pests into the building/attic.

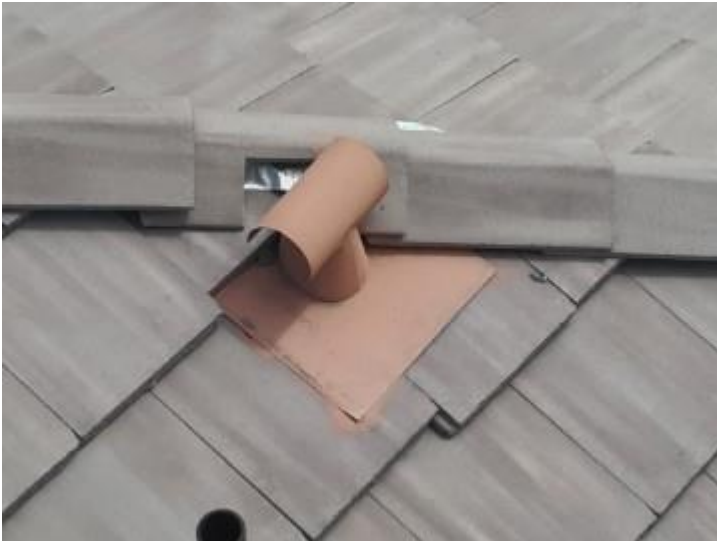
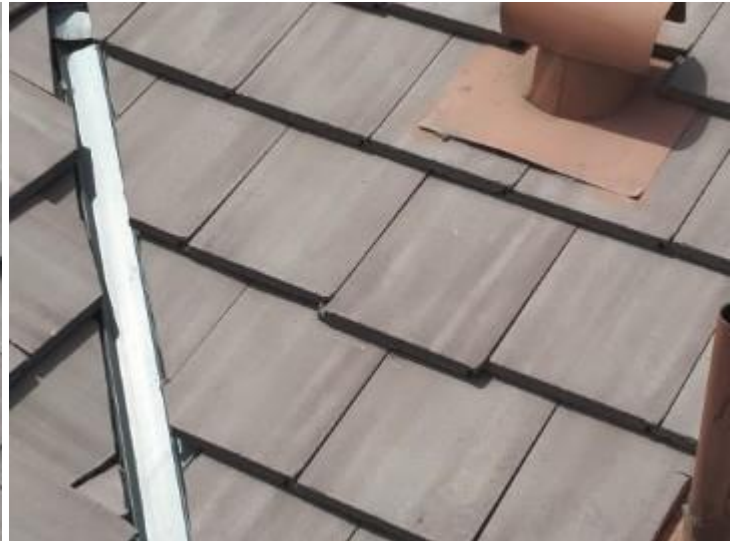
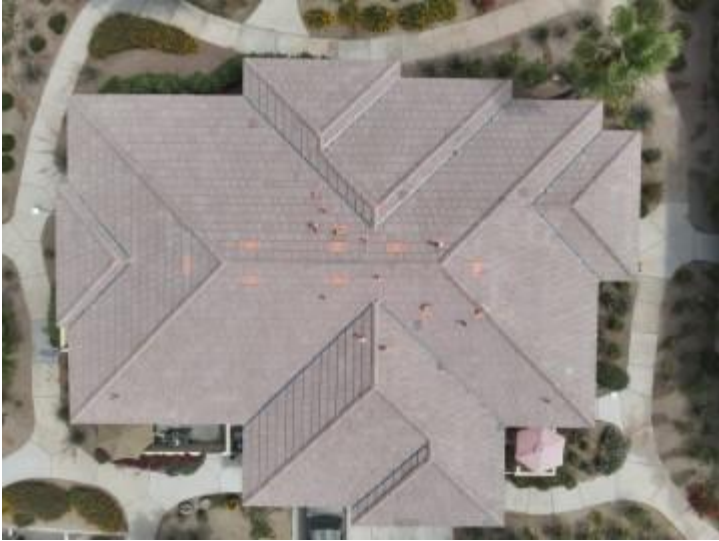
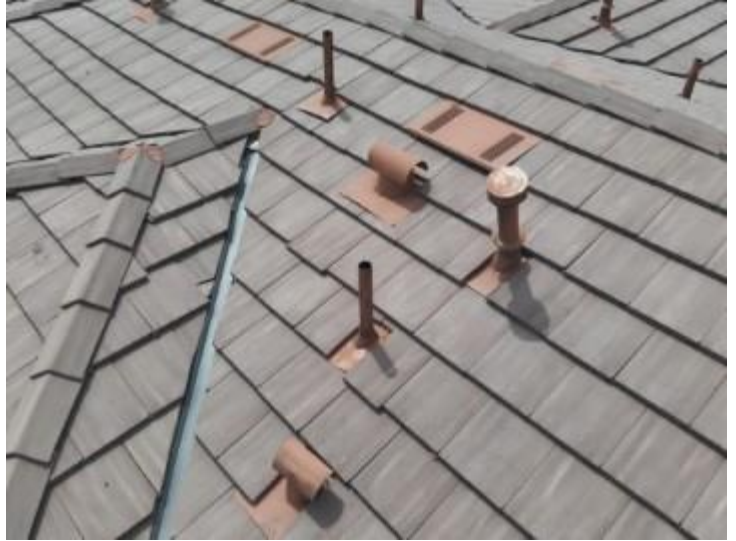
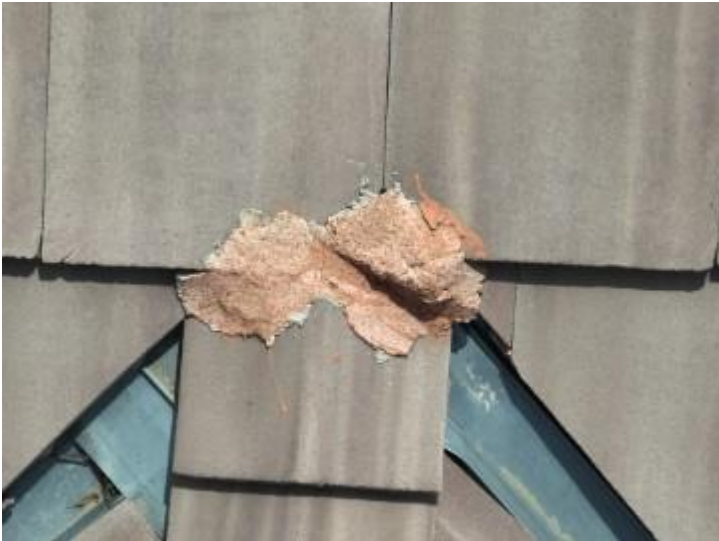
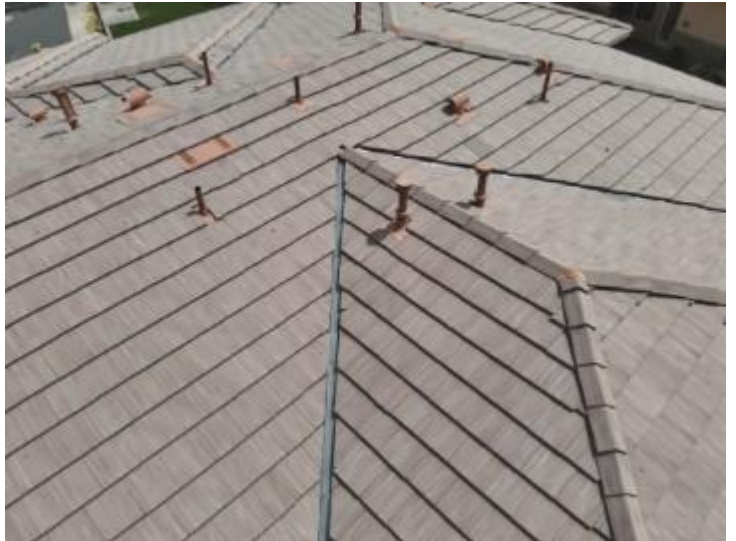
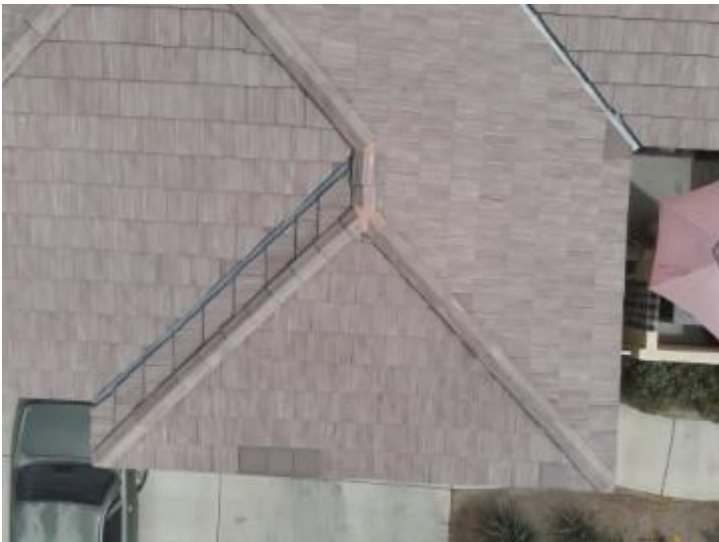
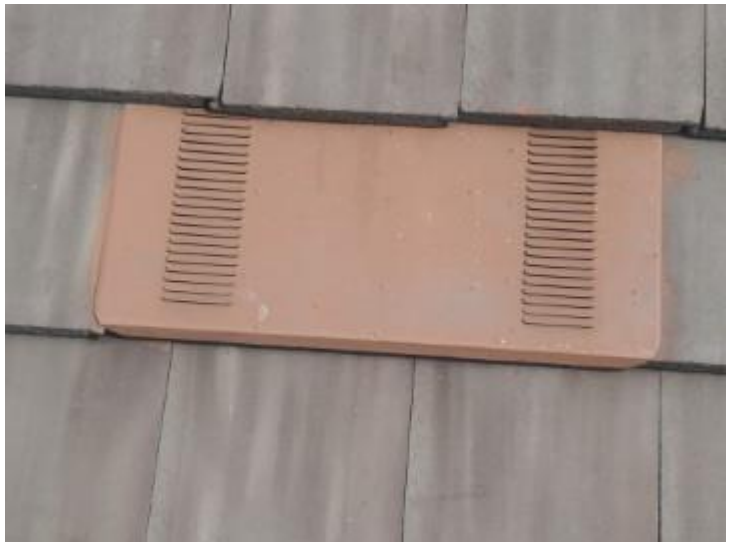
Building 13 -

ITEM	Good	Fair	Poor	N/A	COMMENTS
A - Perimeter details		X			
B - Drainage		X			
C - Penetration flashings		X			
D - Overall Tile condition		X			Some isolated tile slippage noted. A tile notched for a penetration may be exposing flashing underneath.
E - Wall/Curb flashings				X	
F - Insulation				X	
G - Other				X

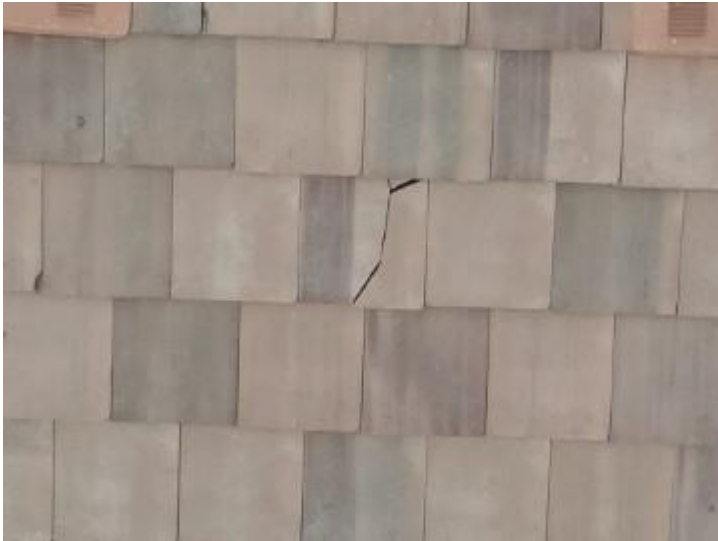
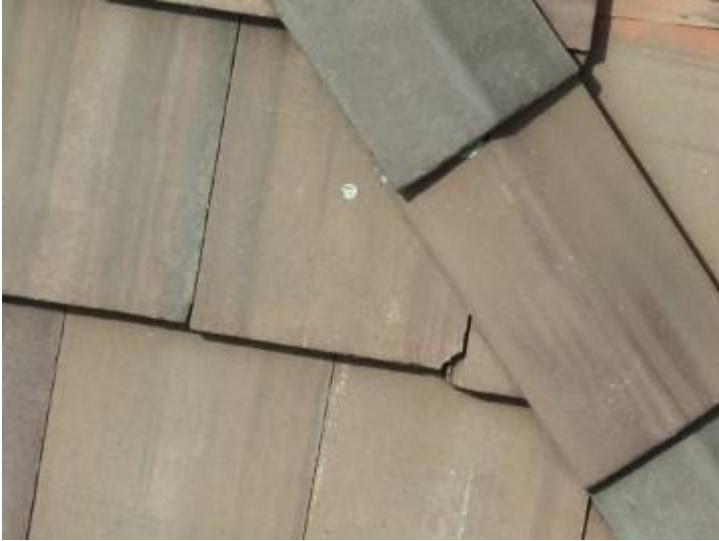
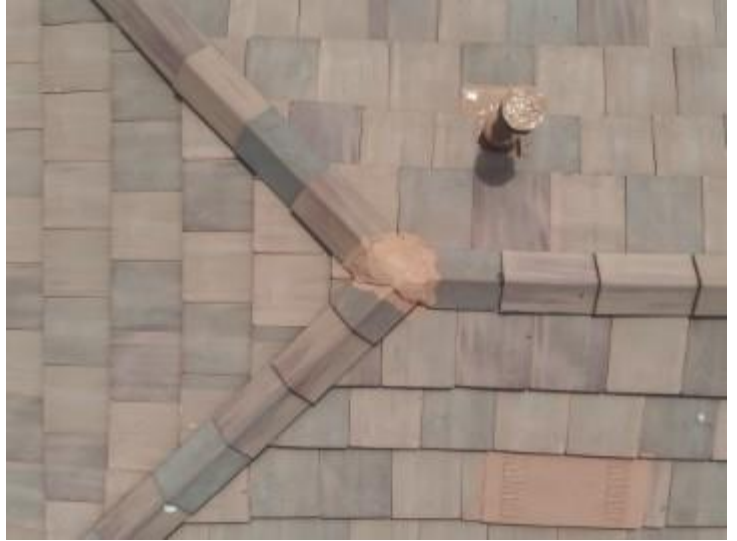
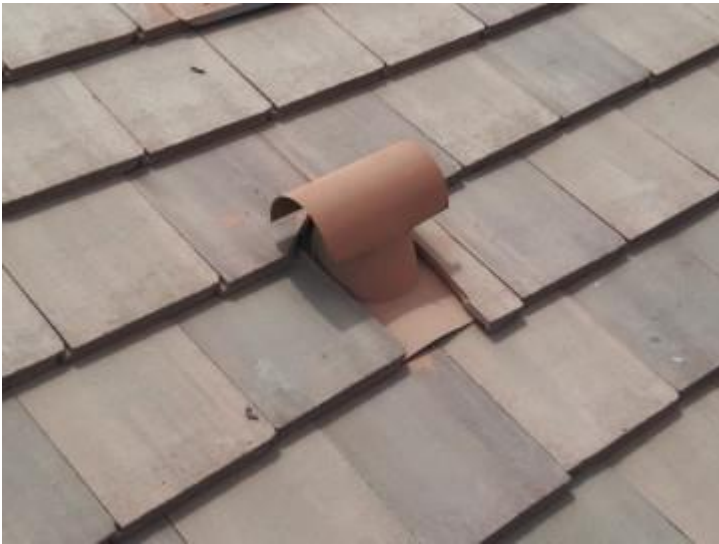
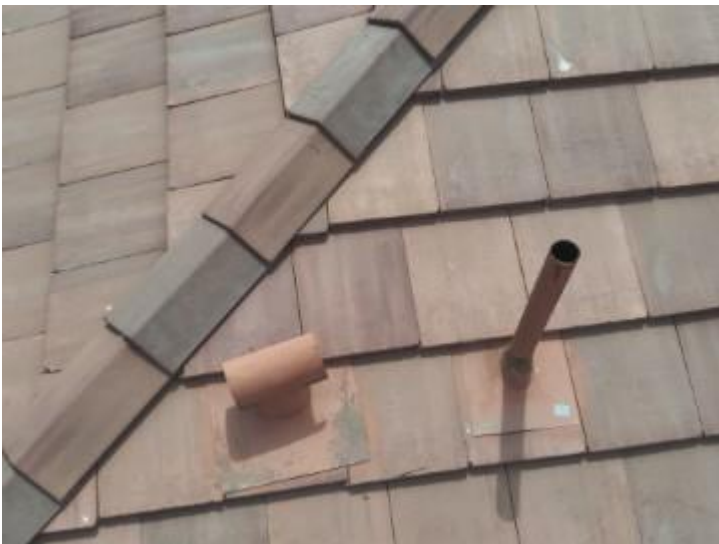
Building 14 -

ITEM	Good	Fair	Poor	N/A	COMMENTS
A - Perimeter details		X			
B - Drainage		X			
C - Penetration flashings		X			
D - Overall Tile condition		X			Some isolated cracked tiles noted. Some isolated chipped tiles noted. Some cracking noted at mortar.
E - Wall/Curb flashings				X	
F - Insulation				X	
G - Other				X

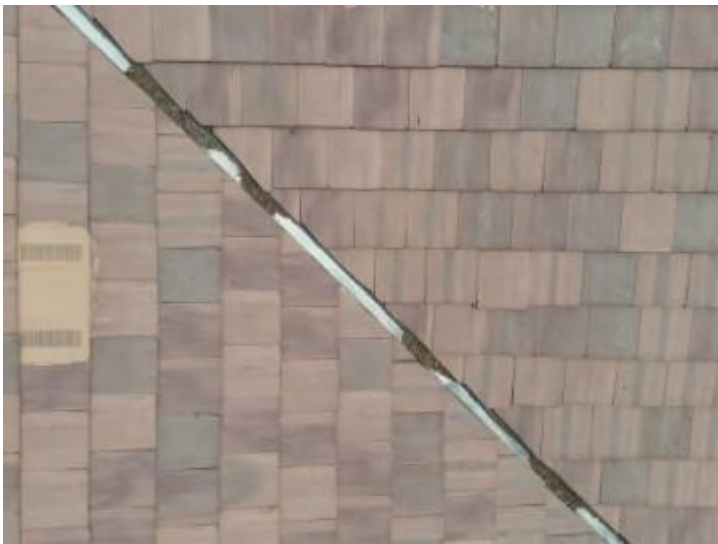
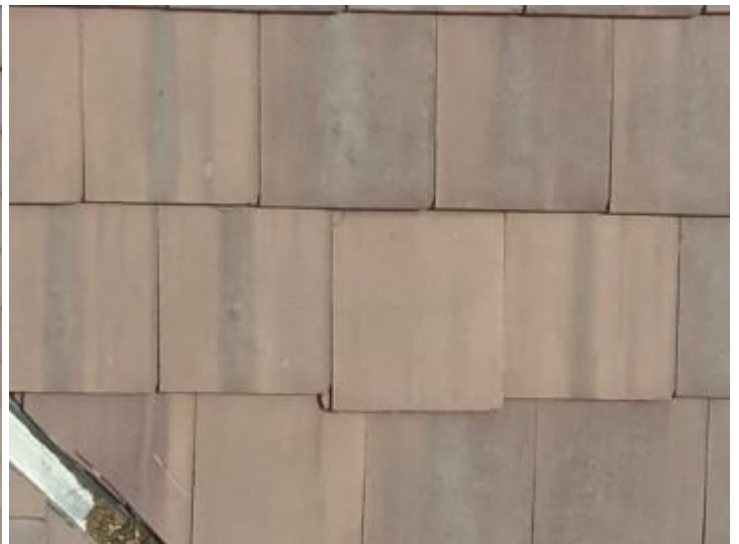
Building 15 -

ITEM	Good	Fair	Poor	N/A	COMMENTS
A - Perimeter details		X			
B - Drainage		X			Some debris noted in the valleys.
C - Penetration flashings		X			
D - Overall Tile condition		X			Some isolated chipped tiles noted. Some cracking noted at mortar. Some isolated slipping tiles noted.
E - Wall/Curb flashings				X	
F - Insulation				X	
G - Other				X

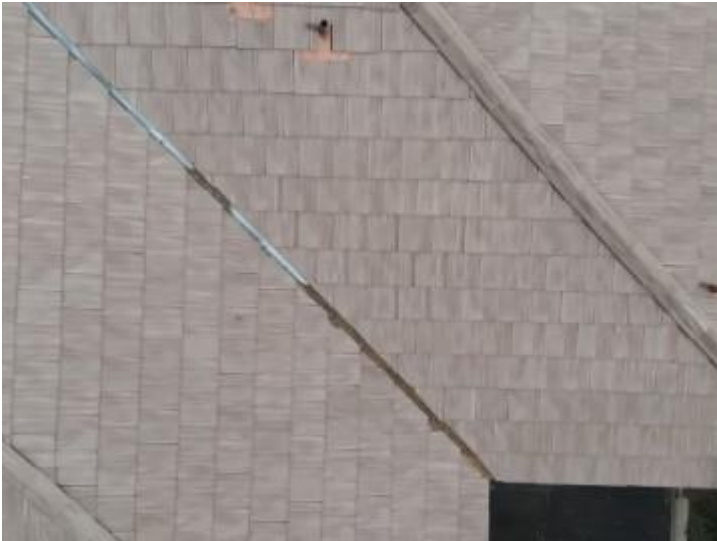
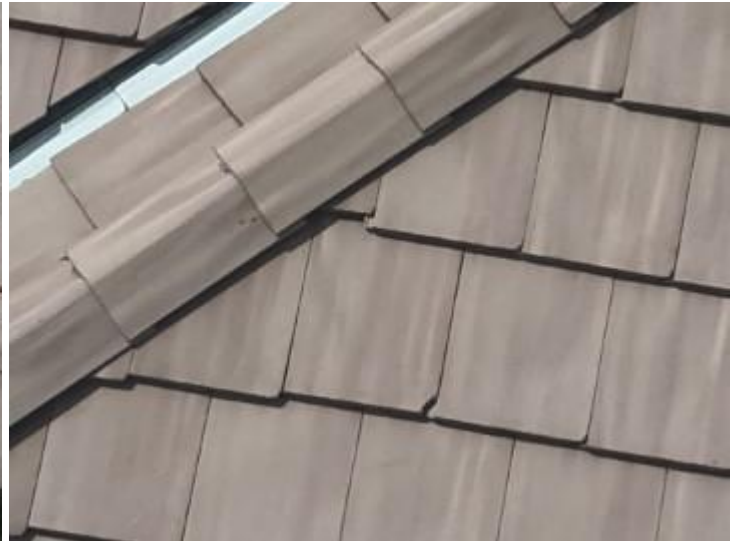
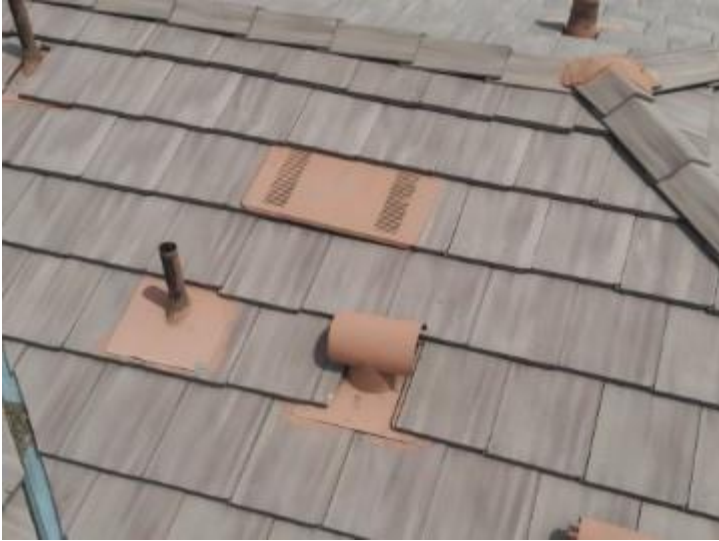
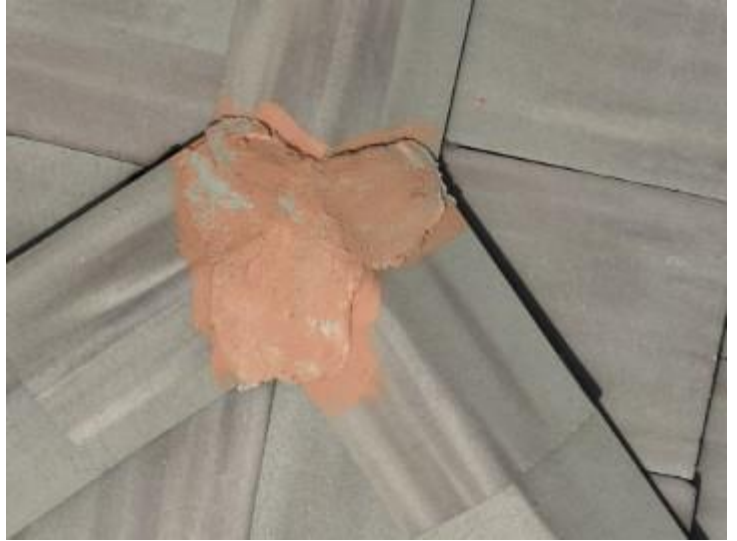
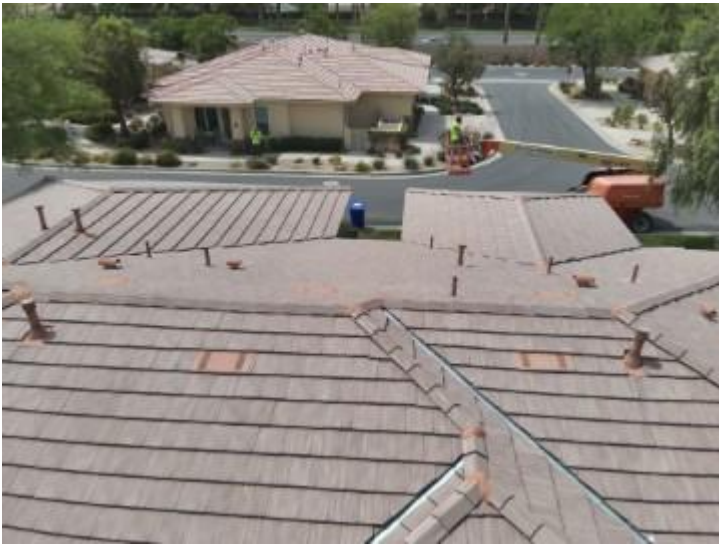
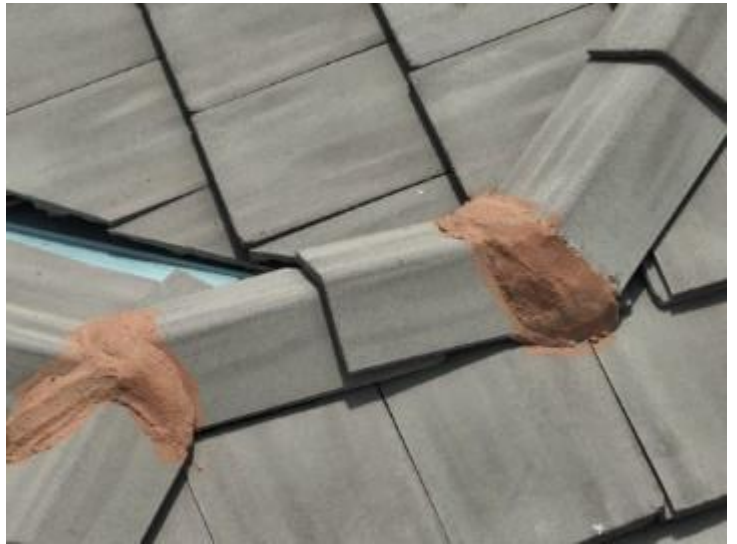
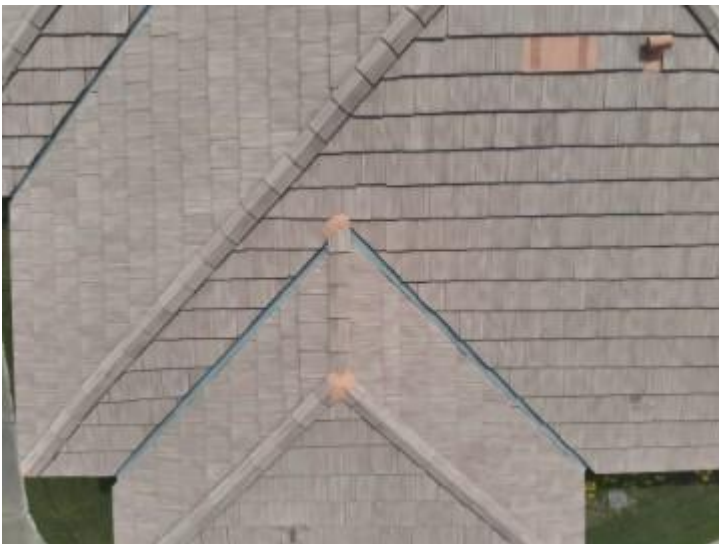
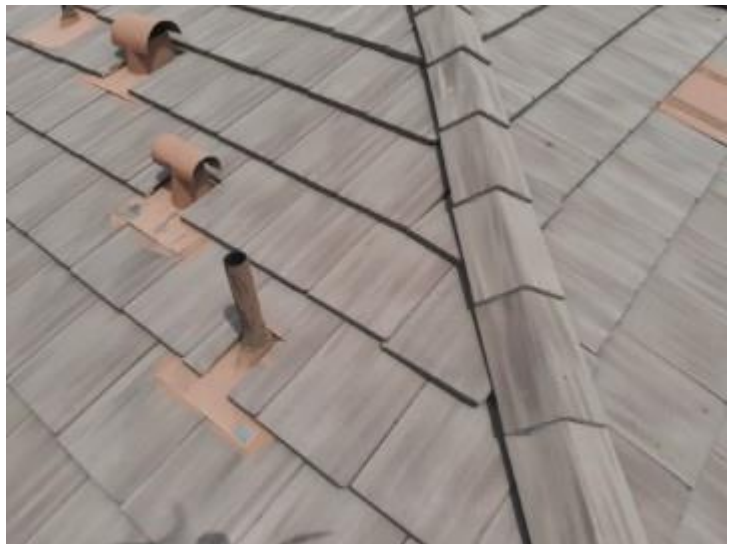
Building 16 –

ITEM	Good	Fair	Poor	N/A	COMMENTS
A - Perimeter details		X			
B - Drainage		X			Some debris noted in the valleys.
C - Penetration flashings		X			
D - Overall Tile condition		X			Some isolated chipped tiles noted.
E - Wall/Curb flashings				X	
F - Insulation				X	
G – Other				X

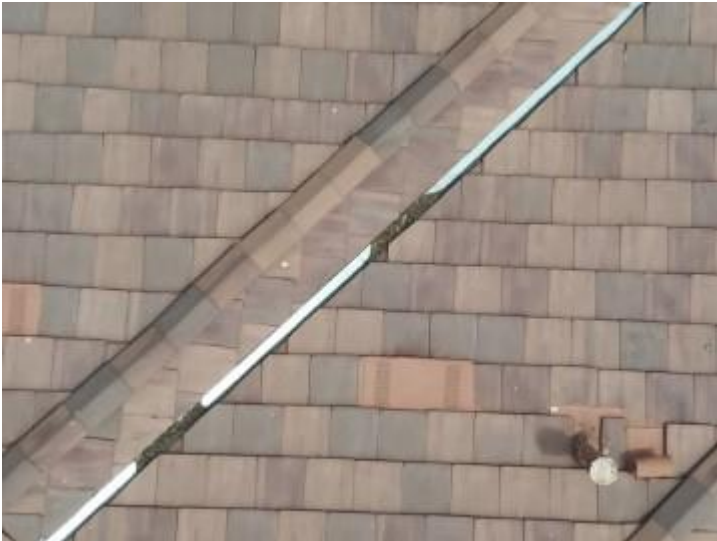
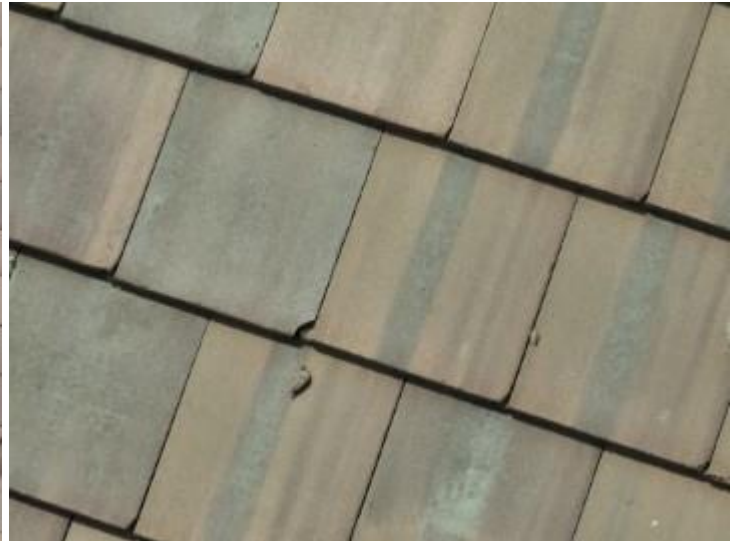
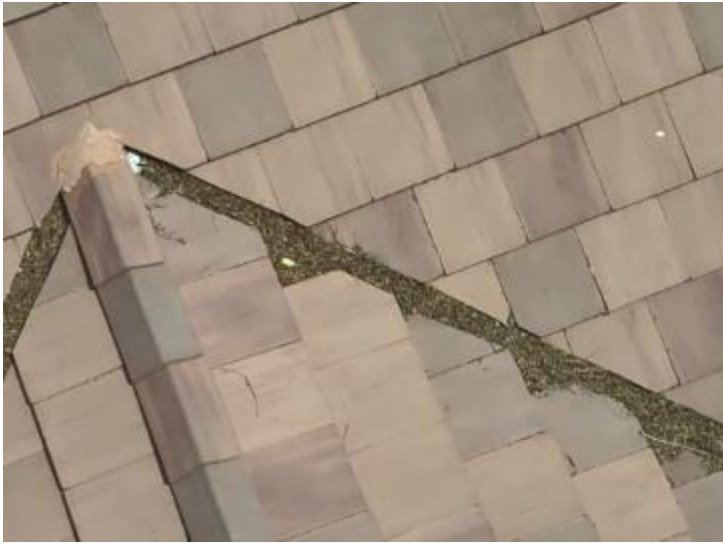
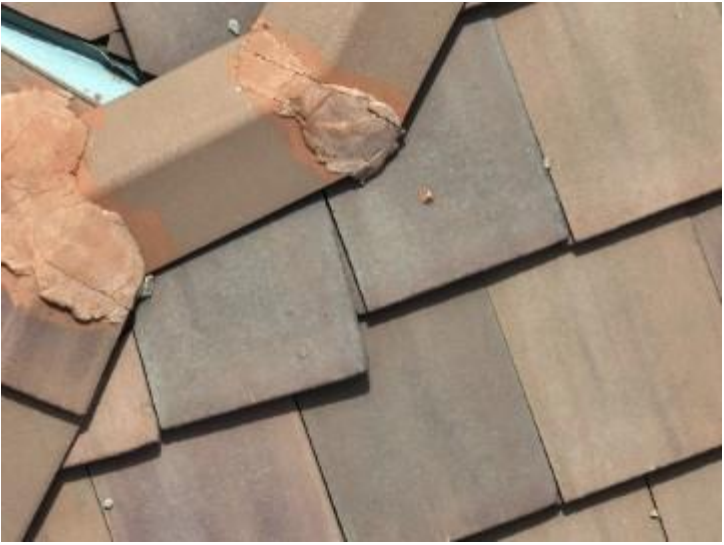
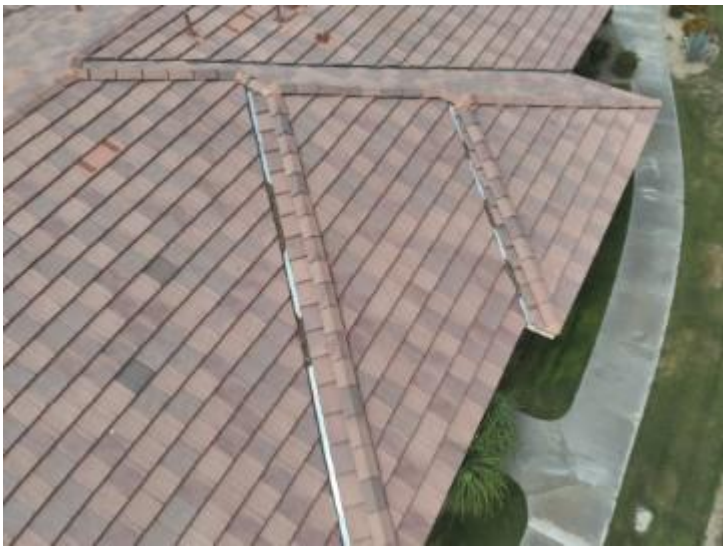
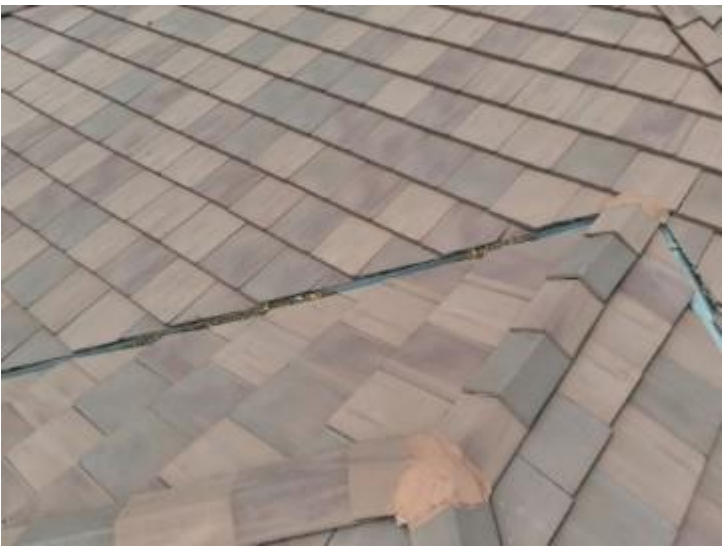
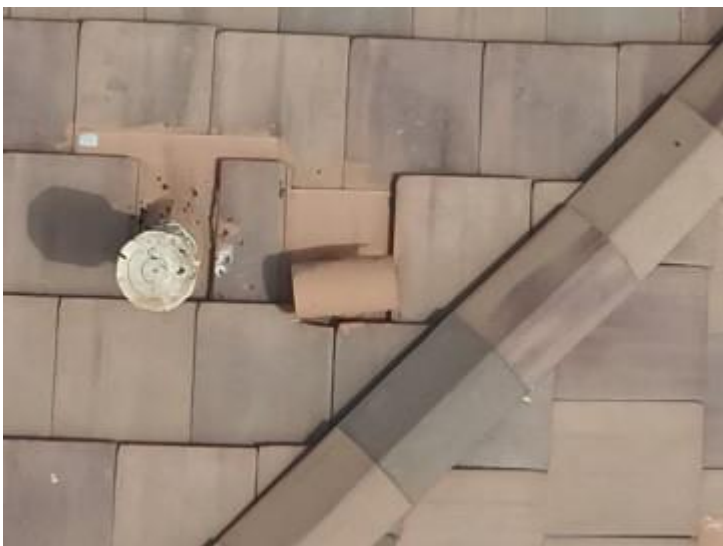
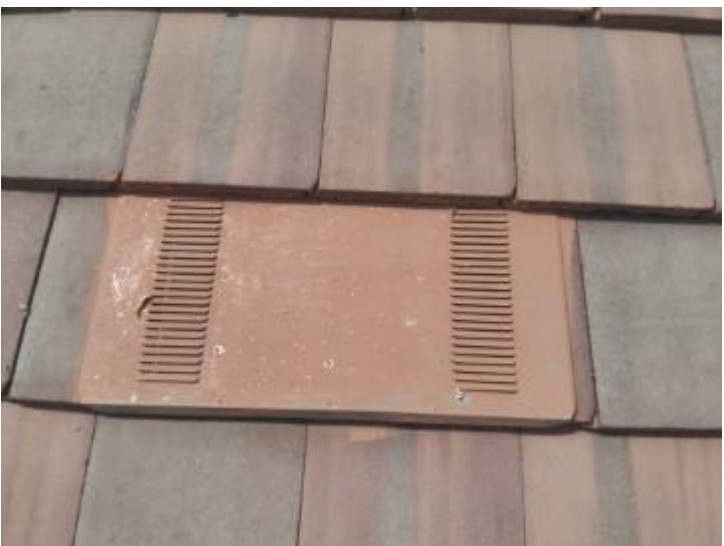
Building 17 -

ITEM	Good	Fair	Poor	N/A	COMMENTS
A - Perimeter details		X			
B - Drainage		X			Some debris noted in the valleys.
C - Penetration flashings		X			
D - Overall Tile condition		X			Some isolated chipped tiles noted. Some cracking noted at mortar.
E - Wall/Curb flashings				X	
F - Insulation				X	
G - Other				X
