June 13th, 2024

Re: Roof Consulting
Mountain View Villas
78000 Betty Barker Way
Indian Wells, CA 92210

Alliance Consulting & Testing Inc. has completed our initial roof surveys and we have the following report of our findings and opinions regarding the roofing systems on this property. We understand the purpose of the surveys was to determine the overall condition of the roofing systems including past repairs, what repairs still need to be made, the remaining service life of the systems and/or does the roofing systems need to be replaced.

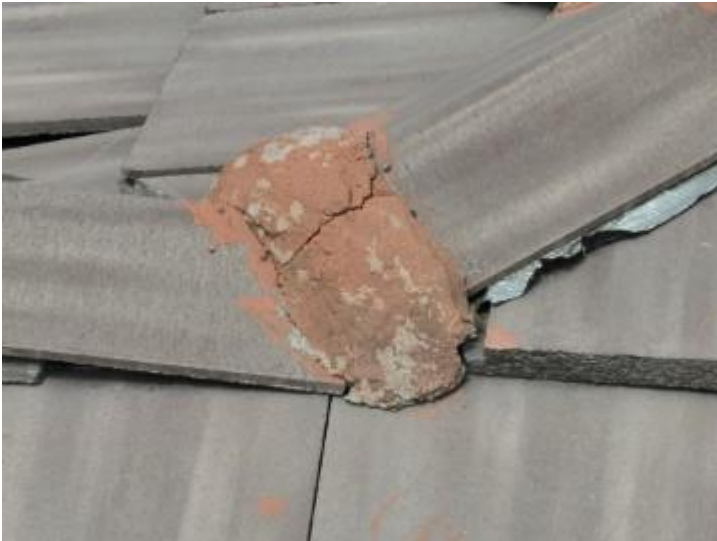
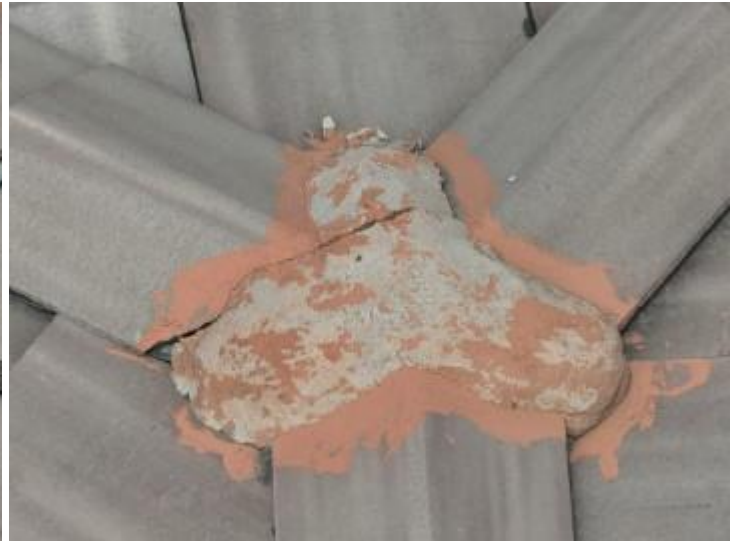
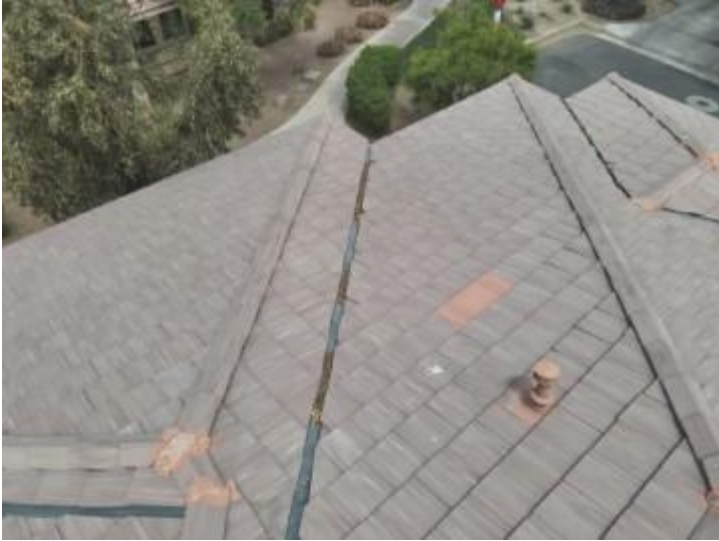
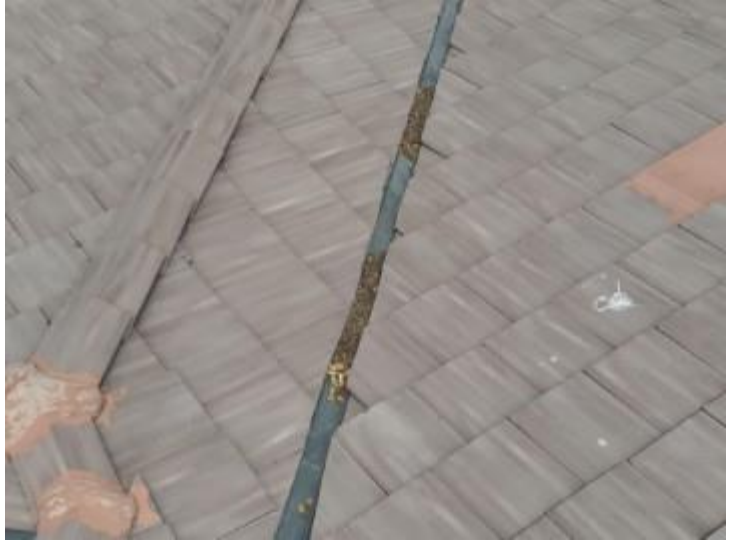
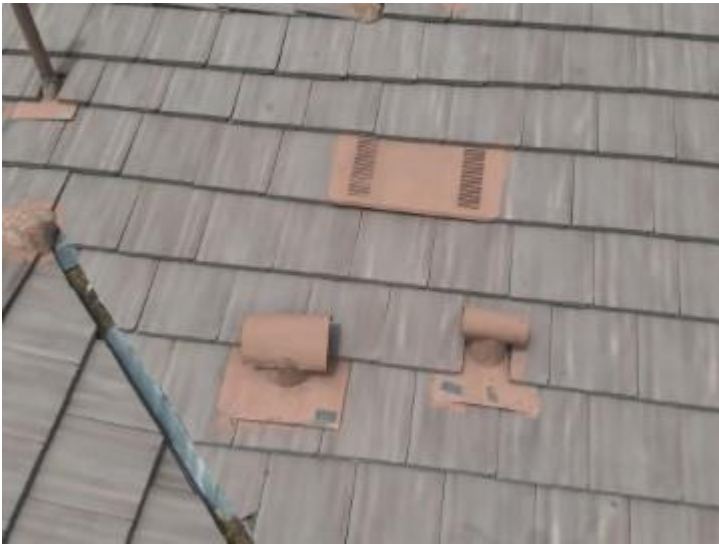
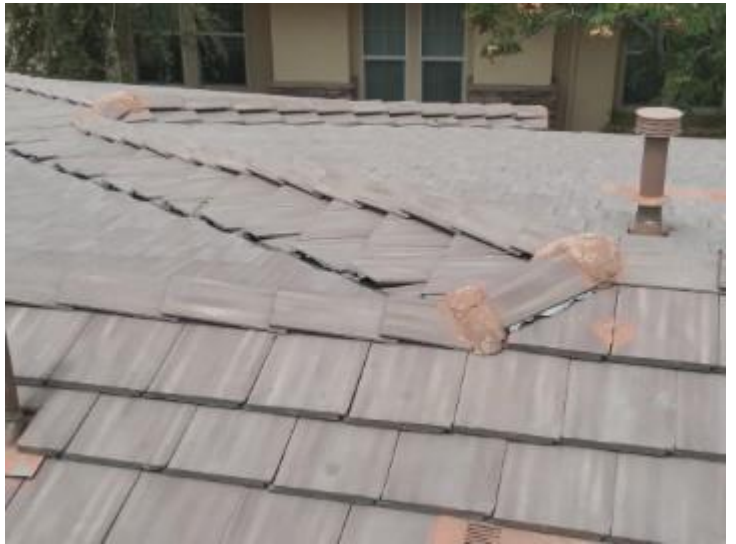
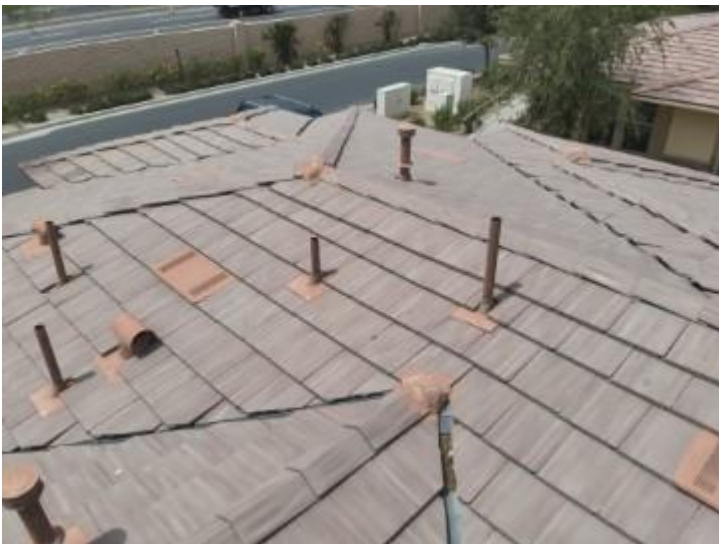
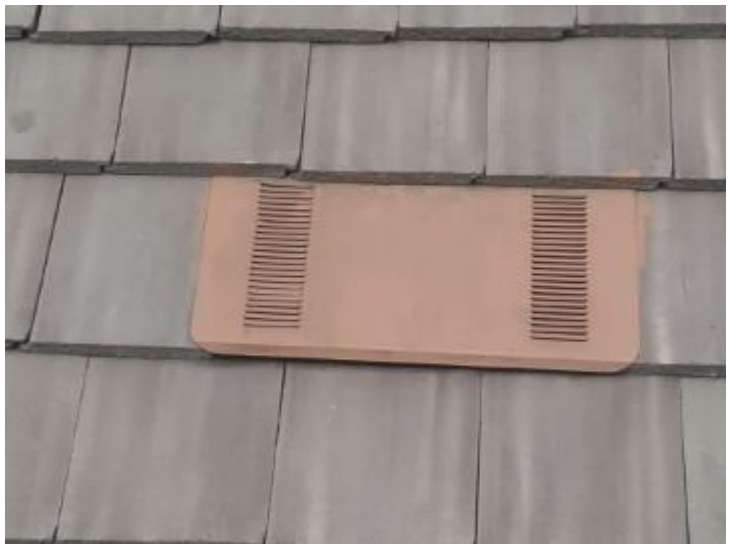
Building 18 -

ITEM	Good	Fair	Poor	N/A	COMMENTS
A - Perimeter details		X			
B - Drainage		X			Some debris noted in the valleys.
C - Penetration flashings		X			
D - Overall Tile condition		X			Some cracking noted at mortar.
E - Wall/Curb flashings				X	
F - Insulation				X	
G - Other				X

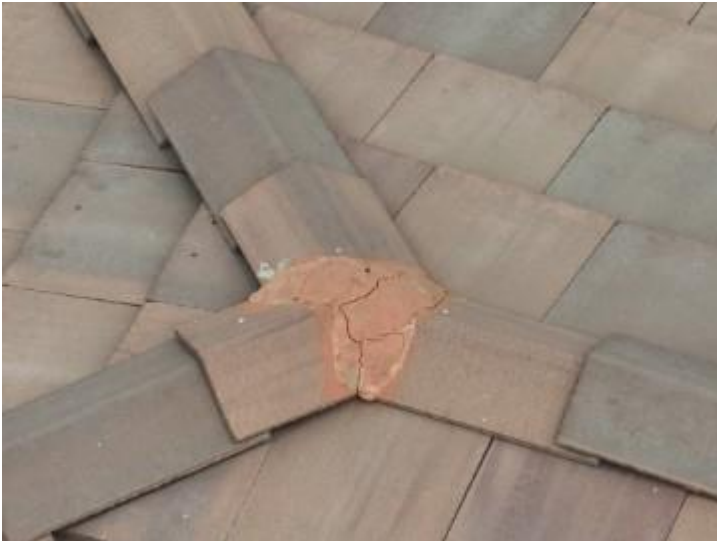
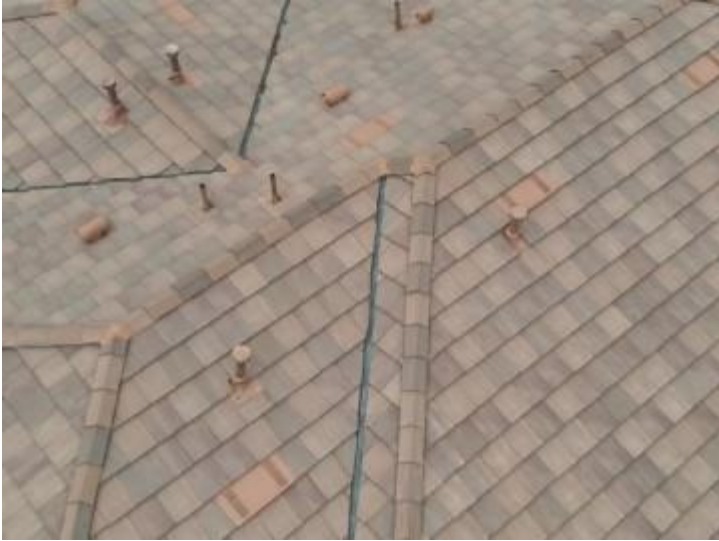
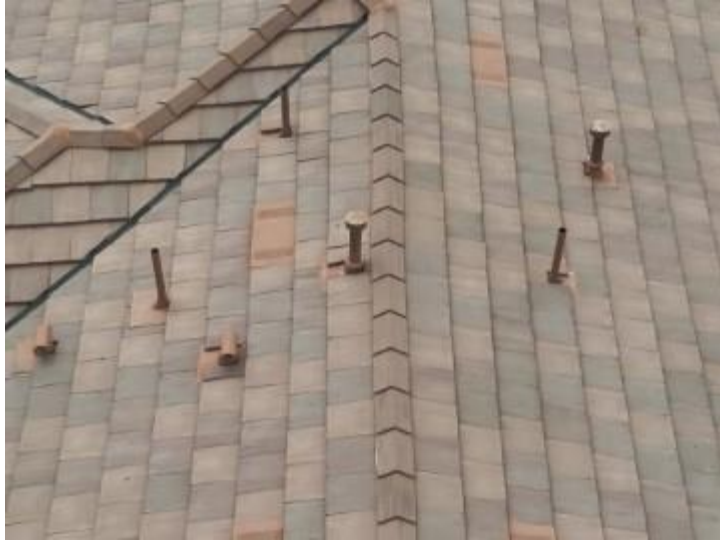
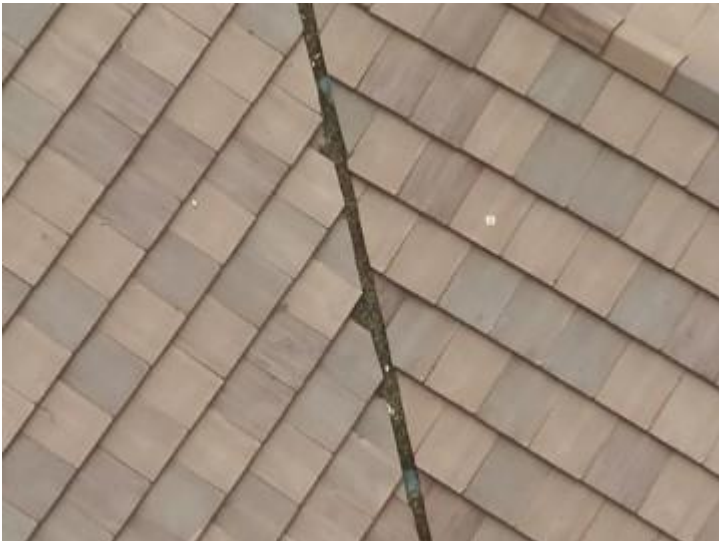
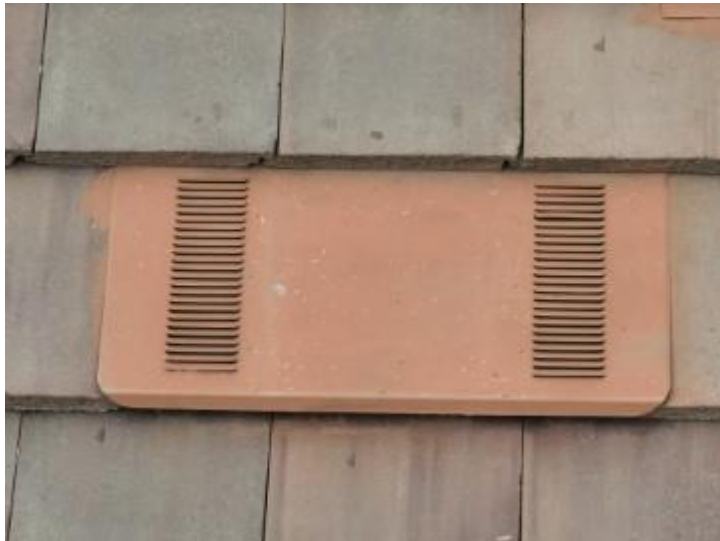
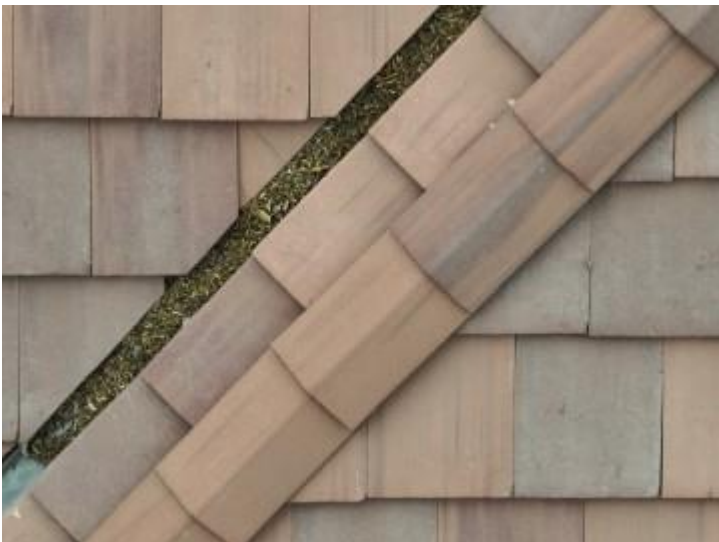
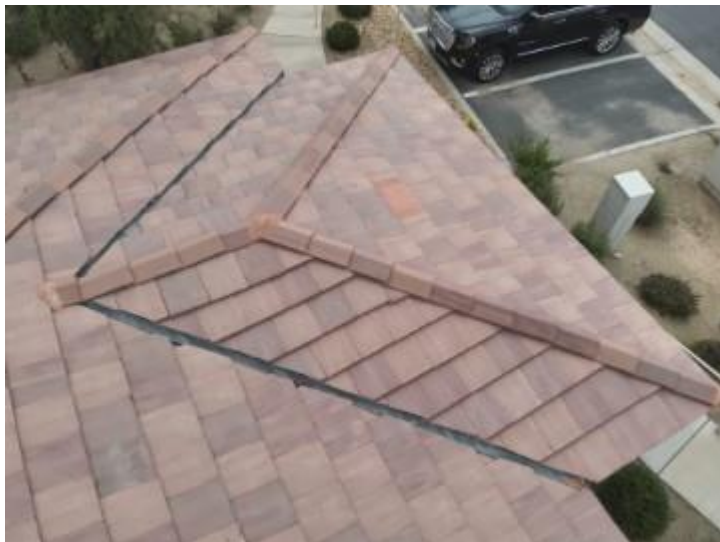
Building 19 -

ITEM	Good	Fair	Poor	N/A	COMMENTS
A - Perimeter details		X			
B - Drainage		X			Some debris noted in the valleys.
C - Penetration flashings		X			
D - Overall Tile condition		X			Some cracking noted at mortar. A missing tile notes at valley.
E - Wall/Curb flashings				X	
F - Insulation				X	
G - Other				X

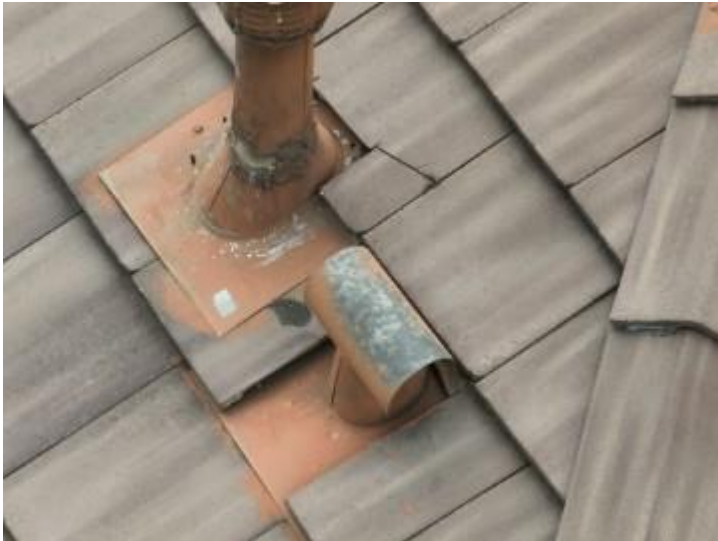
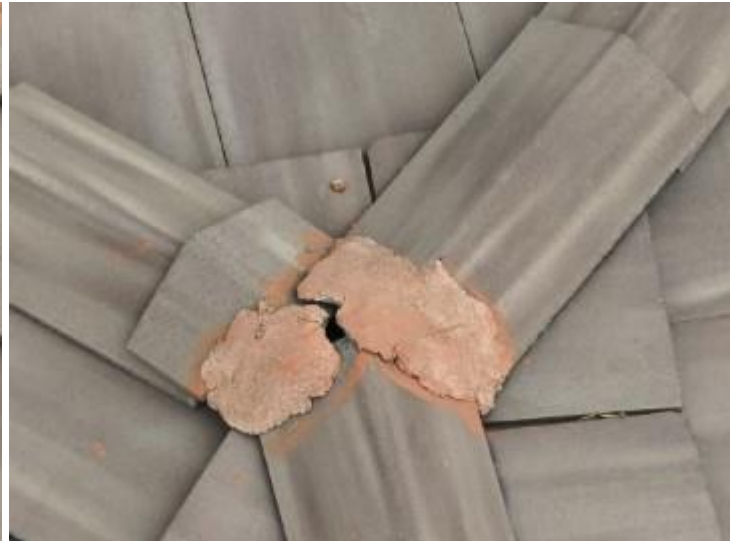
Building 20 -

ITEM	Good	Fair	Poor	N/A	COMMENTS
A - Perimeter details		X			
B - Drainage		X			Some debris noted in the valleys.
C - Penetration flashings		X			
D - Overall Tile condition		X			Some isolated cracked tiles noted. Some cracking noted at mortar.
E - Wall/Curb flashings				X	
F - Insulation				X	
G - Other				X

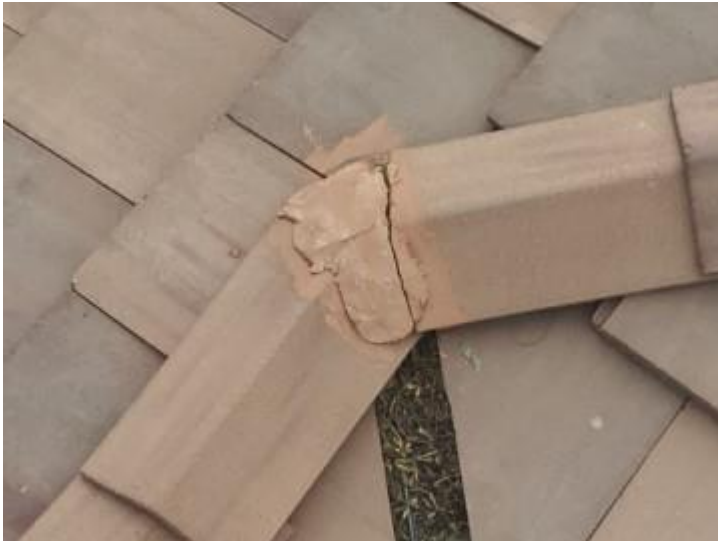
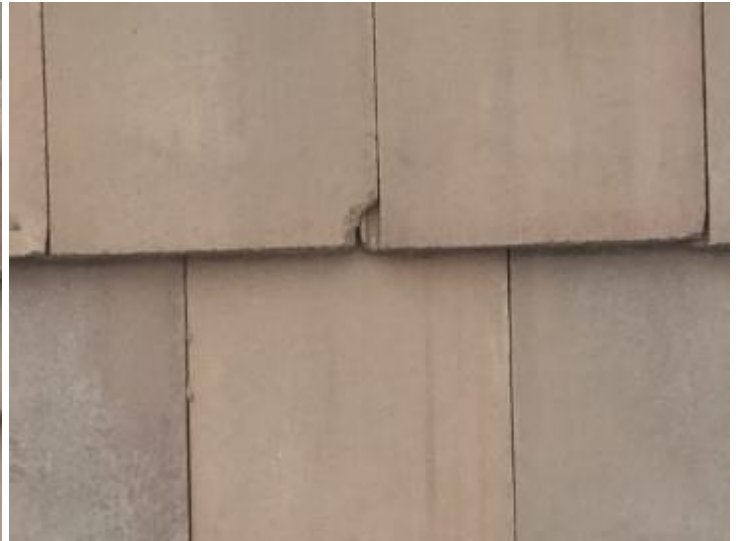
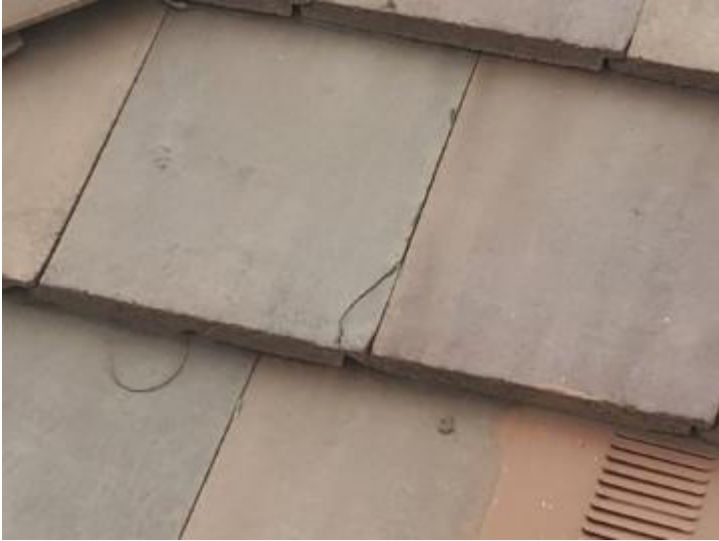
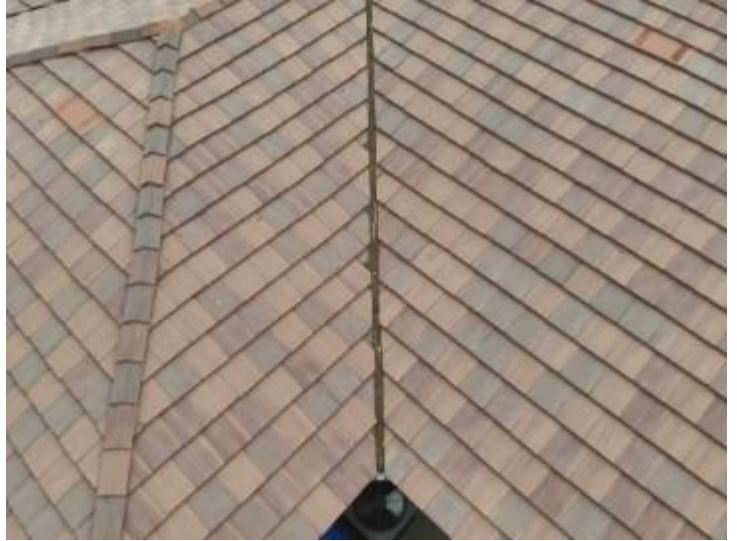
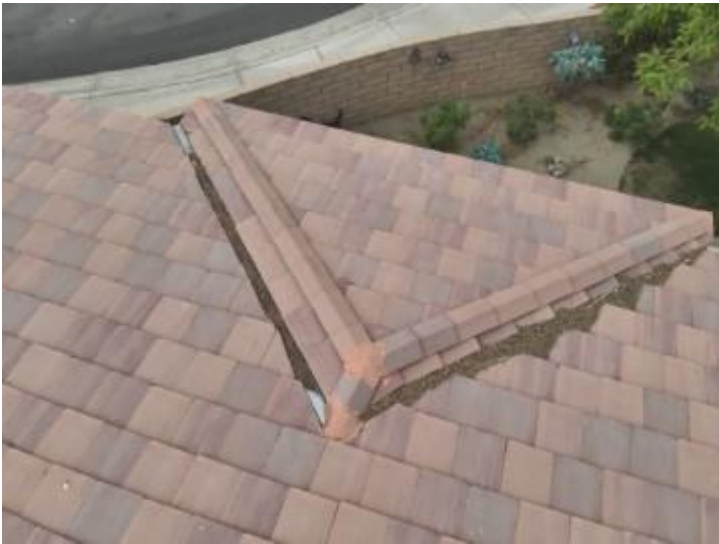
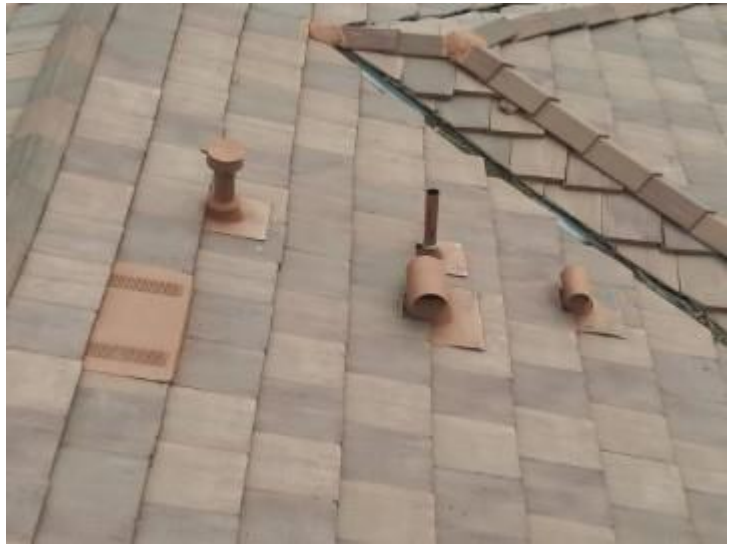
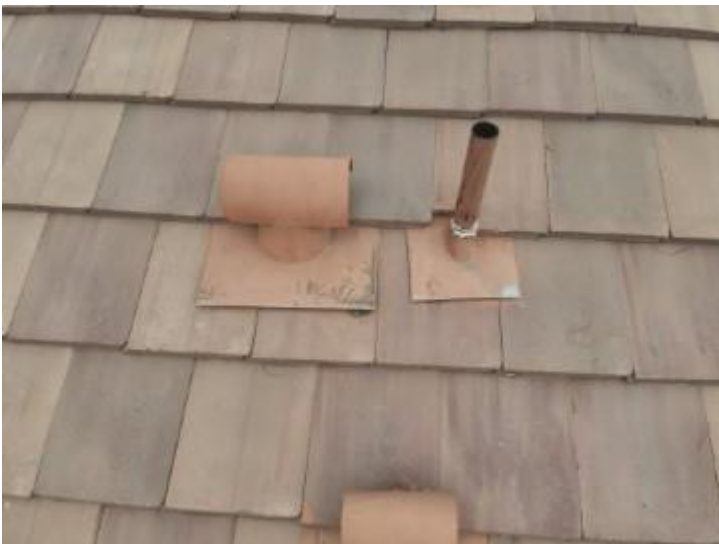
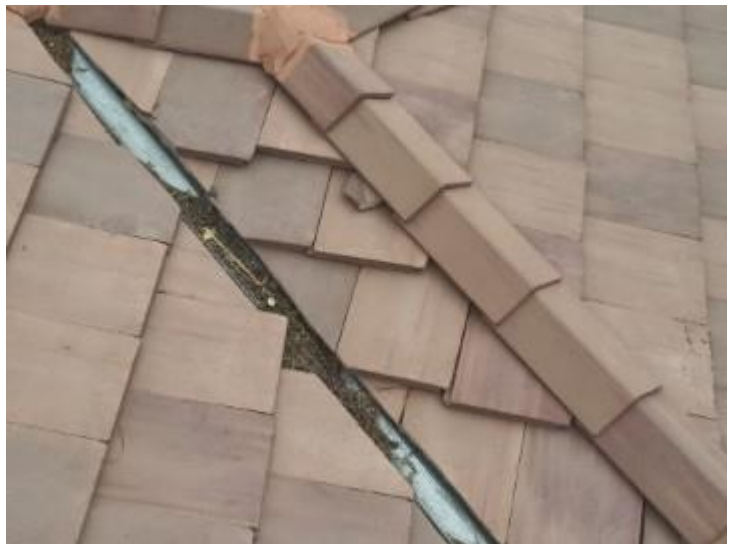
Building 21 -

ITEM	Good	Fair	Poor	N/A	COMMENTS
A - Perimeter details		X			
B - Drainage		X			Some debris noted in the valleys.
C - Penetration flashings		X			
D - Overall Tile condition		X			Some isolated chipped tiles noted. Some cracking noted at mortar.
E - Wall/Curb flashings				X	
F - Insulation				X	
G - Other				X

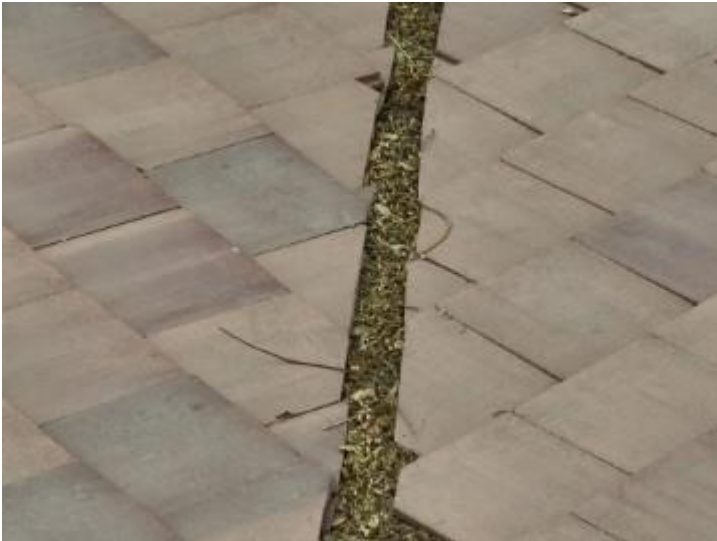
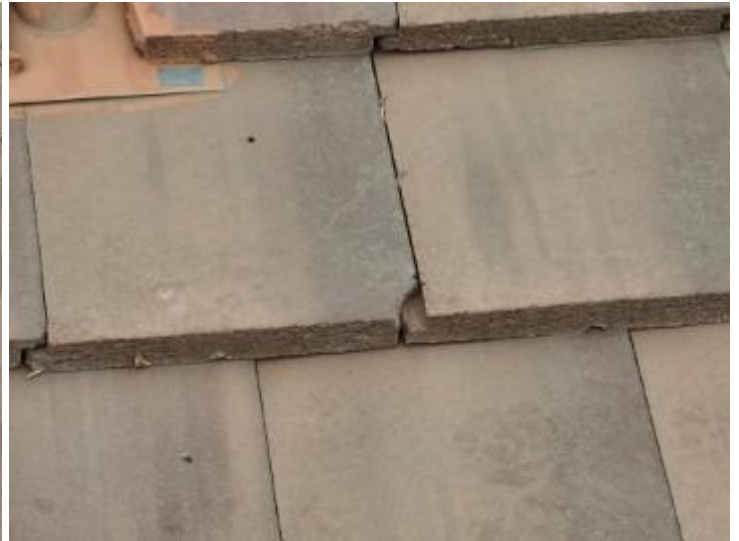
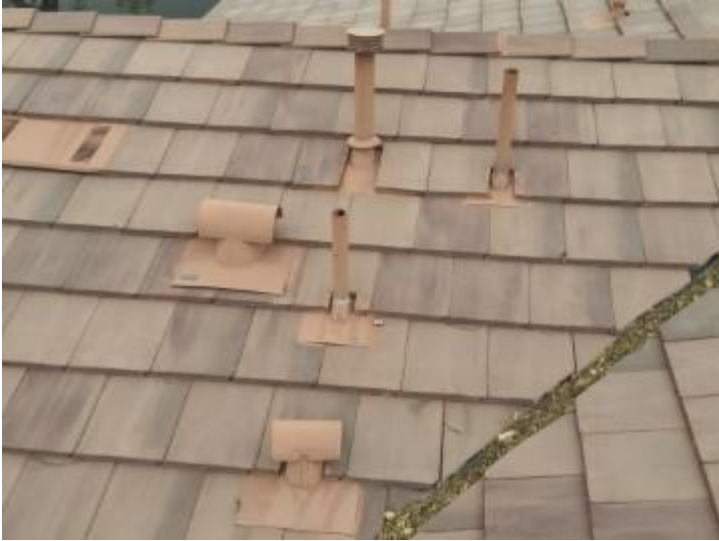
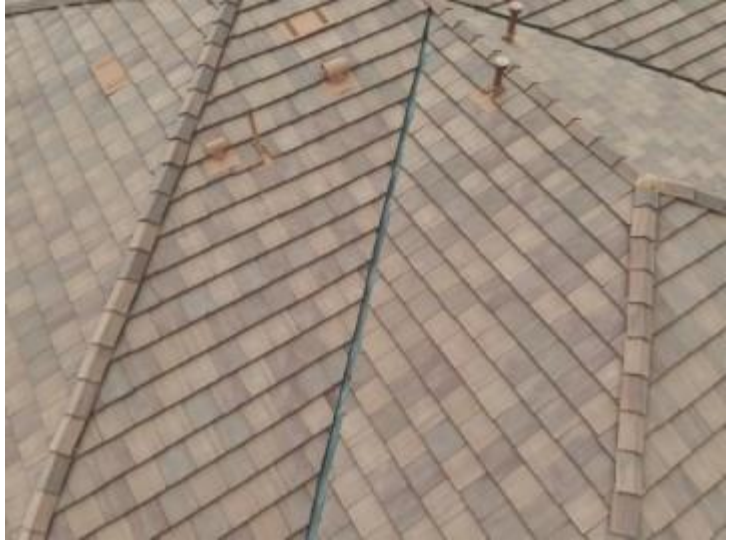
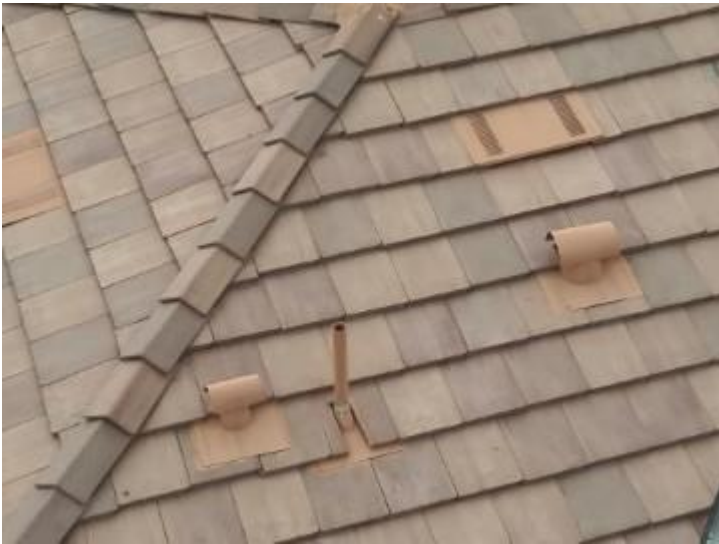
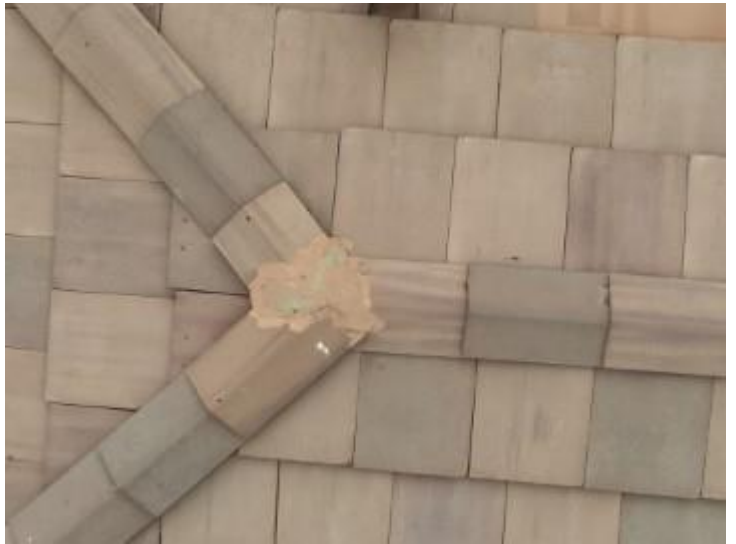
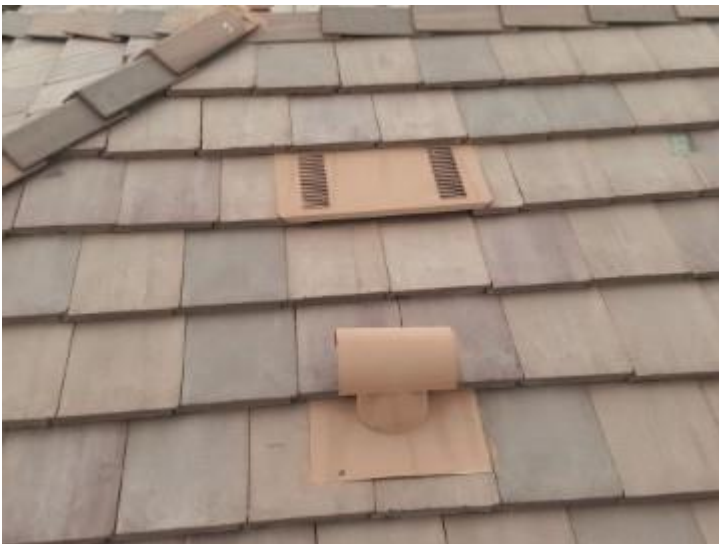
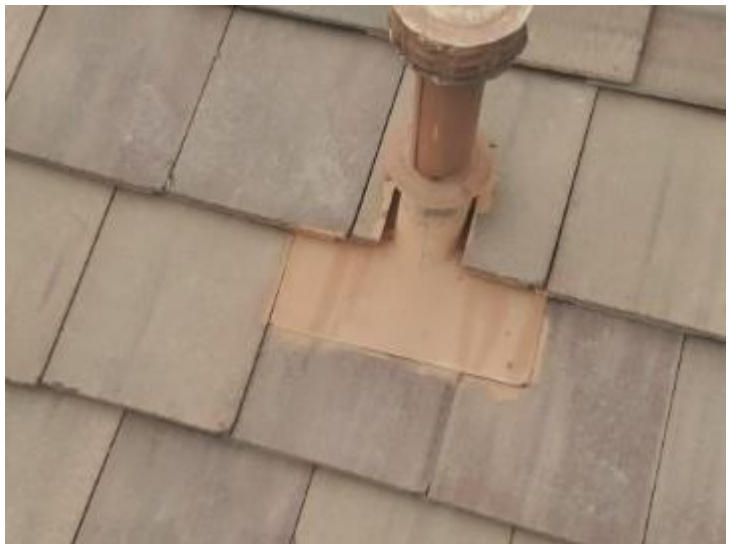
Building 22 -

ITEM	Good	Fair	Poor	N/A	COMMENTS
A - Perimeter details		X			
B - Drainage		X			Some debris noted in the valleys.
C - Penetration flashings		X			
D - Overall Tile condition		X			Some isolated chipped tiles noted. Some cracking noted at mortar.
E - Wall/Curb flashings				X	
F - Insulation				X	
G - Other				X

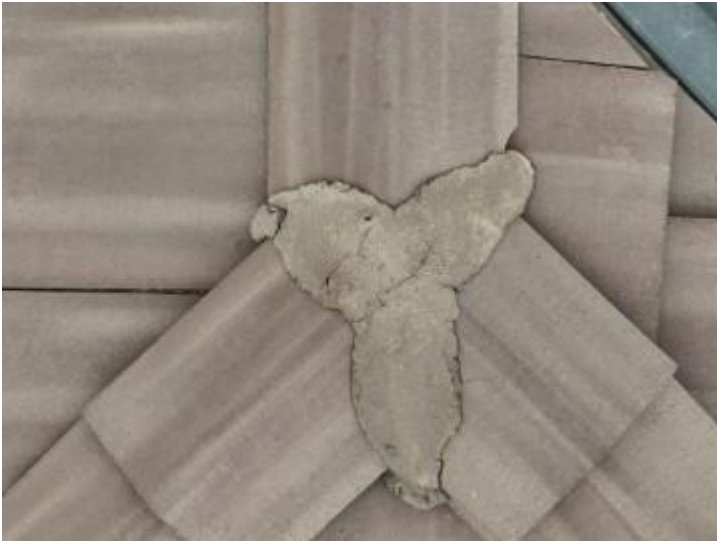
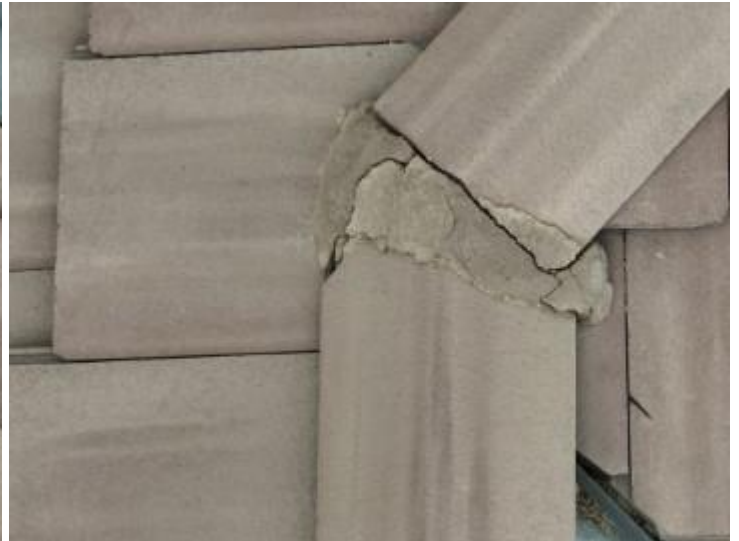
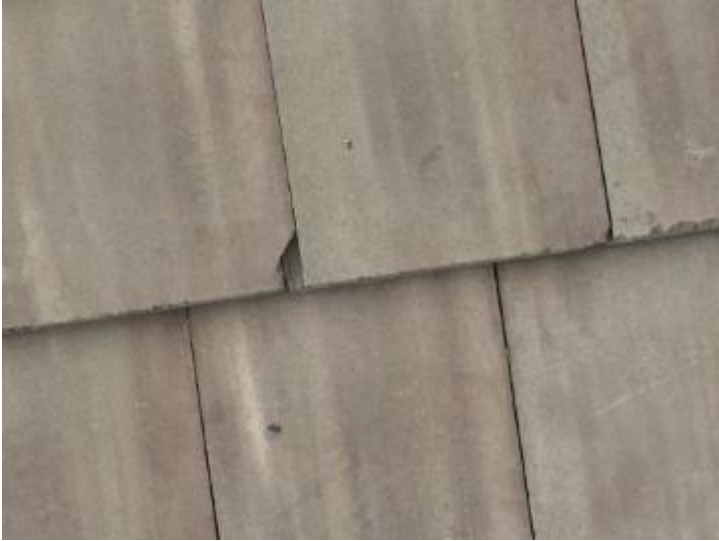
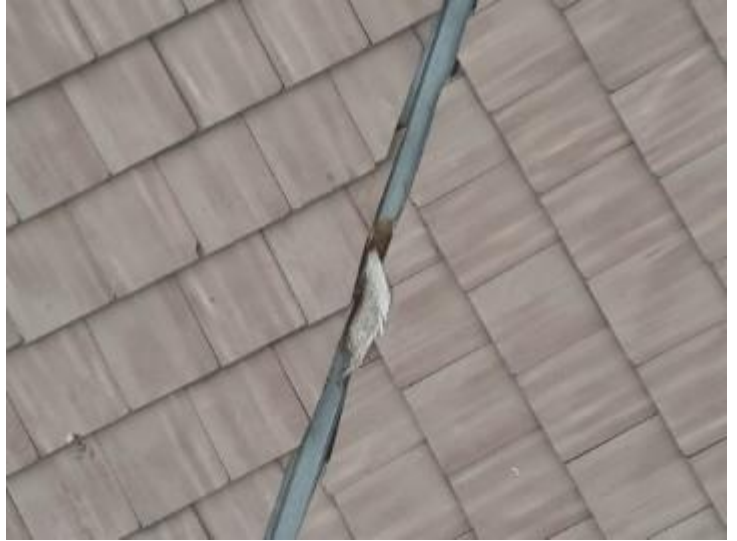
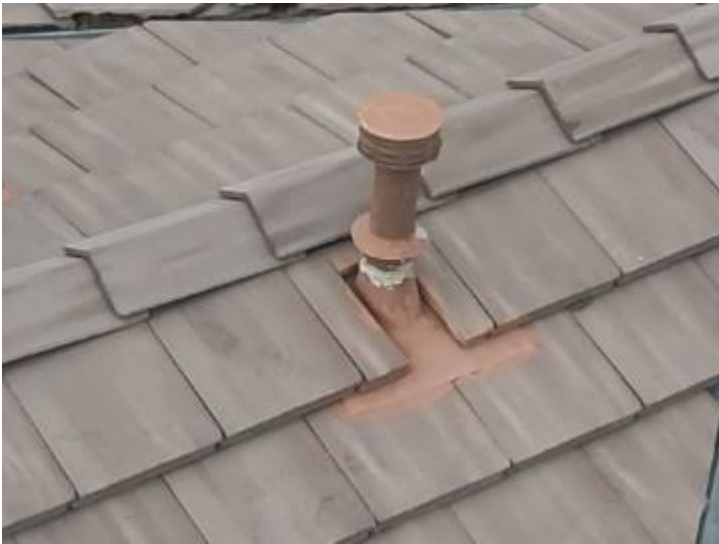
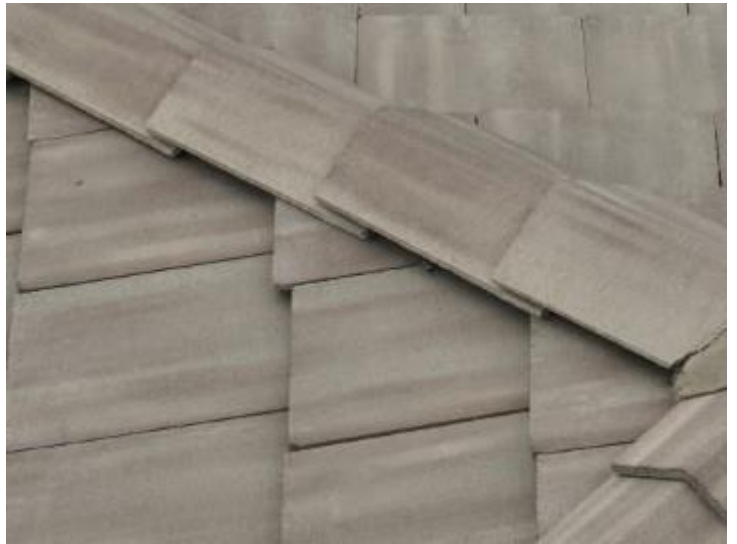
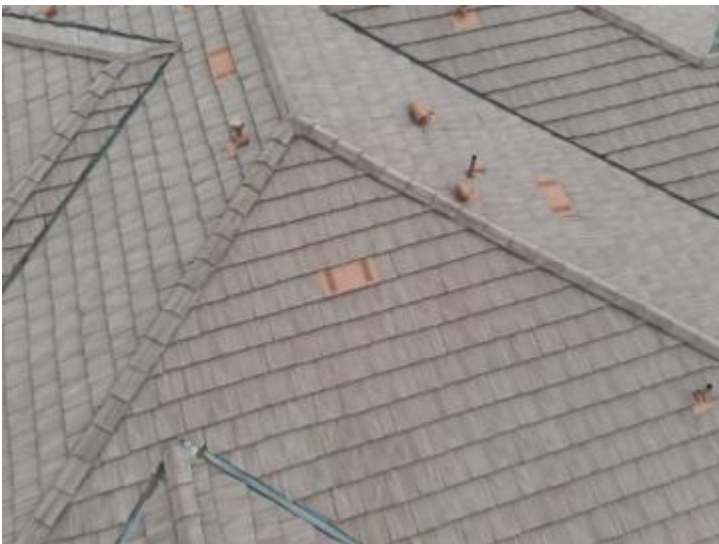
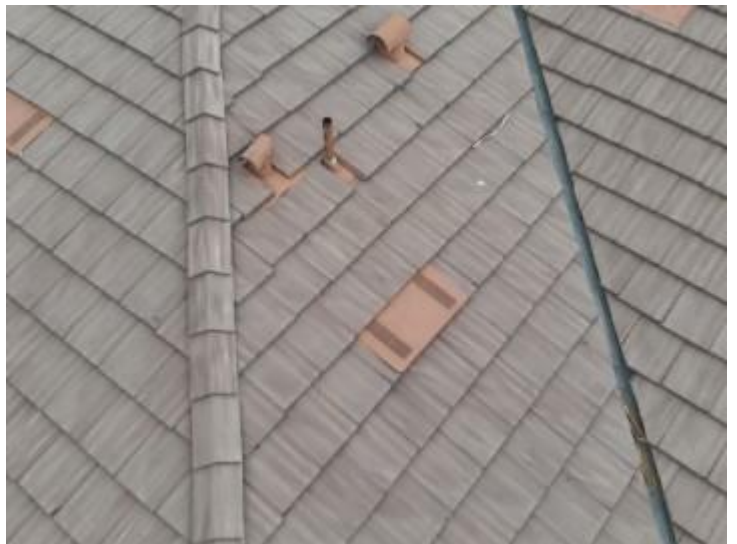
Building 23 -

ITEM	Good	Fair	Poor	N/A	COMMENTS
A - Perimeter details		X			
B - Drainage		X			Some debris noted in the valleys.
C - Penetration flashings		X			
D - Overall Tile condition		X			Some isolated chipped tiles noted. Some cracking noted at mortar.
E - Wall/Curb flashings				X	
F - Insulation				X	
G - Other				X

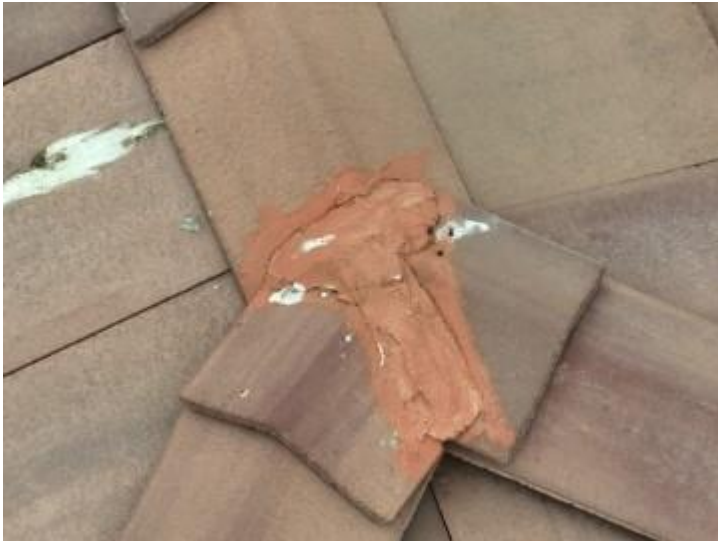
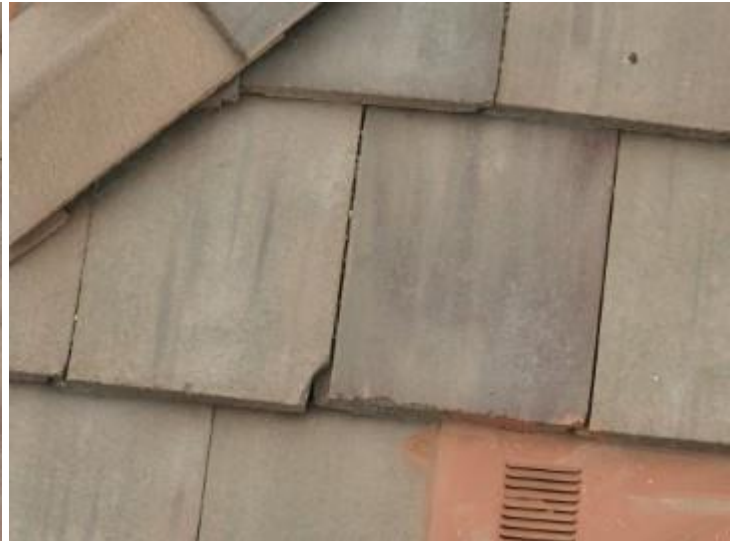
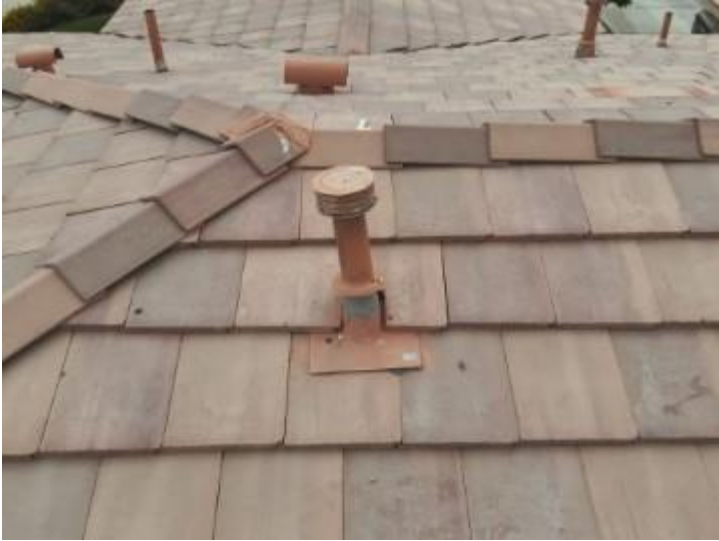
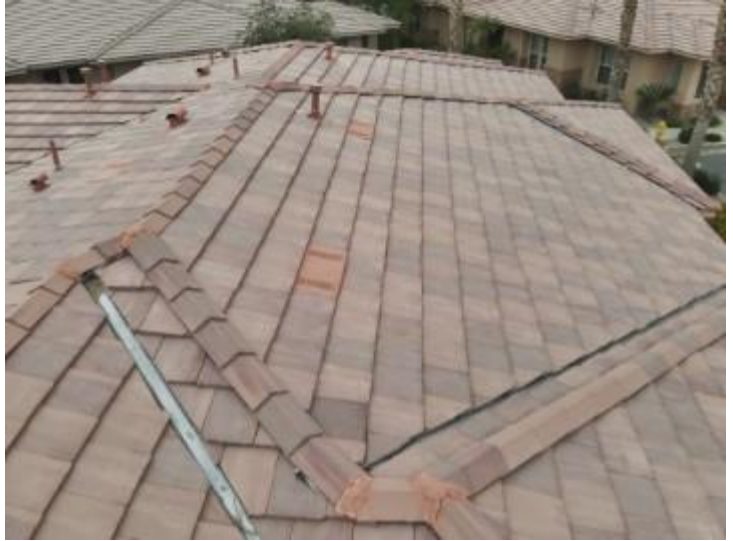
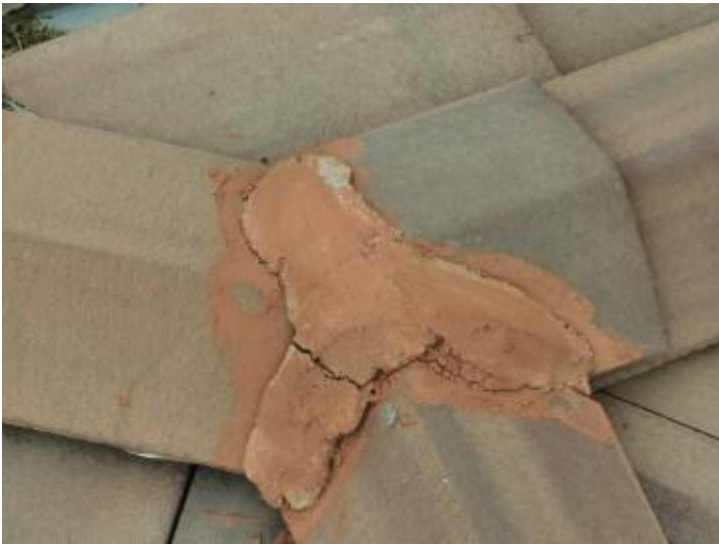
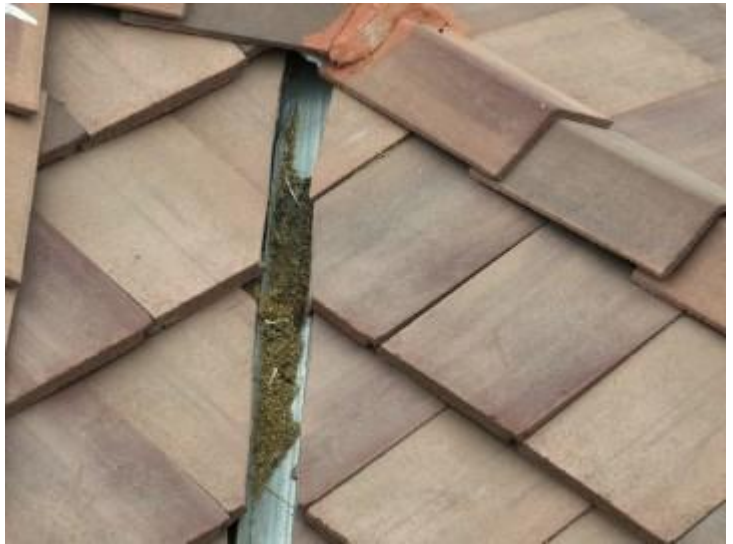
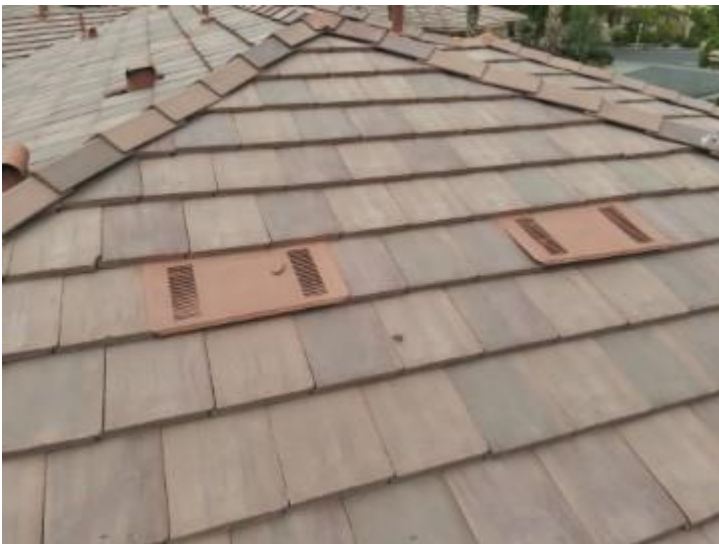
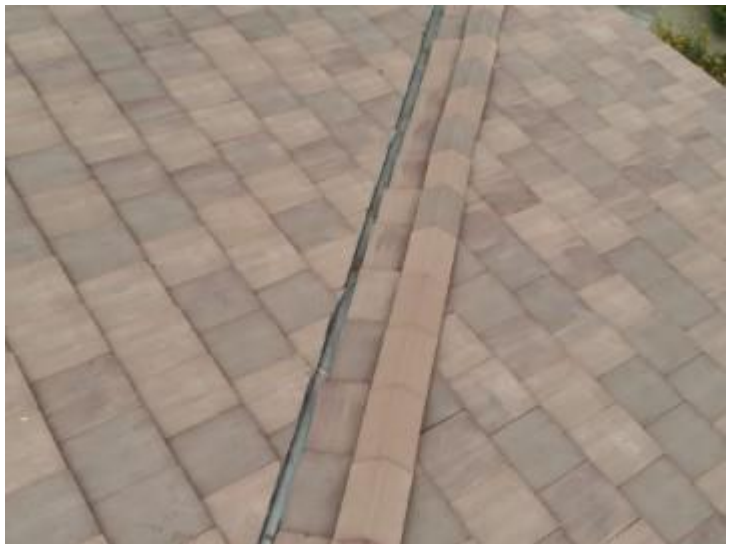
Building 24 -

ITEM	Good	Fair	Poor	N/A	COMMENTS
A - Perimeter details		X			
B - Drainage		X			Some debris noted in the valleys.
C - Penetration flashings		X			
D - Overall Tile condition		X			Some isolated chipped tiles noted. Some cracking noted at mortar.
E - Wall/Curb flashings				X	
F - Insulation				X	
G - Other				X

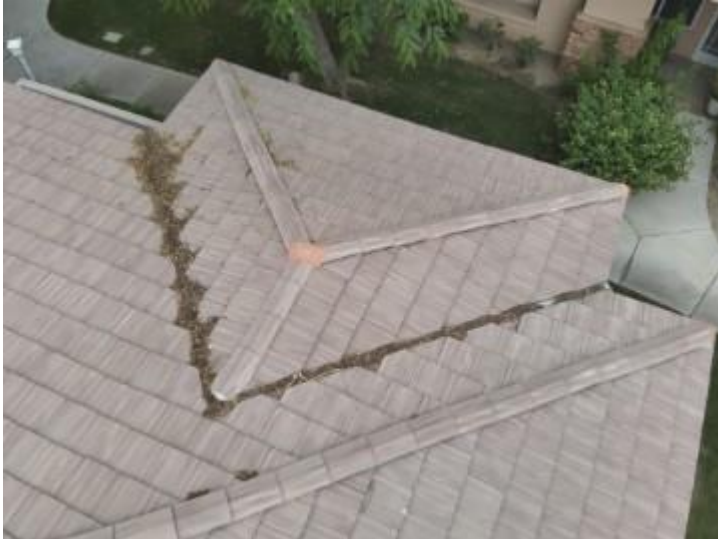
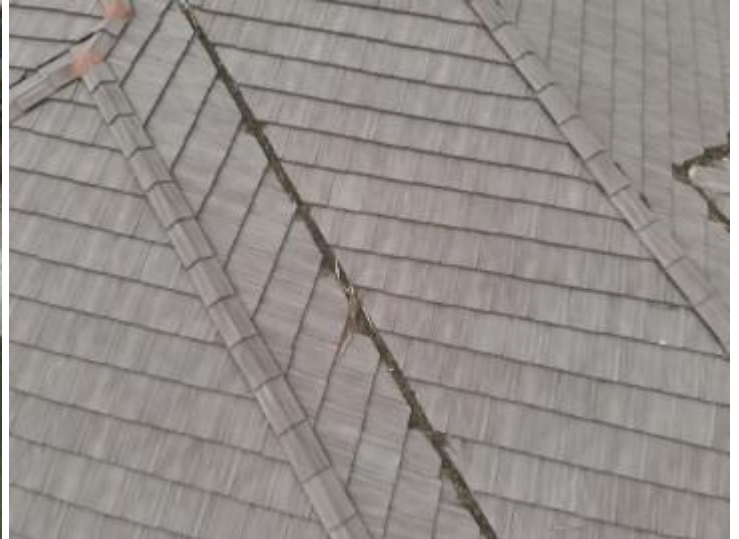
Building 25 -

ITEM	Good	Fair	Poor	N/A	COMMENTS
A - Perimeter details		X			
B - Drainage		X			Some debris noted in the valleys.
C - Penetration flashings		X			
D - Overall Tile condition		X			Some isolated chipped tiles noted. Some cracking noted at mortar.
E - Wall/Curb flashings				X	
F - Insulation				X	
G - Other				X
