June 13th, 2024

Re: Roof Consulting
Mountain View Villas
78000 Betty Barker Way
Indian Wells, CA 92210

Alliance Consulting & Testing Inc. has completed our initial roof surveys and we have the following report of our findings and opinions regarding the roofing systems on this property. We understand the purpose of the surveys was to determine the overall condition of the roofing systems including past repairs, what repairs still need to be made, the remaining service life of the systems and/or does the roofing systems need to be replaced.

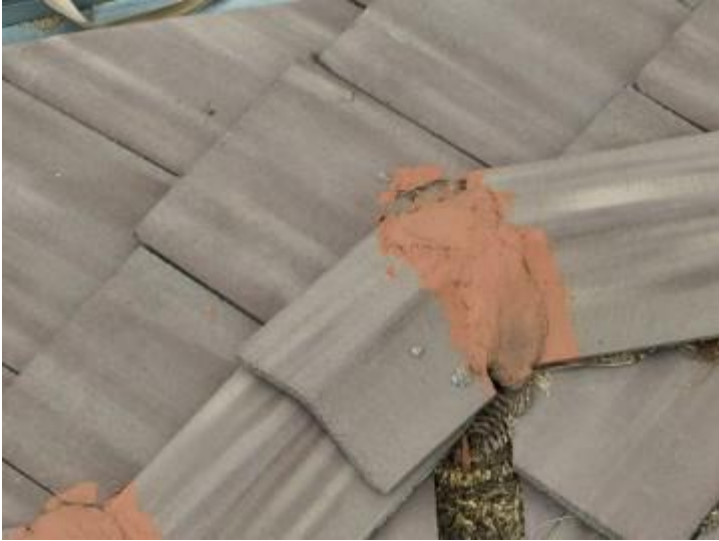
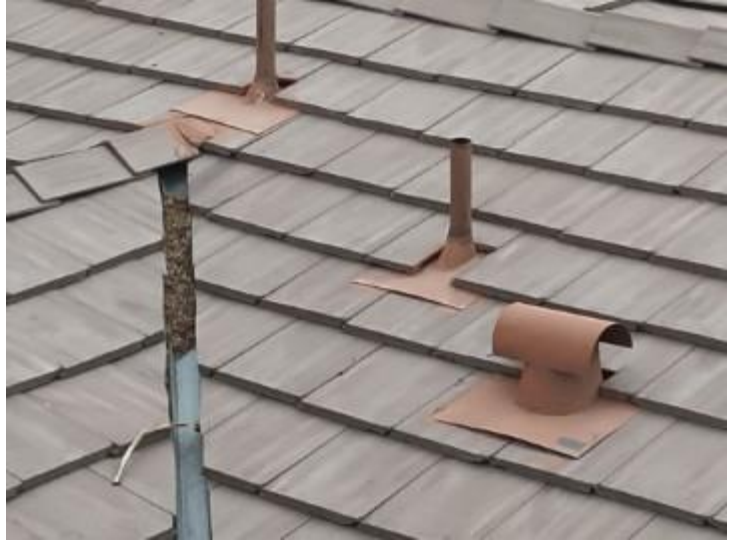
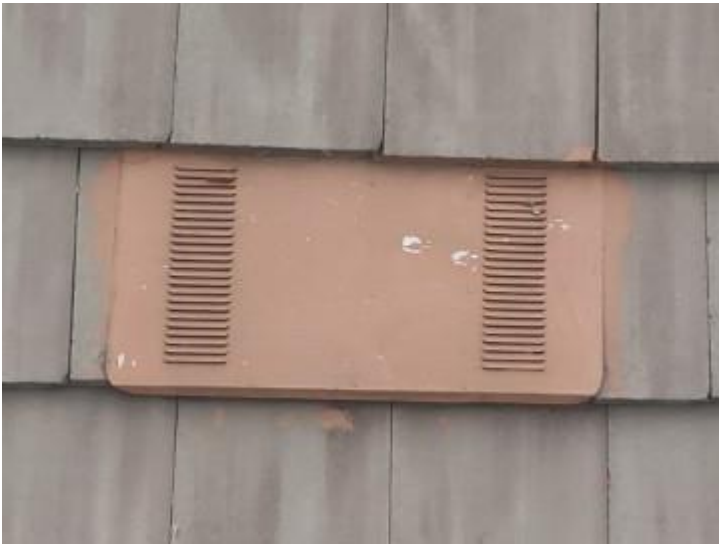
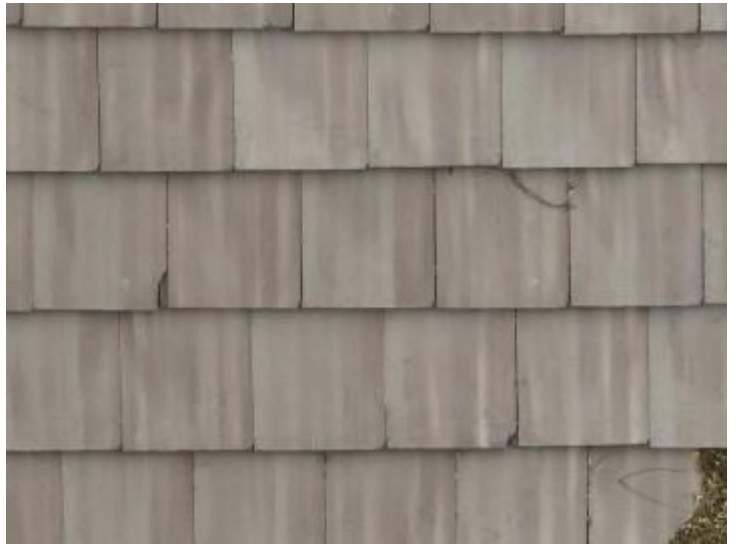
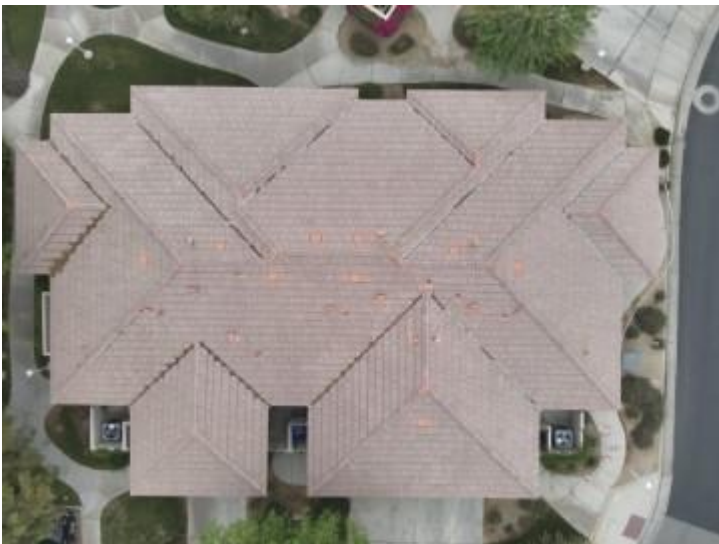
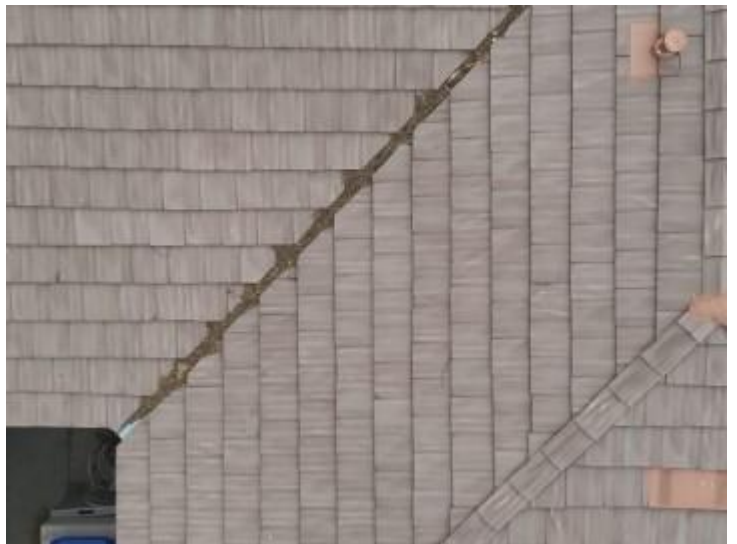
ITEM	Good	Fair	Poor	N/A	COMMENTS
A - Perimeter details		X			
B - Drainage		X			Some debris noted in the valleys.
C - Penetration flashings		X			
D - Overall Tile condition		X			Some isolated chipped tiles noted. Some cracking noted at mortar.
E - Wall/Curb flashings				X	
F - Insulation				X	
G - Other				X

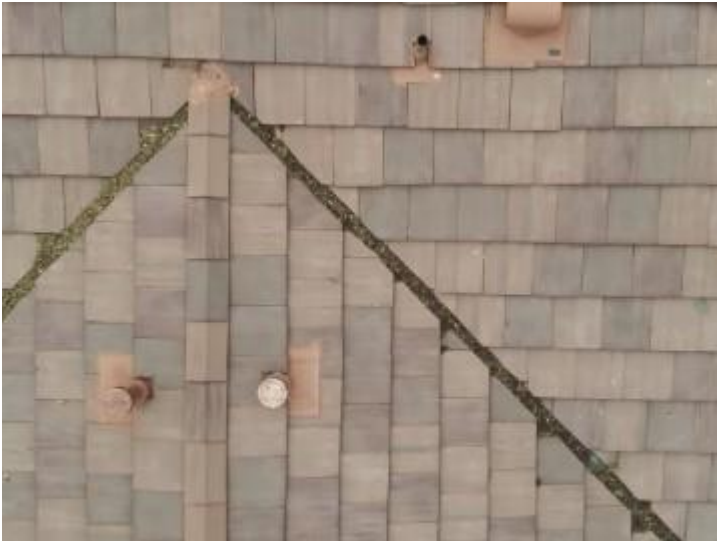
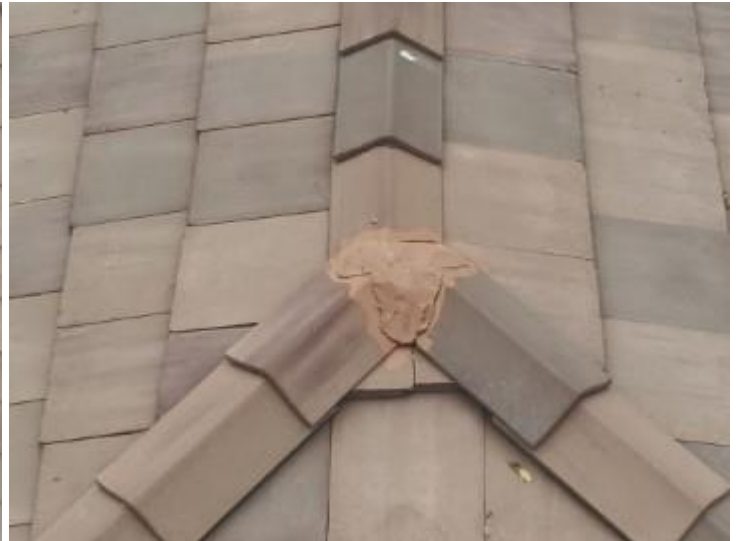
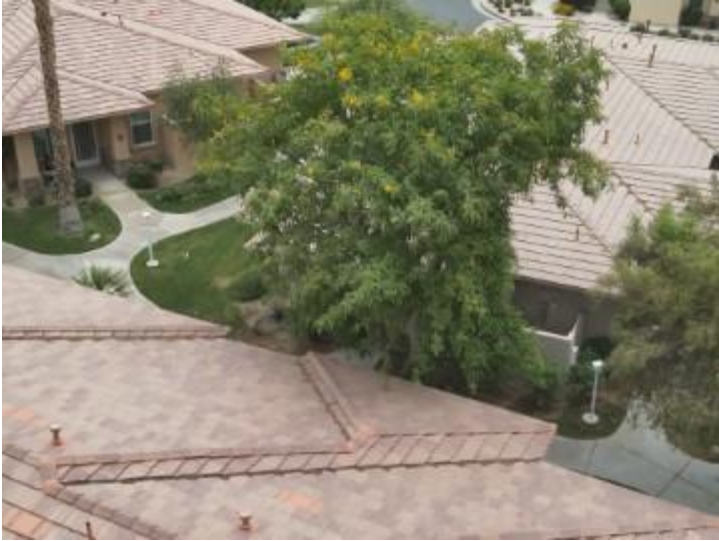
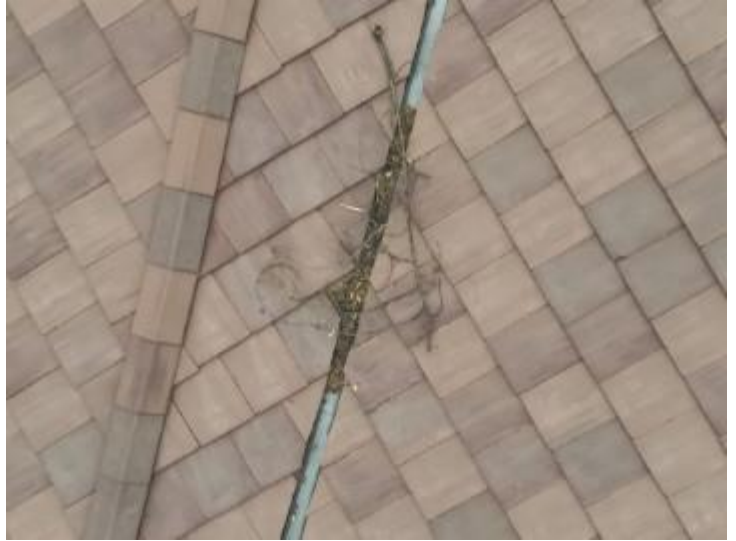
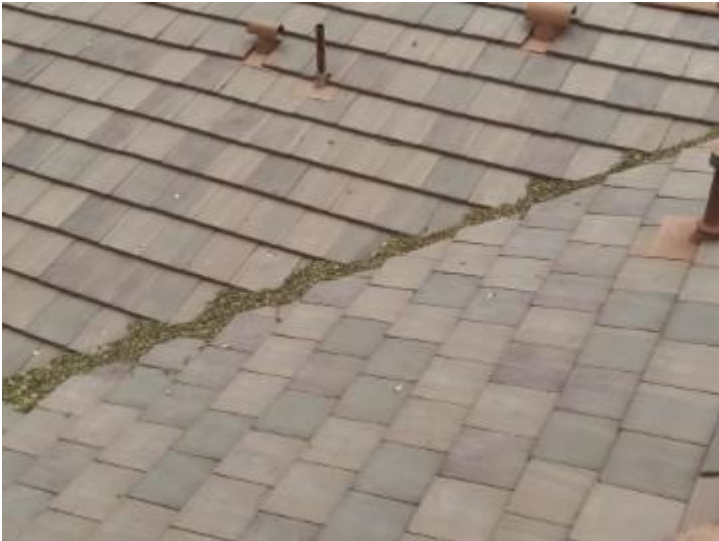
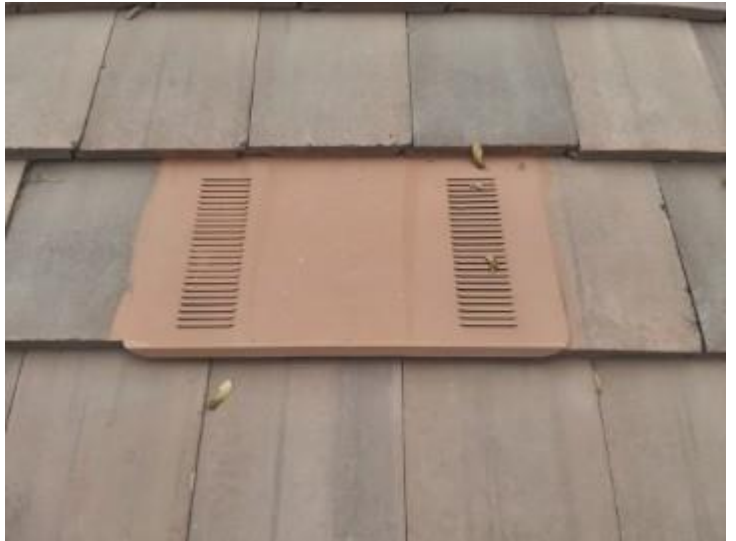
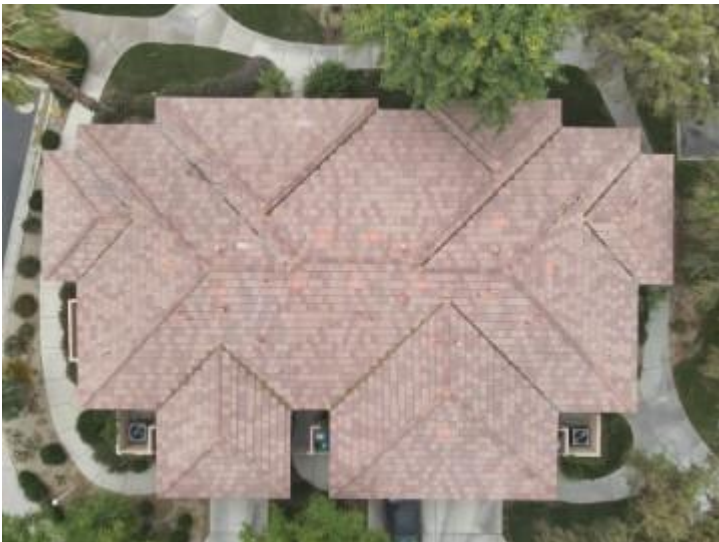
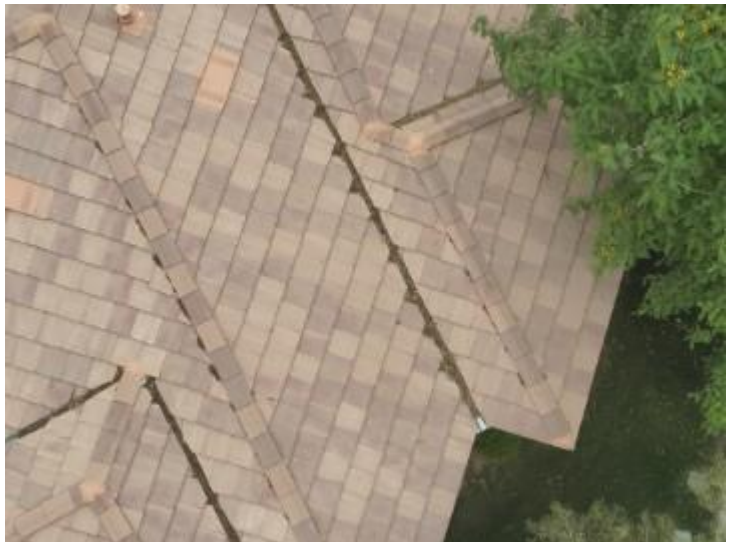
Building 26 -

ITEM	Good	Fair	Poor	N/A	COMMENTS
A - Perimeter details		X			
B - Drainage		X			Some debris noted in the valleys.
C - Penetration flashings		X			
D - Overall Tile condition		X			Some isolated chipped tiles noted. Some cracking noted at mortar.
E - Wall/Curb flashings				X	
F - Insulation				X	
G - Other				X

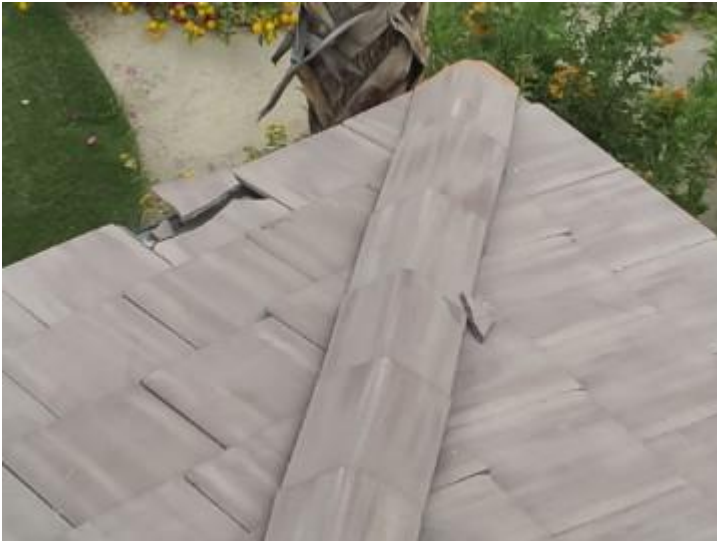
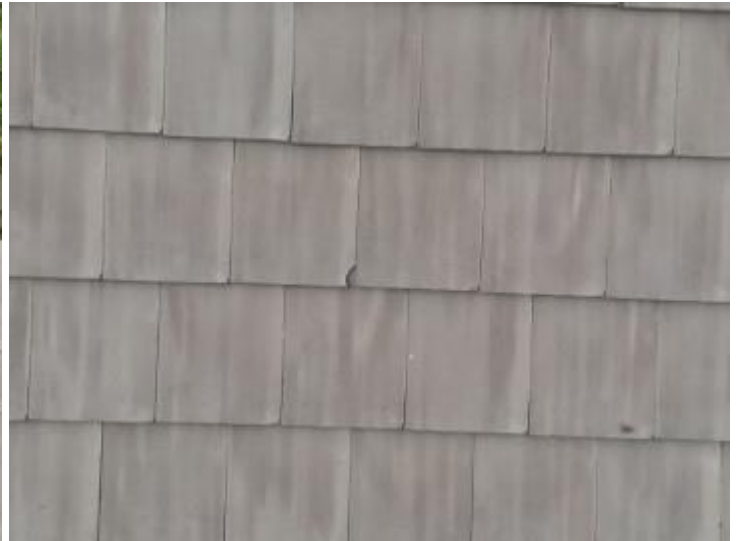
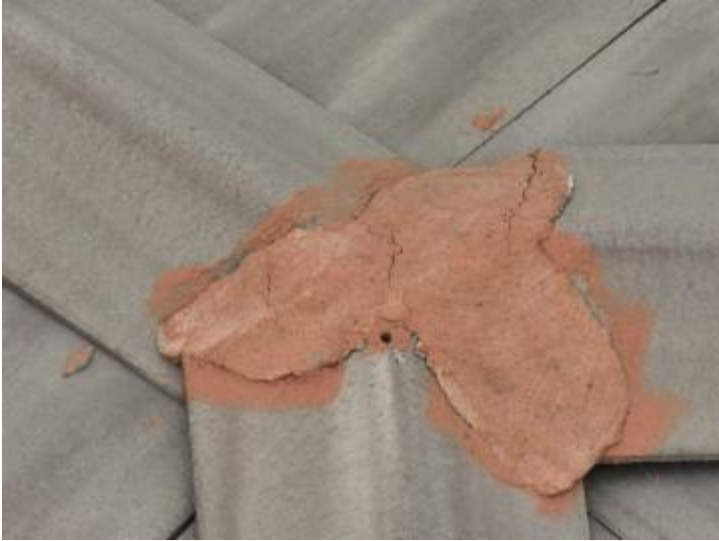
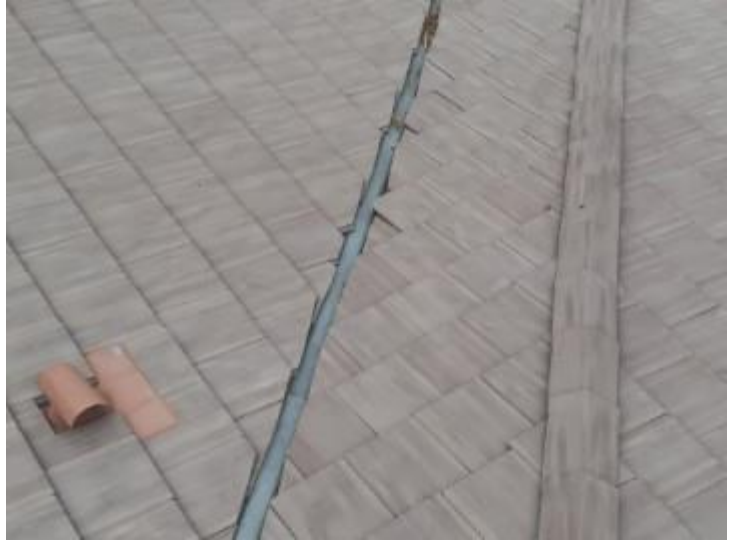
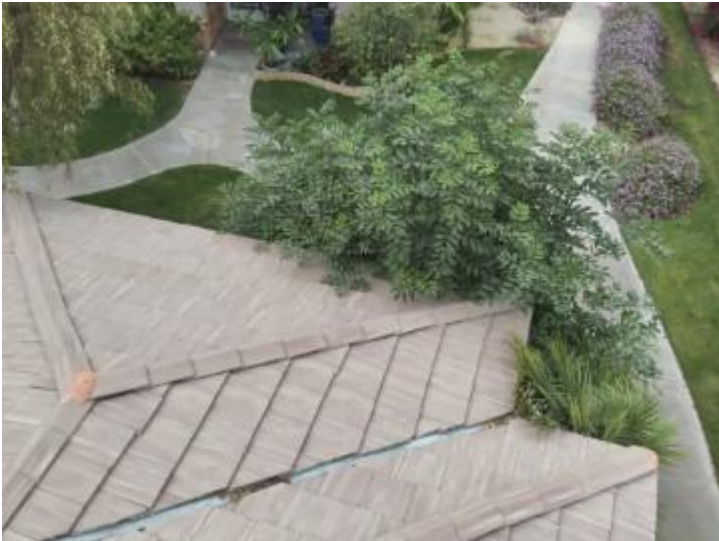
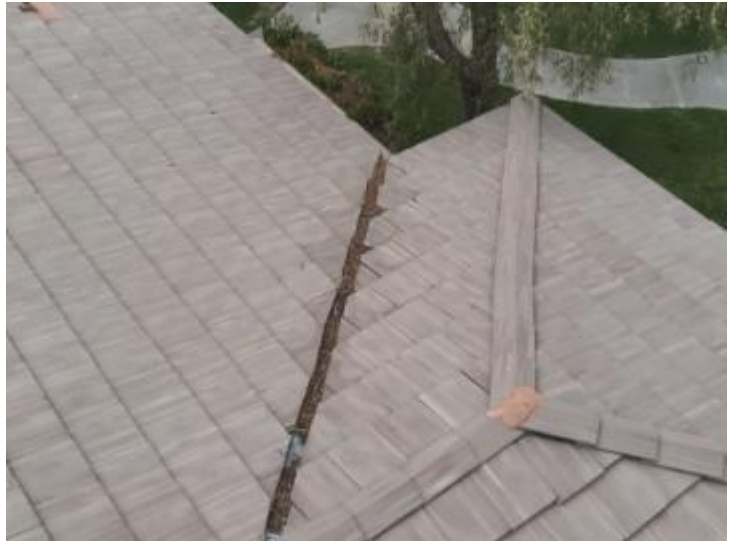
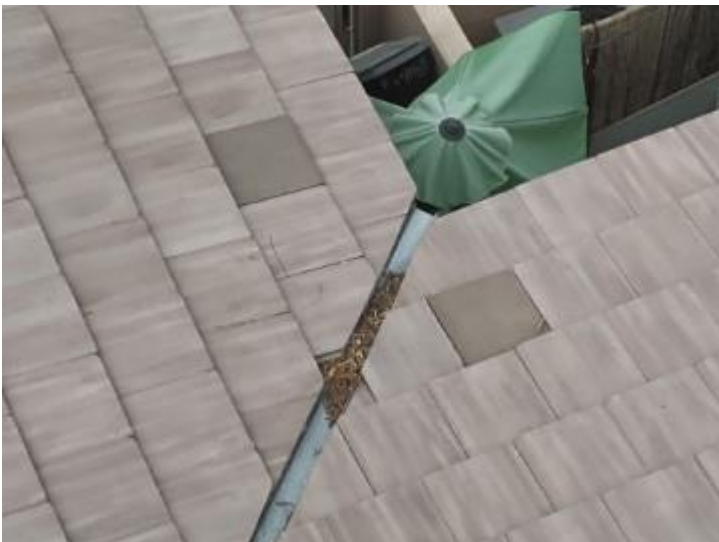
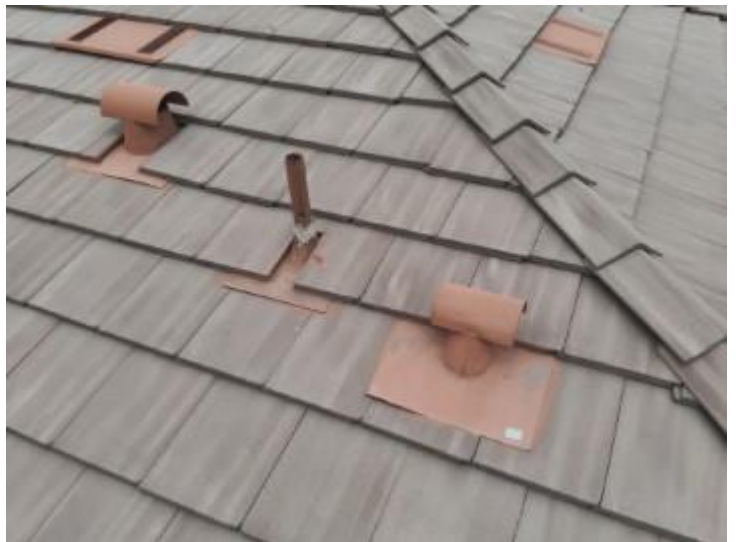
Building 27 -

ITEM	Good	Fair	Poor	N/A	COMMENTS
A - Perimeter details		X			
B - Drainage		X			Some debris noted in the valleys.
C - Penetration flashings		X			
D - Overall Tile condition		X			Some isolated broken tiles noted. Some isolated chipped tiles noted. Some cracking noted at mortar.
E - Wall/Curb flashings				X	
F - Insulation				X	
G - Other				X

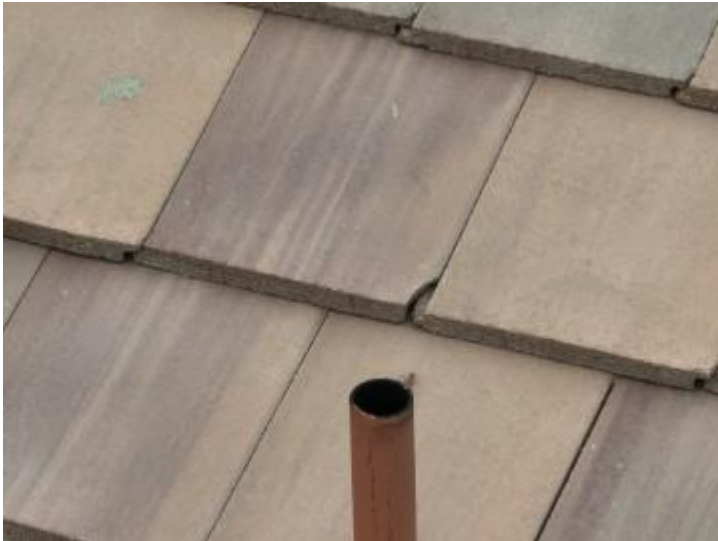
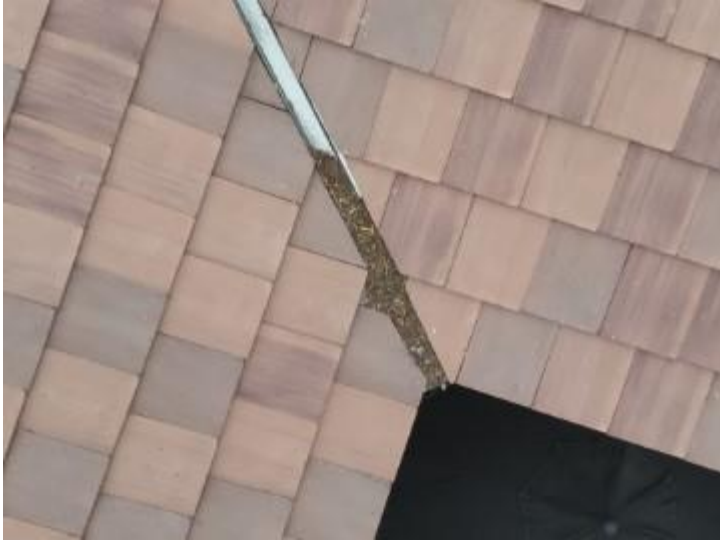
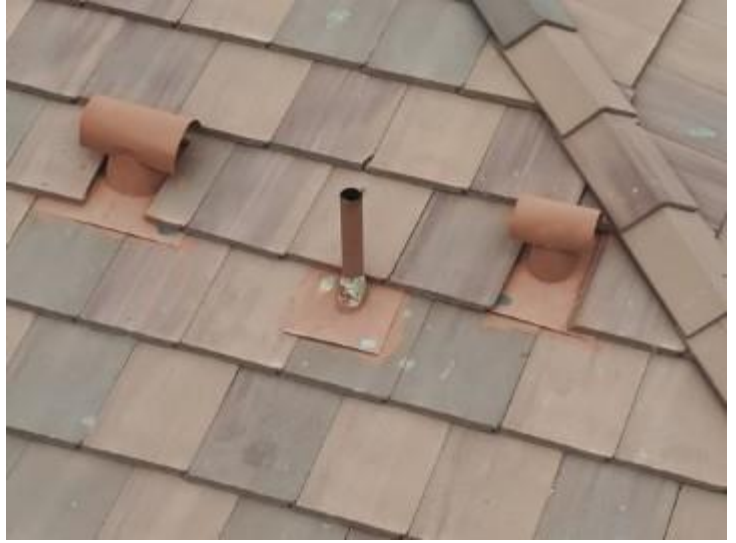
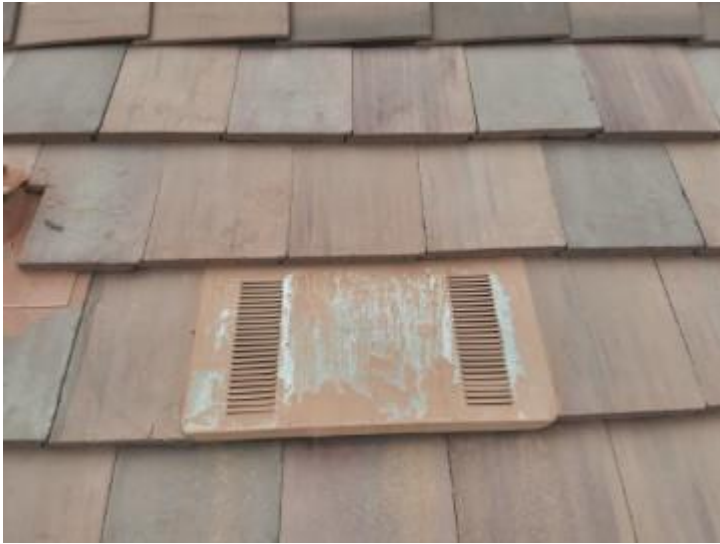
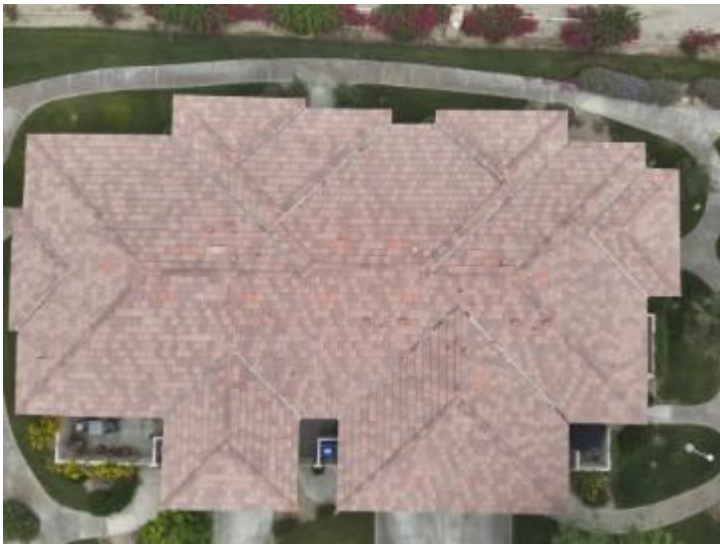
Building 28 -

ITEM	Good	Fair	Poor	N/A	COMMENTS
A - Perimeter details		X			
B - Drainage		X			Some debris noted in the valleys.
C - Penetration flashings		X			A loose flashing was noted at a plumbing vent.
D - Overall Tile condition		X			Some isolated chipped tiles noted. Some cracking noted at mortar.
E - Wall/Curb flashings				X	
F - Insulation				X	
G - Other				X

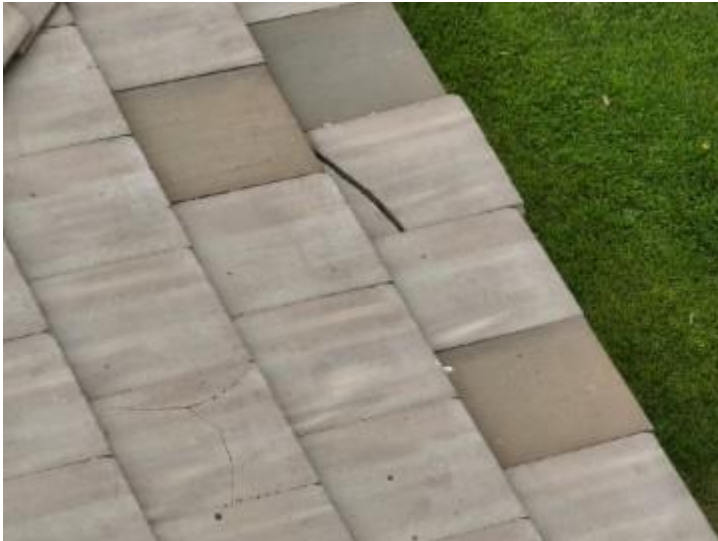
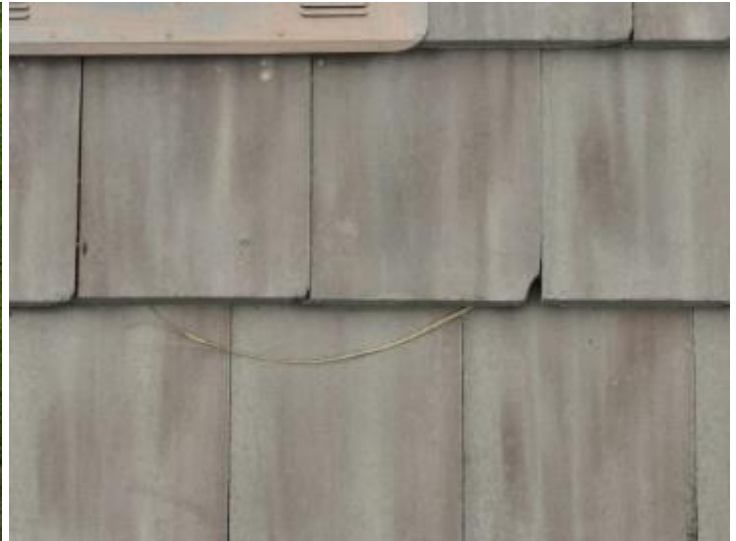
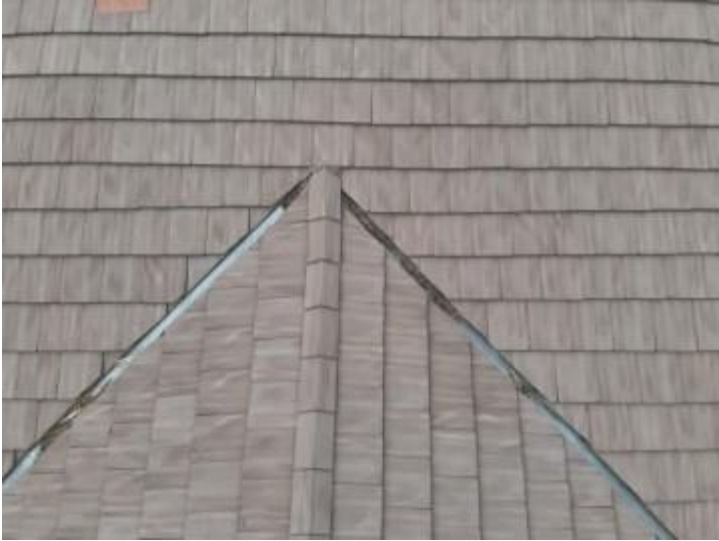
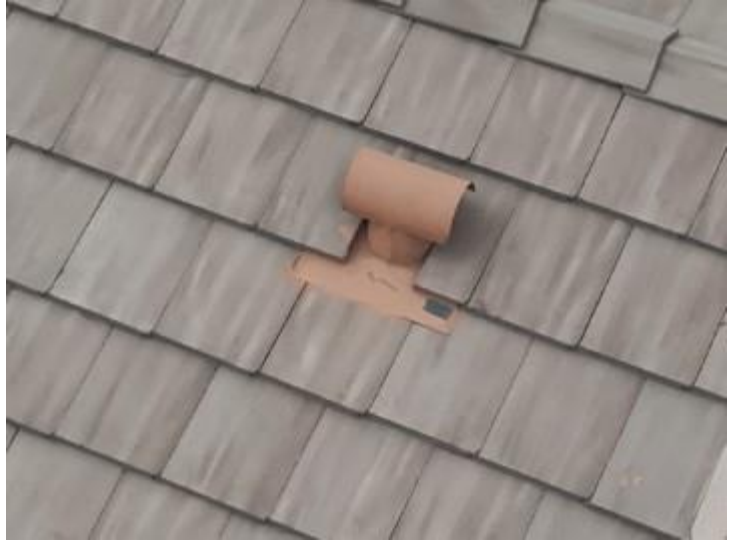
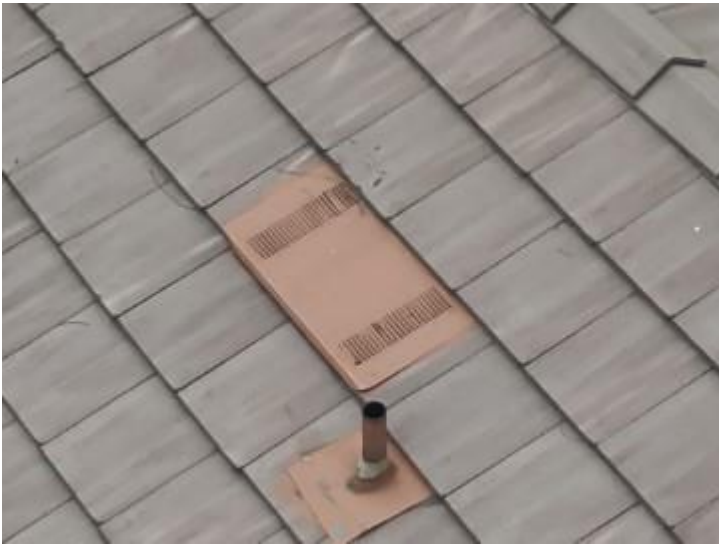
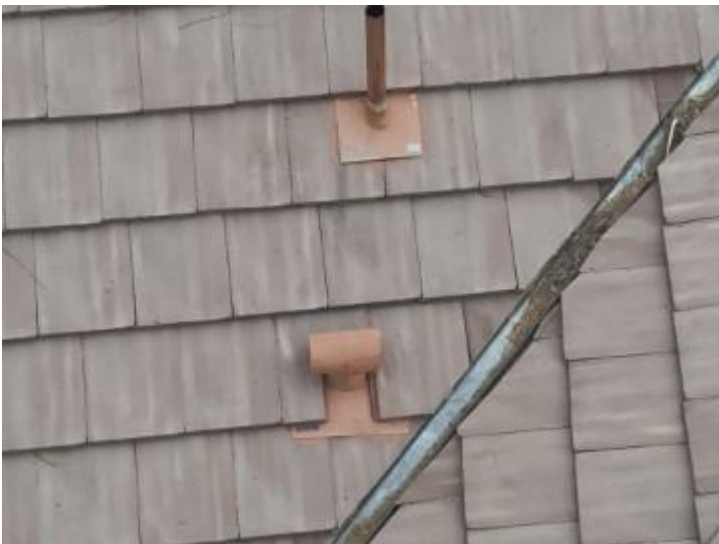
Building 29 -

ITEM	Good	Fair	Poor	N/A	COMMENTS
A - Perimeter details		X			
B - Drainage		X			Some debris noted in the valleys.
C - Penetration flashings		X			
D - Overall Tile condition		X			Some isolated cracked tiles noted. Some isolated chipped tiles noted. Some cracking noted at mortar.
E - Wall/Curb flashings				X	
F - Insulation				X	
G - Other				X

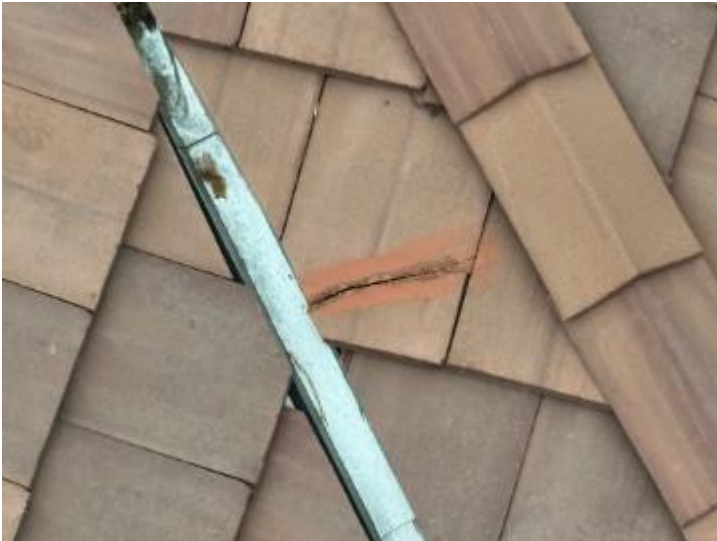
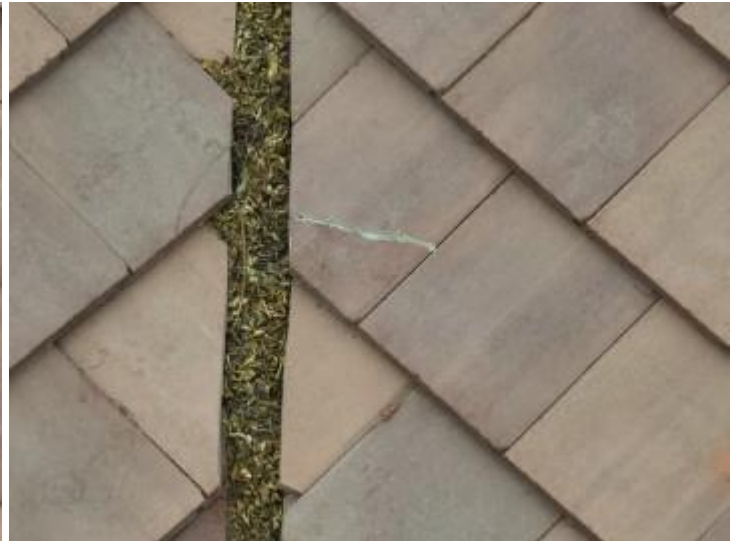
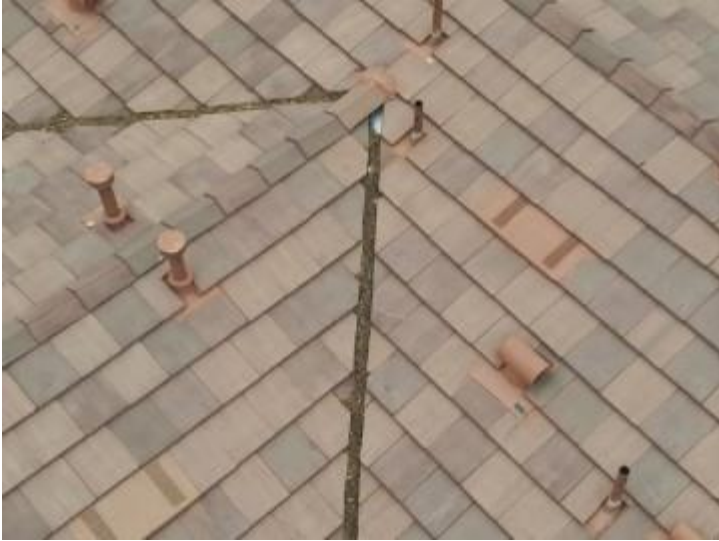
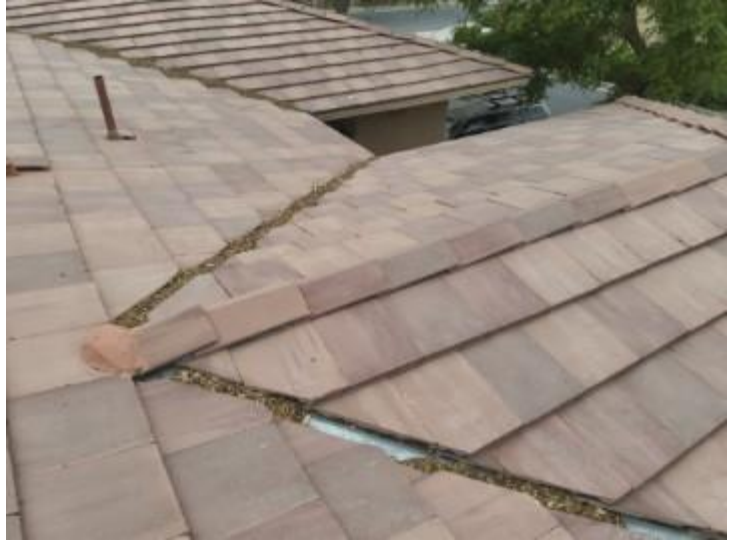
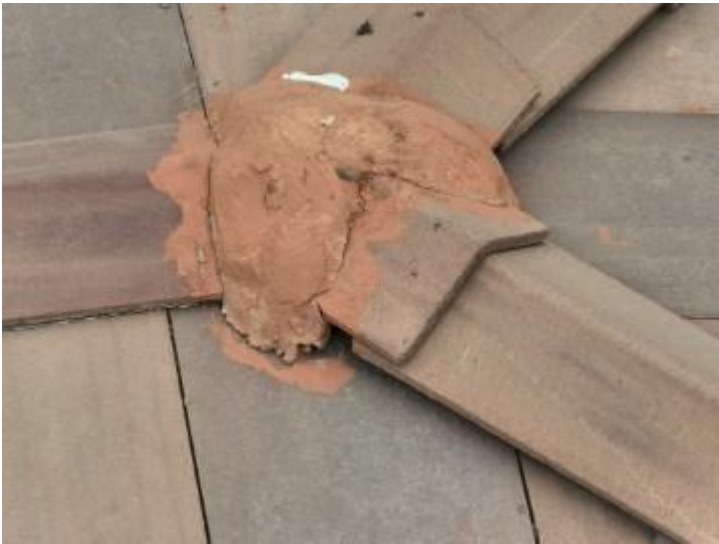
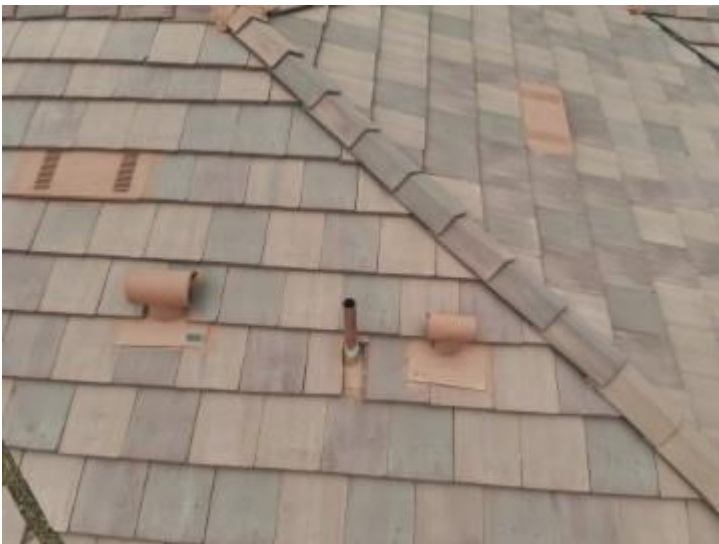
Building 30 -

ITEM	Good	Fair	Poor	N/A	COMMENTS
A - Perimeter details		X			
B - Drainage		X			Some debris noted in the valleys.
C - Penetration flashings		X			
D - Overall Tile condition		X			Some isolated cracked tiles noted. Some isolated chipped tiles noted. Some cracking noted at mortar.
E - Wall/Curb flashings				X	
F - Insulation				X	
G - Other				X

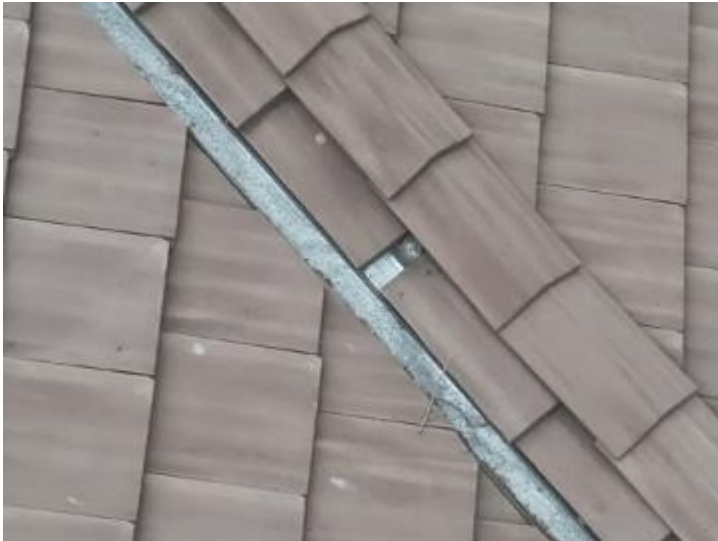
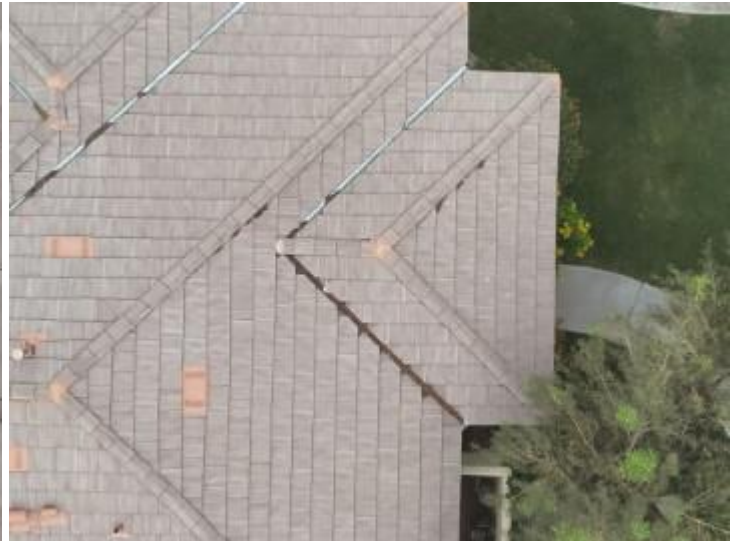
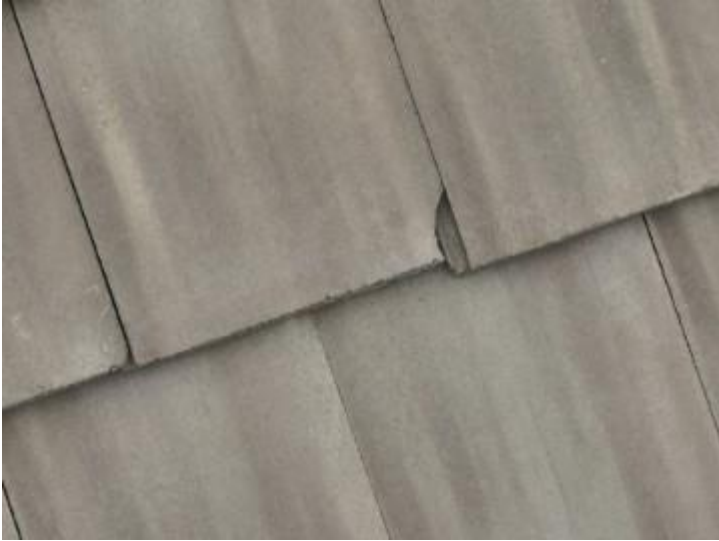
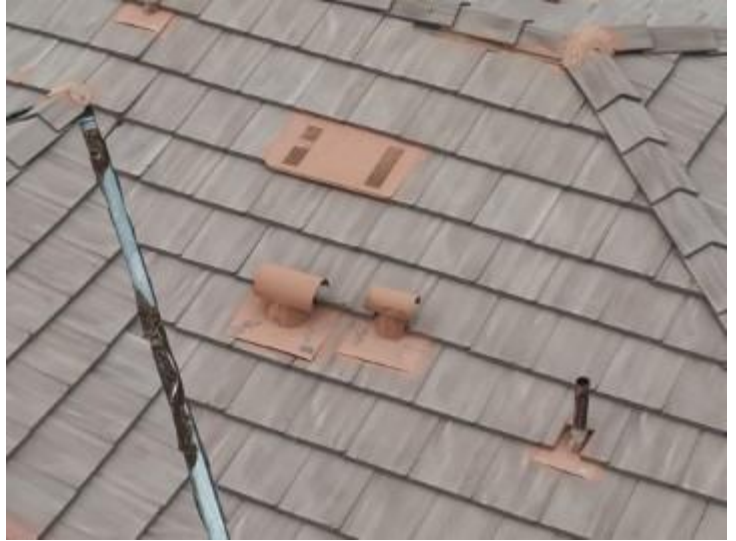
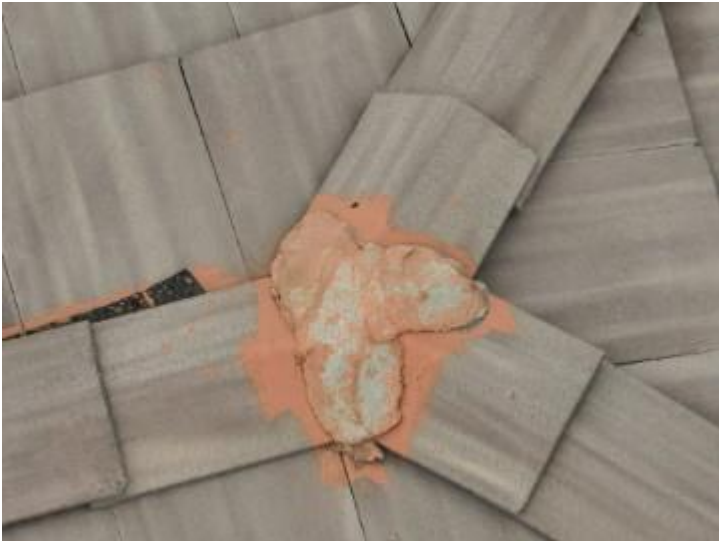
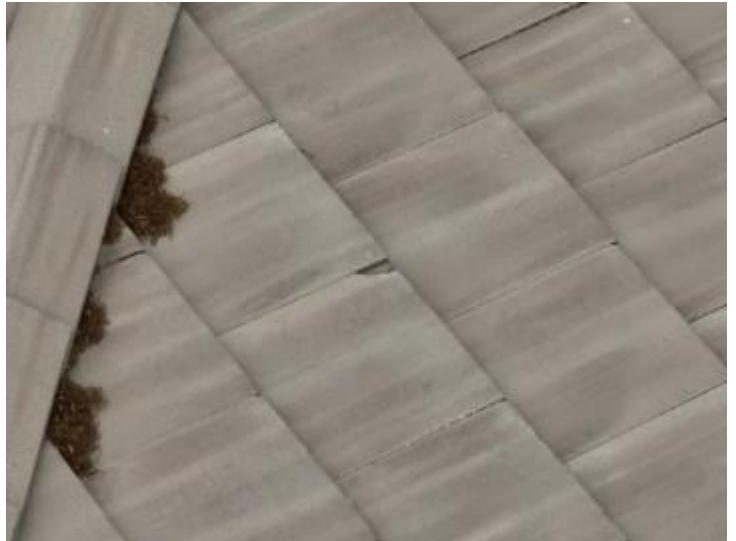
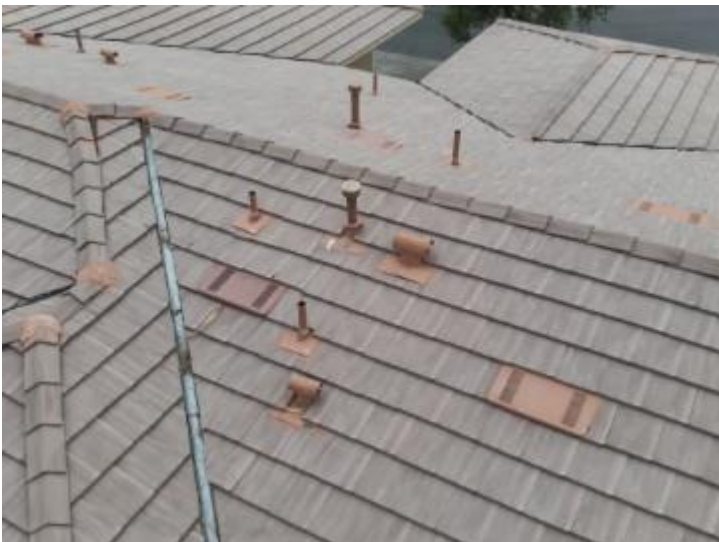
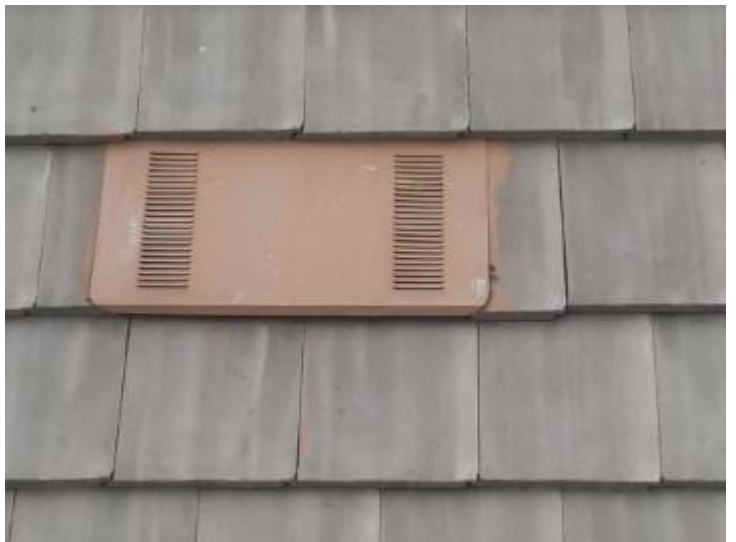
ITEM	Good	Fair	Poor	N/A	COMMENTS
A - Perimeter details		X			
B - Drainage		X			Some debris noted in the valleys.
C - Penetration flashings		X			
D - Overall Tile condition		X			A slipped tile noted at a valley. Some isolated chipped tiles noted. Some cracking noted at mortar.
E - Wall/Curb flashings				X	
F - Insulation				X	
G - Other				X

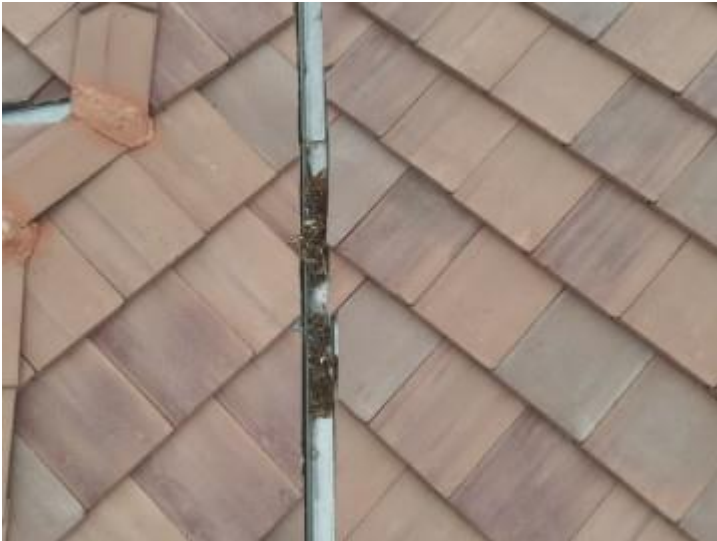
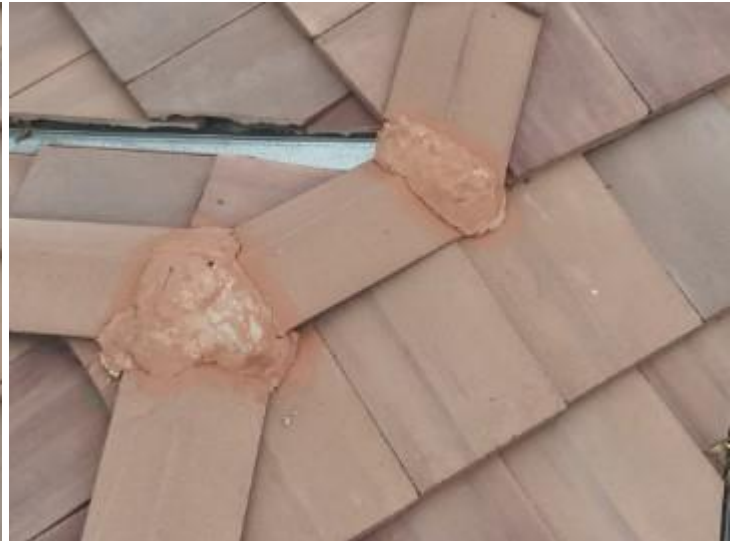
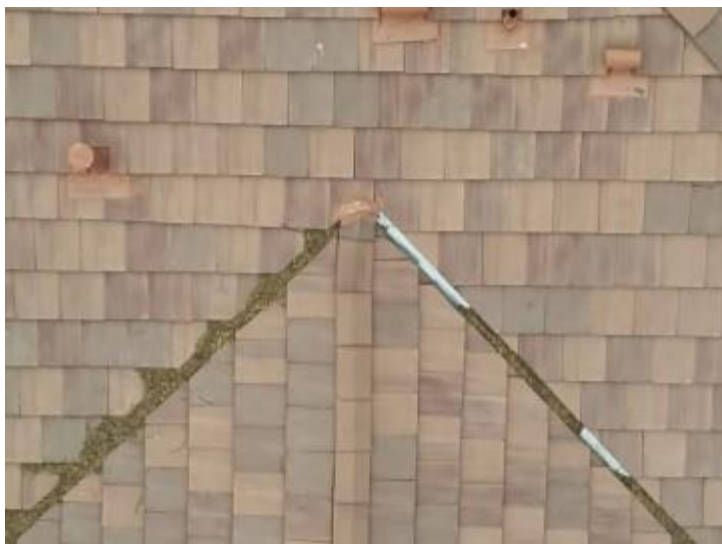
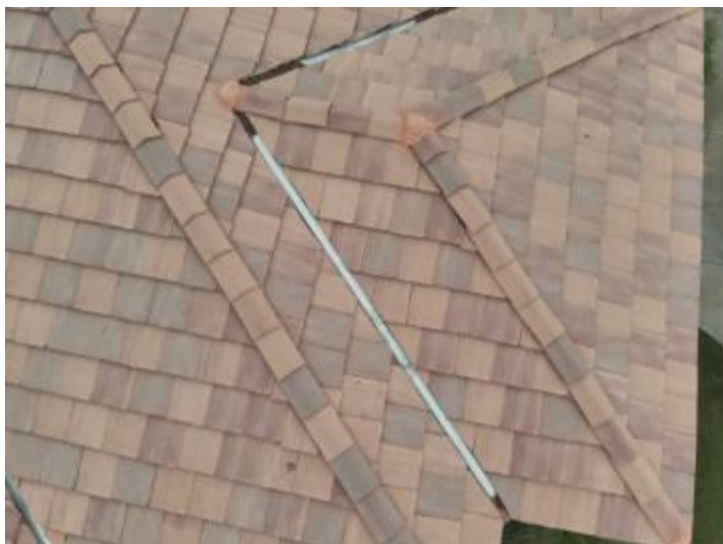
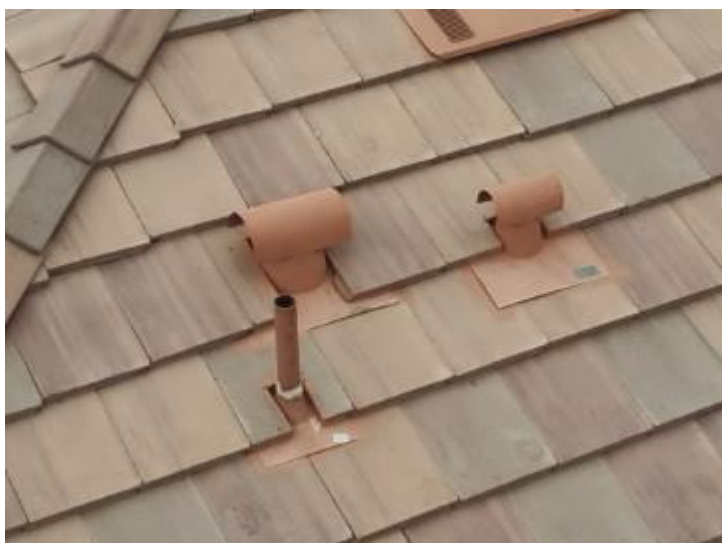
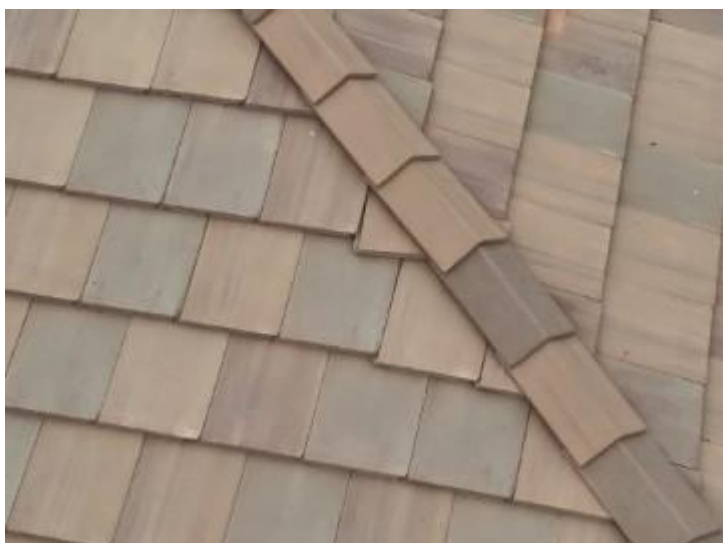
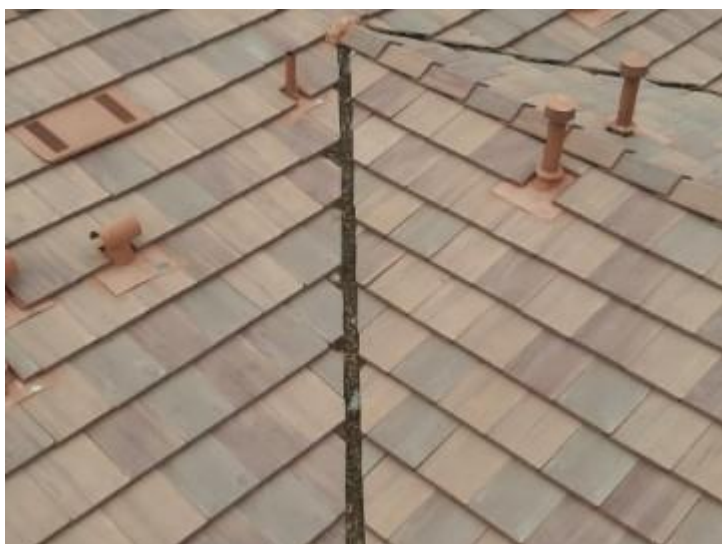
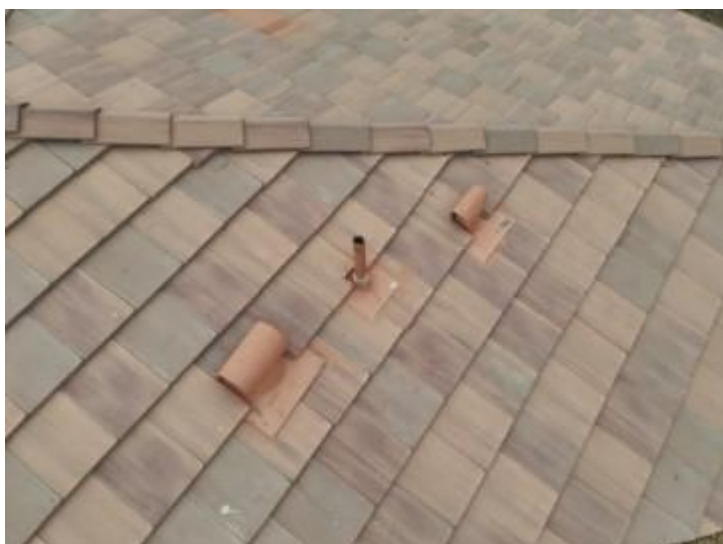
Building 32 -

ITEM	Good	Fair	Poor	N/A	COMMENTS
A - Perimeter details		X			
B - Drainage		X			Some debris noted in the valleys.
C - Penetration flashings		X			
D - Overall Tile condition		X			Some cracking noted at mortar. A slipped tile noted at hip.
E - Wall/Curb flashings				X	
F - Insulation				X	
G - Other				X
