June 13th, 2024

Re: Roof Consulting
Mountain View Villas
78000 Betty Barker Way
Indian Wells, CA 92210

Alliance Consulting & Testing Inc. has completed our initial roof surveys and we have the following report of our findings and opinions regarding the roofing systems on this property. We understand the purpose of the surveys was to determine the overall condition of the roofing systems including past repairs, what repairs still need to be made, the remaining service life of the systems and/or does the roofing systems need to be replaced.

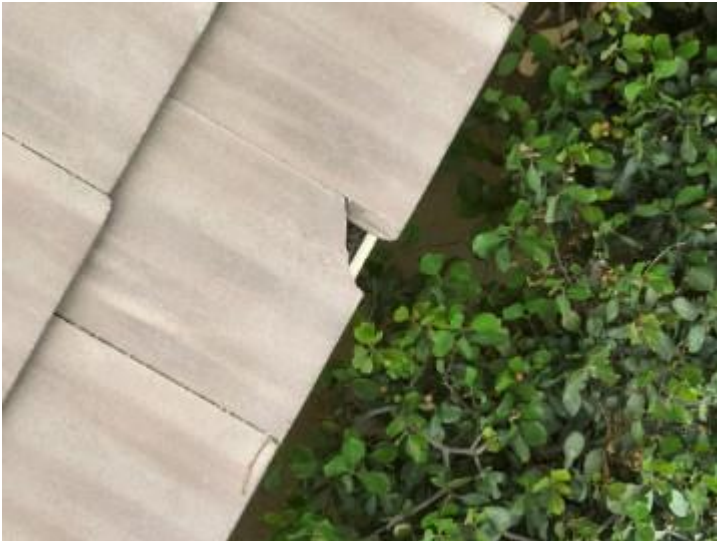
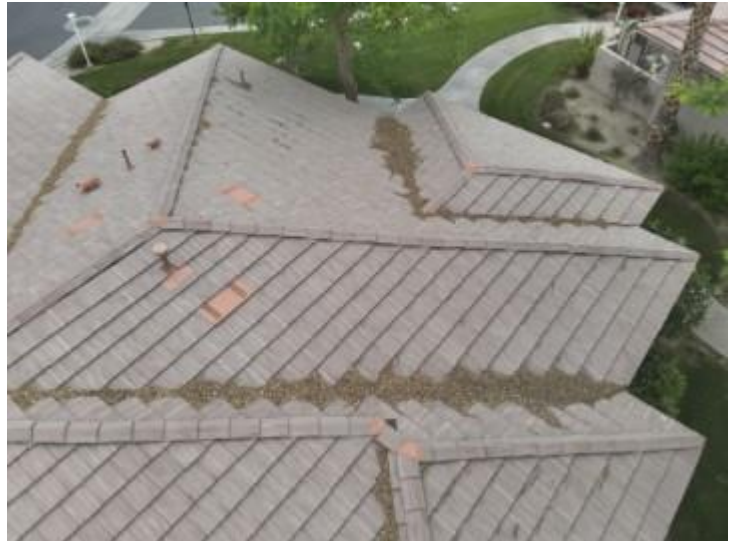
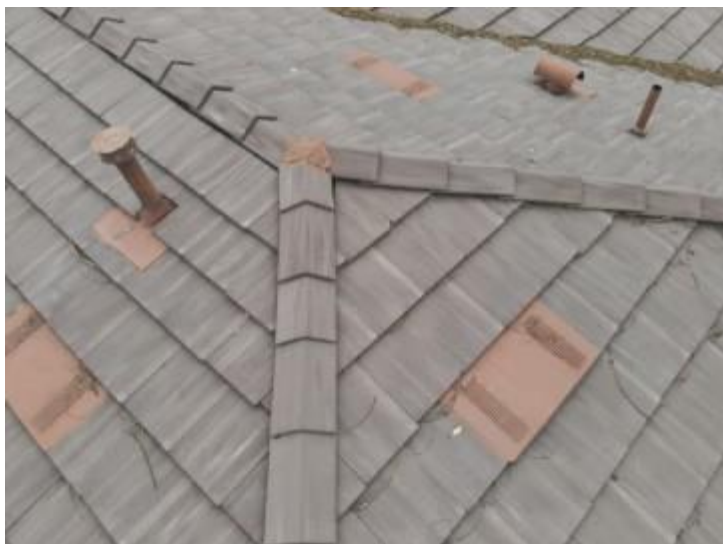
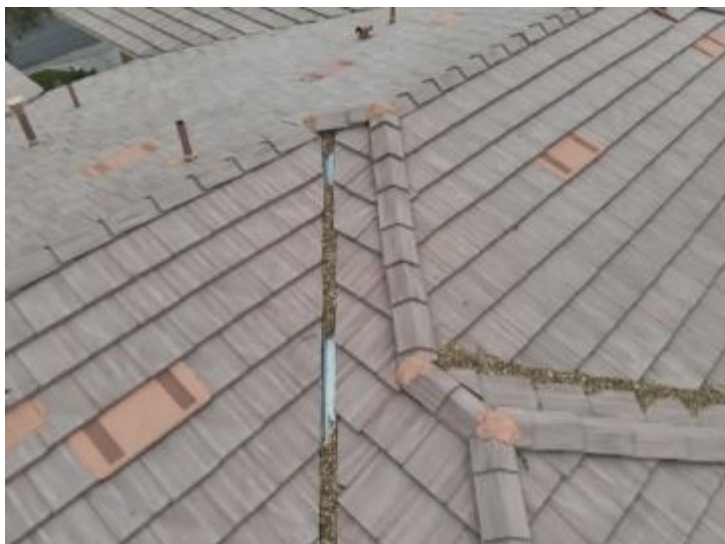
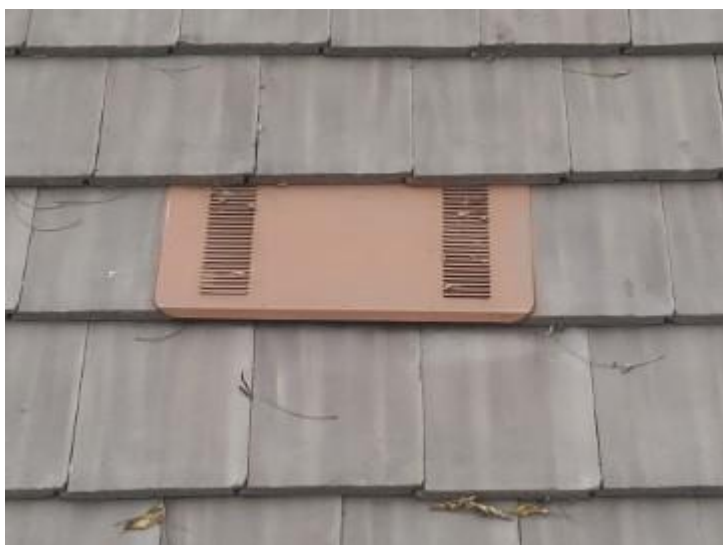
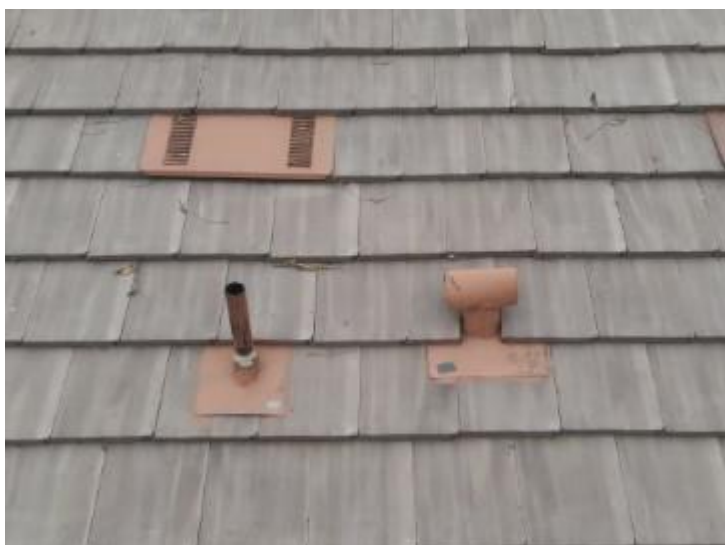
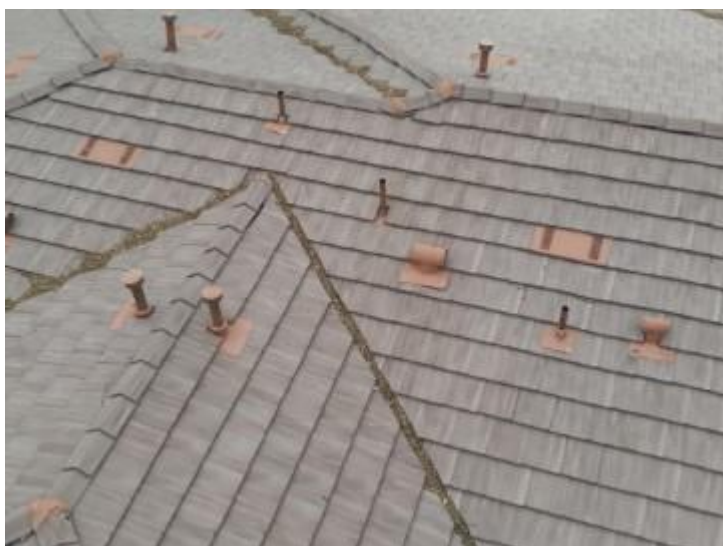
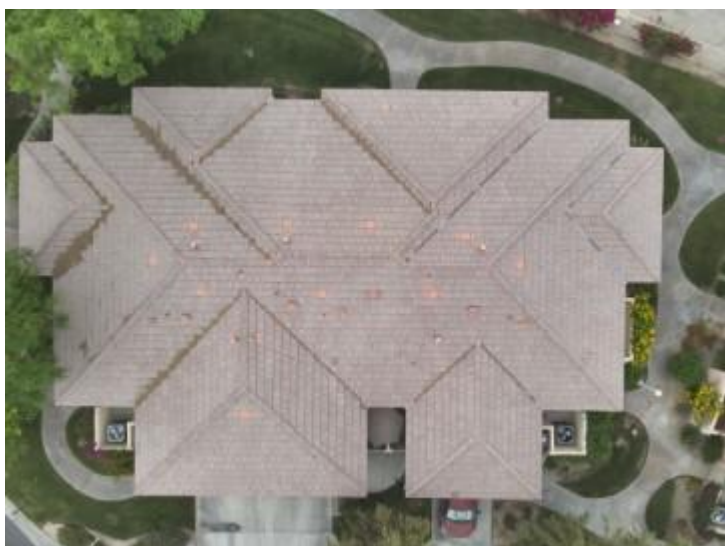
Building 33 -

ITEM	Good	Fair	Poor	N/A	COMMENTS
A - Perimeter details		X			
B - Drainage		X			Some debris noted in the valleys.
C - Penetration flashings		X			
D - Overall Tile condition		X			Some isolated cracked tiles noted. Some isolated chipped tiles noted. Some cracking noted at mortar.
E - Wall/Curb flashings				X	
F - Insulation				X	
G - Other				X

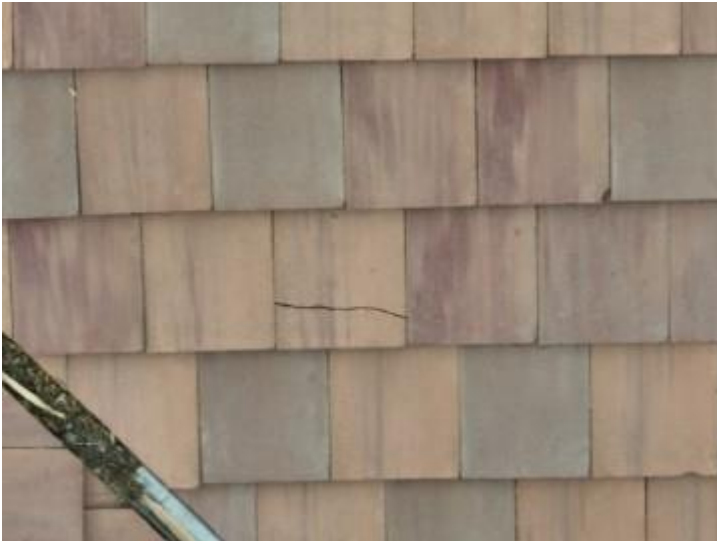
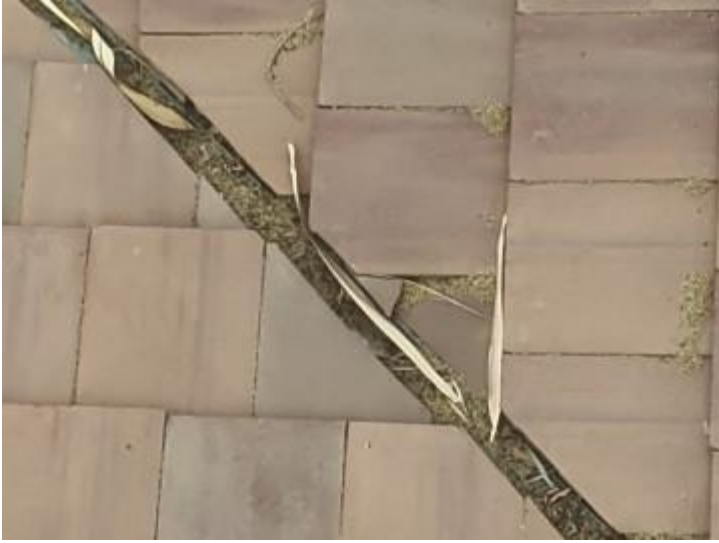
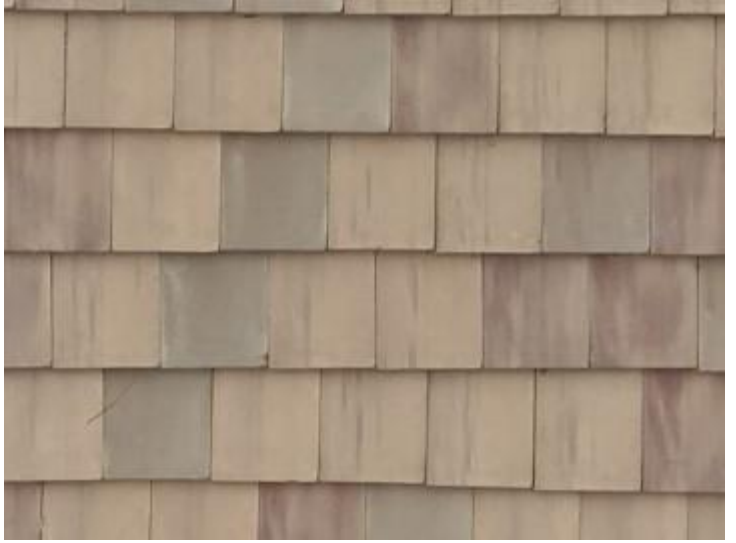
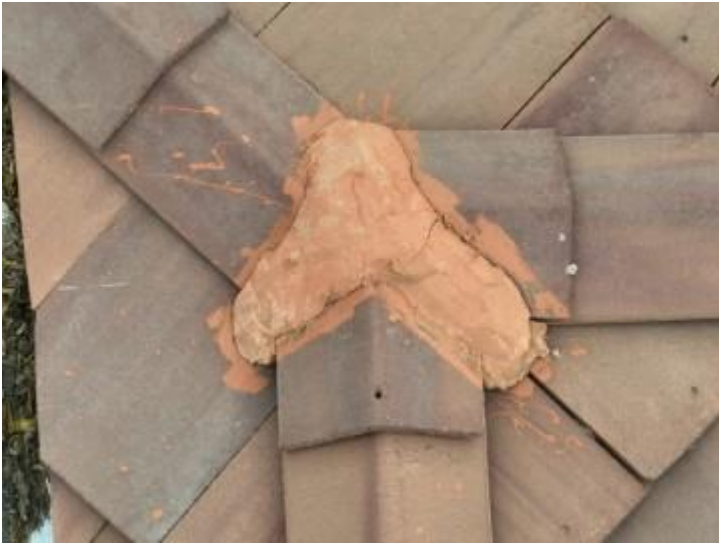
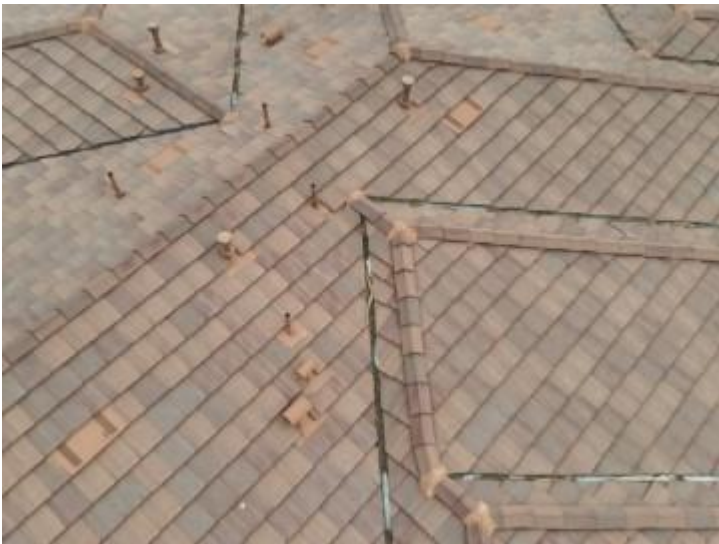
Building 34 -

ITEM	Good	Fair	Poor	N/A	COMMENTS
A - Perimeter details		X			
B - Drainage		X			Some debris noted in the valleys.
C - Penetration flashings		X			
D - Overall Tile condition		X			Some isolated cracked/ broken tiles noted. Some isolated chipped tiles noted. Some cracking noted at mortar.
E - Wall/Curb flashings				X	
F - Insulation				X	
G - Other				X

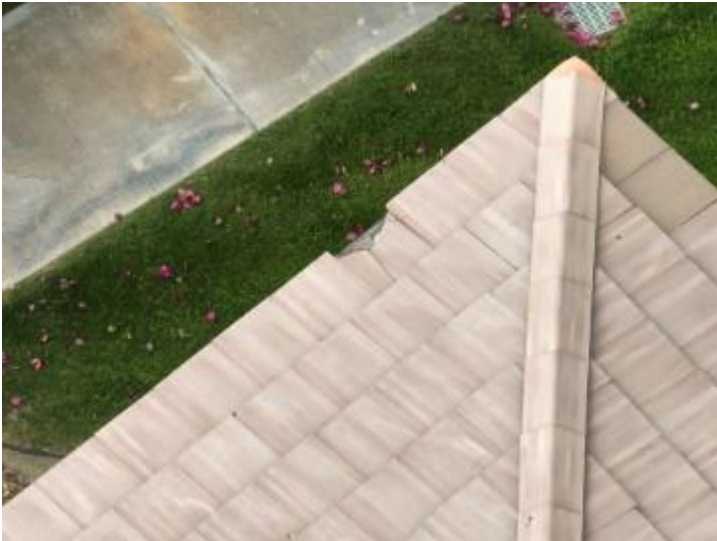
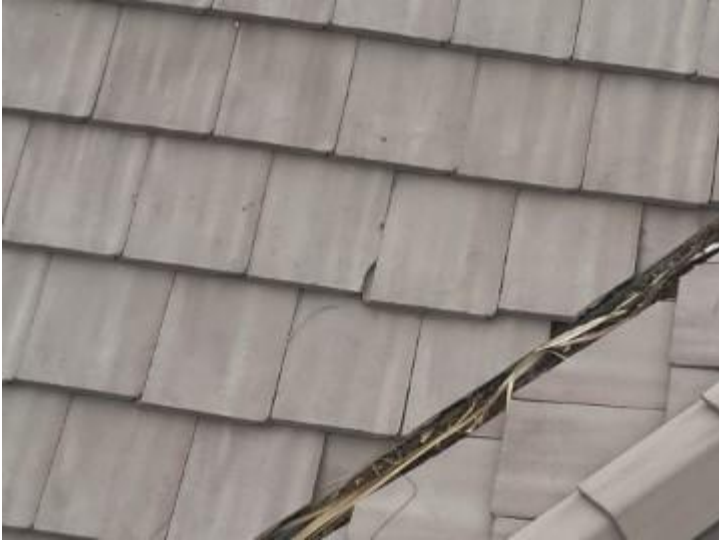
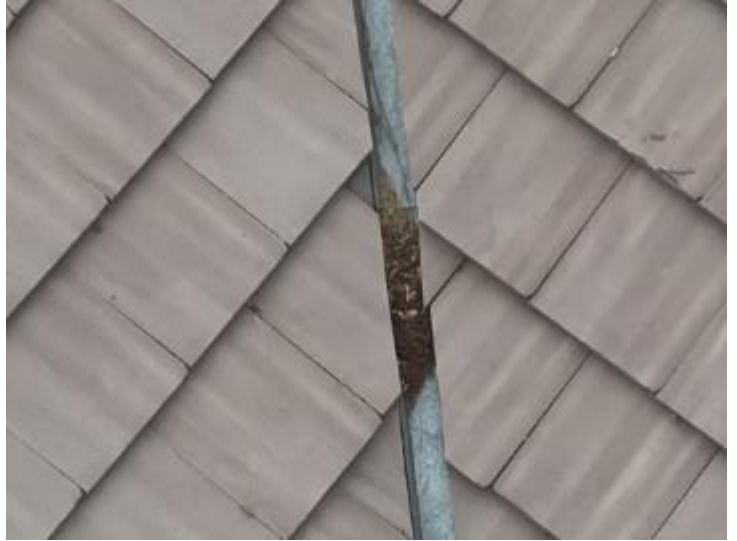
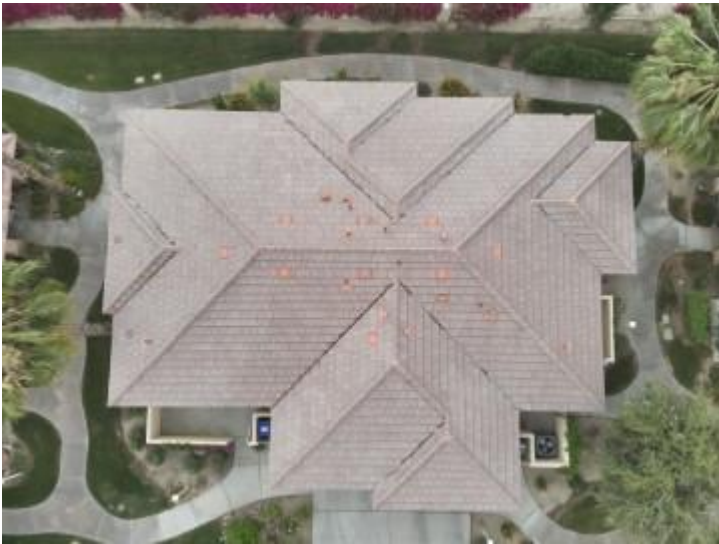
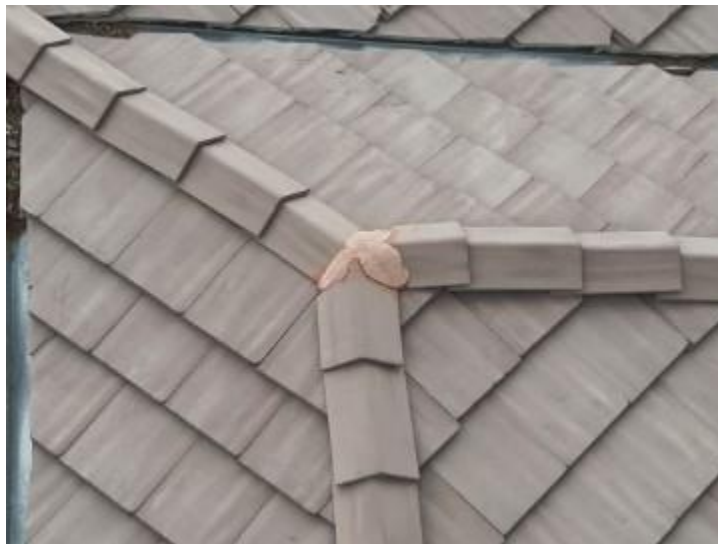
Building 35 -

ITEM	Good	Fair	Poor	N/A	COMMENTS
A - Perimeter details		X			
B - Drainage		X			Some debris noted in the valleys.
C - Penetration flashings		X			
D - Overall Tile condition		X			Some isolated cracked/broken tiles noted. Some isolated chipped tiles noted. Some cracking noted at mortar.
E - Wall/Curb flashings				X	
F - Insulation				X	
G - Other				X

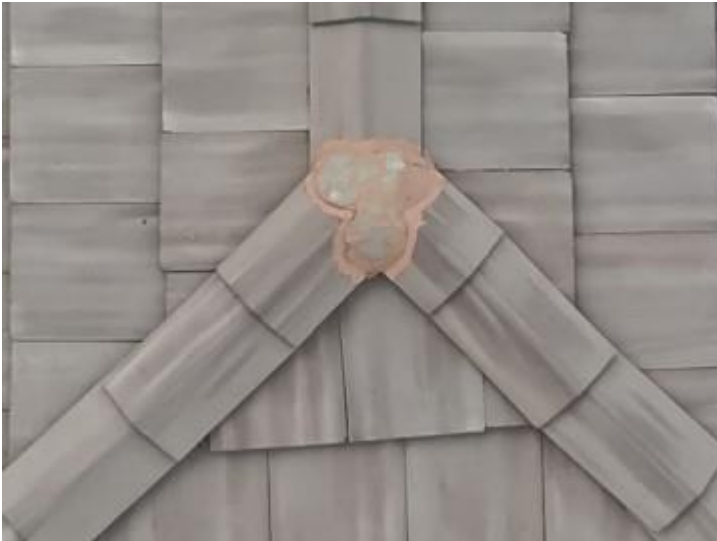
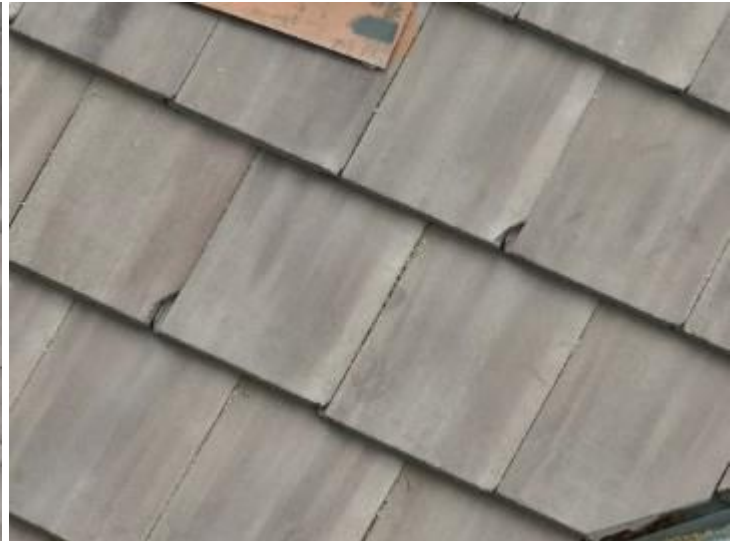
Building 36 -

ITEM	Good	Fair	Poor	N/A	COMMENTS
A - Perimeter details		X			
B - Drainage		X			Some debris noted in the valleys.
C - Penetration flashings		X			
D - Overall Tile condition		X			Some isolated chipped tiles noted. Some cracking noted at mortar.
E - Wall/Curb flashings		X			
F - Insulation				X	
G - Other				X

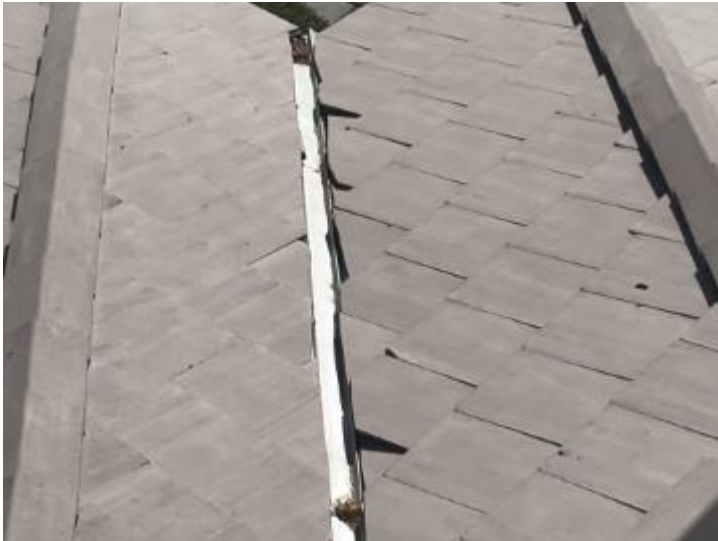
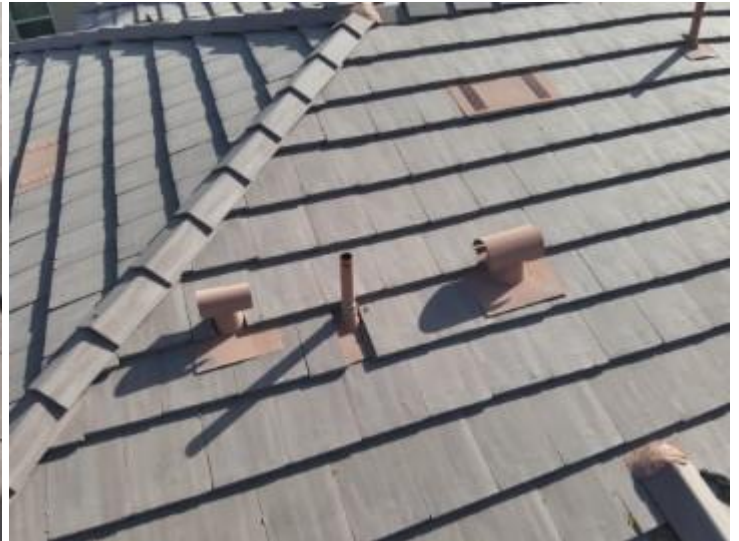
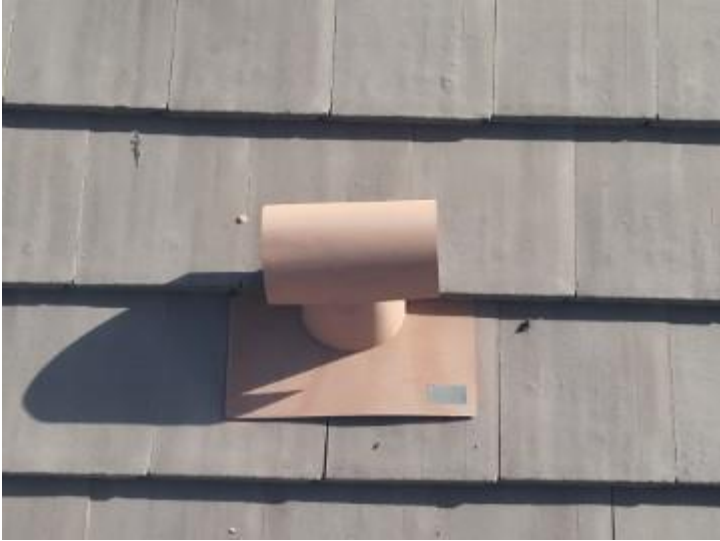
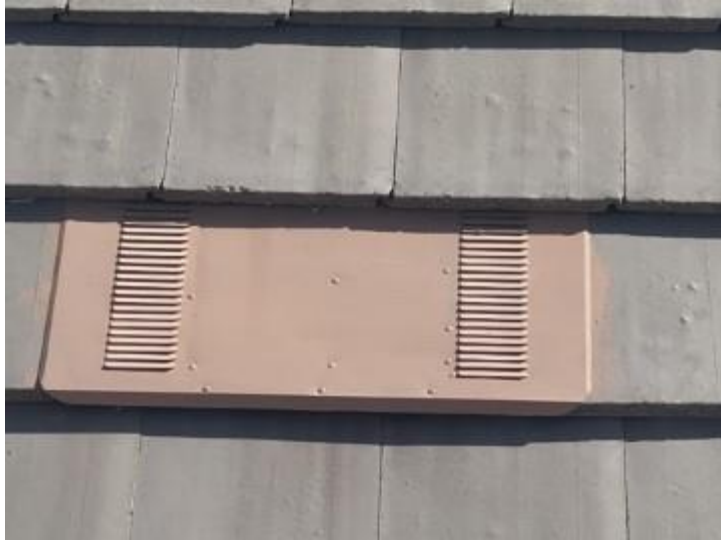
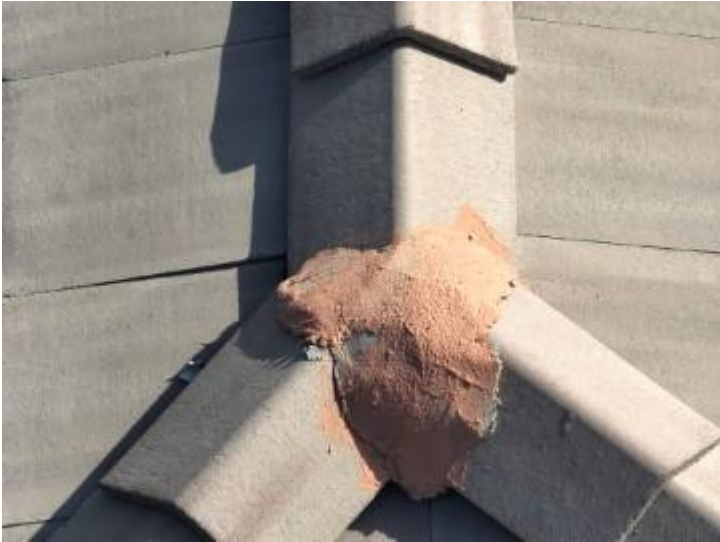
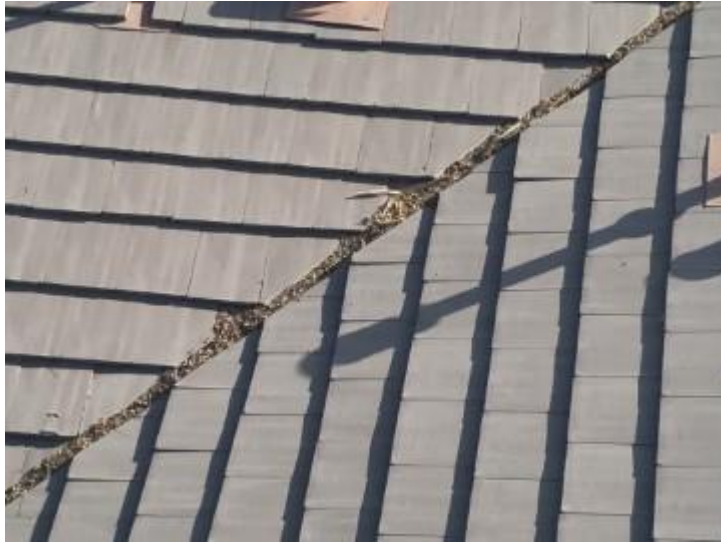
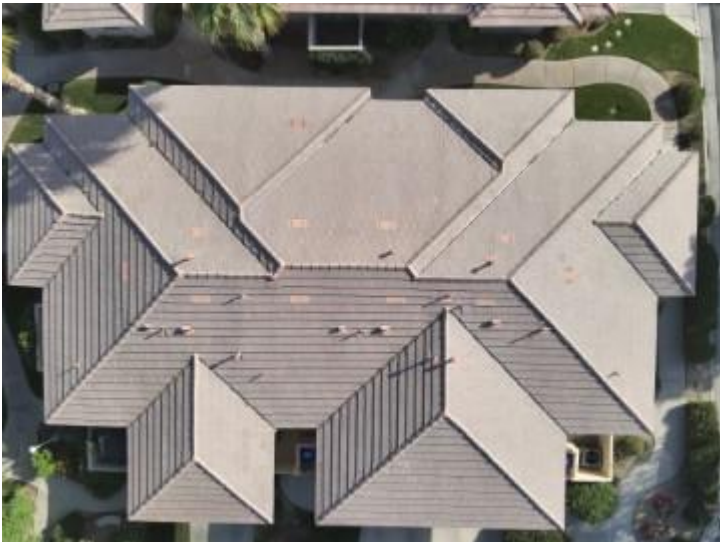
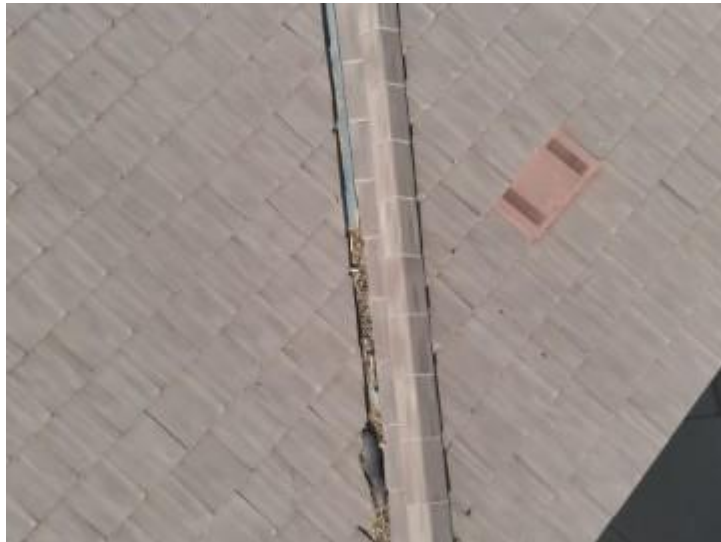
Building 37 -

ITEM	Good	Fair	Poor	N/A	COMMENTS
A - Perimeter details		X			
B - Drainage		X			Some debris noted in the valleys.
C - Penetration flashings		X			
D - Overall Tile condition		X			Some isolated chipped tiles noted. Some cracking noted at mortar.
E - Wall/Curb flashings				X	
F - Insulation				X	
G - Other				X

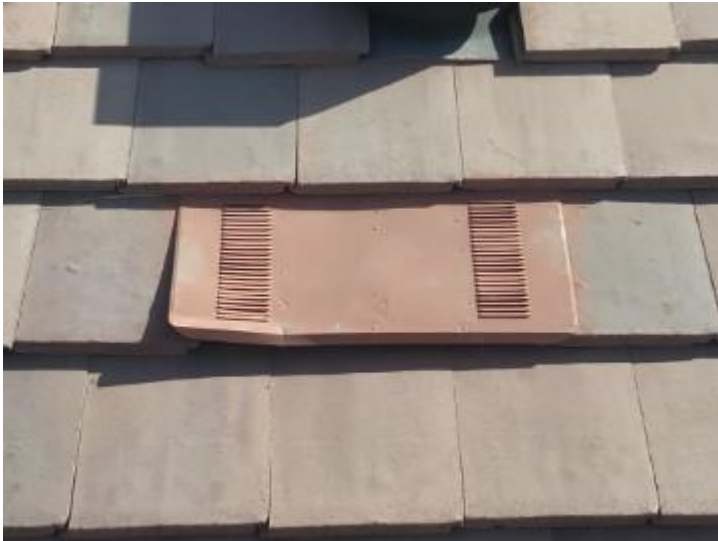
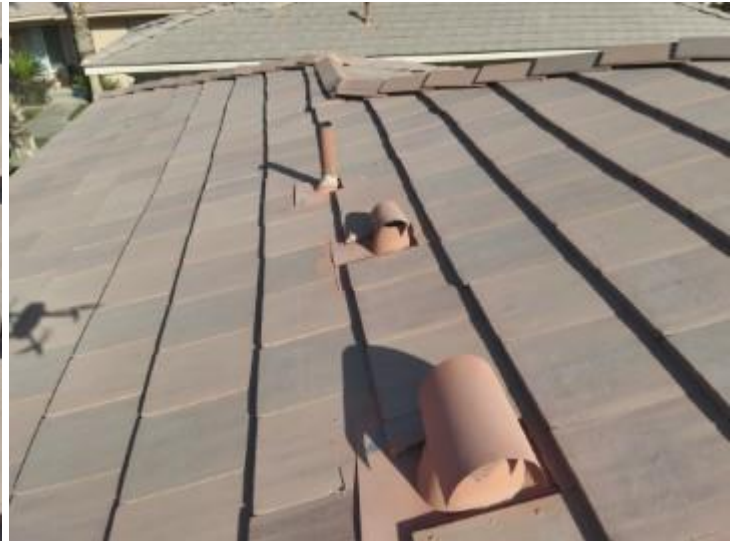
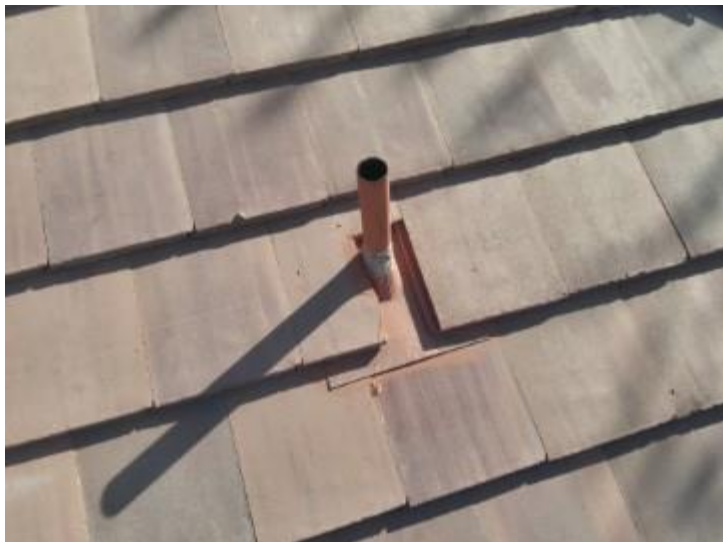
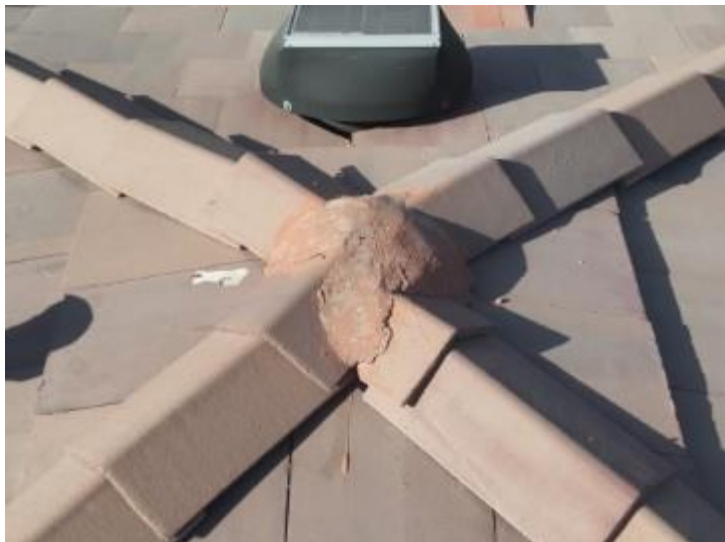
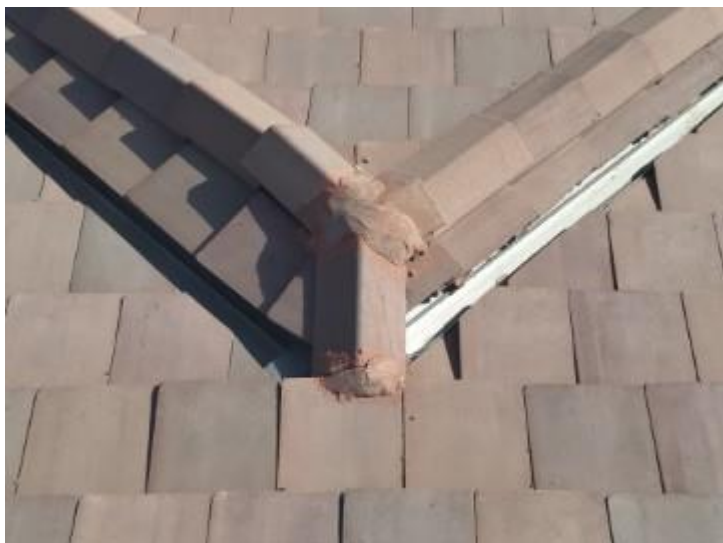
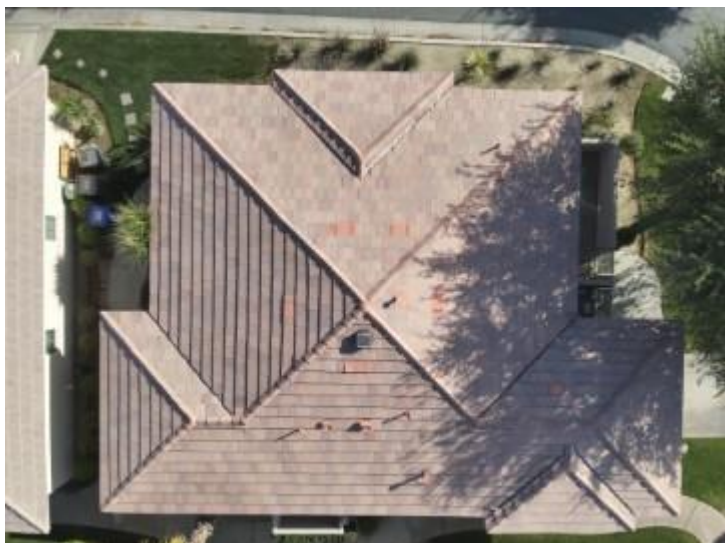
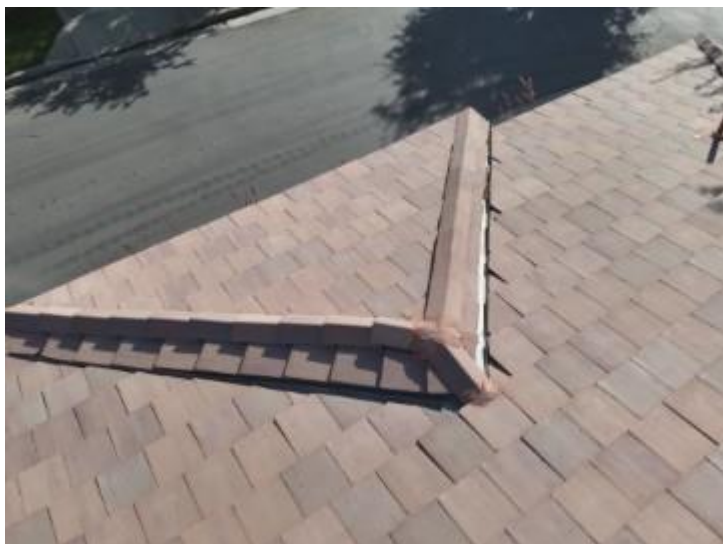
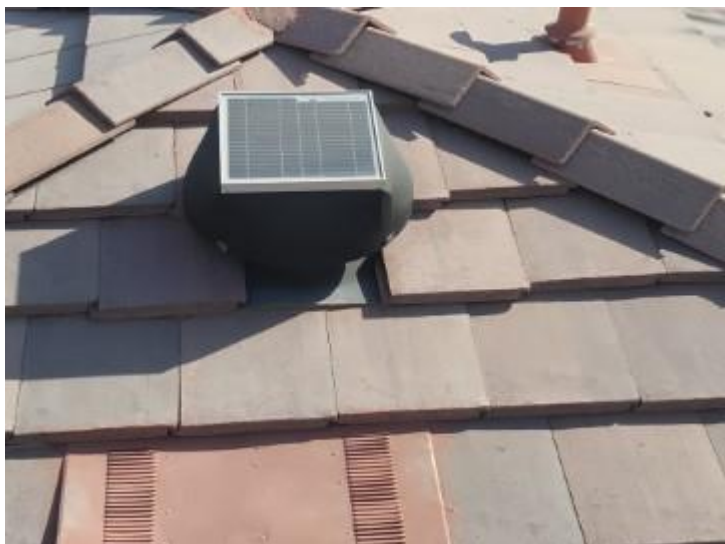
Building 38 -

ITEM	Good	Fair	Poor	N/A	COMMENTS
A - Perimeter details		X			
B - Drainage		X			Some debris noted in the valleys.
C - Penetration flashings		X			A bent attic vent noted.
D - Overall Tile condition		X			Some cracking noted at mortar.
E - Wall/Curb flashings				X	
F - Insulation				X	
G - Other				X

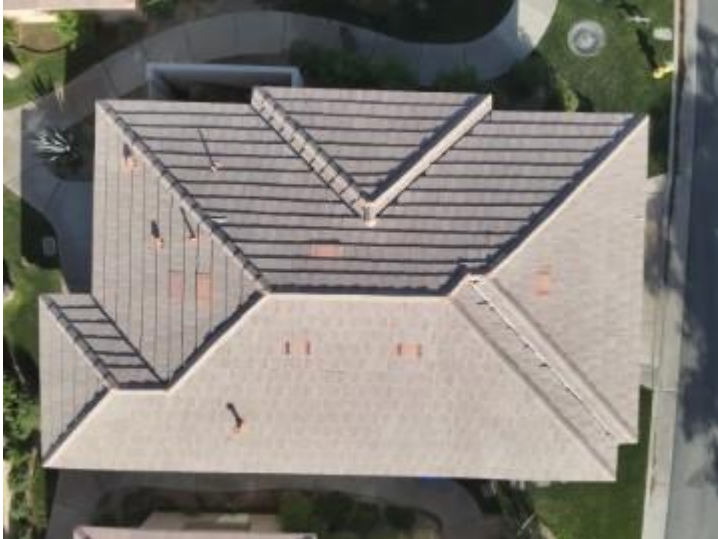
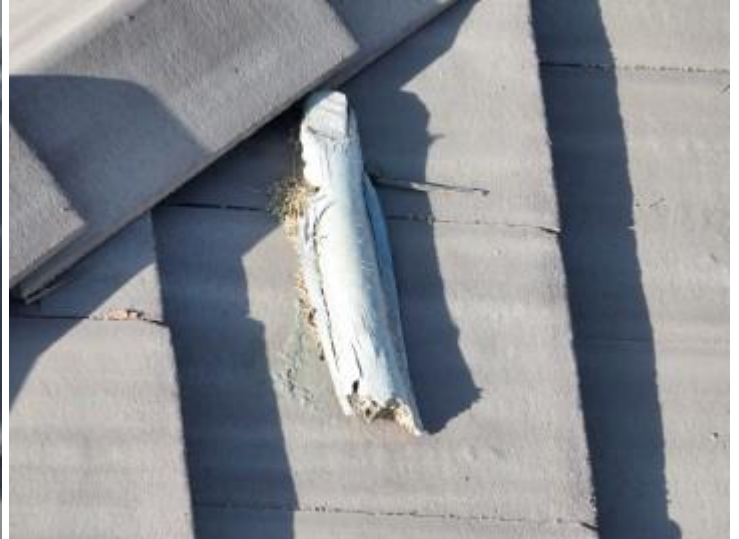
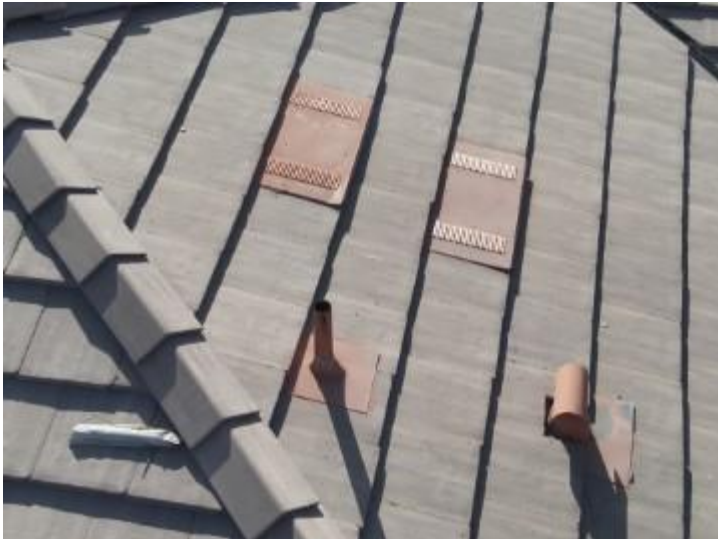
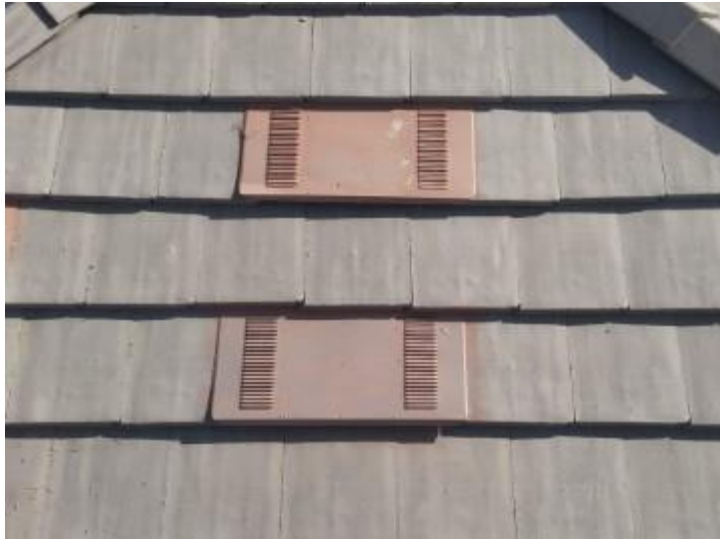
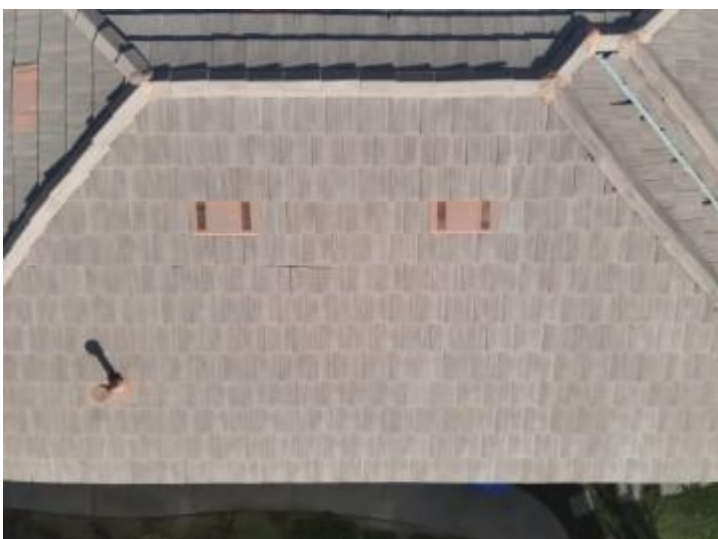
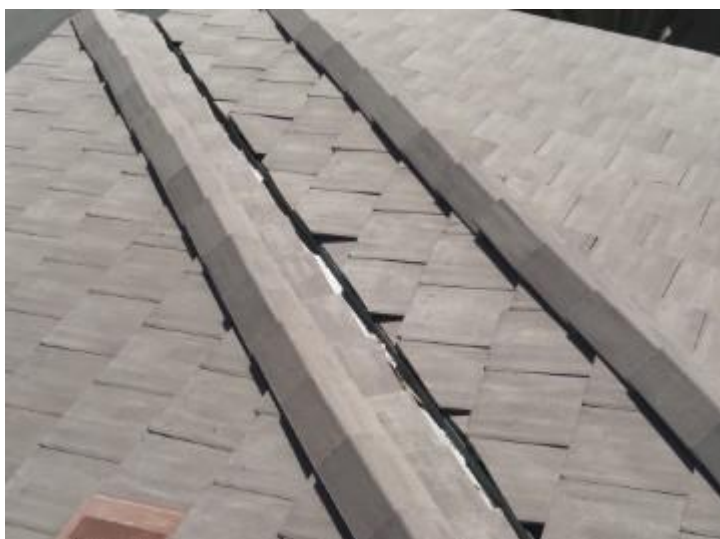
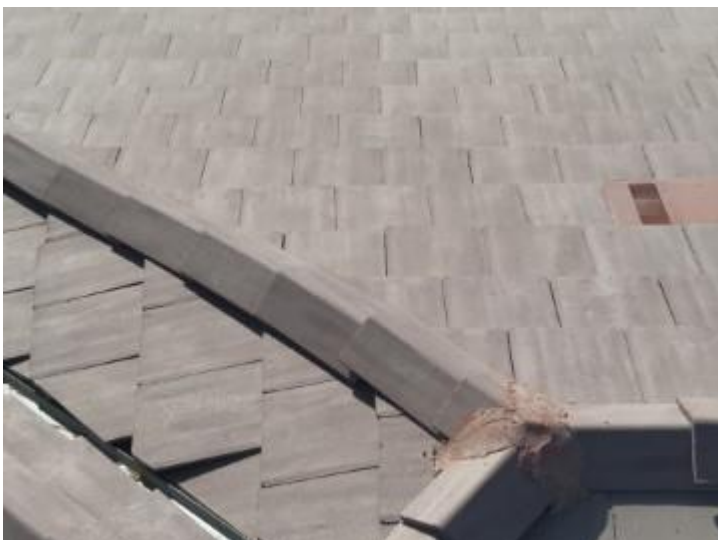
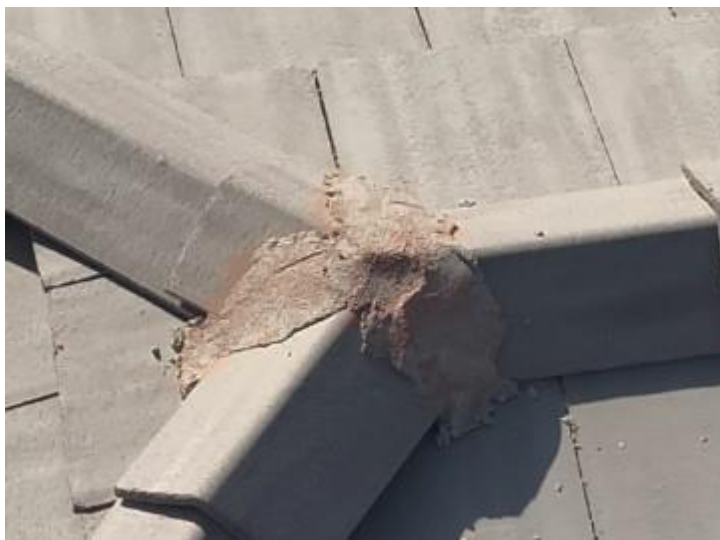
Building 39 -

ITEM	Good	Fair	Poor	N/A	COMMENTS
A - Perimeter details		X			
B - Drainage		X			Some debris noted in the valleys.
C - Penetration flashings		X			
D - Overall Tile condition		X			
E - Wall/Curb flashings		X			
F - Insulation				X	
G - Other				X

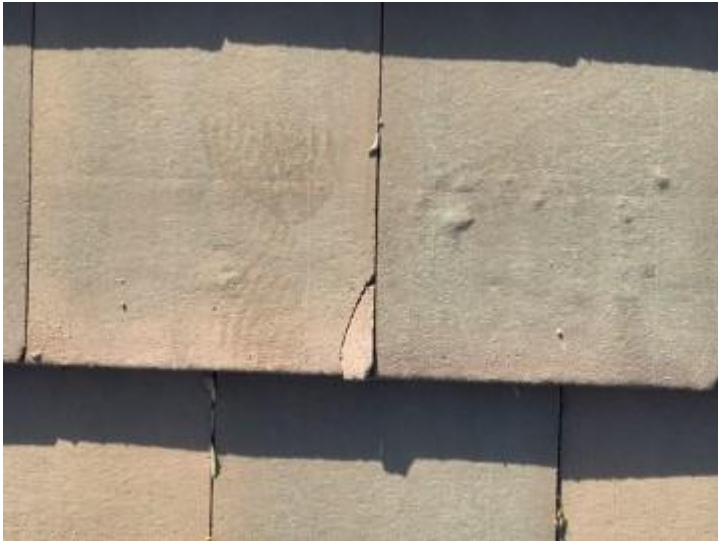
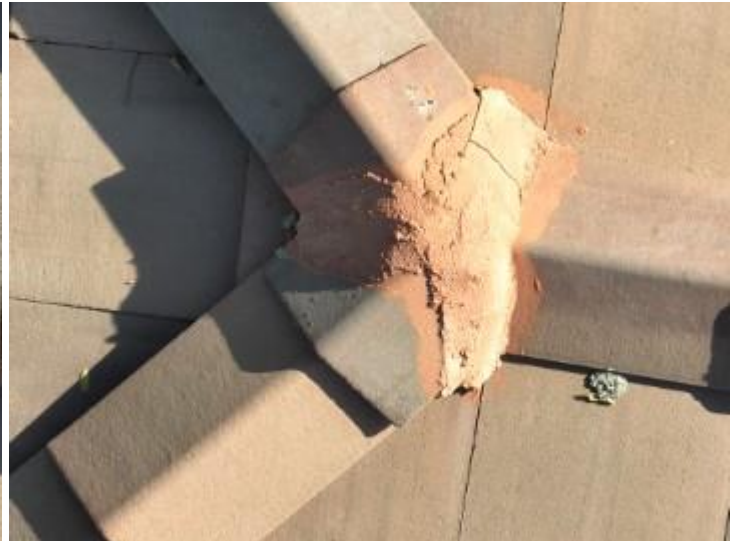
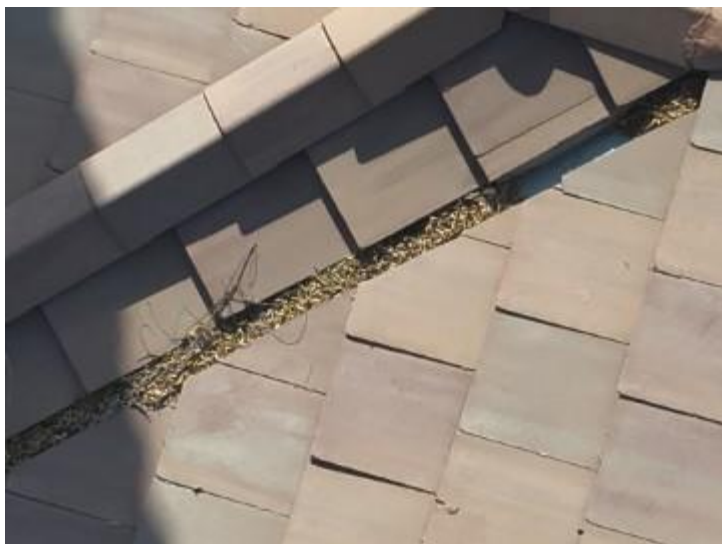
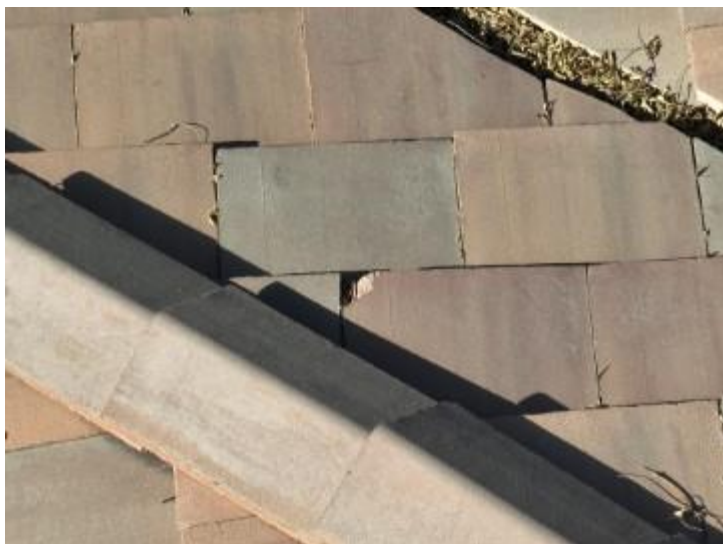
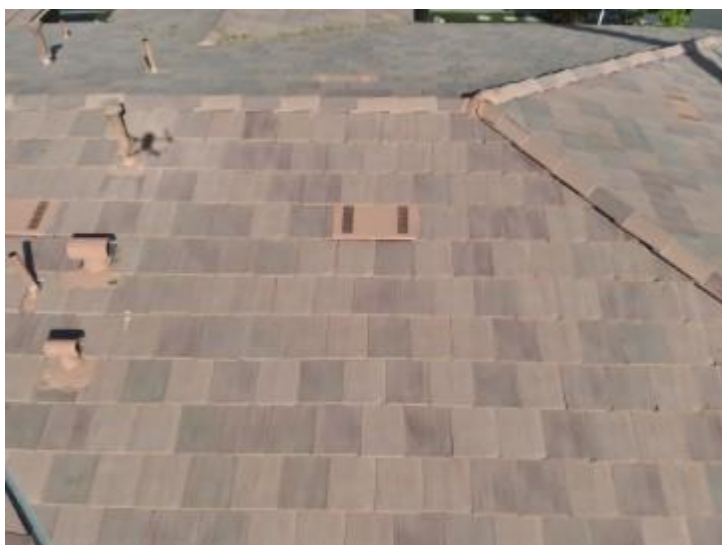
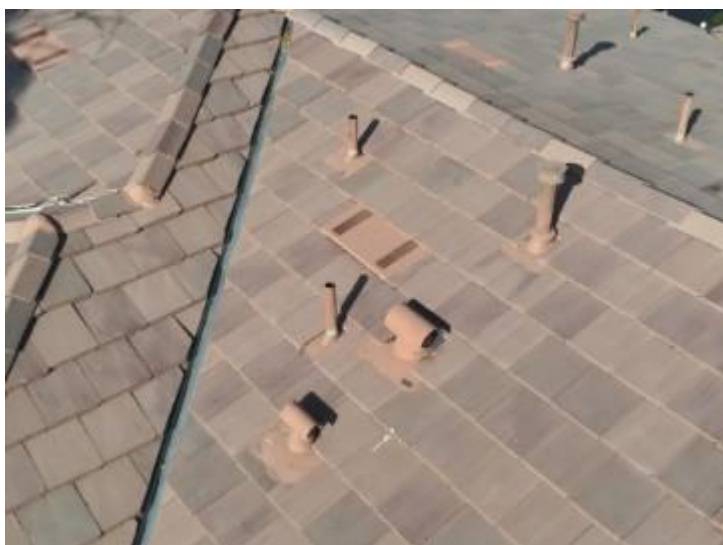
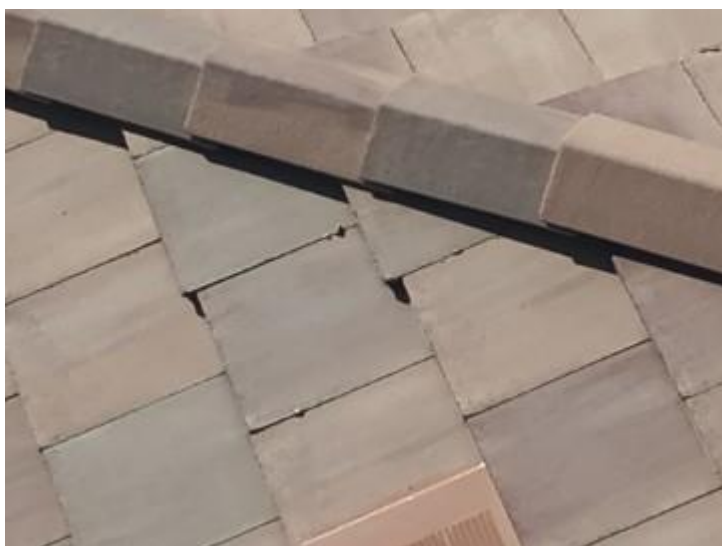
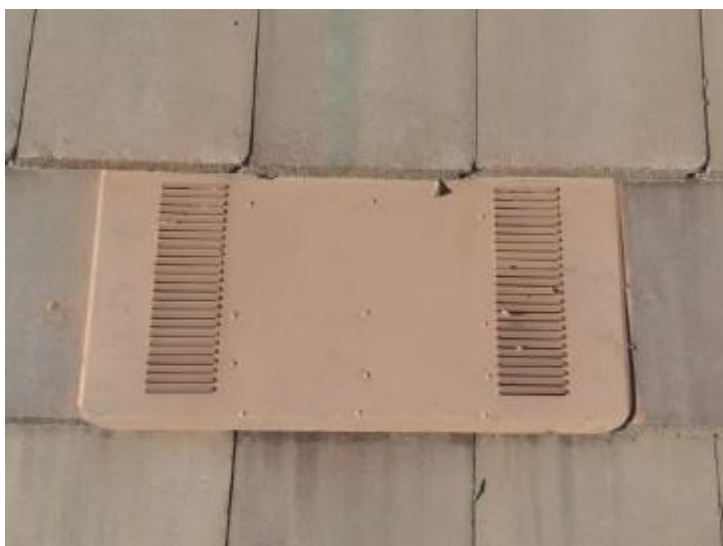
Building 40 -

ITEM	Good	Fair	Poor	N/A	COMMENTS
A - Perimeter details		X			
B - Drainage		X			Some debris noted in the valleys.
C - Penetration flashings		X			
D - Overall Tile condition		X			Some isolated chipped tiles noted. Some cracking noted at mortar.
E - Wall/Curb flashings				X	
F - Insulation				X	
G - Other				X

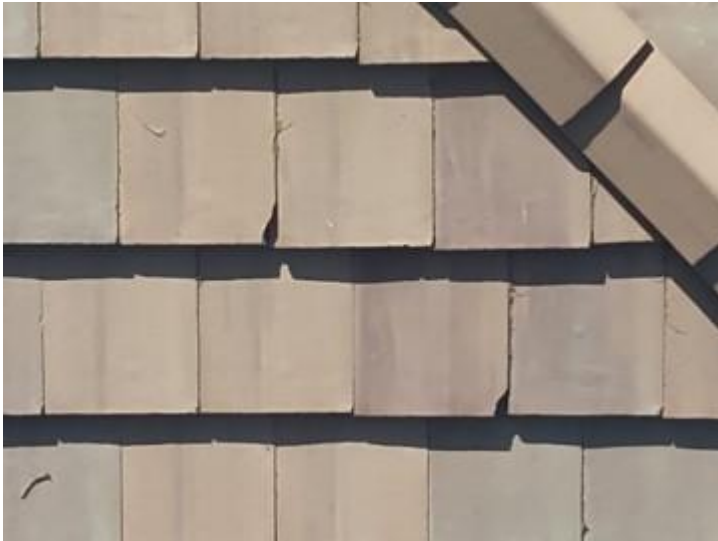
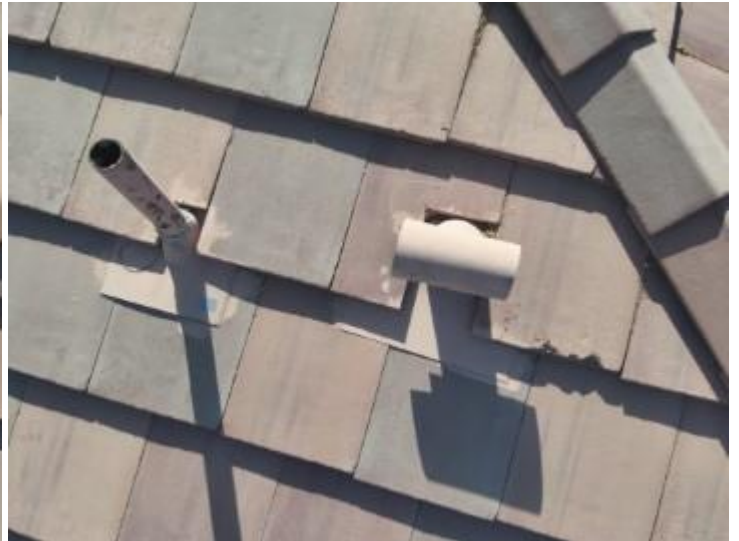
Building 41 -

ITEM	Good	Fair	Poor	N/A	COMMENTS
A - Perimeter details		X			
B - Drainage		X			Some debris noted in the valleys.
C - Penetration flashings		X			
D - Overall Tile condition		X			Some isolated chipped tiles noted. Some cracking noted at mortar.
E - Wall/Curb flashings				X	
F - Insulation				X	
G - Other				X
