June 13th, 2024

Re: Roof Consulting
Mountain View Villas
78000 Betty Barker Way
Indian Wells, CA 92210

Alliance Consulting & Testing Inc. has completed our initial roof surveys and we have the following report of our findings and opinions regarding the roofing systems on this property. We understand the purpose of the surveys was to determine the overall condition of the roofing systems including past repairs, what repairs still need to be made, the remaining service life of the systems and/or does the roofing systems need to be replaced.

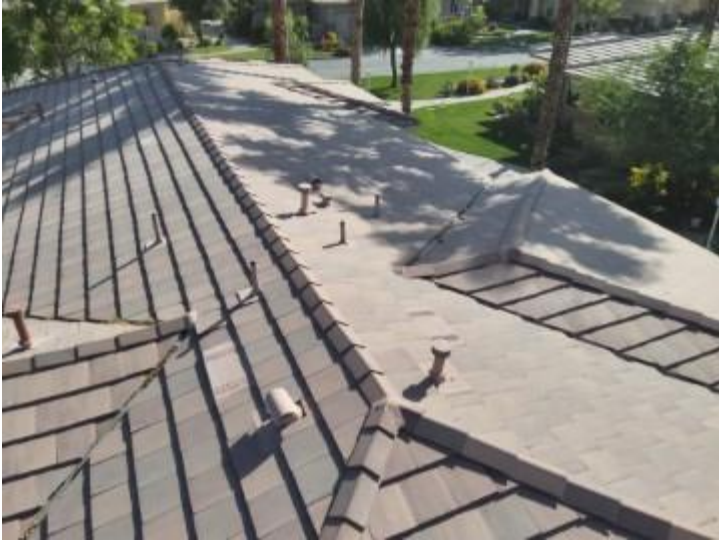
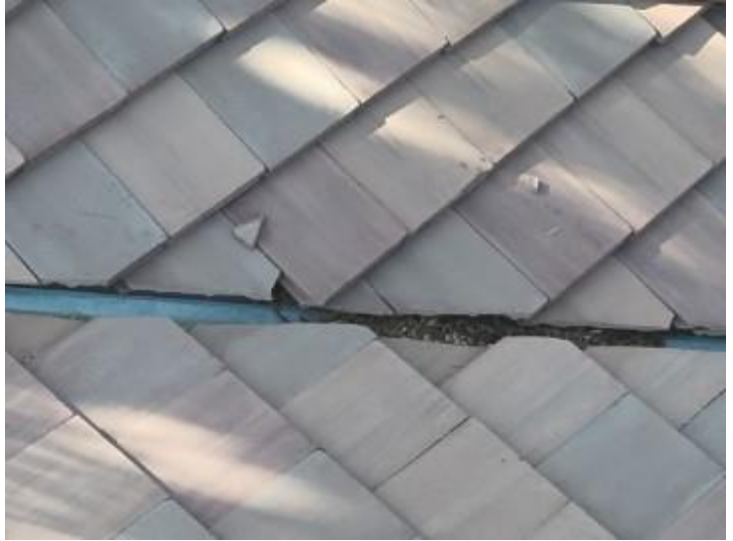
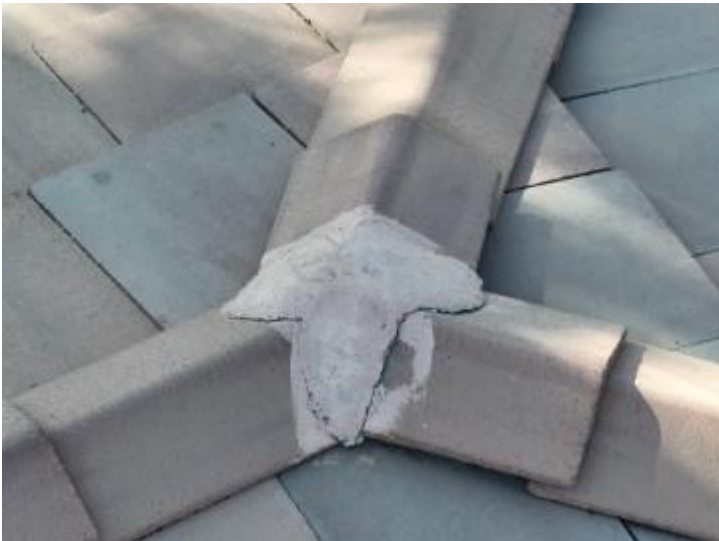
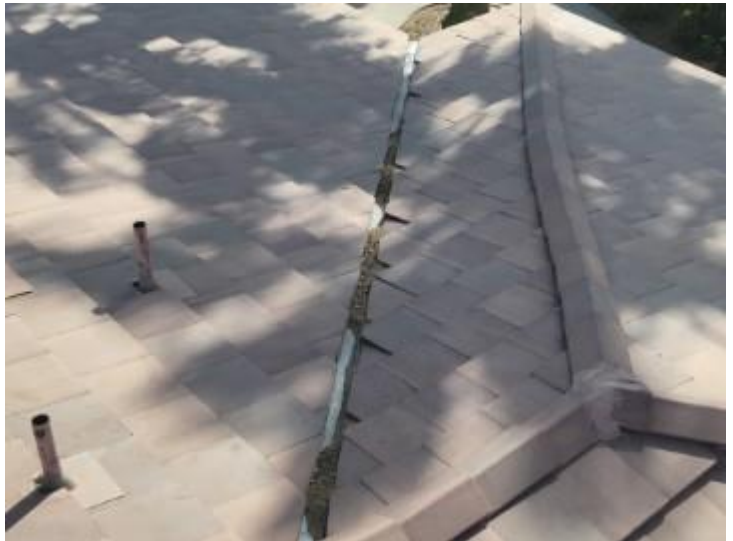
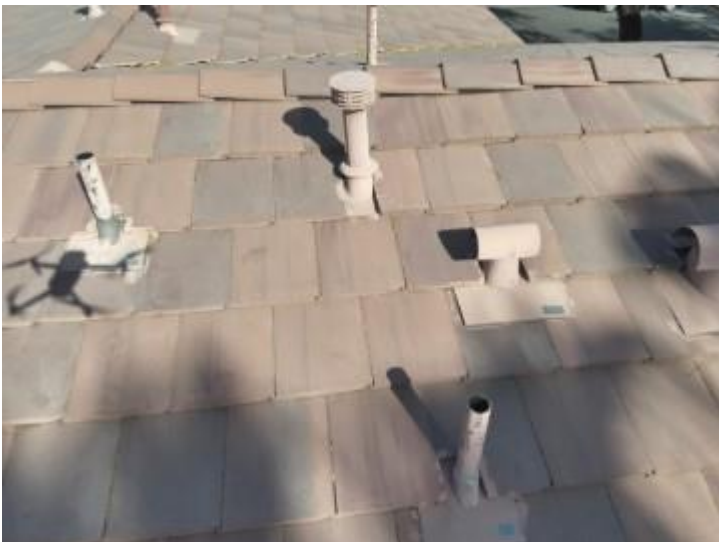
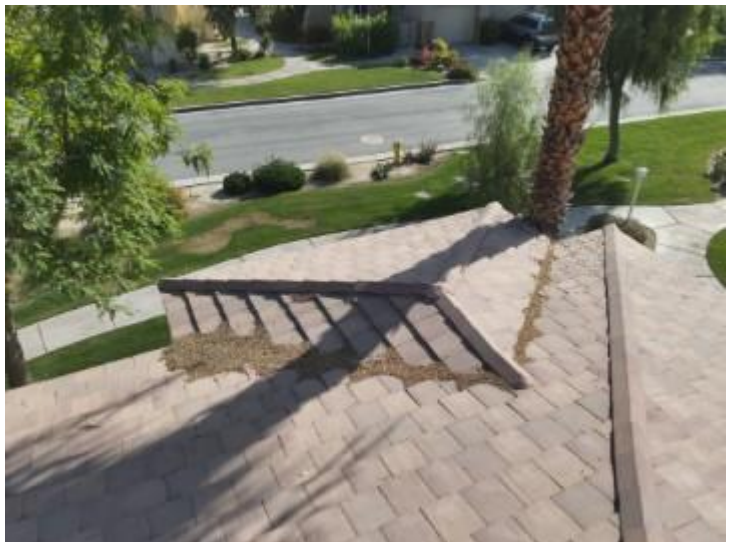
ITEM	Good	Fair	Poor	N/A	COMMENTS
A - Perimeter details		X			
B - Drainage		X			Some debris noted in the valleys.
C - Penetration flashings		X			
D - Overall Tile condition		X			Some isolated chipped tiles noted. Some cracking noted at mortar.
E - Wall/Curb flashings				X	
F - Insulation				X	
G - Other				X

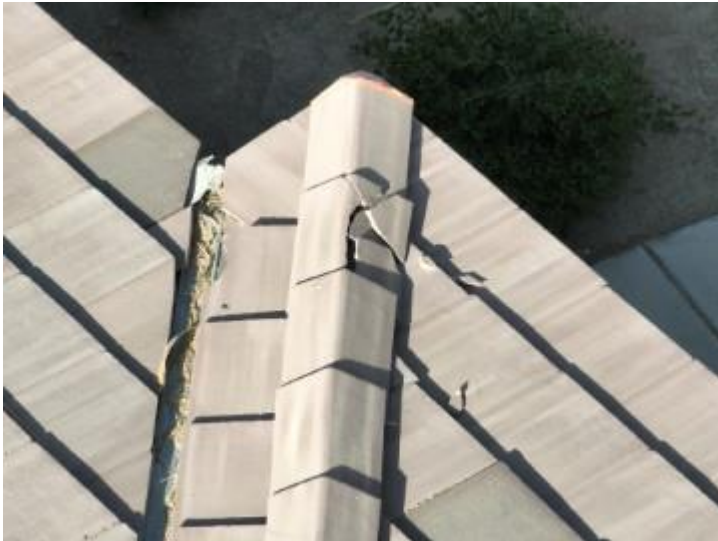
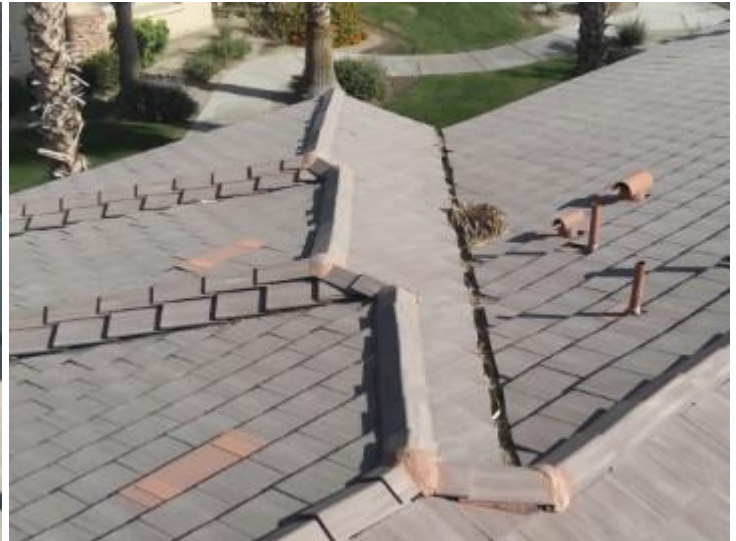
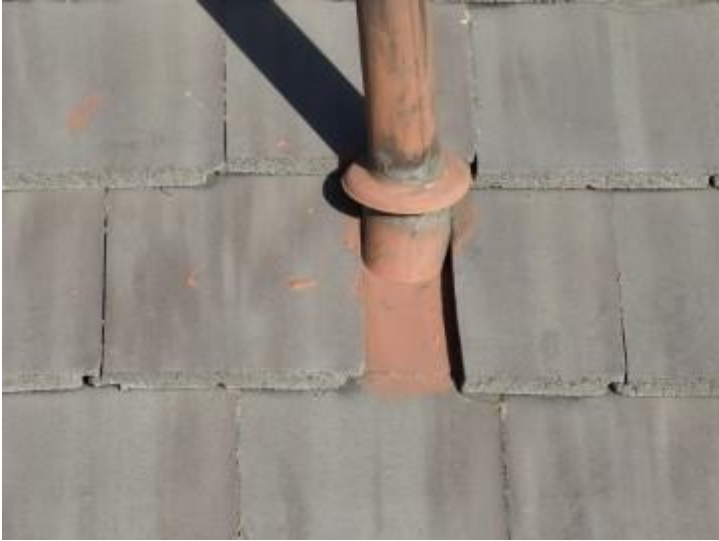
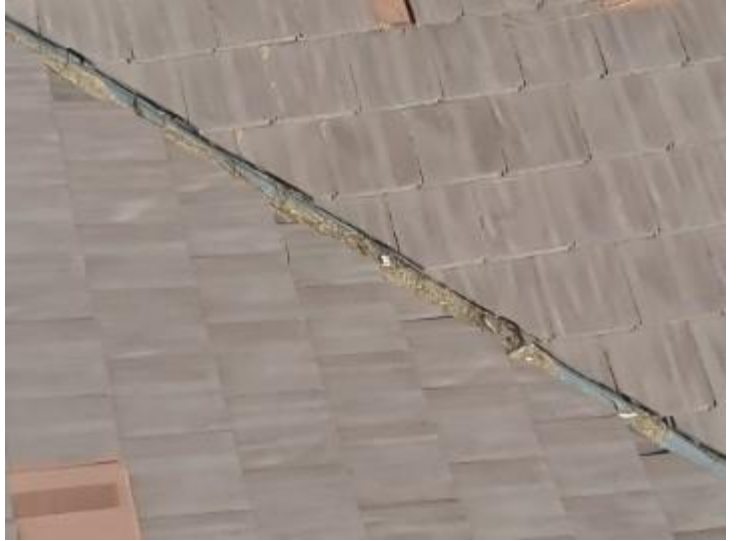
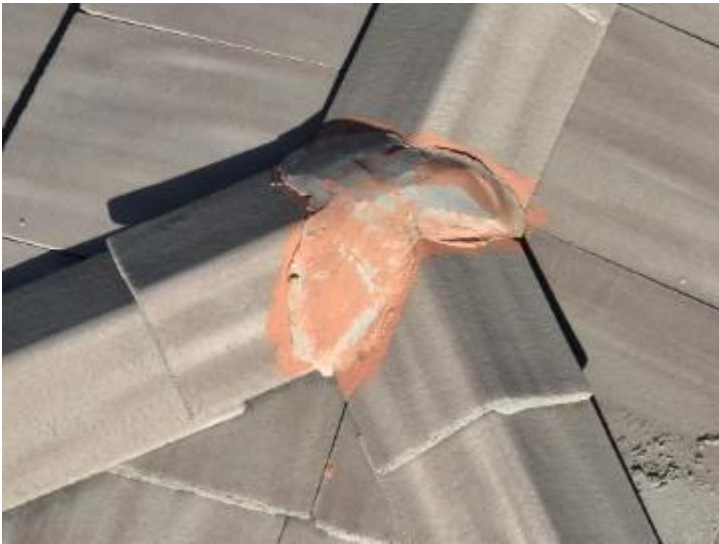
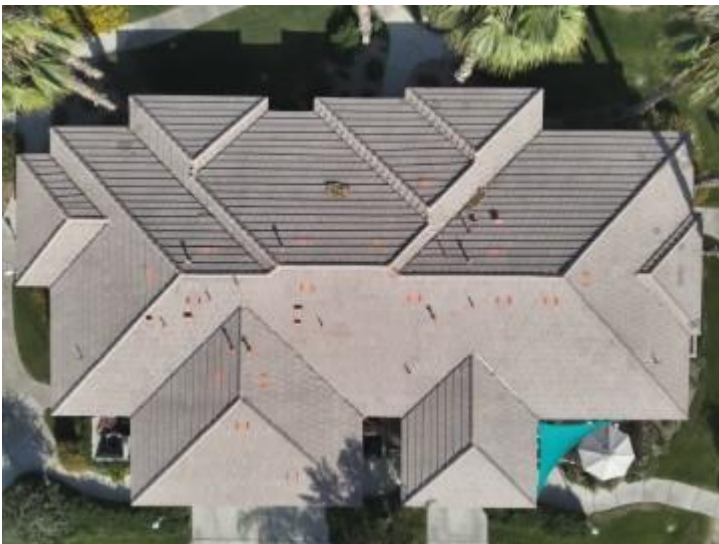
Building 42 -

ITEM	Good	Fair	Poor	N/A	COMMENTS
A - Perimeter details		X			
B - Drainage		X			Some debris noted in the valleys.
C - Penetration flashings		X			
D - Overall Tile condition		X			Some isolated cracked/broken tiles noted. Some isolated chipped tiles noted. Some cracking noted at mortar.
E - Wall/Curb flashings				X	
F - Insulation				X	
G - Other				X

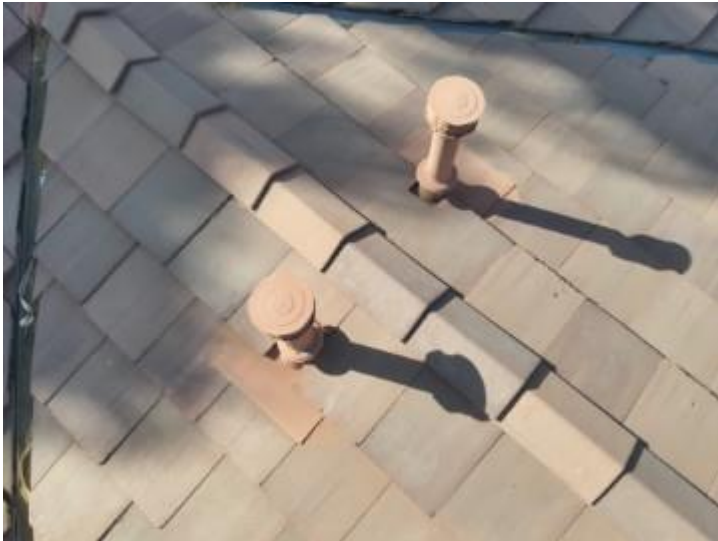
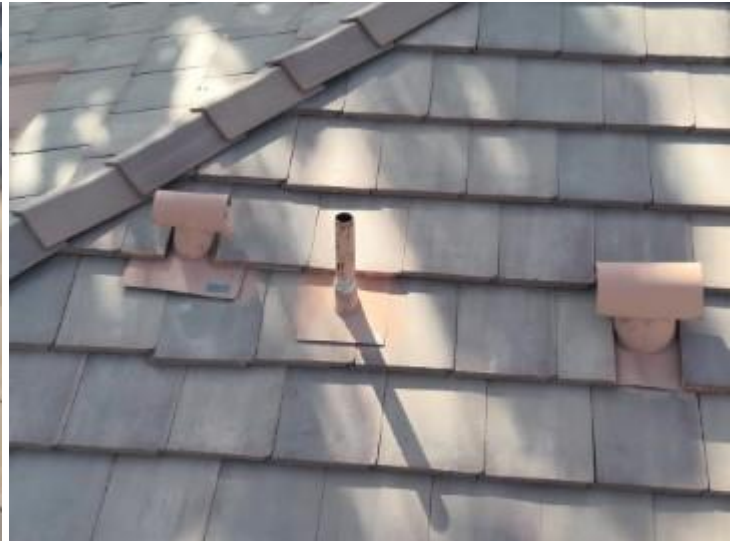
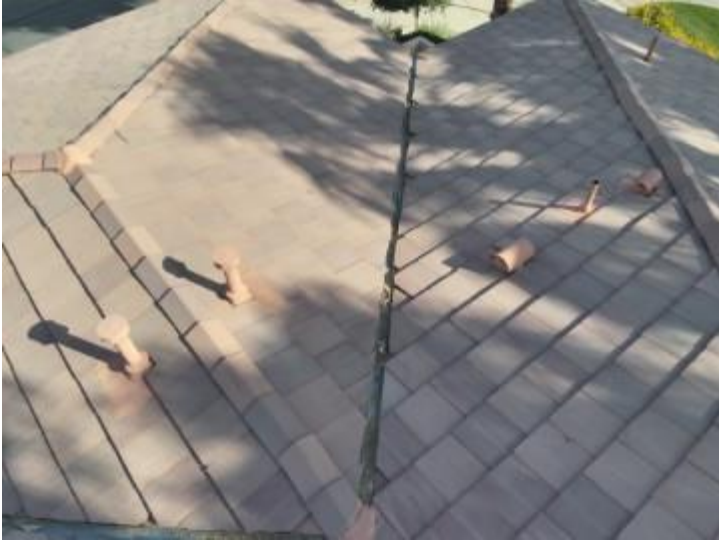
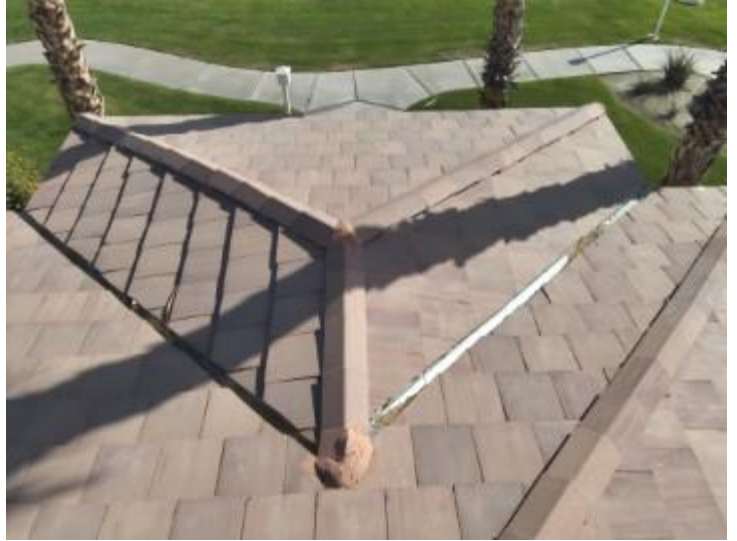
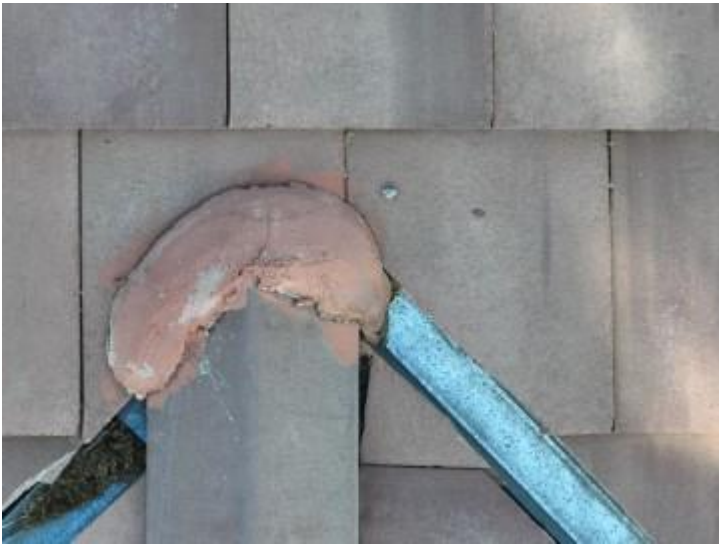
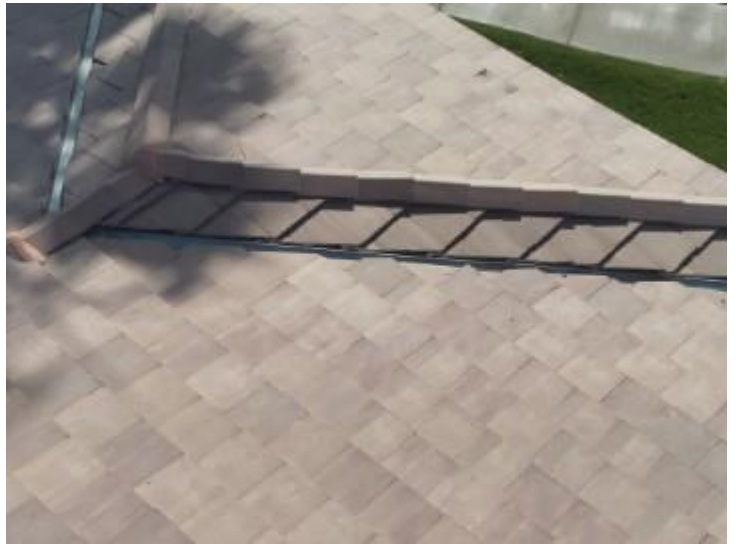
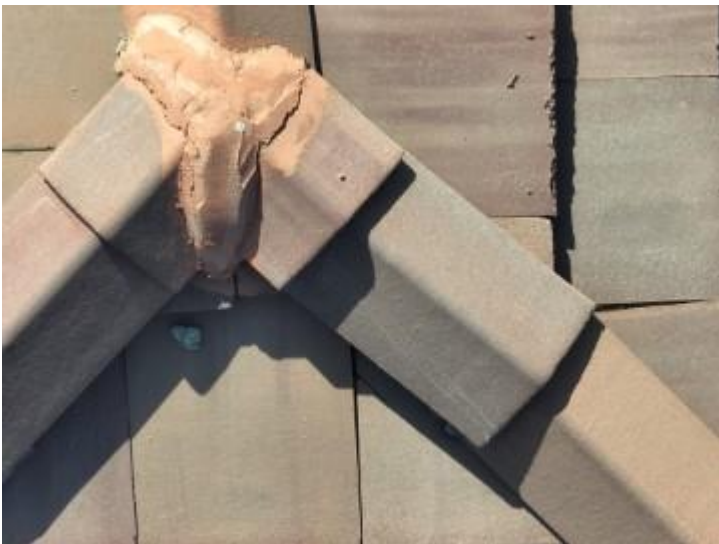
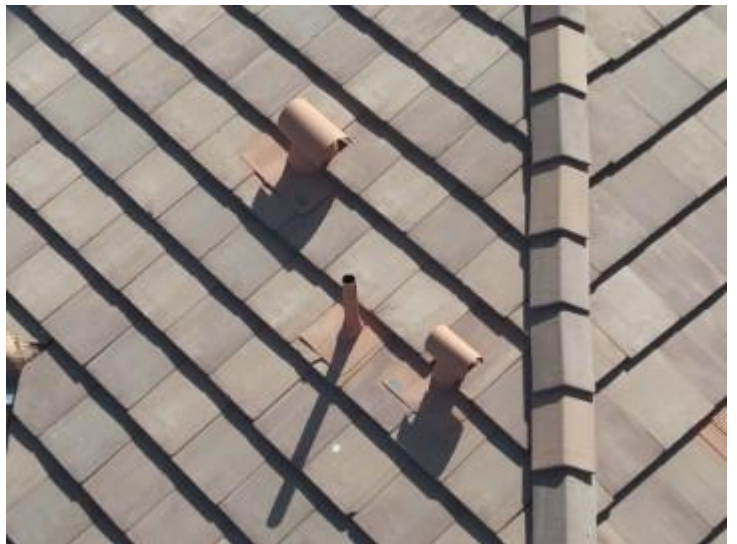
Building 43 -

ITEM	Good	Fair	Poor	N/A	COMMENTS
A - Perimeter details		X			
B - Drainage		X			Some debris noted in the valleys.
C - Penetration flashings		X			
D - Overall Tile condition		X			Some cracking noted at mortar.
E - Wall/Curb flashings		X\		X	
F - Insulation				X	
G - Other				X

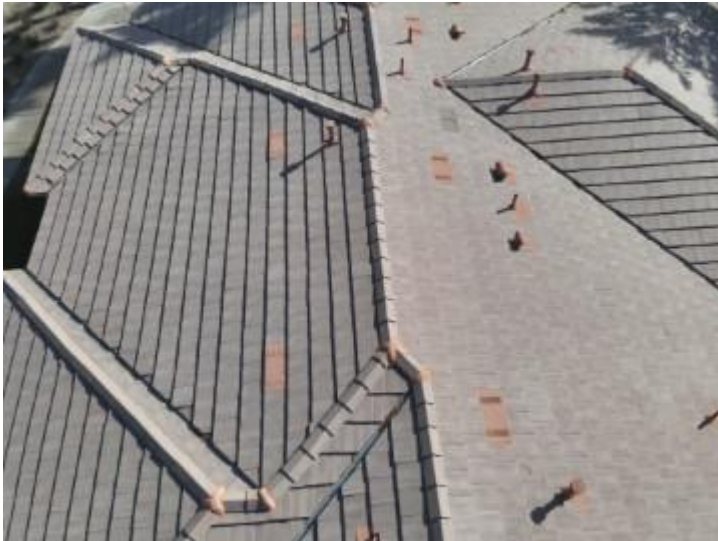
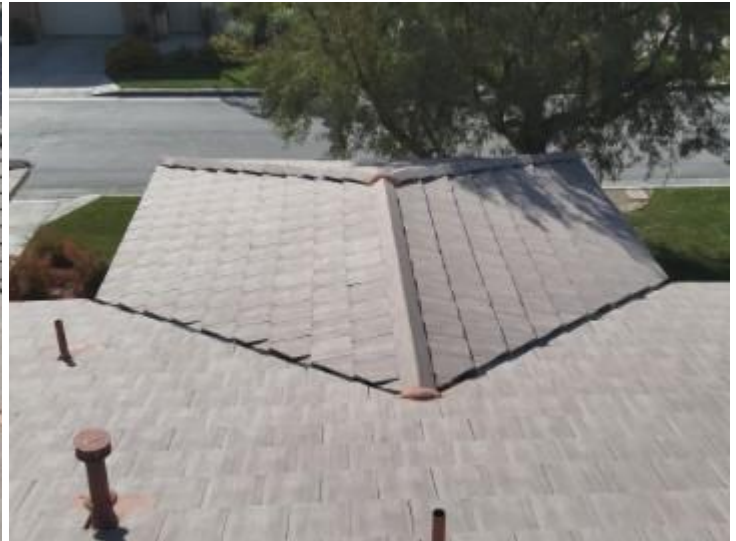
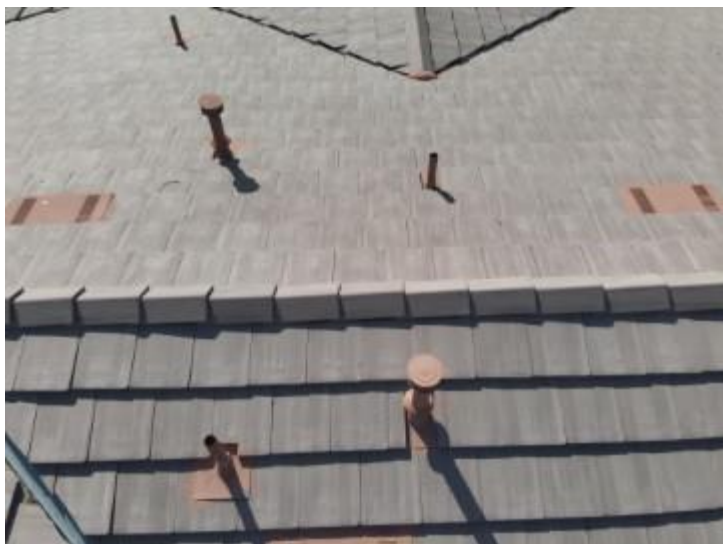
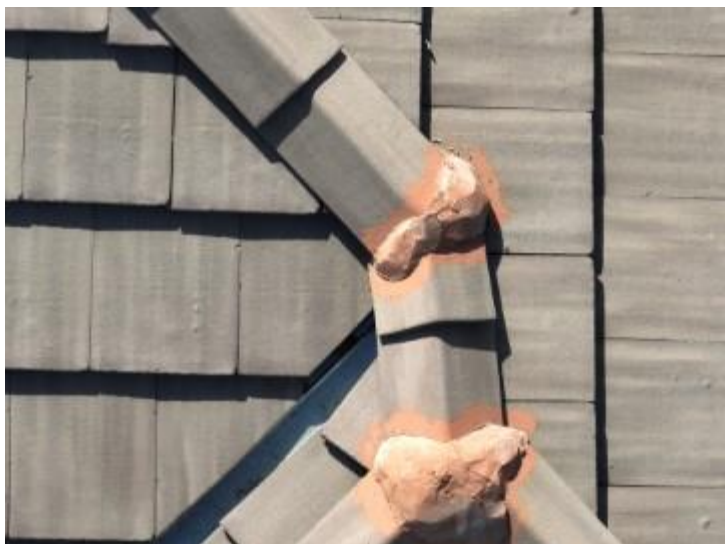
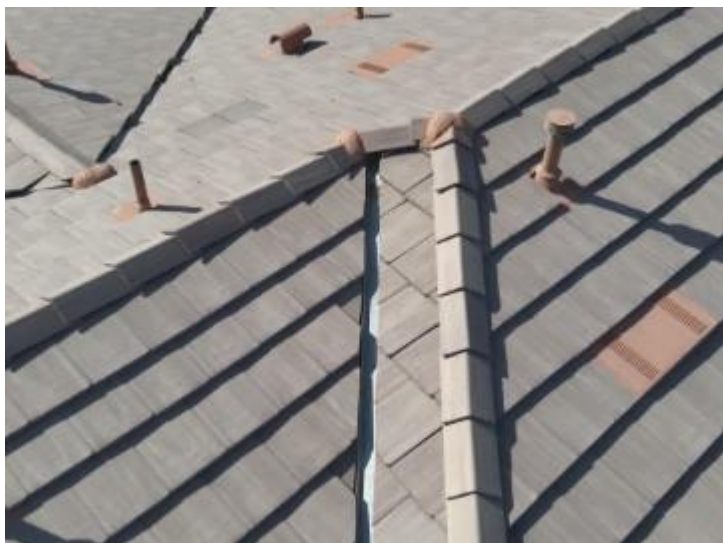
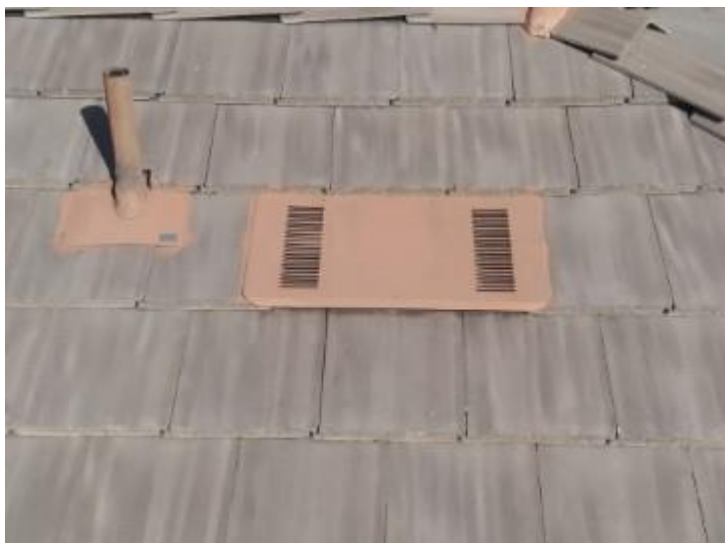
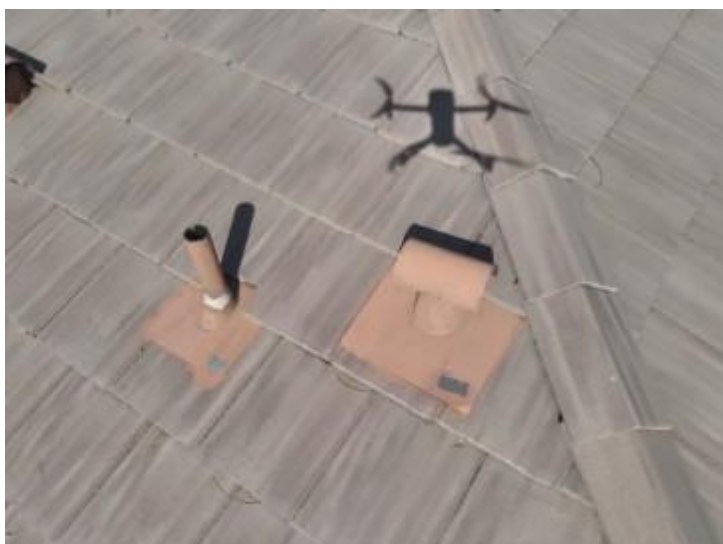
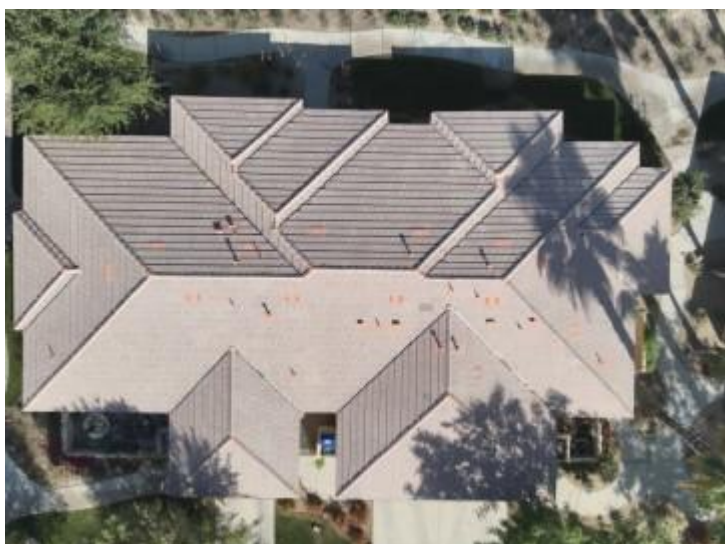
Building 44 -

ITEM	Good	Fair	Poor	N/A	COMMENTS
A - Perimeter details		X			
B - Drainage		X			Some debris noted in the valleys.
C - Penetration flashings		X			
D - Overall Tile condition		X			Some cracking noted at mortar.
E - Wall/Curb flashings				X	
F - Insulation				X	
G - Other				X

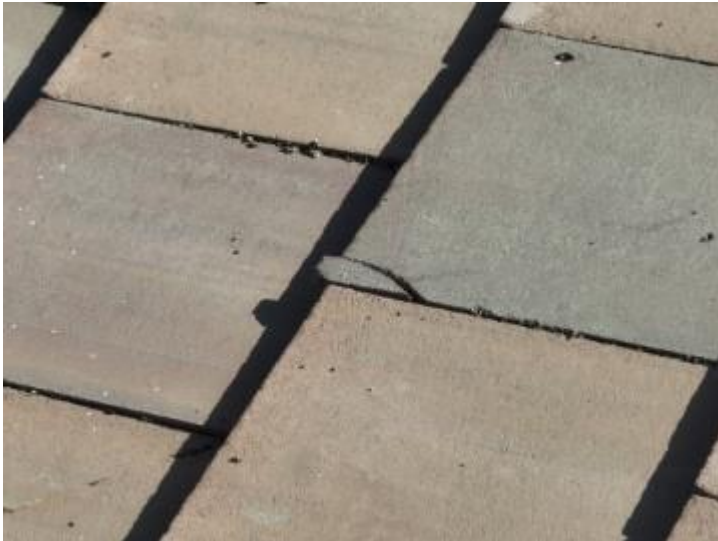
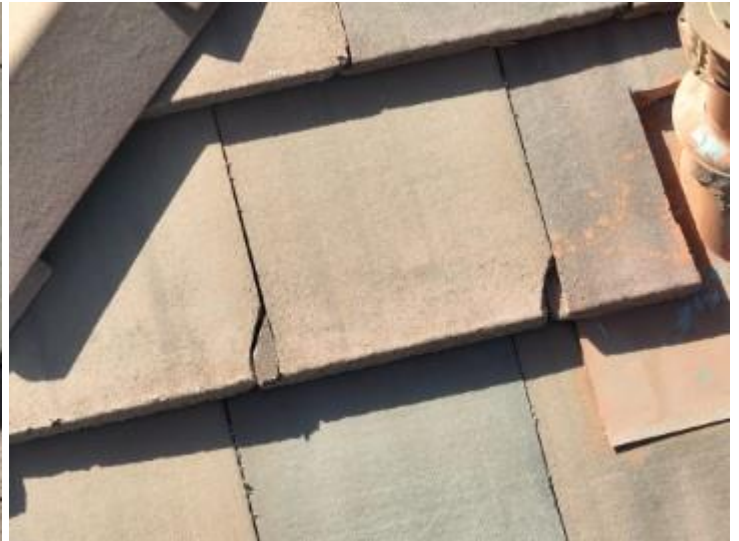
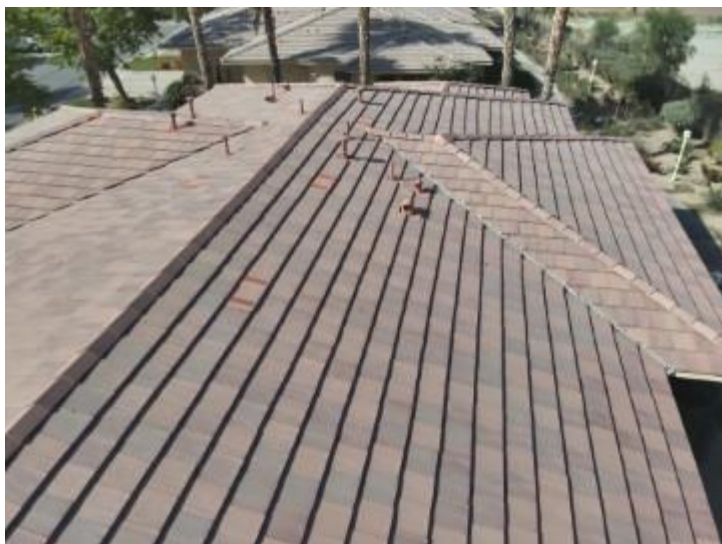
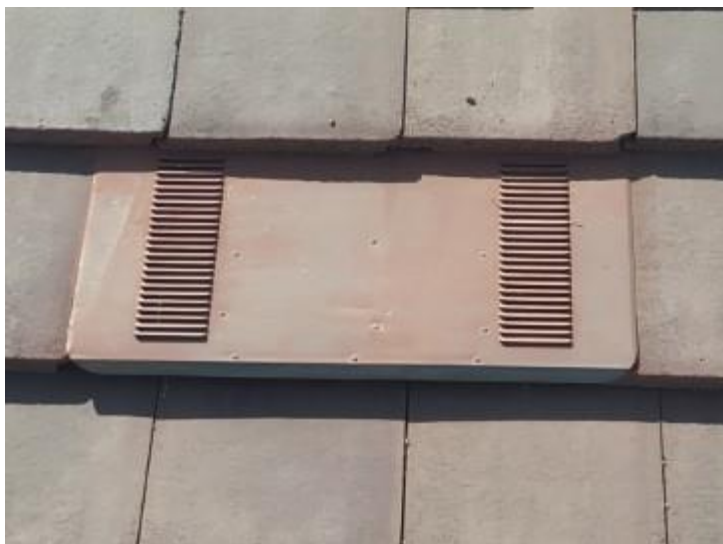
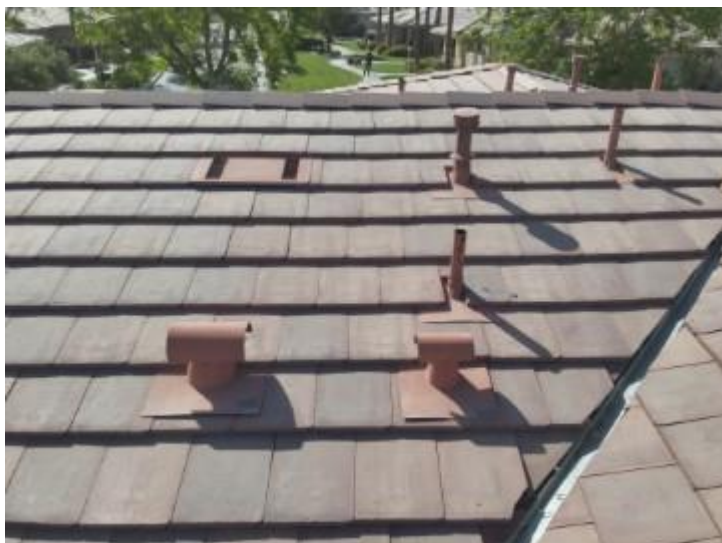
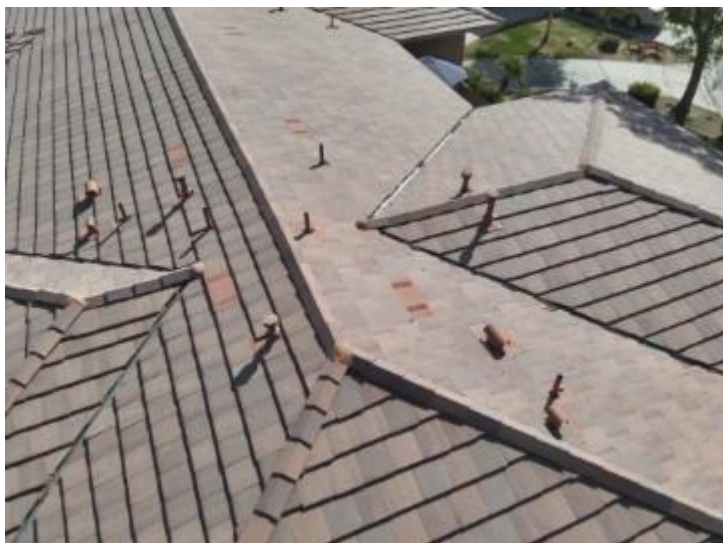
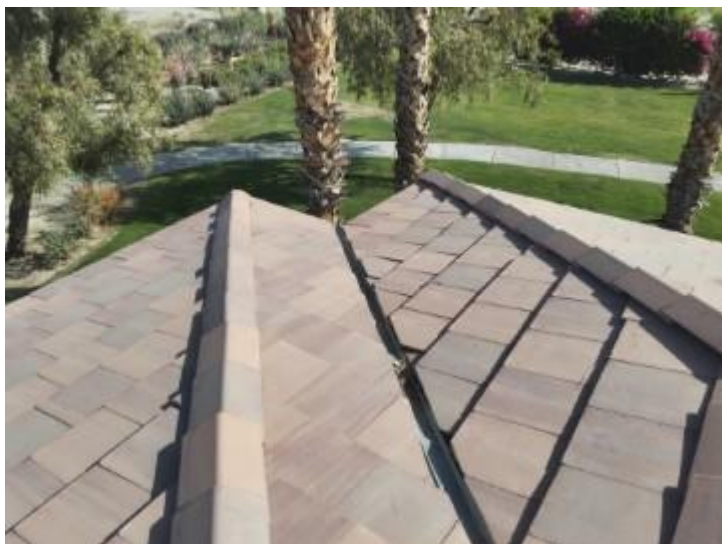
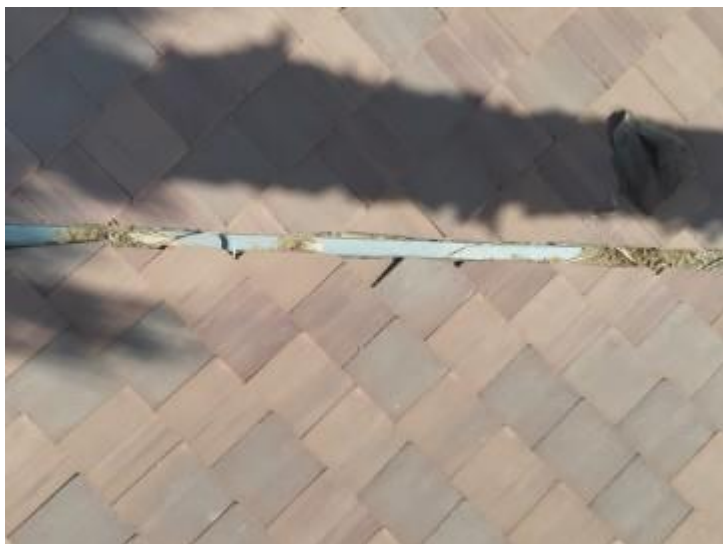
Building 45 -

ITEM	Good	Fair	Poor	N/A	COMMENTS
A - Perimeter details		X			
B - Drainage		X			Some debris noted in the valleys.
C - Penetration flashings		X			
D - Overall Tile condition		X			Some isolated chipped tiles noted. Some cracking noted at mortar.
E - Wall/Curb flashings				X	
F - Insulation				X	
G - Other				X

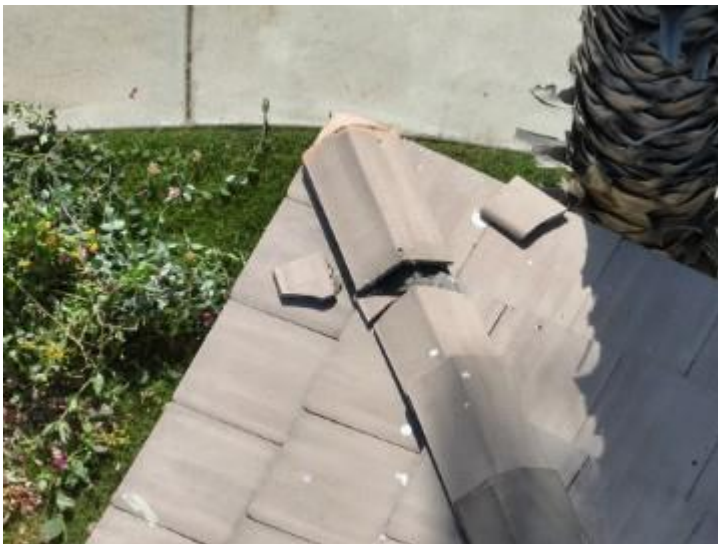
Building 46 -

ITEM	Good	Fair	Poor	N/A	COMMENTS
A - Perimeter details		X			
B - Drainage		X			Some debris noted in the valleys.
C - Penetration flashings		X			
D - Overall Tile condition		X			Some isolated cracked/broken tiles noted. Some isolated chipped tiled noted. Some cracking noted at mortar.
E - Wall/Curb flashings				X	
F - Insulation				X	
G - Other				X

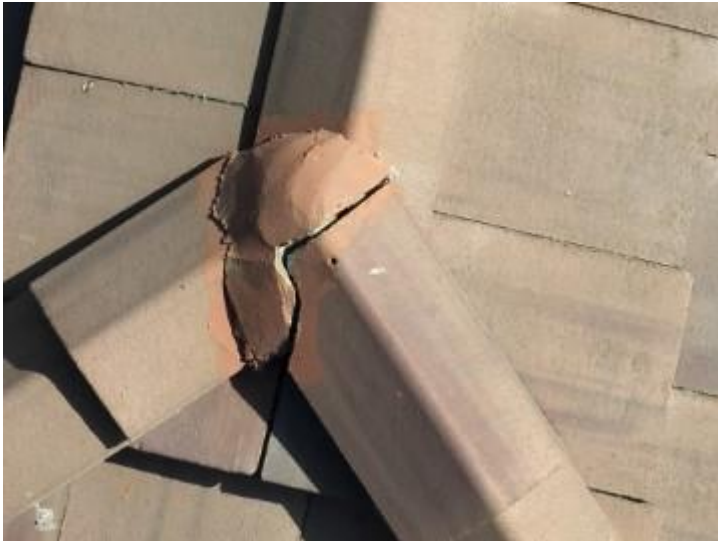
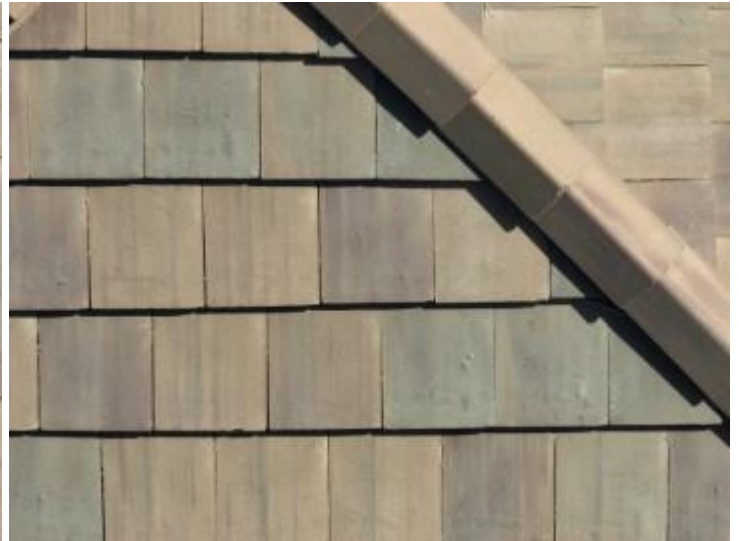
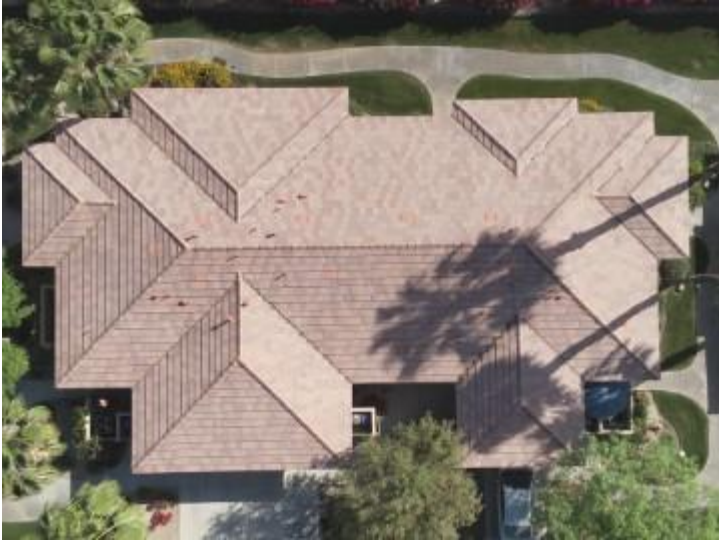
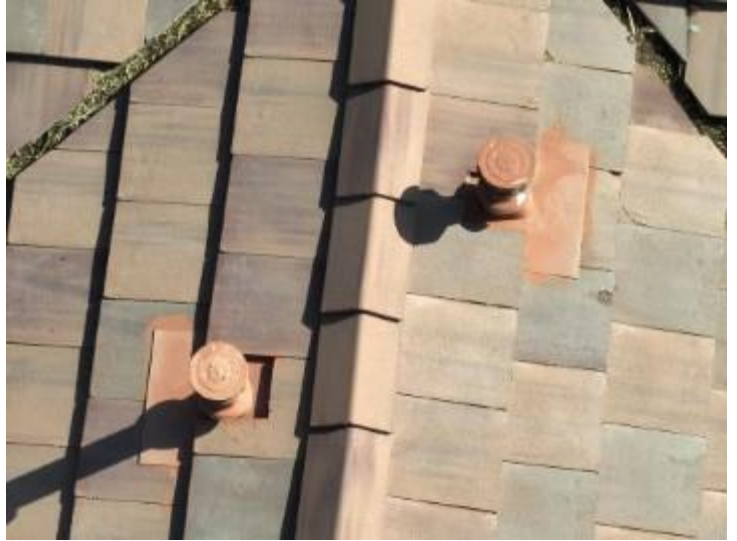
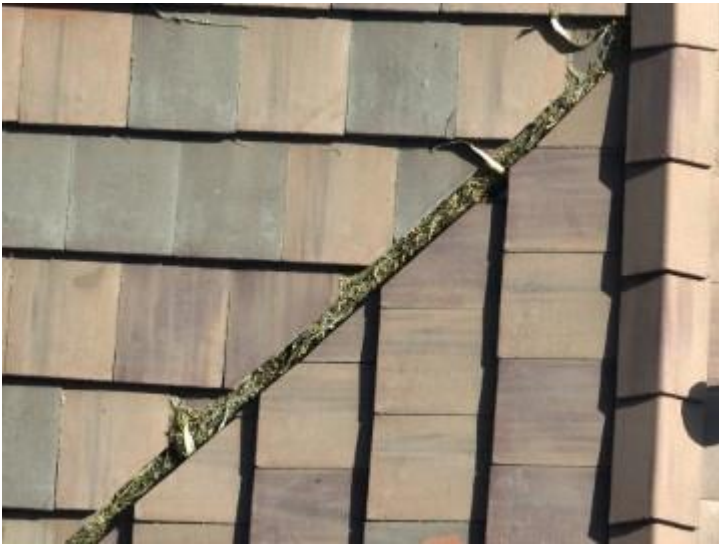
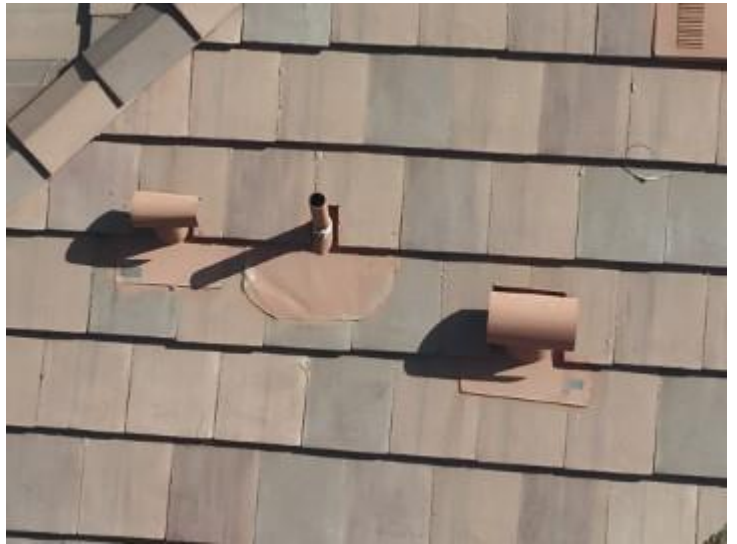
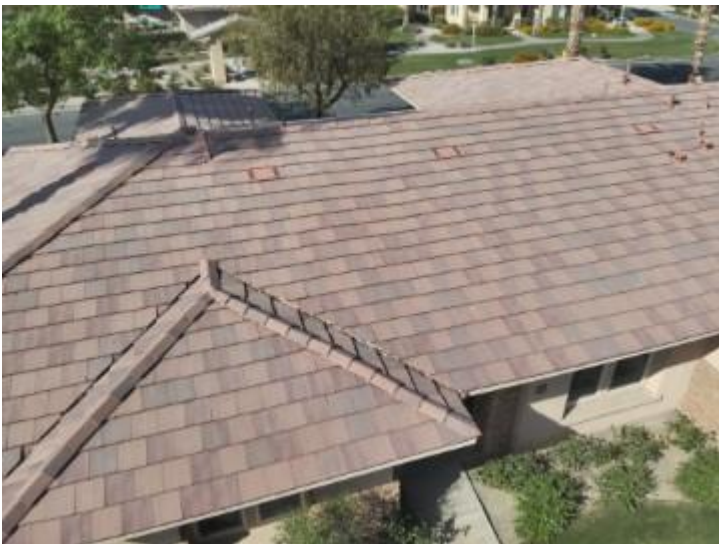
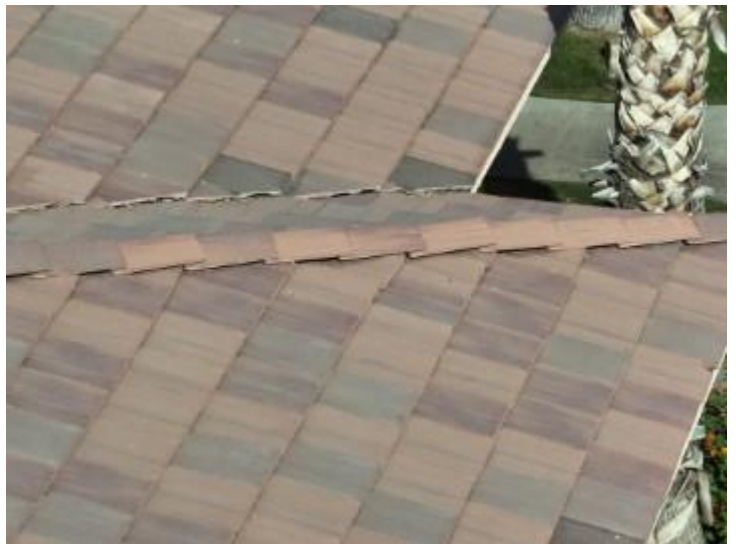
Building 47 -

ITEM	Good	Fair	Poor	N/A	COMMENTS
A - Perimeter details		X			
B - Drainage		X			Some debris noted in the valleys.
C - Penetration flashings		X			
D - Overall Tile condition		X			Some cracking noted at mortar.
E - Wall/Curb flashings				X	
F - Insulation				X	
G - Other				X

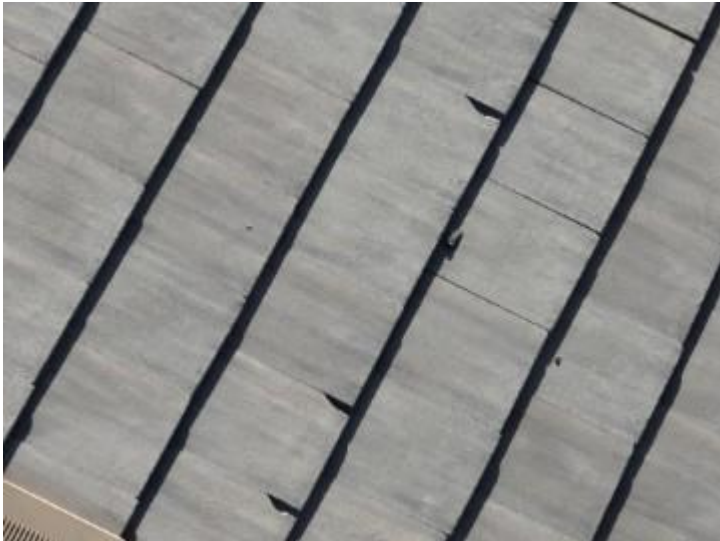
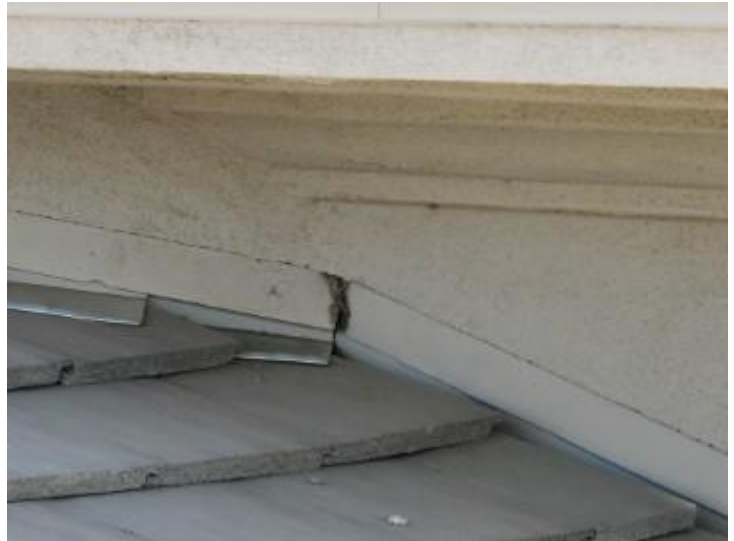
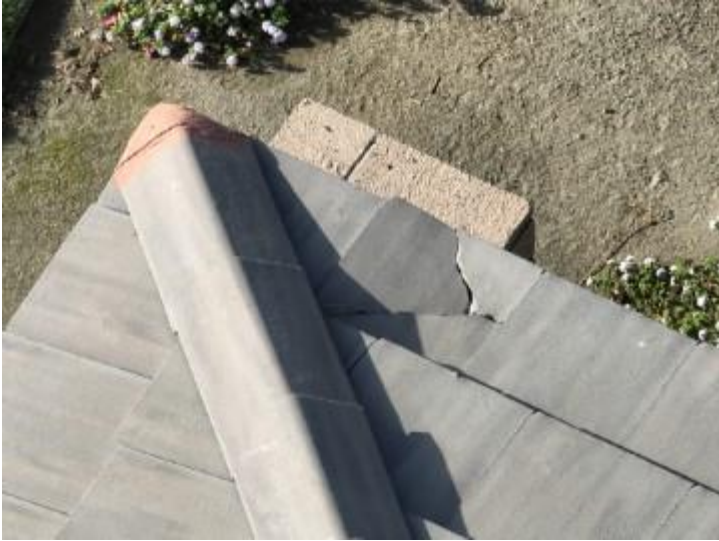
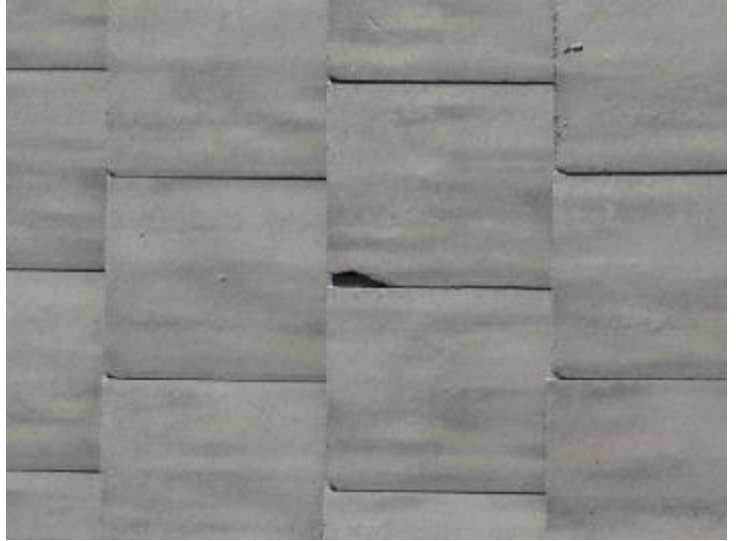
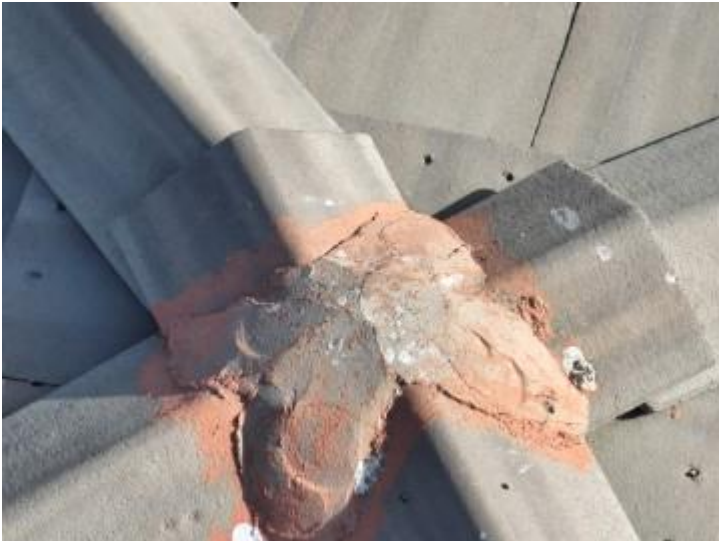
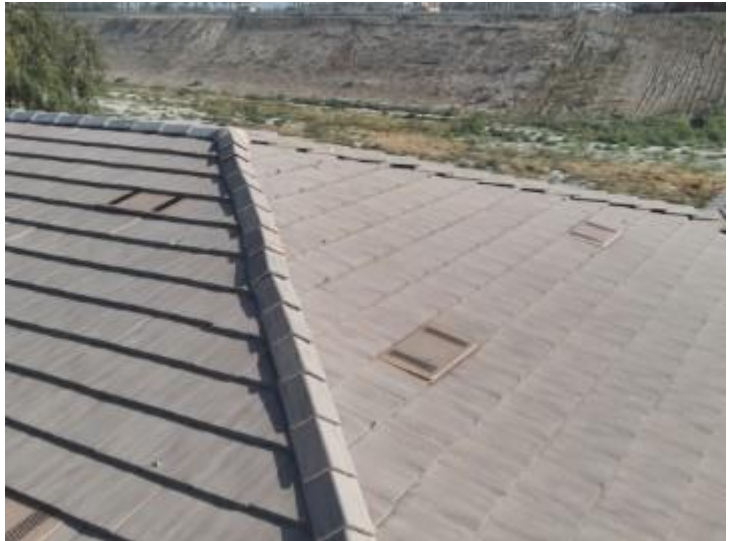
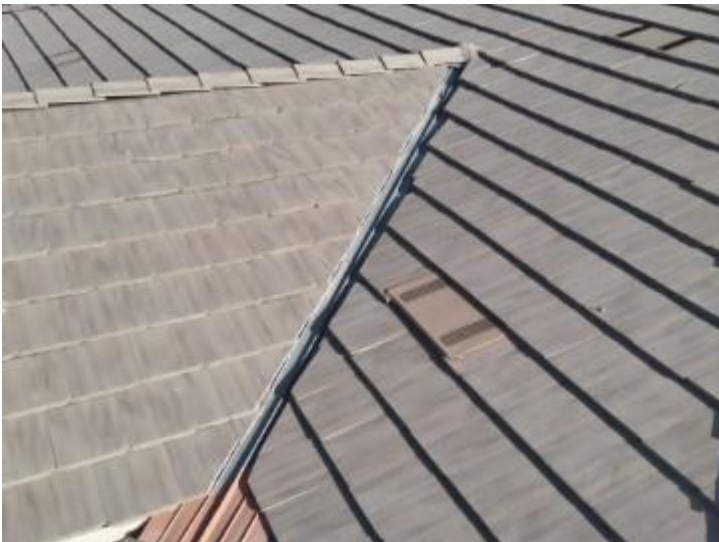
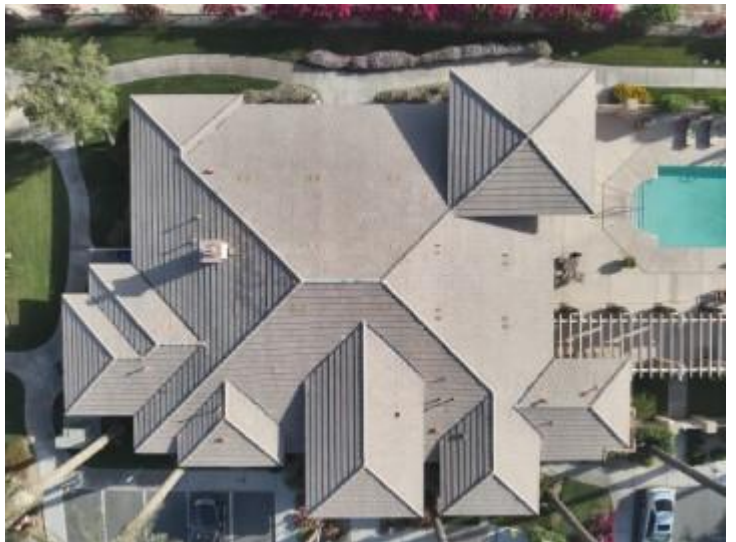
Building Community Center -

ITEM	Good	Fair	Poor	N/A	COMMENTS
A - Perimeter details		X			
B - Drainage		X			Some debris noted in the valleys.
C - Penetration flashings		X			
D - Overall Tile condition		X			Some isolated cracked tiles noted. Some isolated chipped tiles noted. Some cracking noted at mortar.
E - Wall/Curb flashings		X			Some possible rot noted at the wall trim.
F - Insulation				X	
G - Other				X
